**Storm Water Management and Erosion control**  
**Location Name: CAERUS PICEANCE LLC HMU 7-14 (N7SE) Pad**  
**Location #: 334291**

**Location Overview: Location is within High  
Priority/Density/NSO/Black Bear Habitat areas. Location is  
approximately 21 yards from a creek & drainage from location  
contributes to the creek.**

**Section/Township/Range: 7 8S92W**

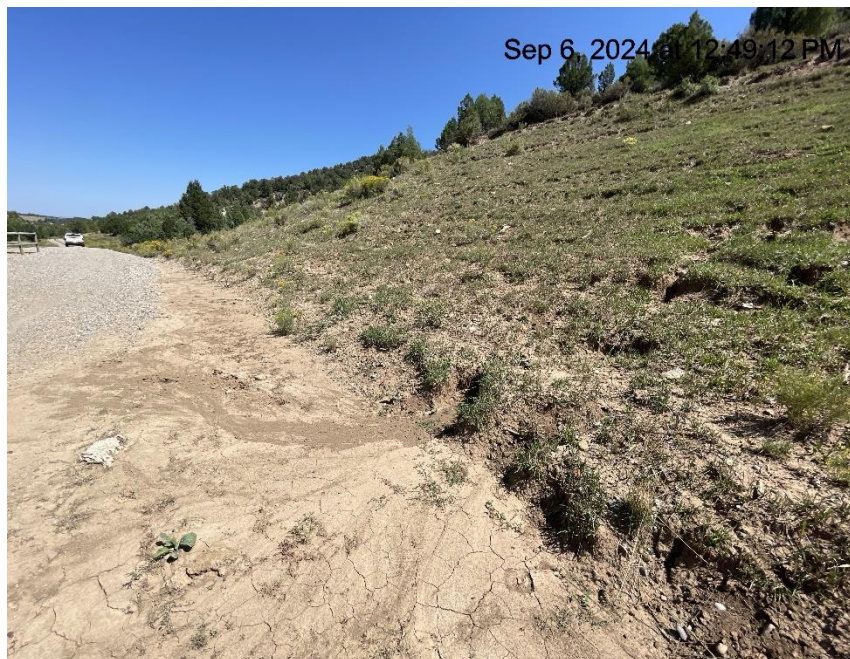
**Photo # 8726 Erosion on slope & transport of sediment onto location/insufficient BMP's (east side of location)**

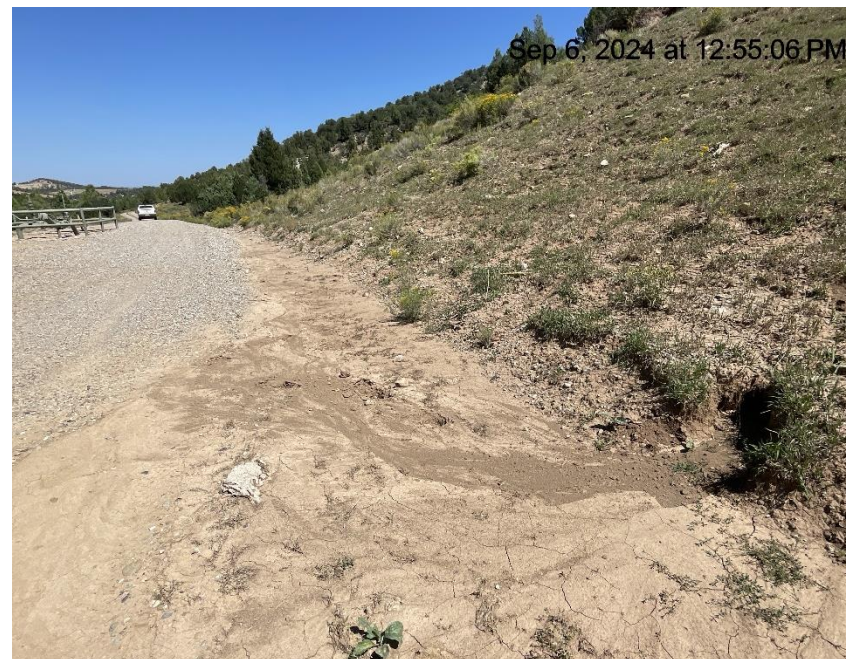
**Photo # 8727 Erosion on slope & transport of sediment onto location/insufficient BMP's (east side of location)**

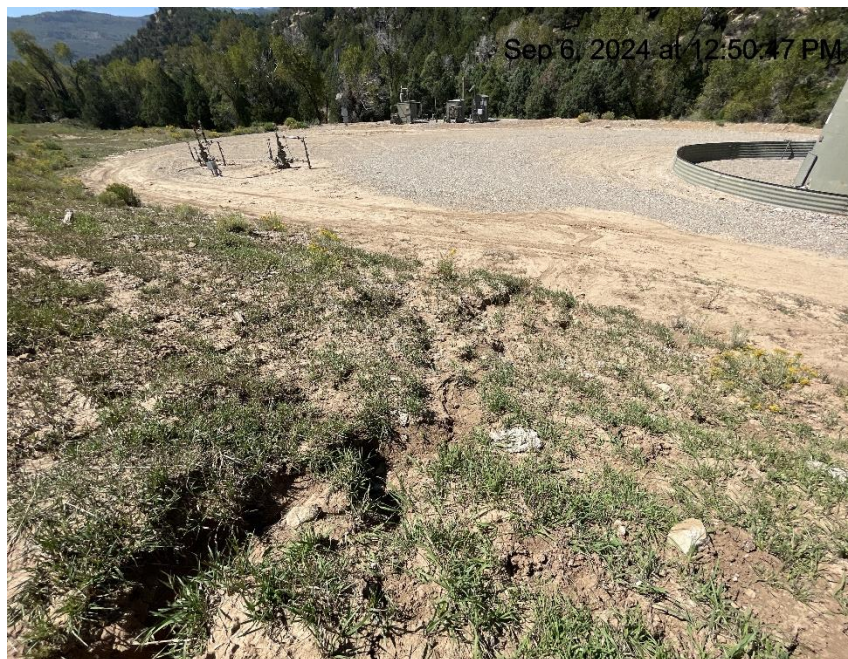
**Photo # 8728 Erosion on slope & transport of sediment onto location/insufficient BMP's (east side of location)**

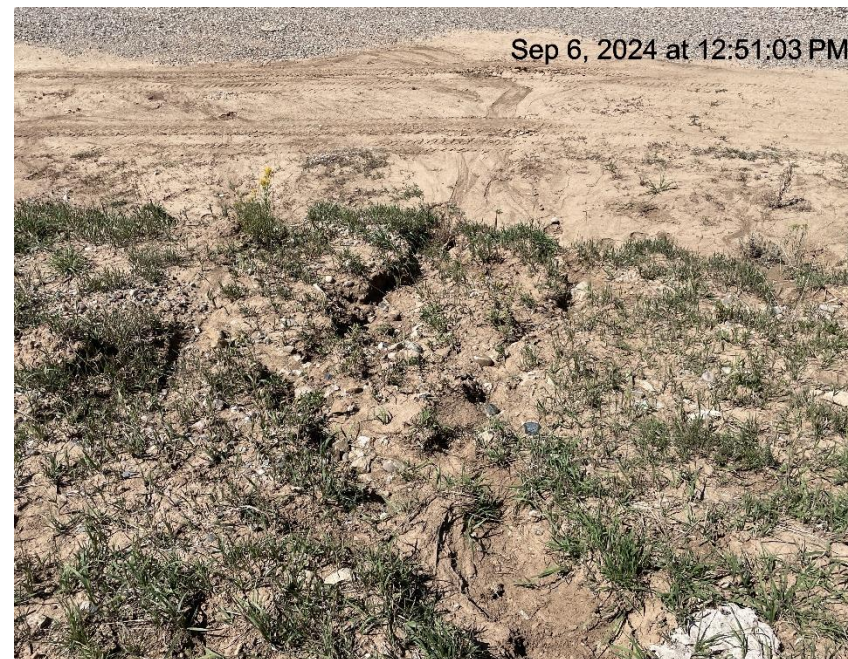
**Photo # 8729 Erosion on slope & transport of sediment onto location/insufficient BMP's (east side of location)**

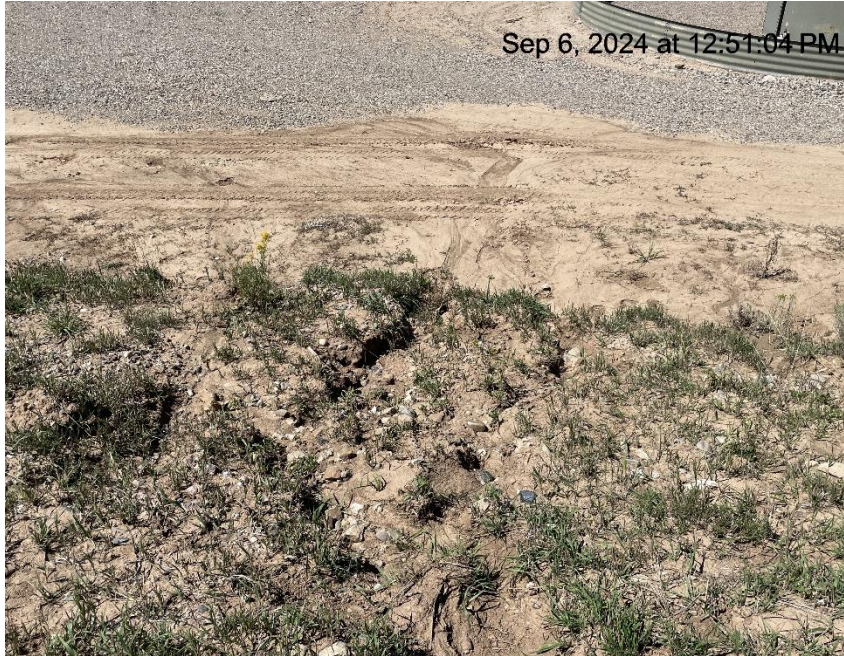
**Photo # 8730 Erosion on slope & transport of sediment onto location/insufficient BMP's (east side of location)**

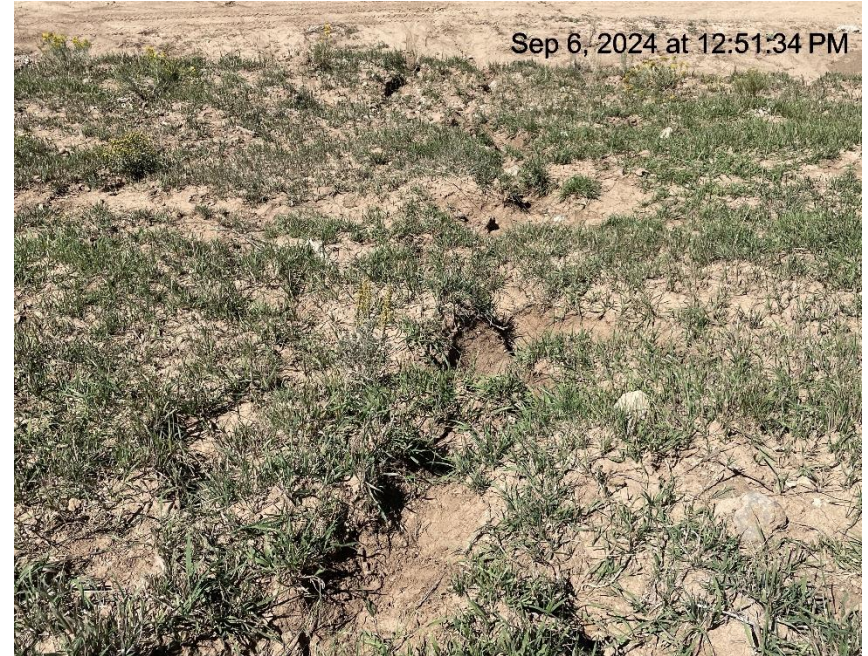
**Photo # 8731 Erosion on slope & transport of sediment onto location/insufficient BMP's (east side of location)**

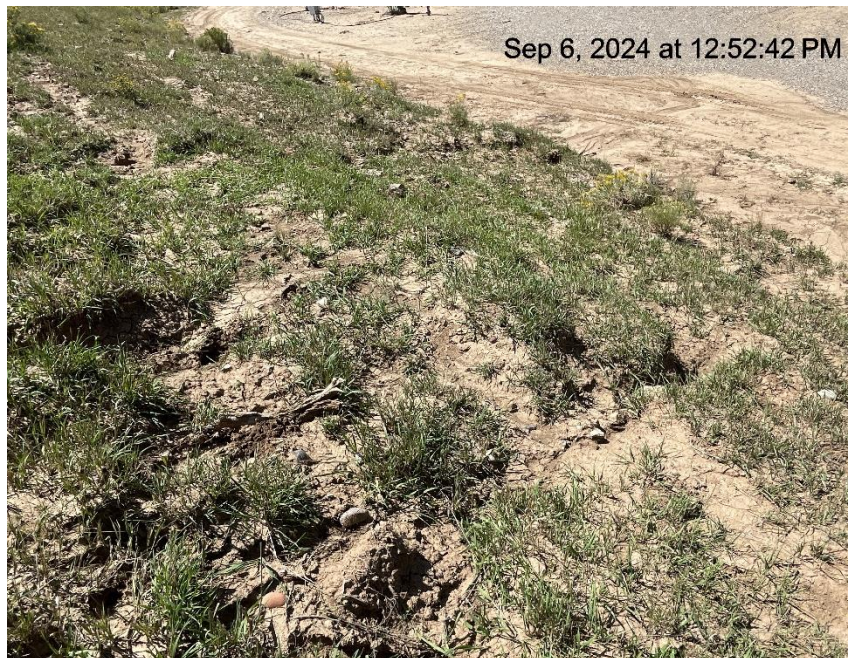
**Photo # 8732 Erosion on slope & transport of sediment onto location/insufficient BMP's (east side of location)**

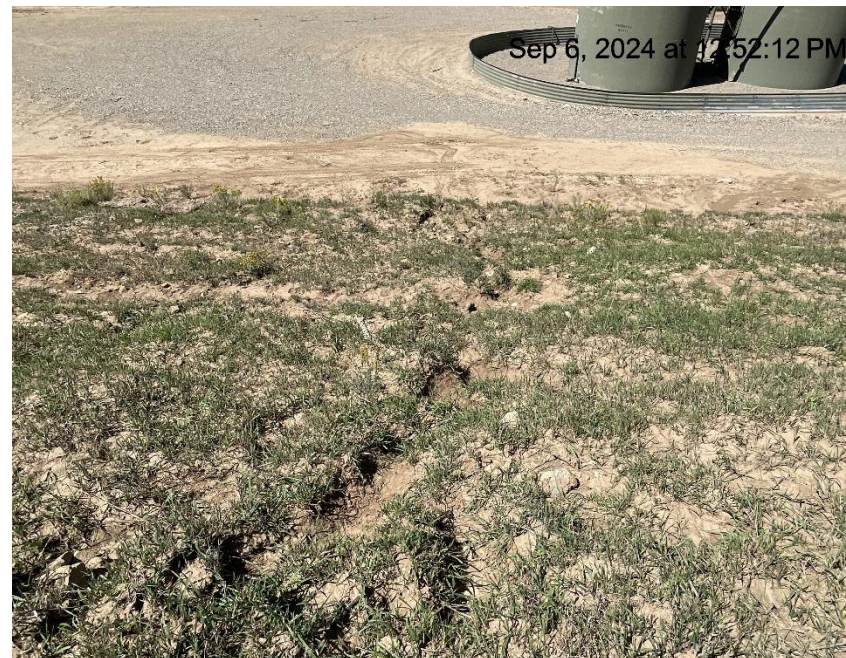
**Photo # 8733 Erosion on slope & transport of sediment onto location/insufficient BMP's (east side of location)**

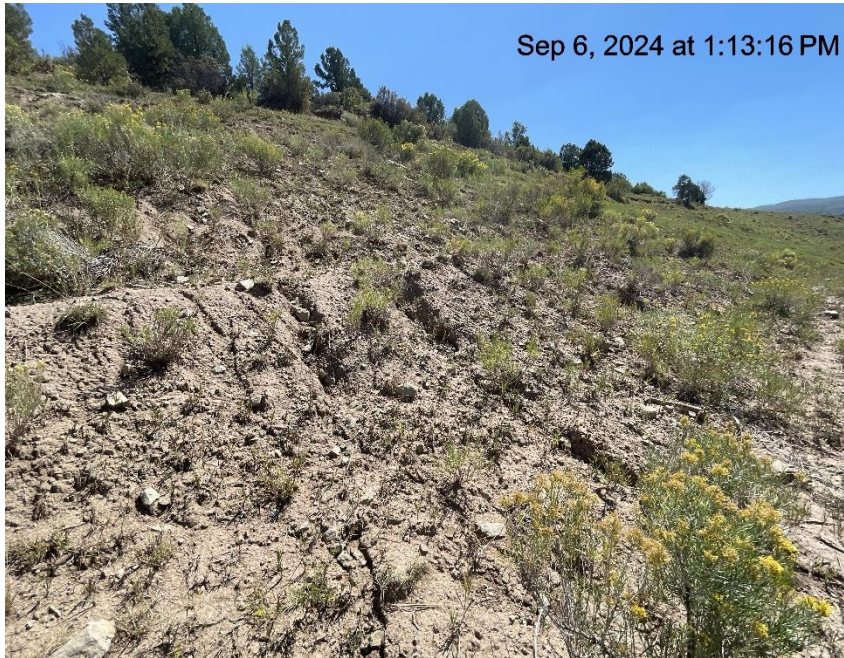
**Photo # 8734 Erosion on slope & transport of sediment  
/insufficient BMP's (E/NE area of location)**

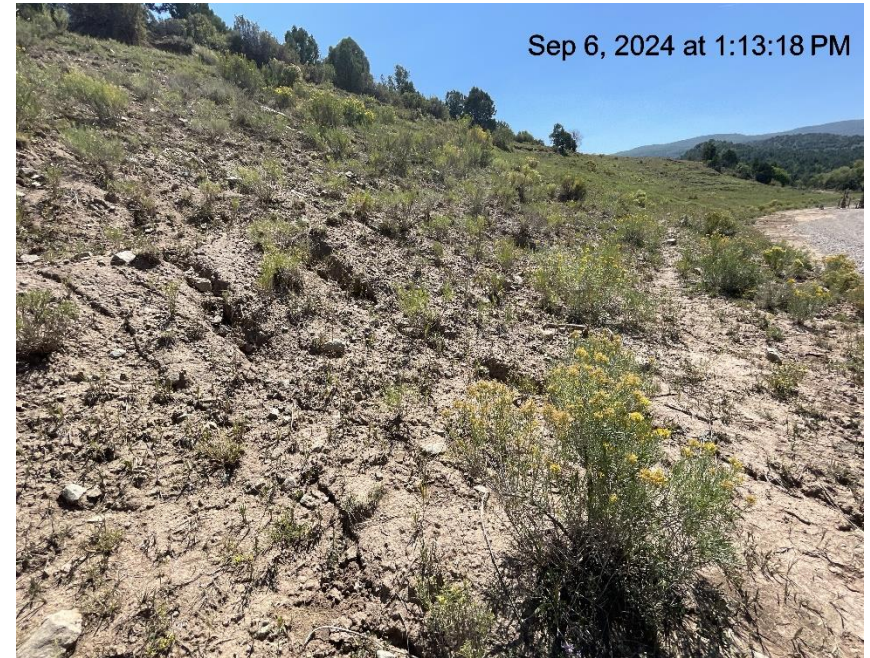
**Photo # 8735 Erosion on slope & transport of sediment  
/insufficient BMP's (E/NE area of location)**

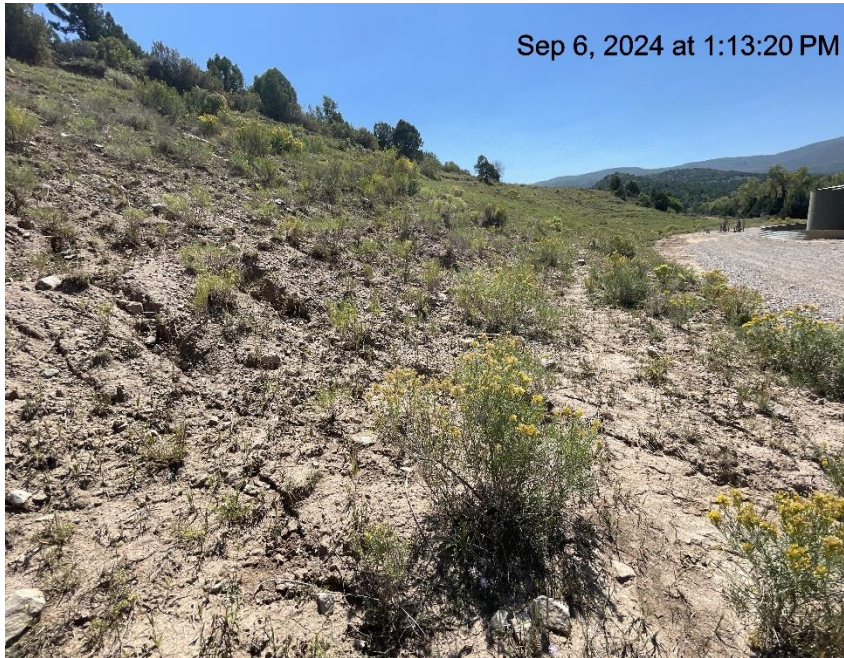
**Photo # 8736 Erosion on slope & transport of sediment /insufficient BMP's (E/NE area of location)**

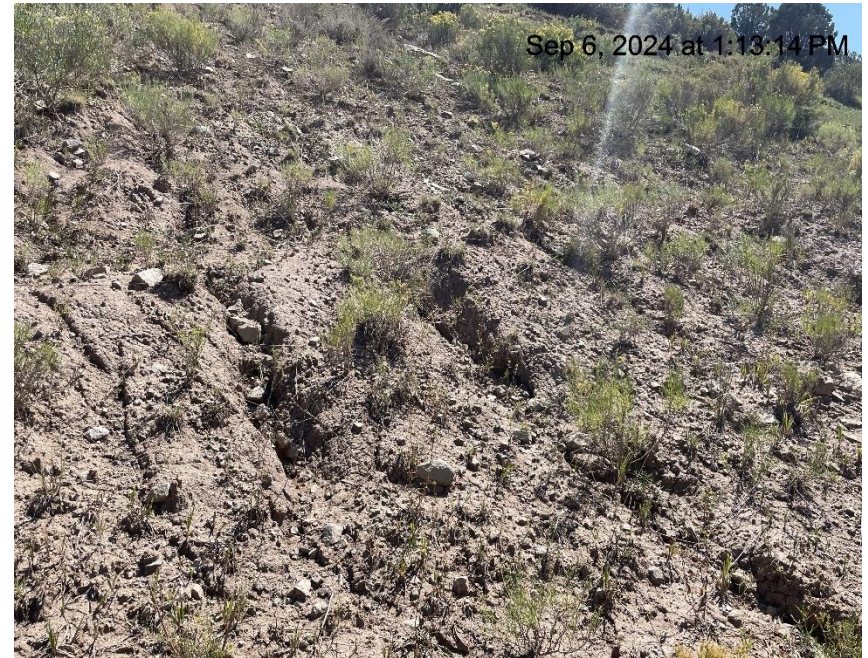
**Photo # 8737 Erosion on slope & transport of sediment /insufficient BMP's (E/NE area of location)**

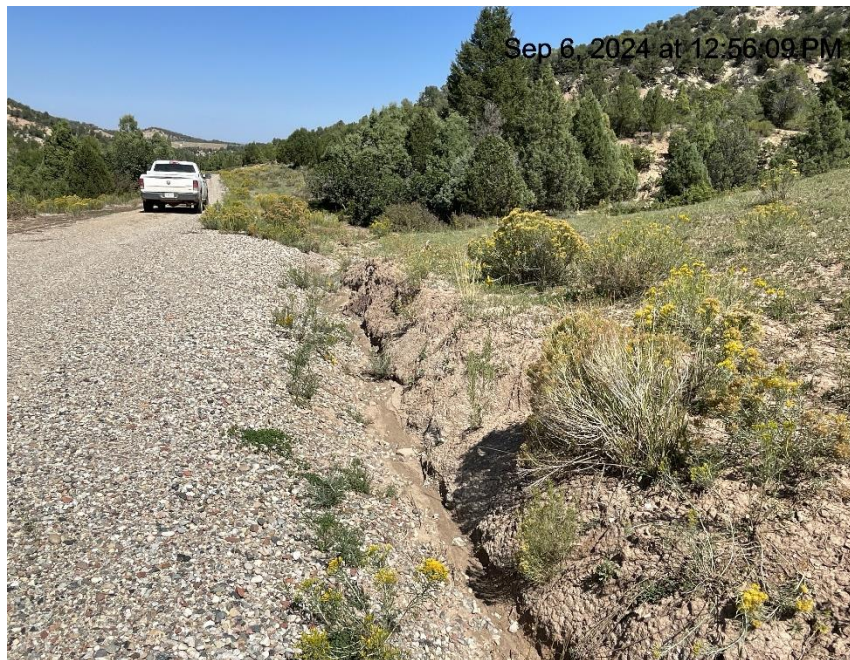
**Photo # 8738 Insufficient BMP's/runoff controls in ditch  
(E/NE area of location near entrance to location)**

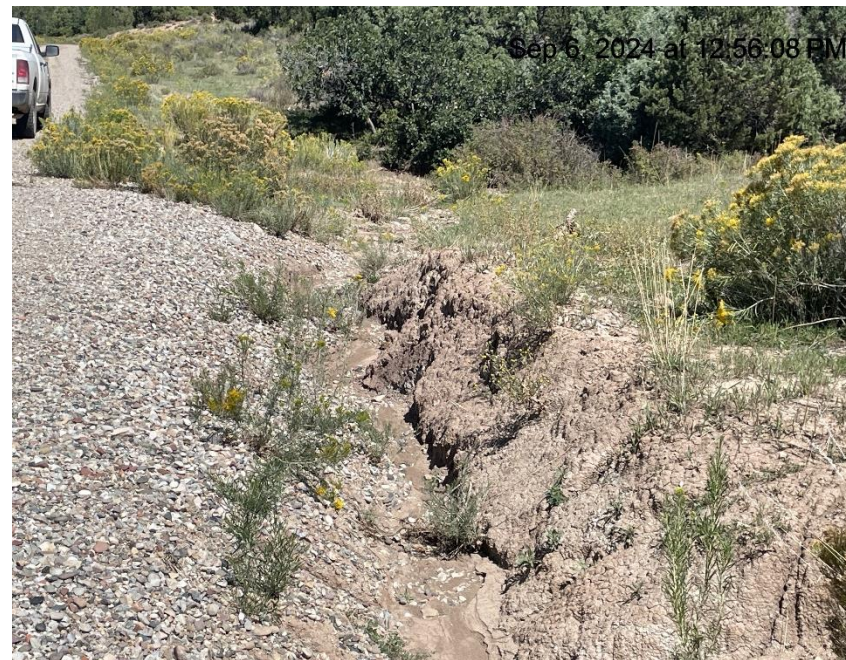
**Photo # 8739 Insufficient BMP's/runoff controls in ditch  
(E/NE area of location near entrance to location)**

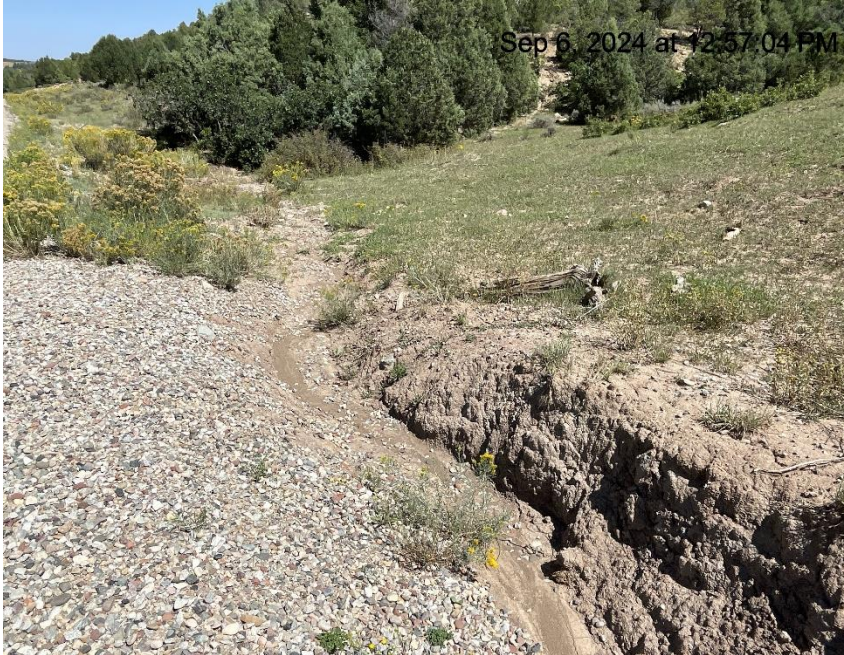
**Photo # 8740 Insufficient BMP's/runoff controls in ditch, sediment is being carried off location & into a vegetated area & towards a nearby creek/drainage (NE area of location near entrance to location)**

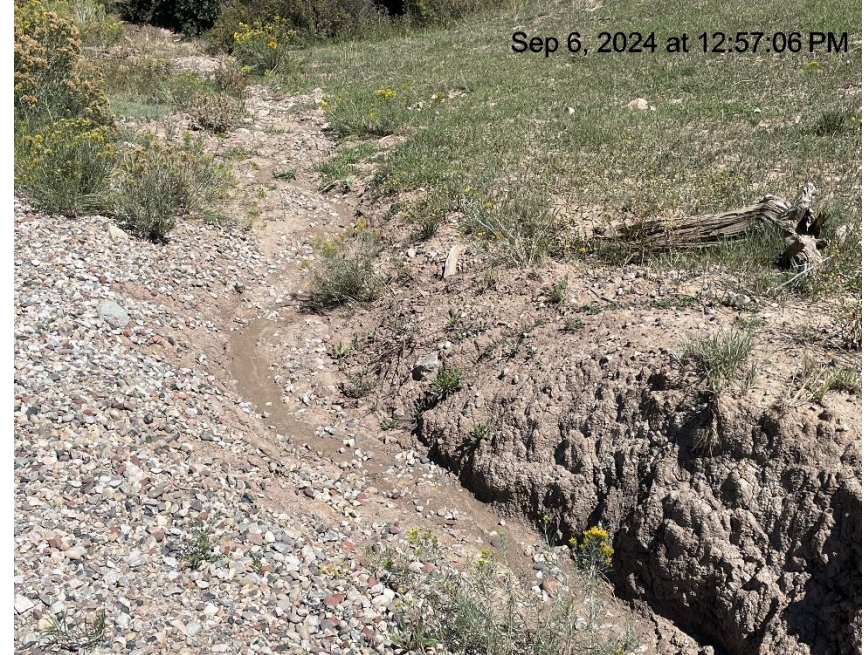
**Photo # 8741 Insufficient BMP's/runoff controls in ditch, sediment is being carried off location & into a vegetated area & towards a nearby creek/drainage (NE area of location near entrance to location)**

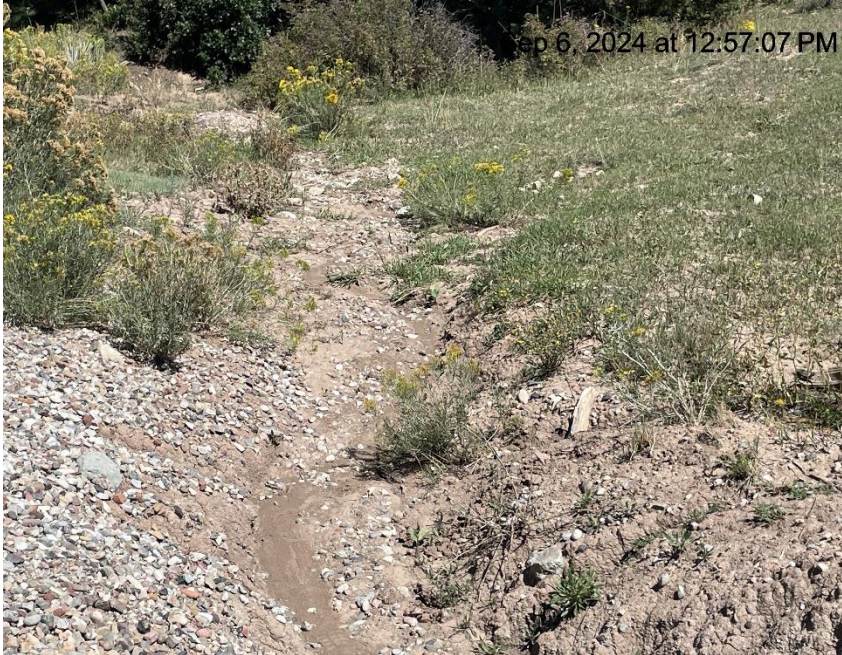
**Photo # 8742 Insufficient BMP's/runoff controls in ditch, sediment is being carried off location & into a vegetated area & towards a nearby creek/drainage (NE area of location near entrance to location)**

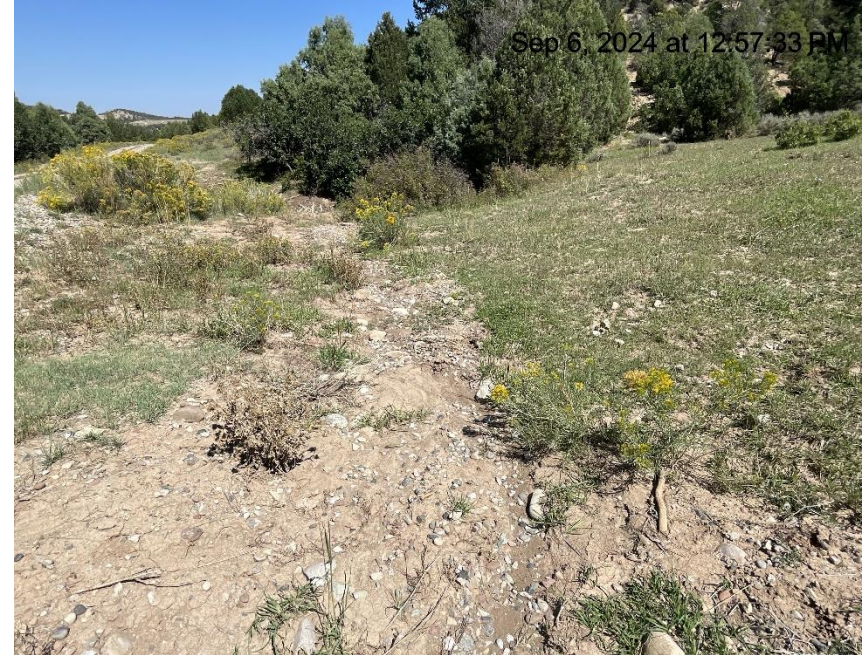
**Photo # 8743 Insufficient BMP's/runoff controls in ditch, sediment is being carried off location & into a vegetated area & towards a nearby creek/drainage (NE area of location near entrance to location)**

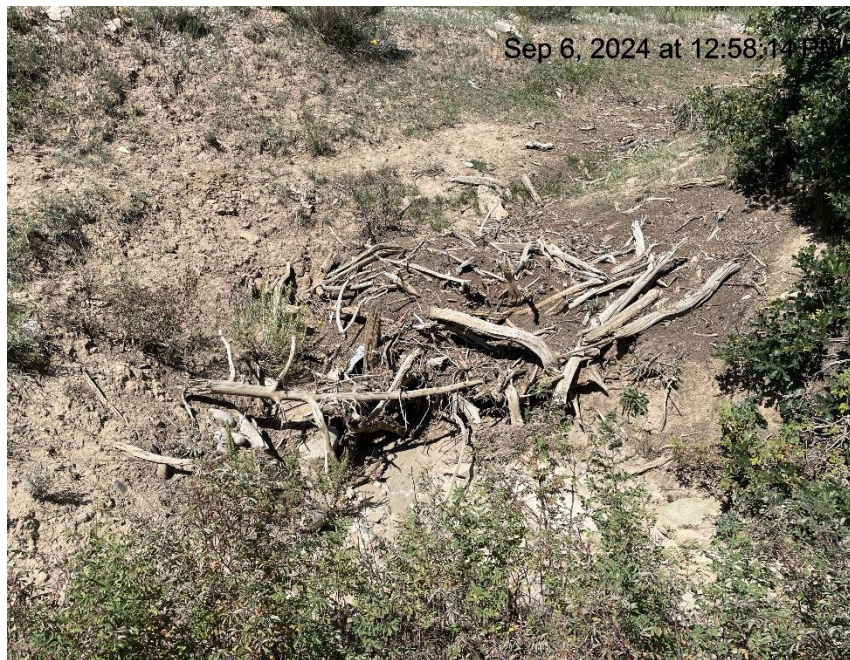
**Photo # 8744 Large amount of sediment & debris built up at culvert inlet/capacity of BMP reduced (on lease road near entrance to location**

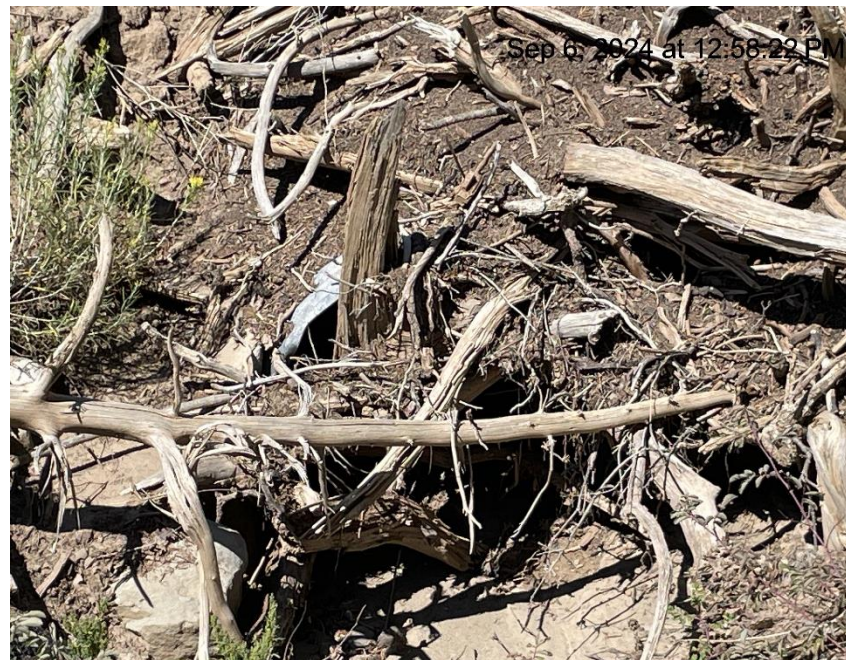
**Photo # 8745 Large amount of sediment & debris built up at culvert inlet/capacity of BMP reduced (on lease road near entrance to location**

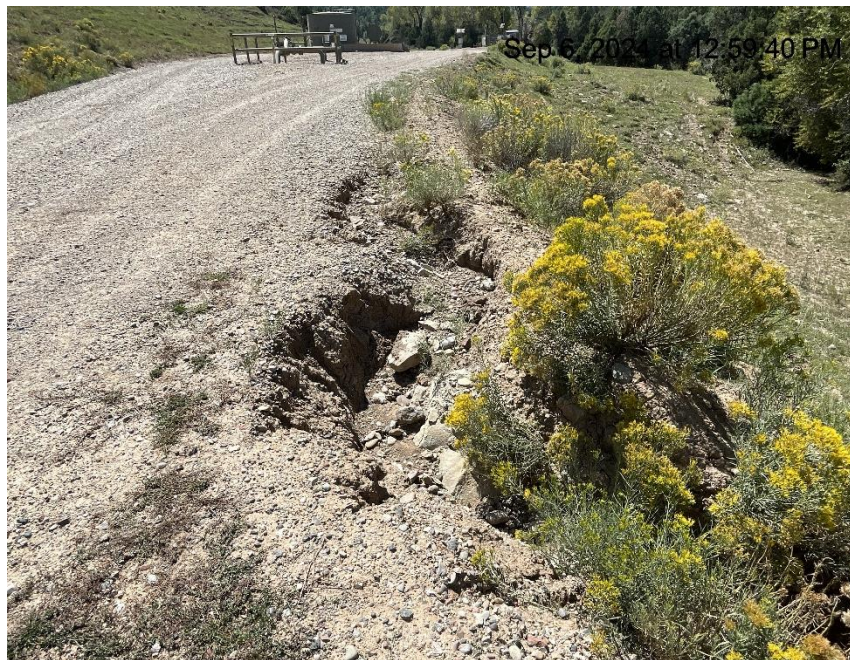
**Photo # 8746 Erosion & transport of sediment (near entrance to location)**

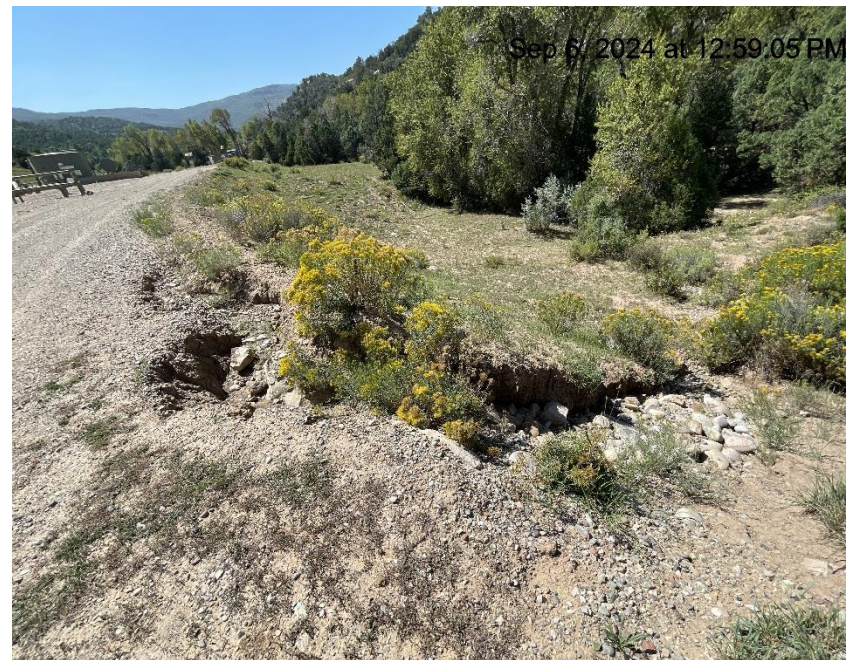
**Photo # 8747 Erosion & transport of sediment into a vegetated area/BMP's need maintenance (near entrance to location)**

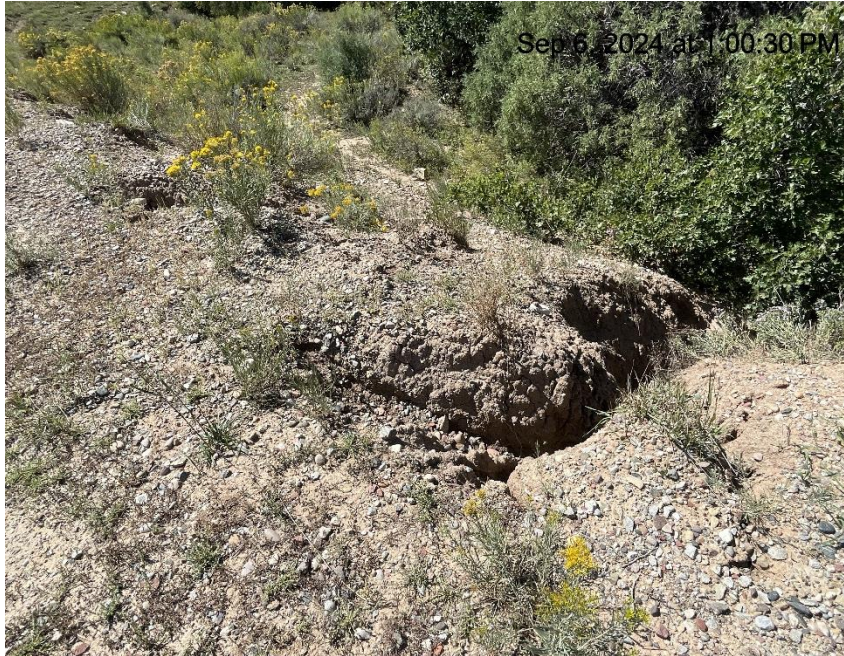
**Photo # 8748 Erosion & transport of sediment off edge of lease road (near culvert on lease road near entrance to location)**

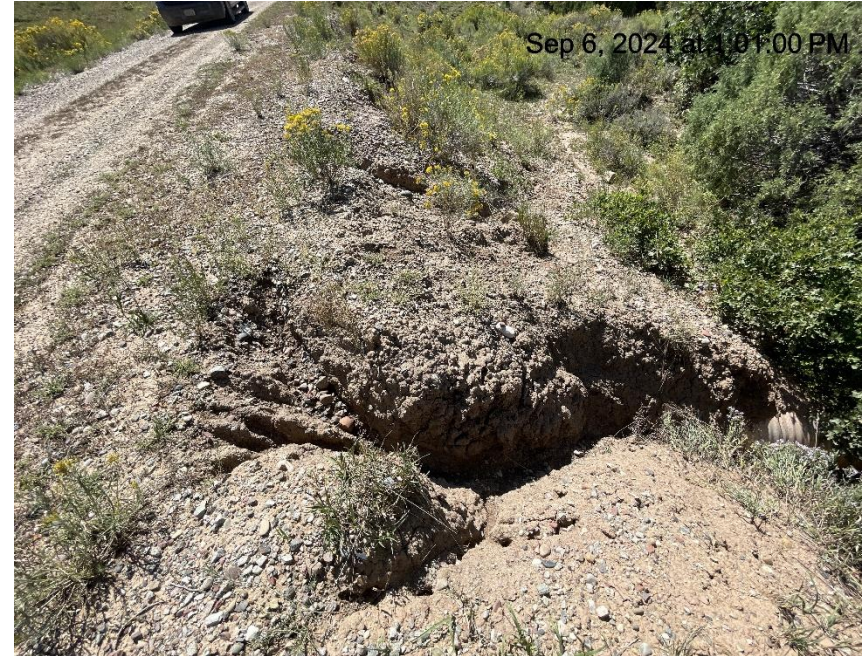
**Photo # 8749 Erosion & transport of sediment off edge of lease road (near culvert on lease road near entrance to location)**

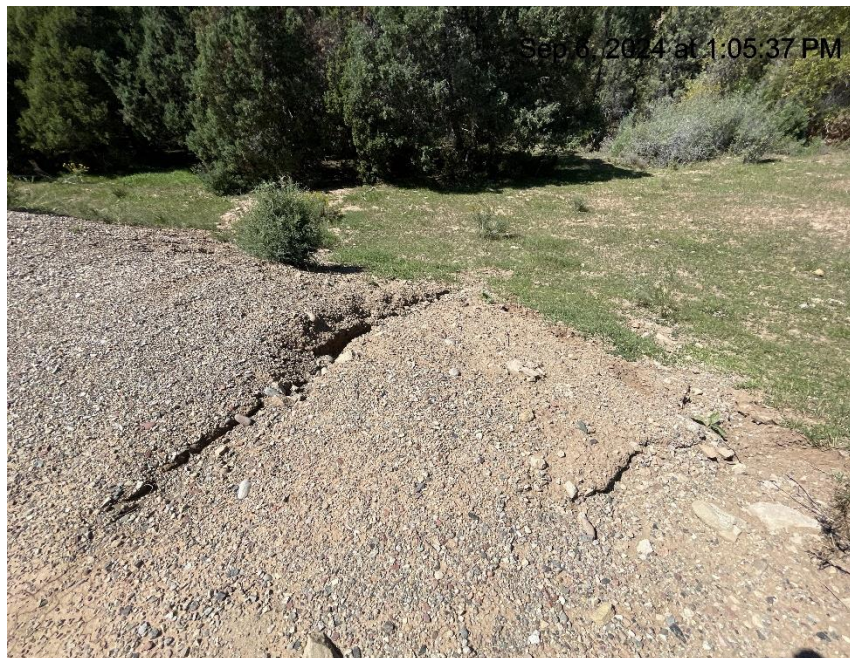
**Photo # 8750 Erosion on slope & transport of sediment off location & into a vegetated area (near Summit Midstream meter house)**

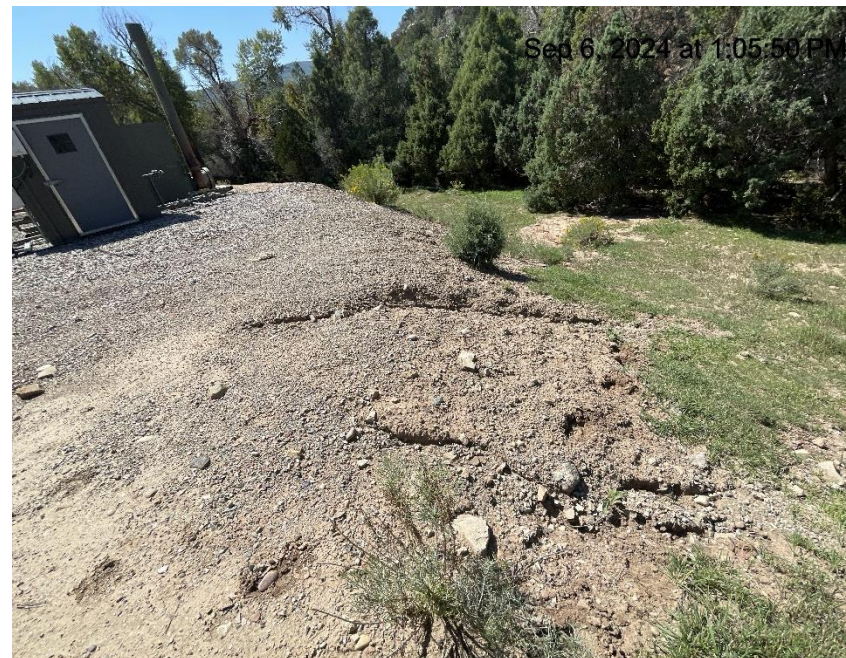
**Photo # 8751 Erosion on slope & transport of sediment off location & into a vegetated area (near Summit Midstream meter house)**

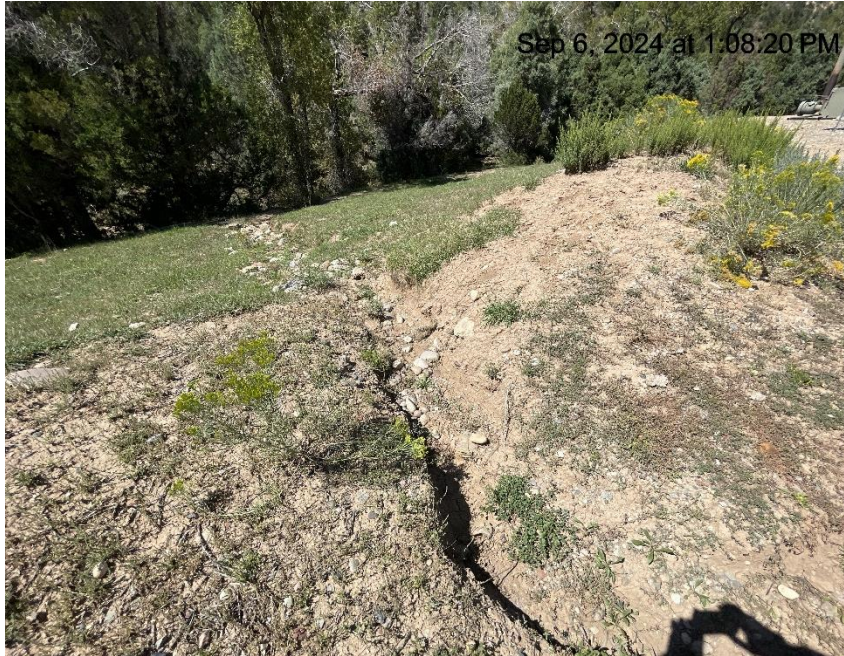
**Photo # 8752 Erosion & sediment transport near Rip Rap Run (S/SE area of location)**

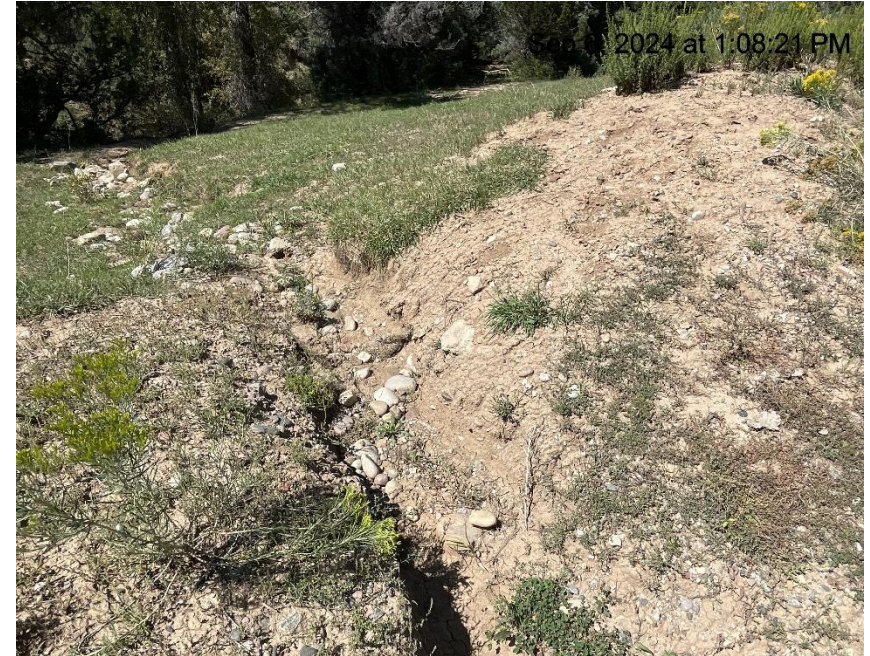
**Photo # 8753 Erosion & sediment transport near Rip Rap Run (S/SE area of location)**
