## Inspection Photos

Location Name: CAERUS PICEANCE LLC HMU 7-14 (N7SE) Pad

Location #: 334291

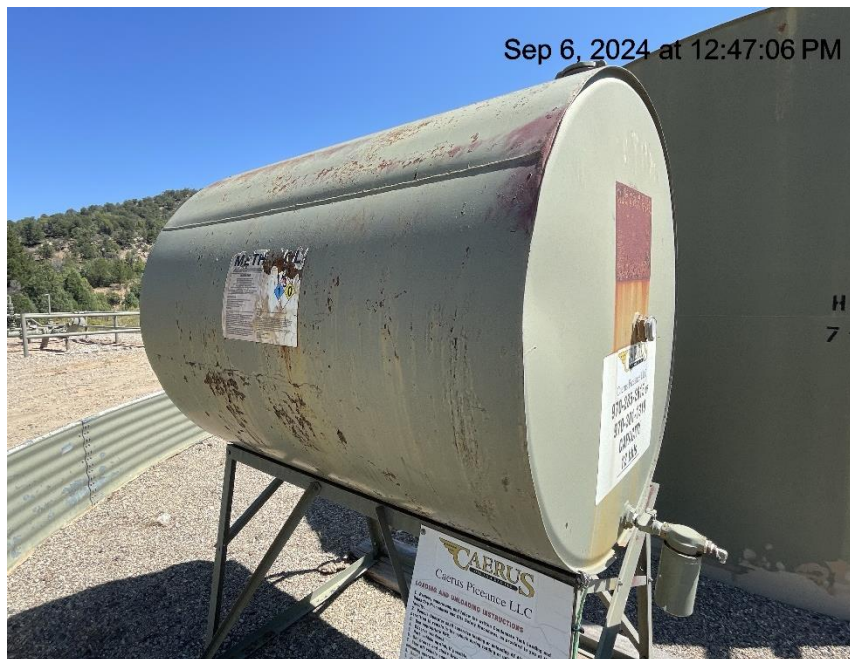
**Photo # 8721 Tank label damaged/does not comply with CECMC labeling rules**

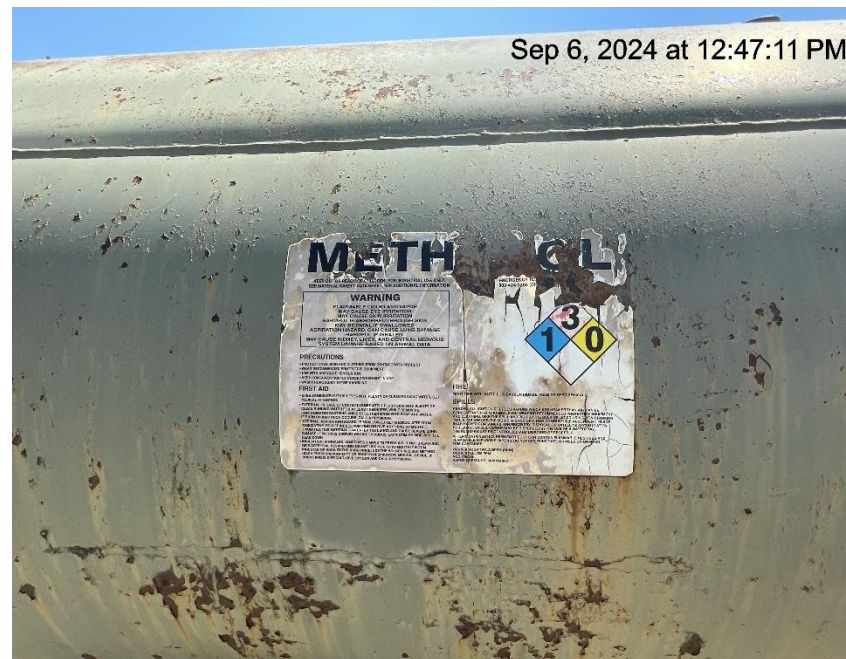
**Photo # 8722 Tank label damaged/does not comply with CECMC labeling rules**

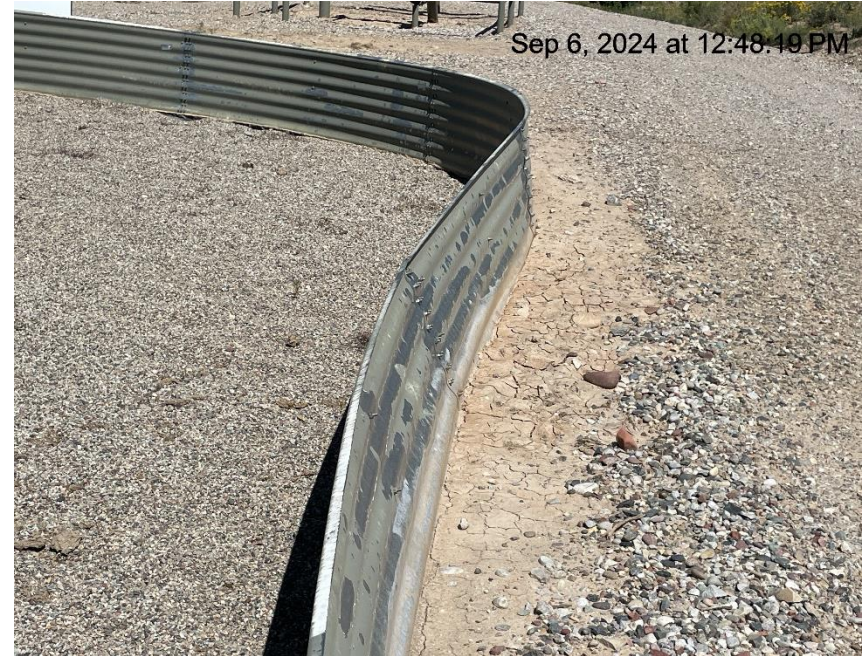
Photo # 8724 Small amount of damage/buckling on secondary containment

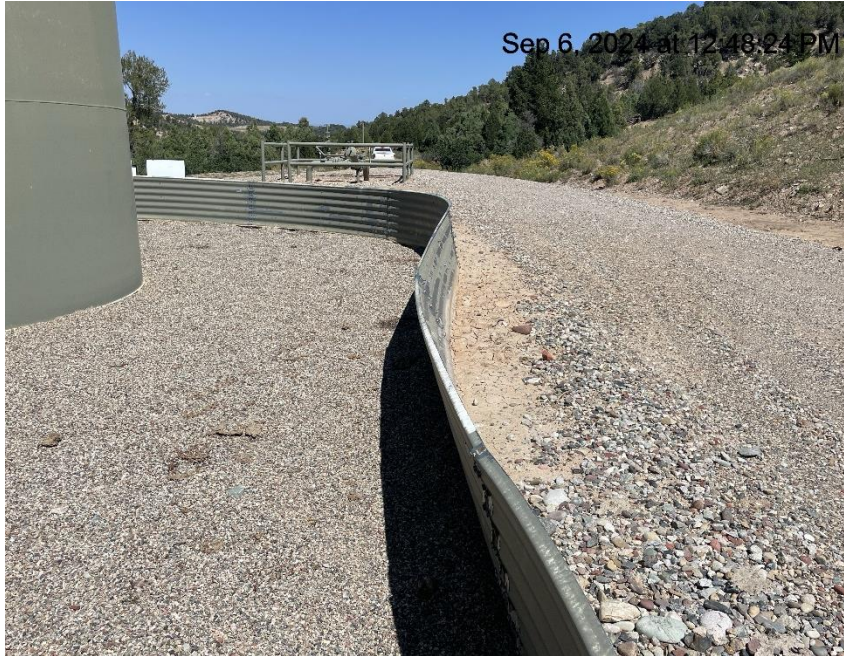
**Photo # 8725 Small amount of damage/buckling on secondary containment**
