Inspection Photos

Location Name: CAERUS PICEANCE LLC SHIDELER 36-15A (C36W) Pad

Location #: 334336

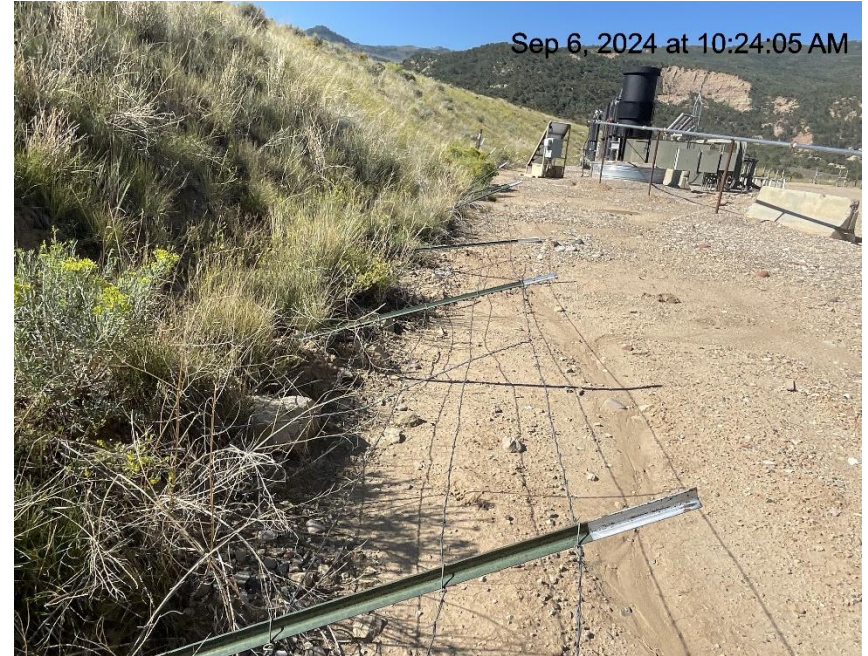
Photo # 8436 Barbed wire fence needs maintenance/wildlife hazard

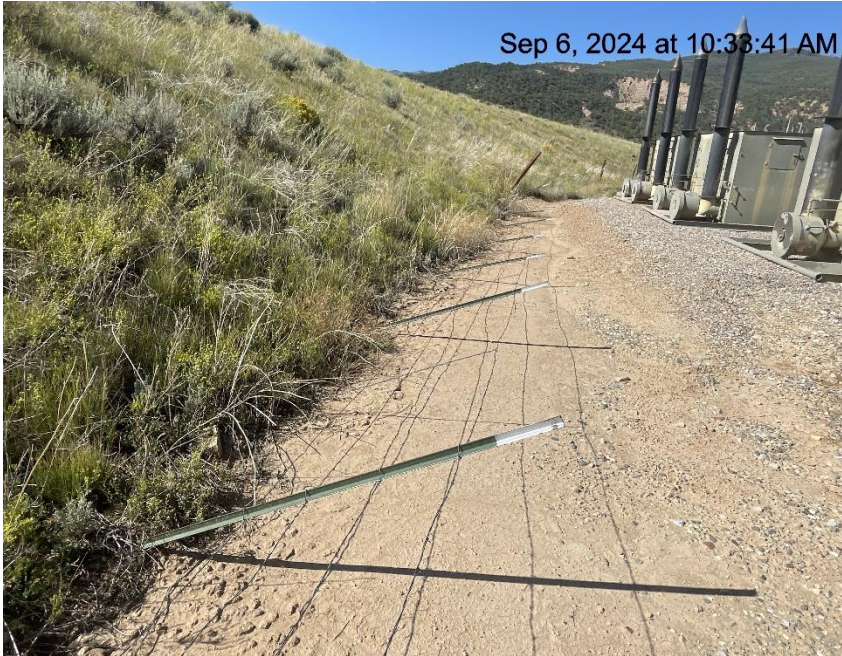
Photo # 8437 Barbed wire fence needs maintenance/wildlife hazard

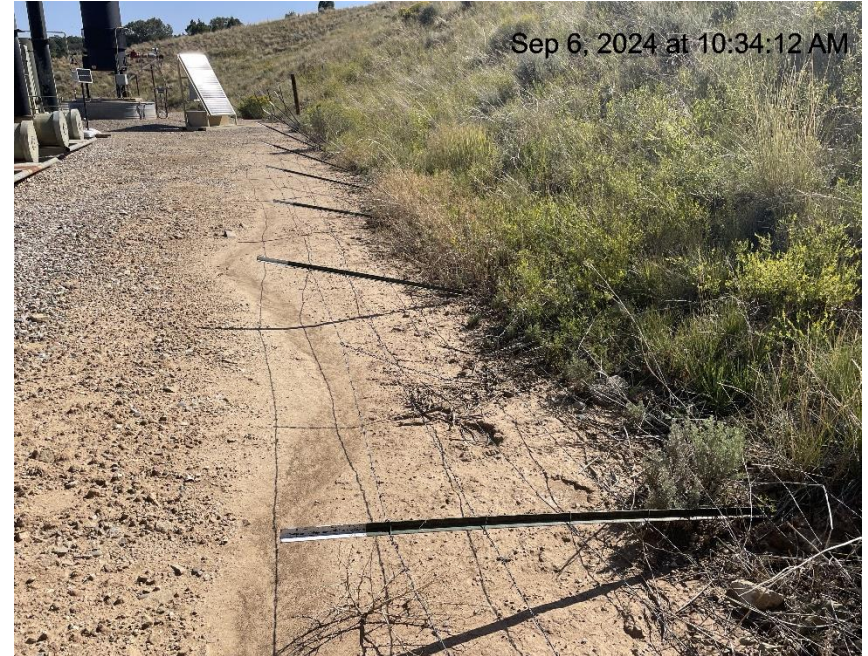
Photo # 8438 Barbed wire fence needs maintenance/wildlife hazard

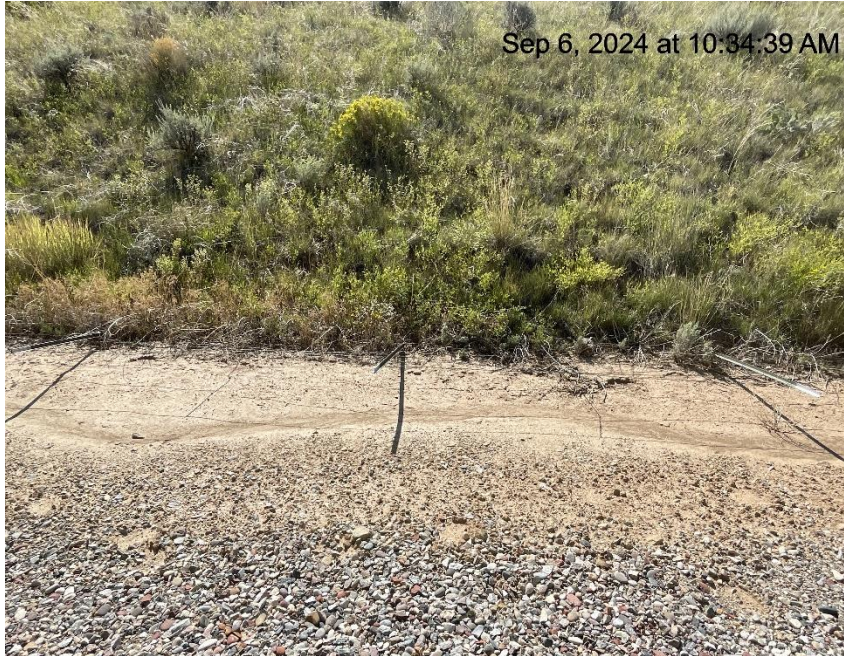
Photo # 8439 Barbed wire fence needs maintenance/wildlife hazard

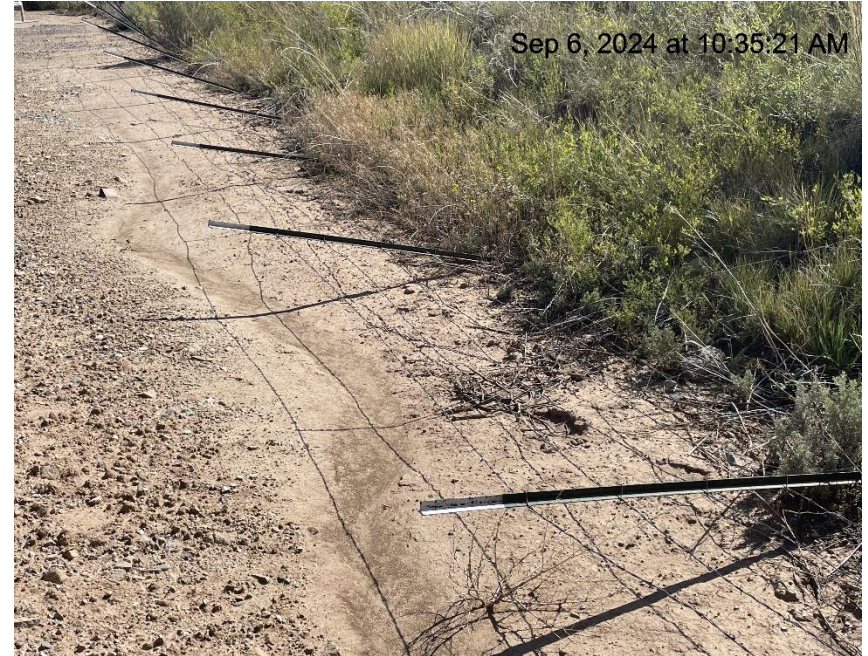
Photo # 8440 Barbed wire fence needs maintenance/wildlife hazard
