Inspection Photos

API: 071-09757

Operator: OGRIS OPERATING LLC

Inspection Date: 9/16/2024

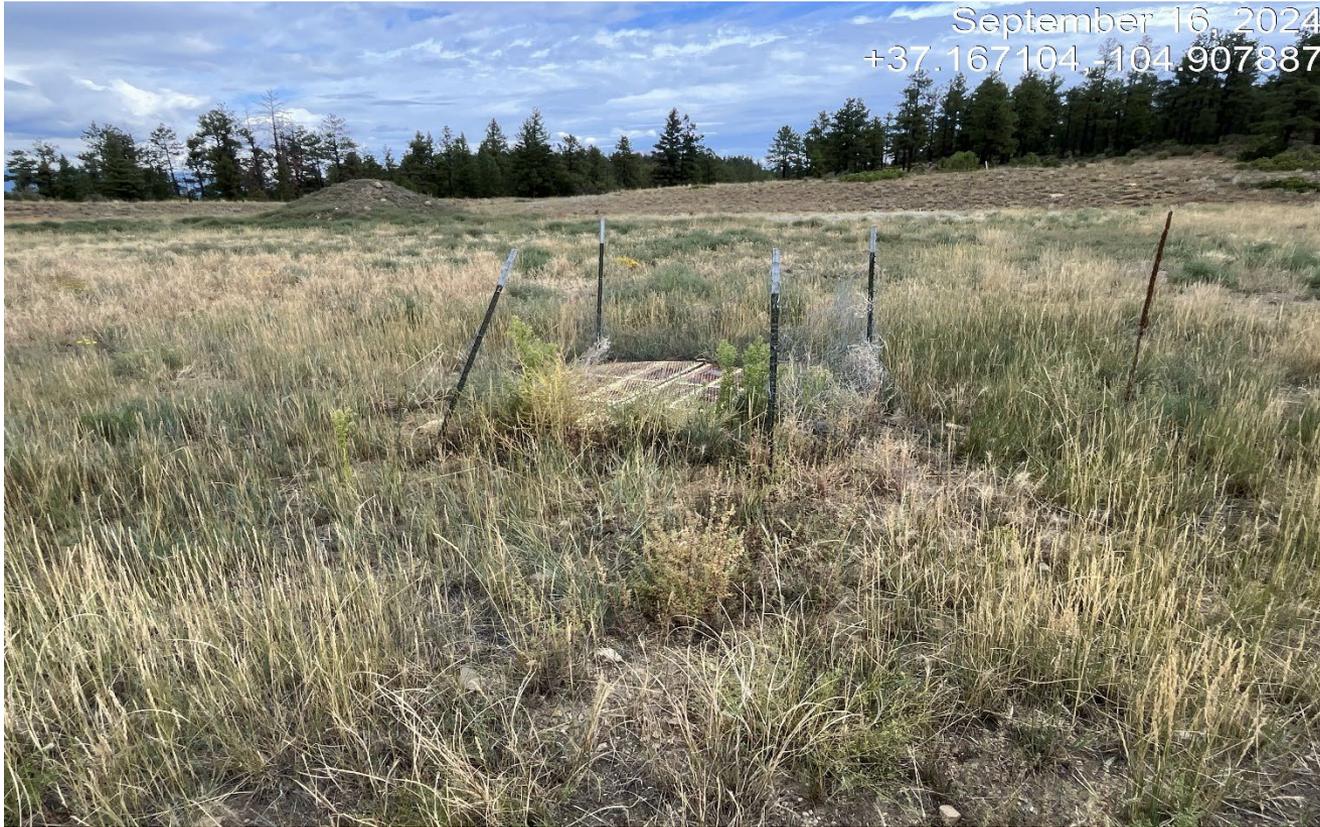
Photo 1. Facing northwest toward the wellsite.

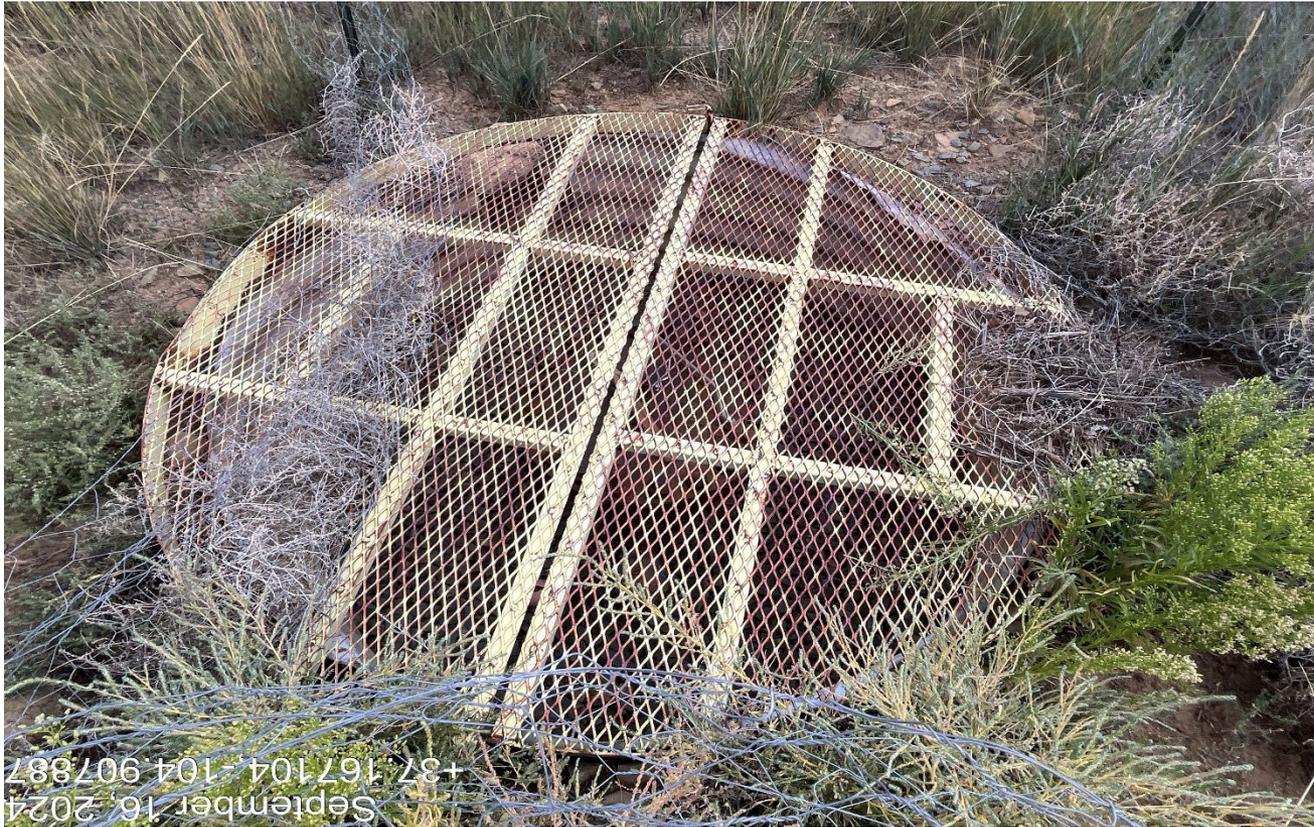
Photo 2. The well is protected with a steel grate.

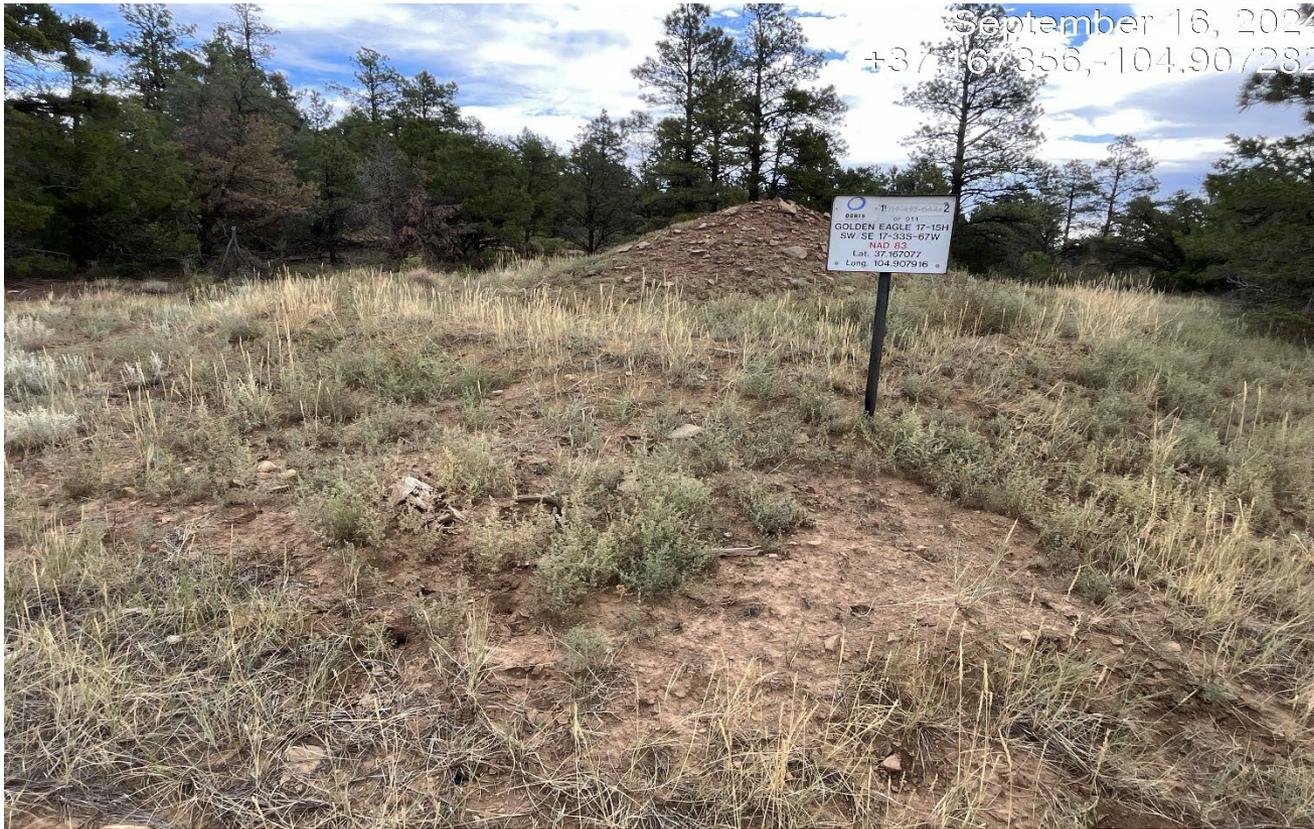
Photo 2. Facing northeast toward the topsoil pile.

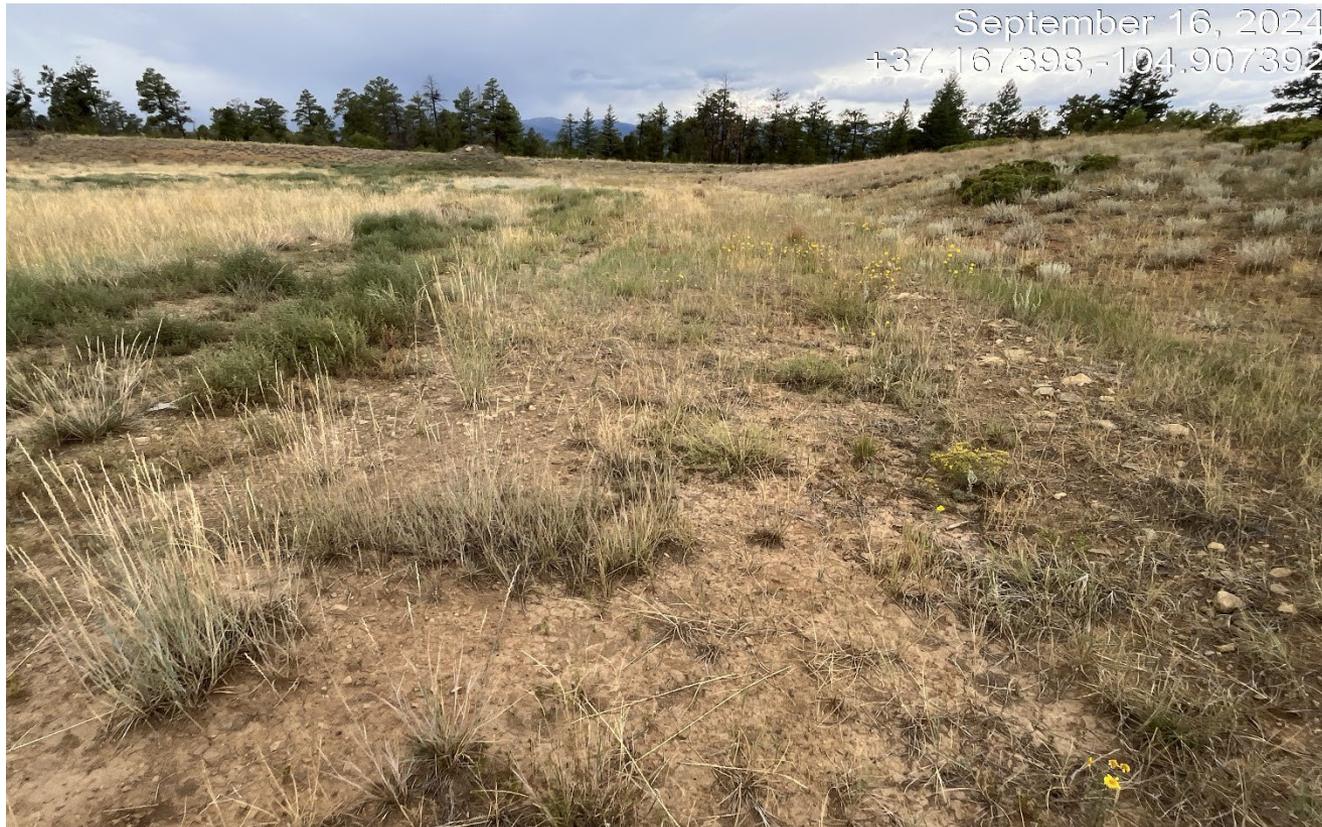
Photo 4. Facing west at the north side of the location. The topsoil piles could be utilized along this area for recontouring.

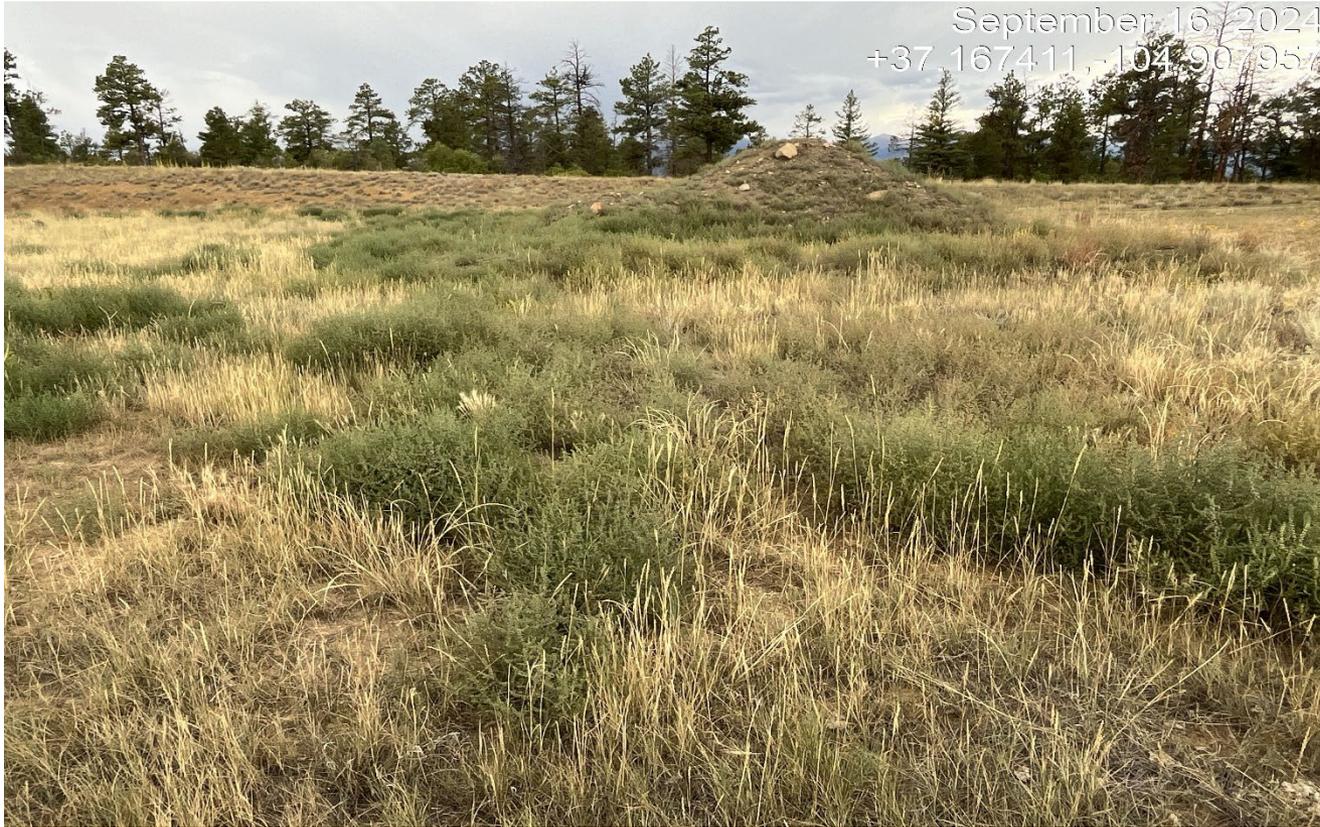
Photo 2. Facing west toward the topsoil pile. There are undesirable weeds on and around the topsoil pile. The topsoil pile needs to be replaced for reclamation.
