Inspection Photos

ID: 453010

Operator: OGRIS OPERATING LLC

Inspection Date: 9/16/2024

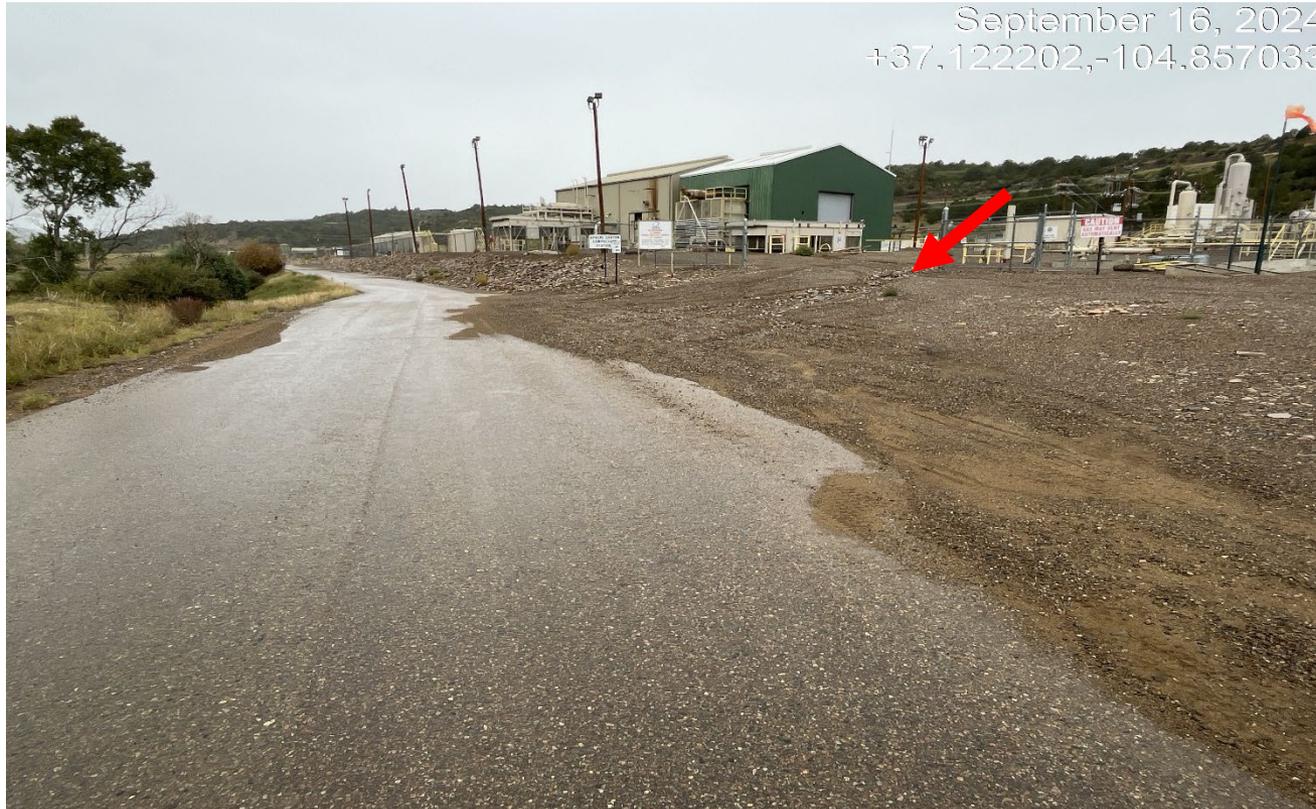
Photo 1. Facing southwest along the main road to the compressor facility. There is erosion occurring at the red arrow which is directing sediment onto the main road. Sediment needs to be removed from the paved road and sediment controlled.

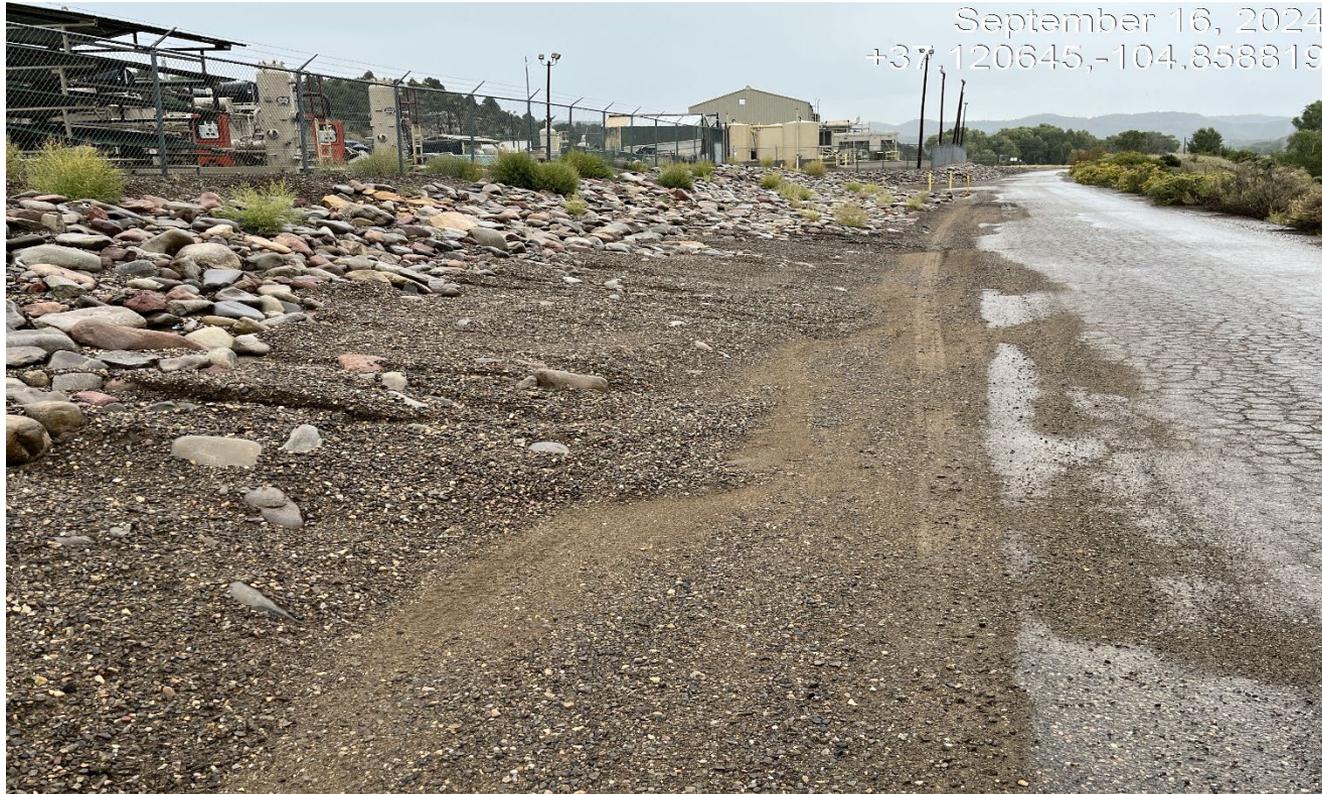
Photo 2. Facing northeast along the main paved road. The sediment and gravel along this area should be cleaned out to prevent sediment movement onto the paved road.
