Interim Reclamation and Stormwater Inspection

Date: 09/10/2024

Operator: MCCARTNEY ENGINEERING LLC - 55030

Location ID: 317041

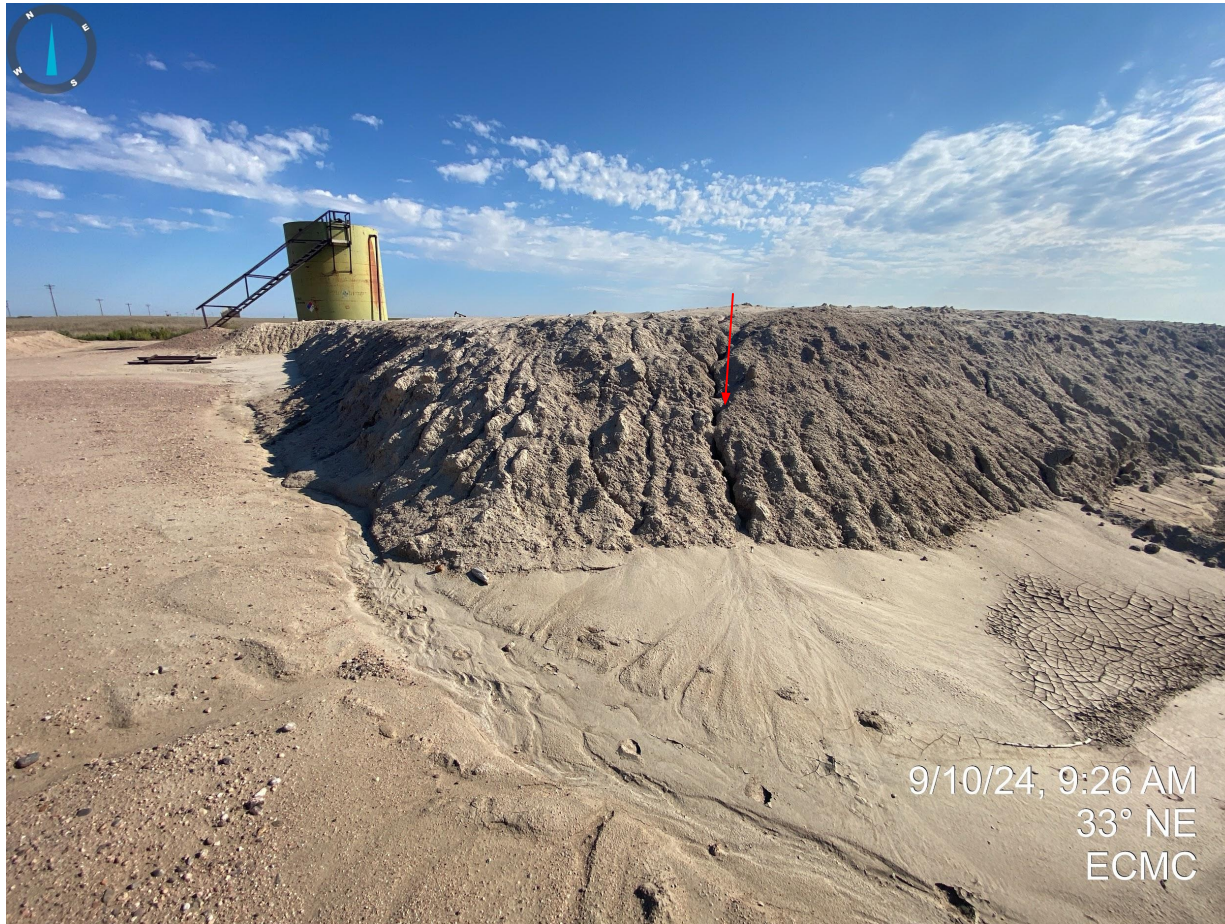
Photo 1. Southwest corner of pit. Evidence of erosion degradation and unstabilized pit berms.

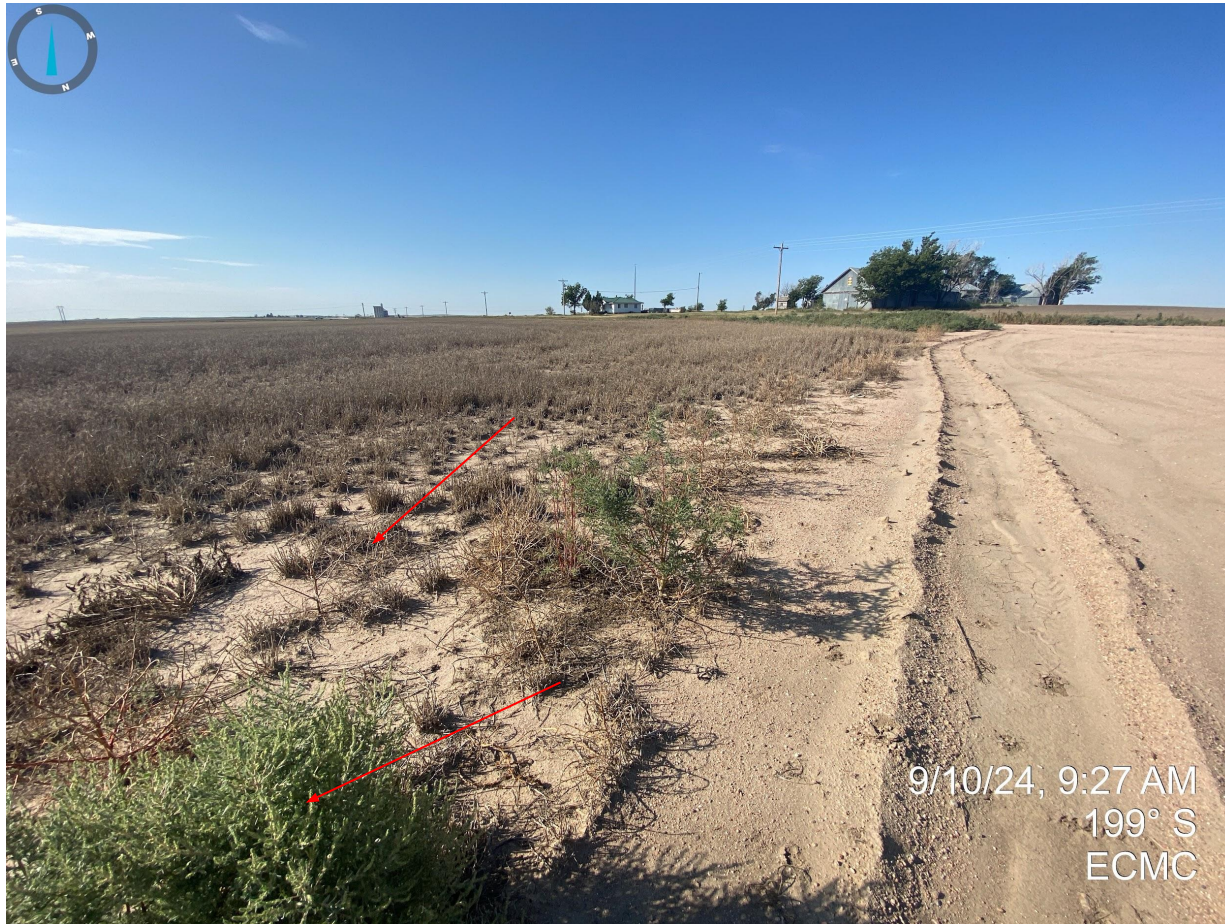
Photo 2. Southern portion of the production facilities, evidence of off location sediment transport and undesirable vegetation.

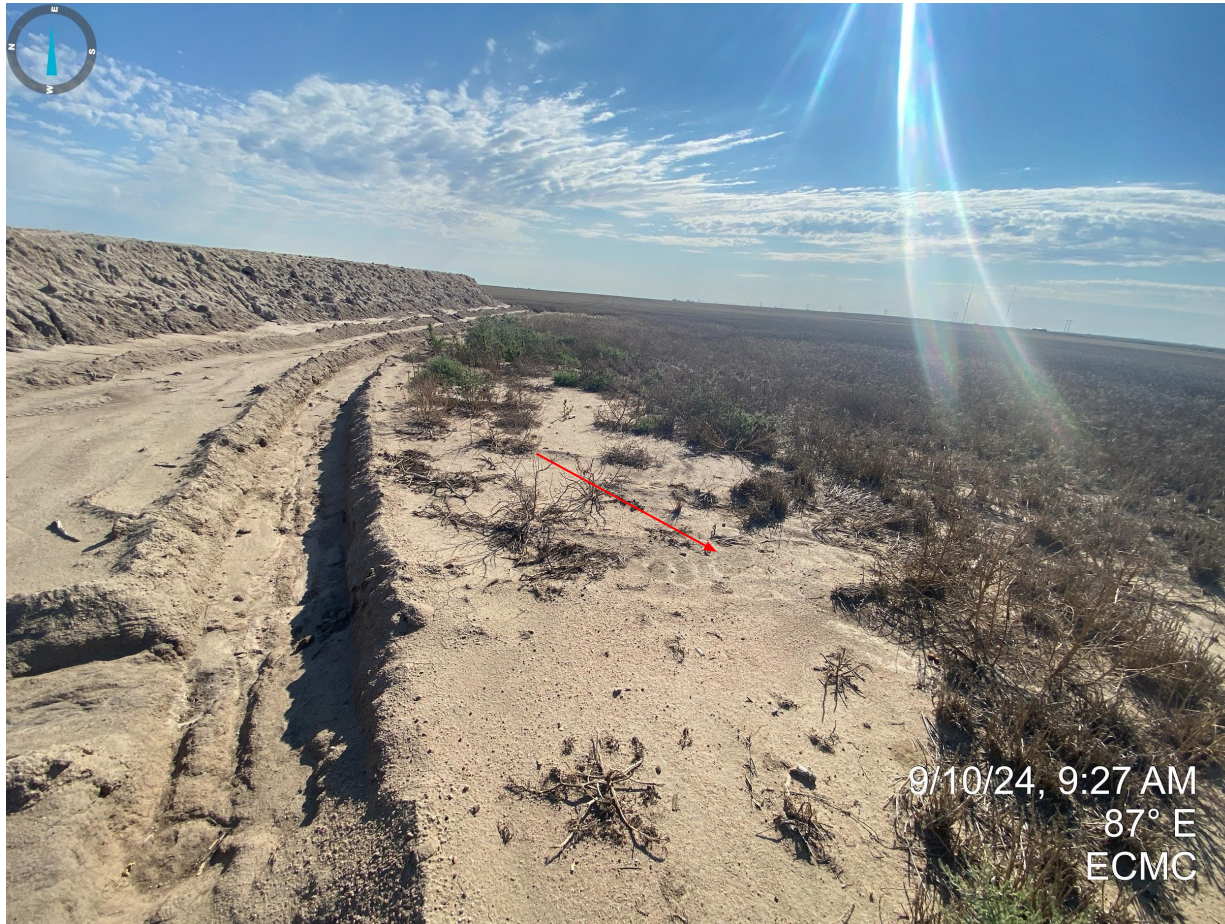
Photo 3. Continued from Photo 2, facing east. Photo illustrates evidence of off location sediment transport and undesirable vegetation.

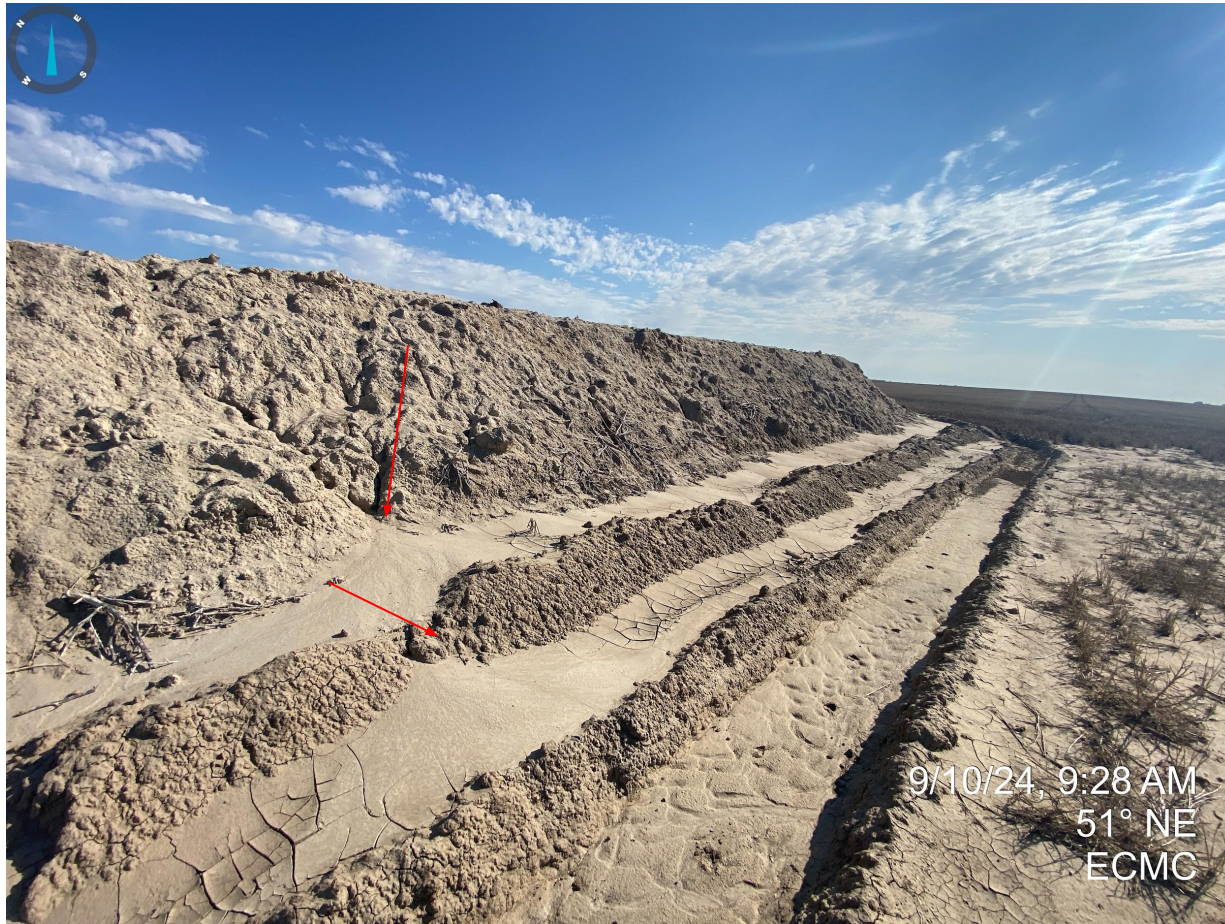
Photo 4. Pit berms do not appear to be properly stabilized with evidence of unconsolidated material and erosion degradation.

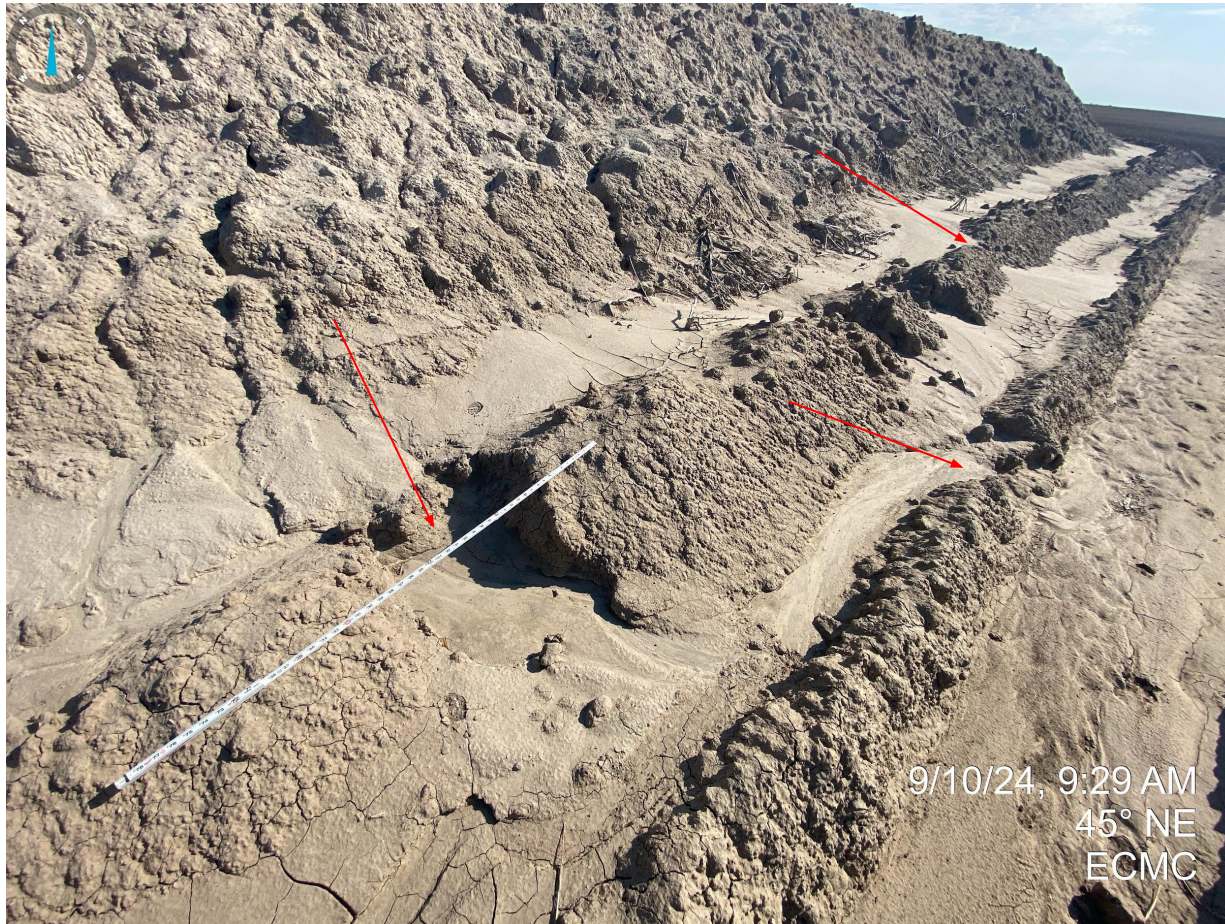
Photo 5. Continued from Photo 4. Berm material does not appear to be properly stabilized.

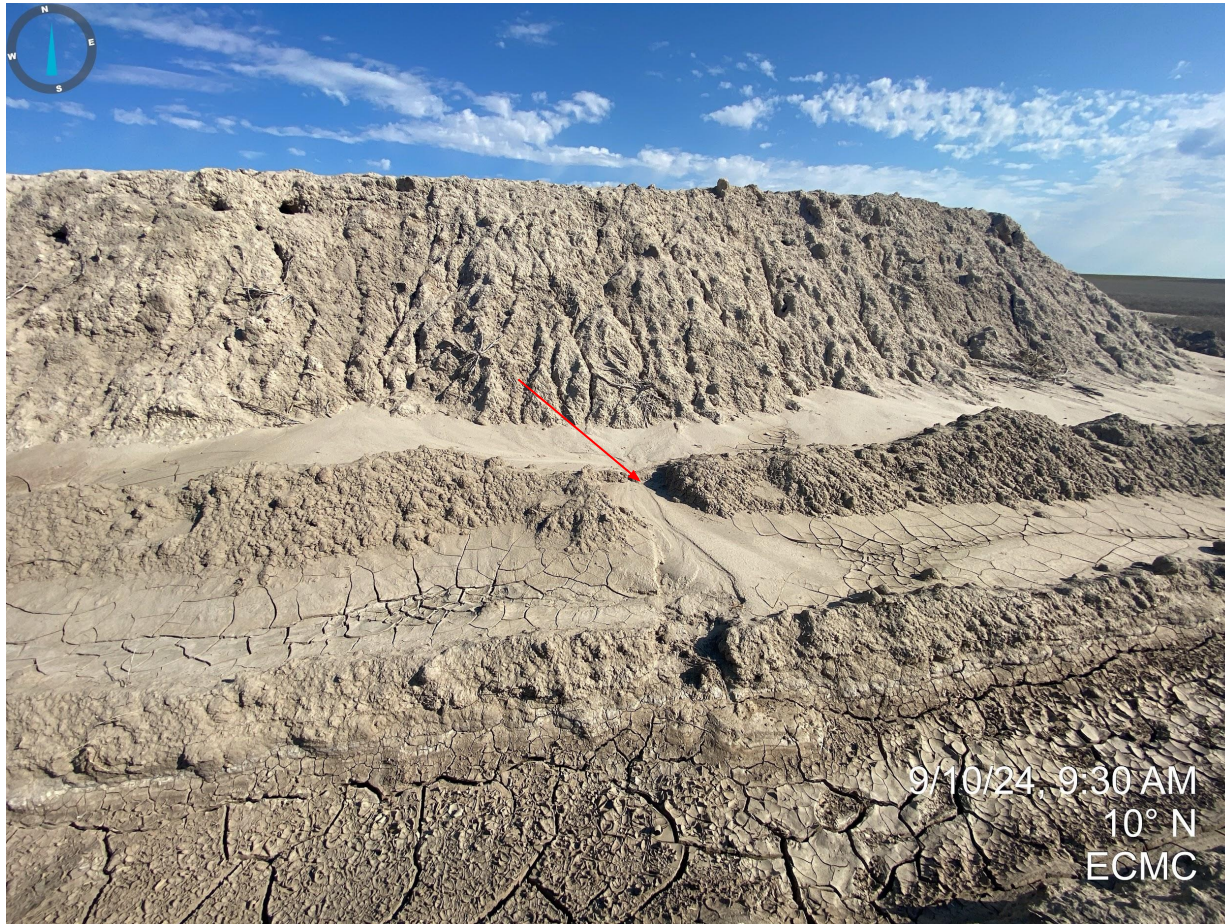
Photo 6. Continued from Photo 4. Berm material does not appear to be properly stabilized.

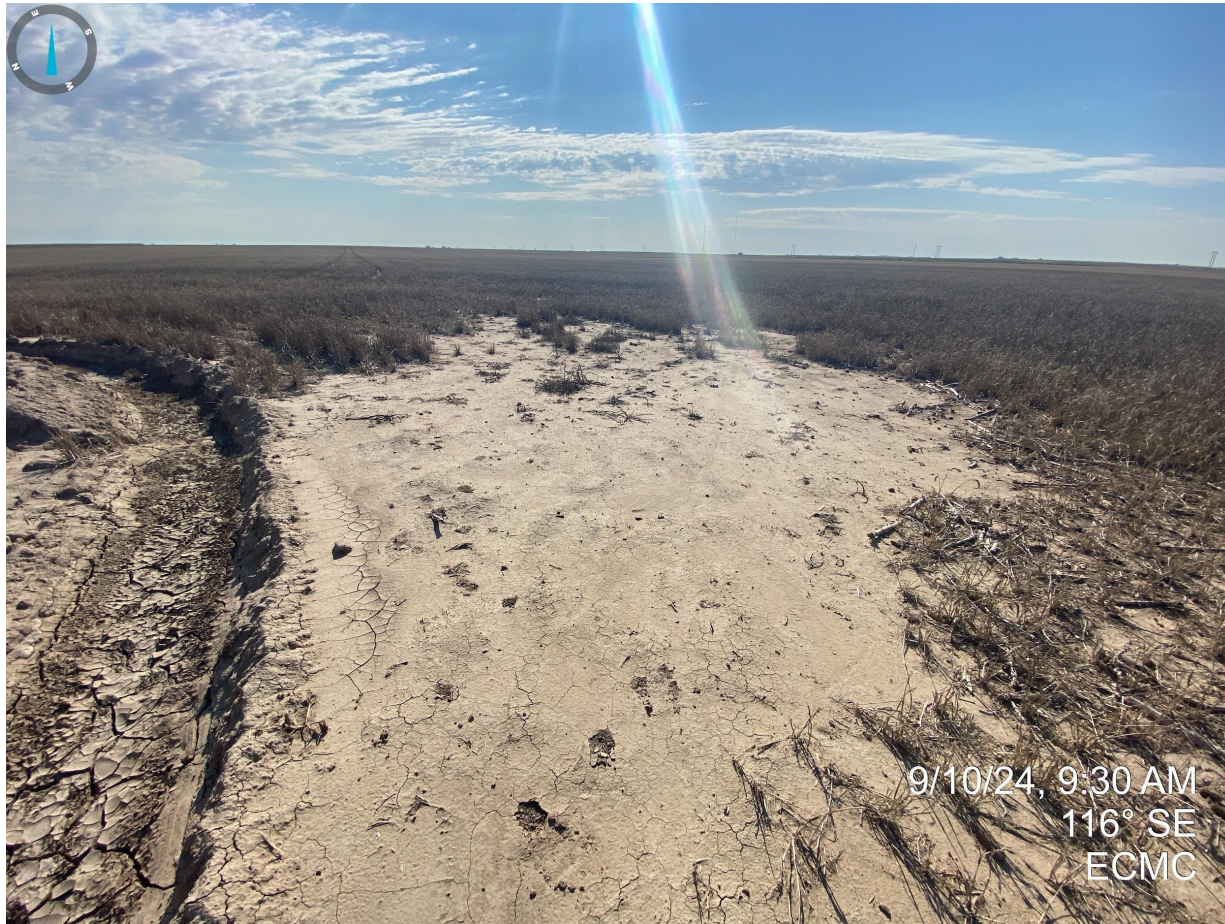
Photo 7. Facing southeast into the impacted area located southeast of the pit. The bare area is failing to vegetate either due to continued sediment deposition, salt kill impacts, or both. Impacted areas require soil sampling and additional reclamation activities.

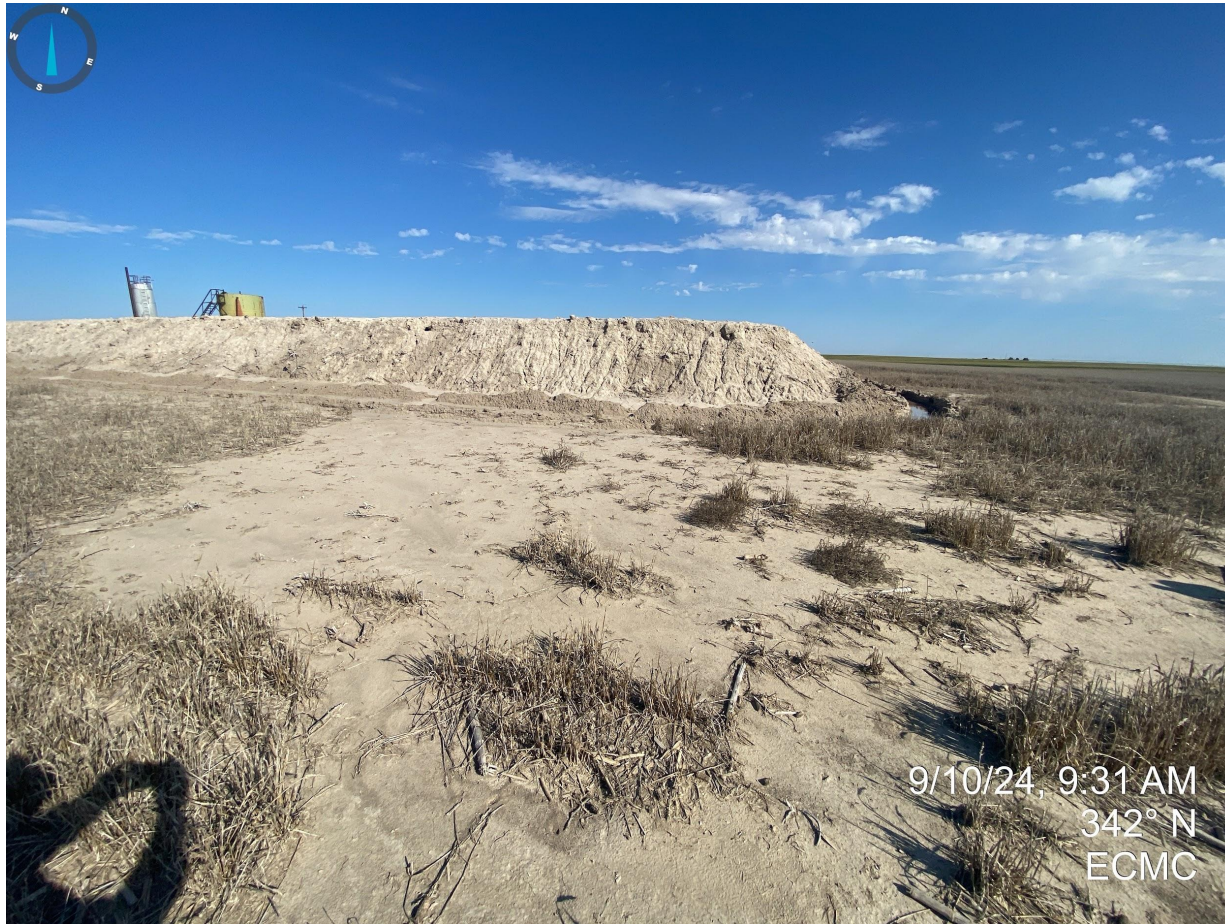
Photo 8. Facing north; see comments in Photo 7.

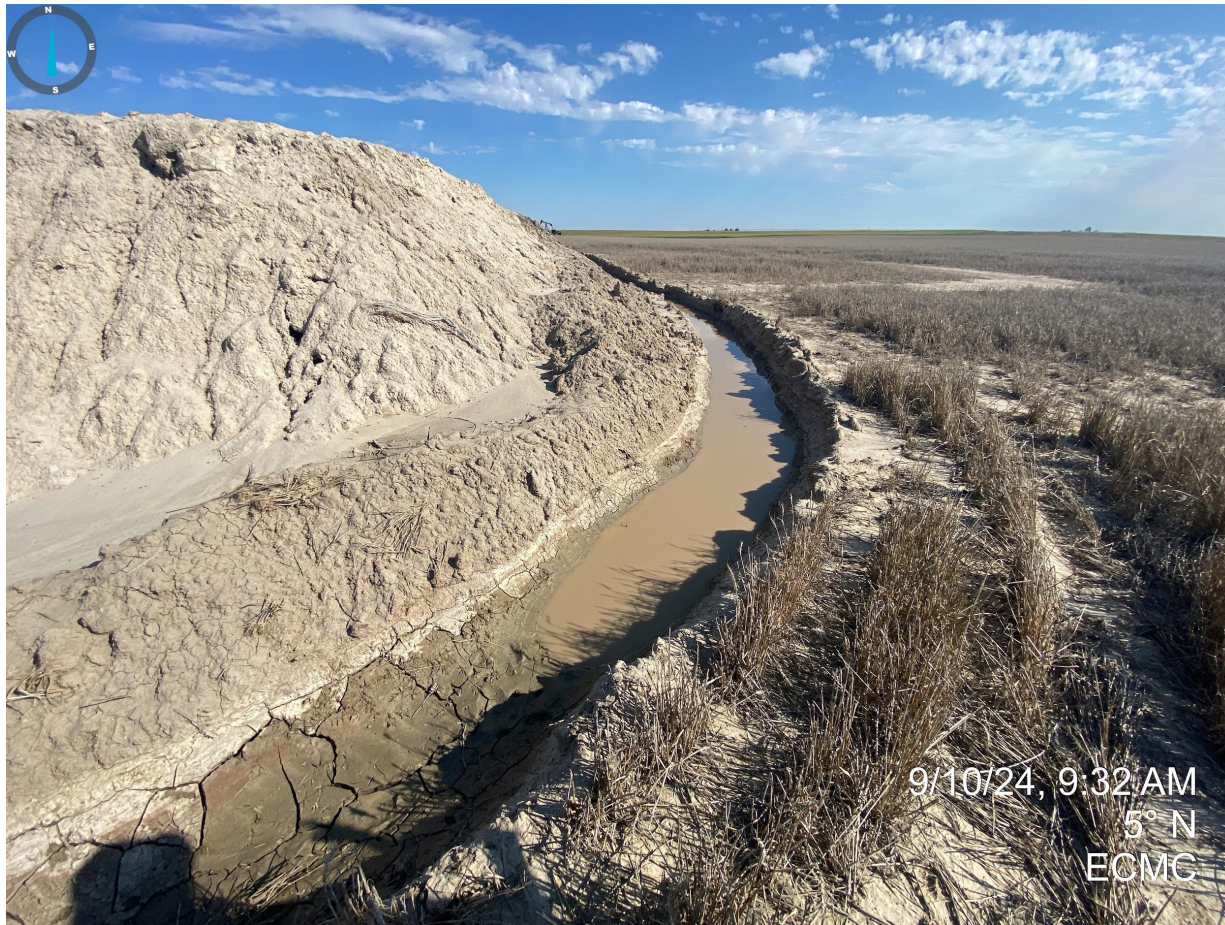
Photo 9. A perimeter ditch has been installed around the southern and eastern side of the pit.

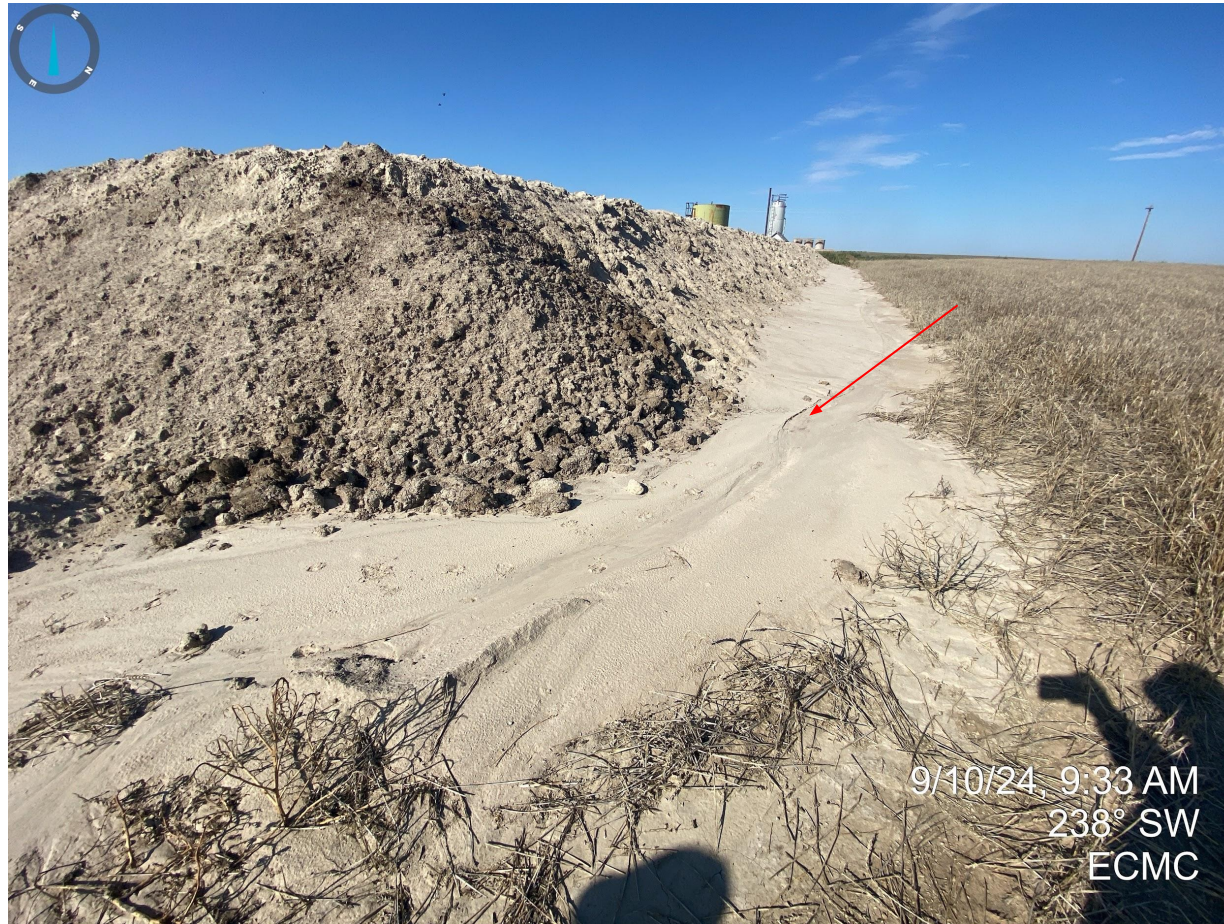
Photo 10. Northeast corner of pit, facing southwest. No apparent stormwater controls measures observed around the northern portion of the pit. Red arrow indicates erosion degradation.

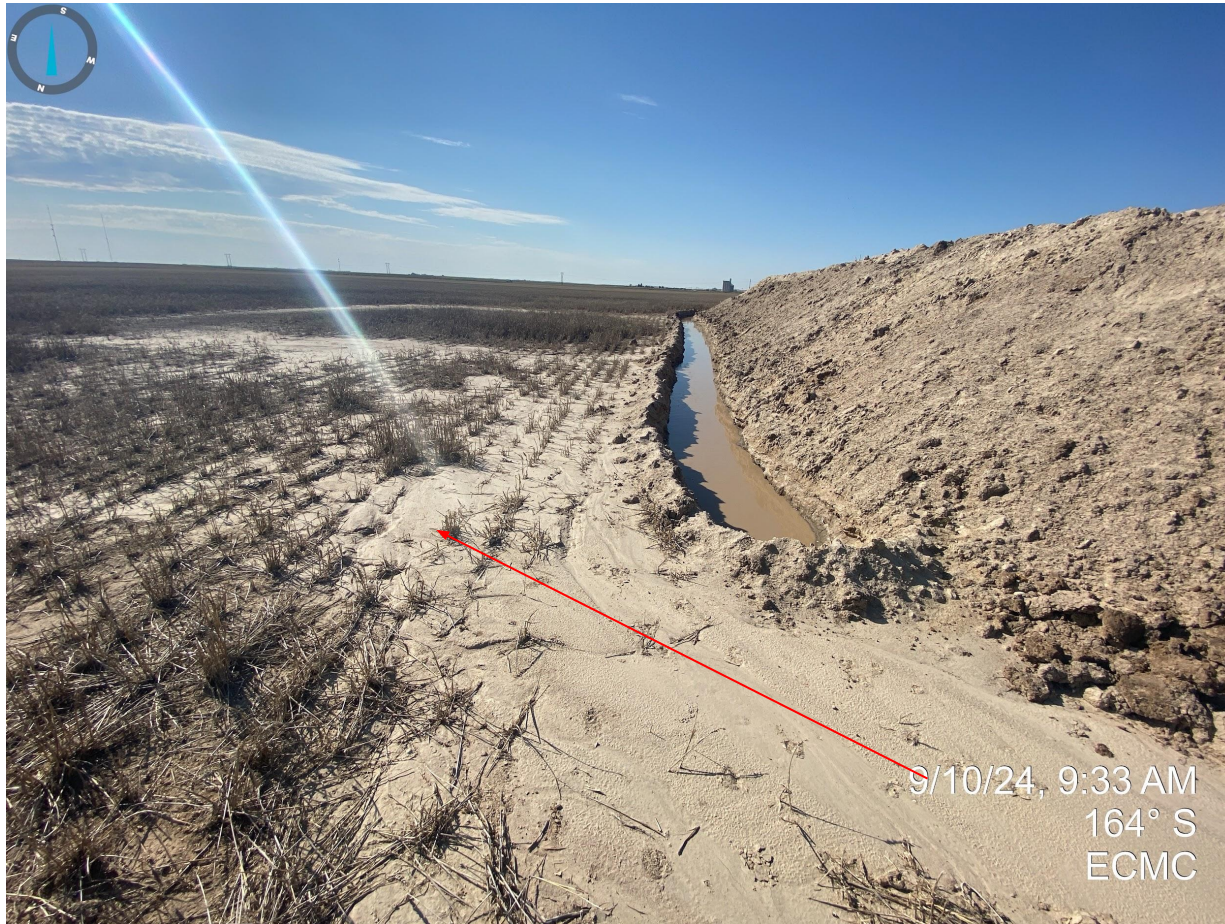
Photo 11. Continued from Photo 10. Evidence of sediment transport in the adjacent field.

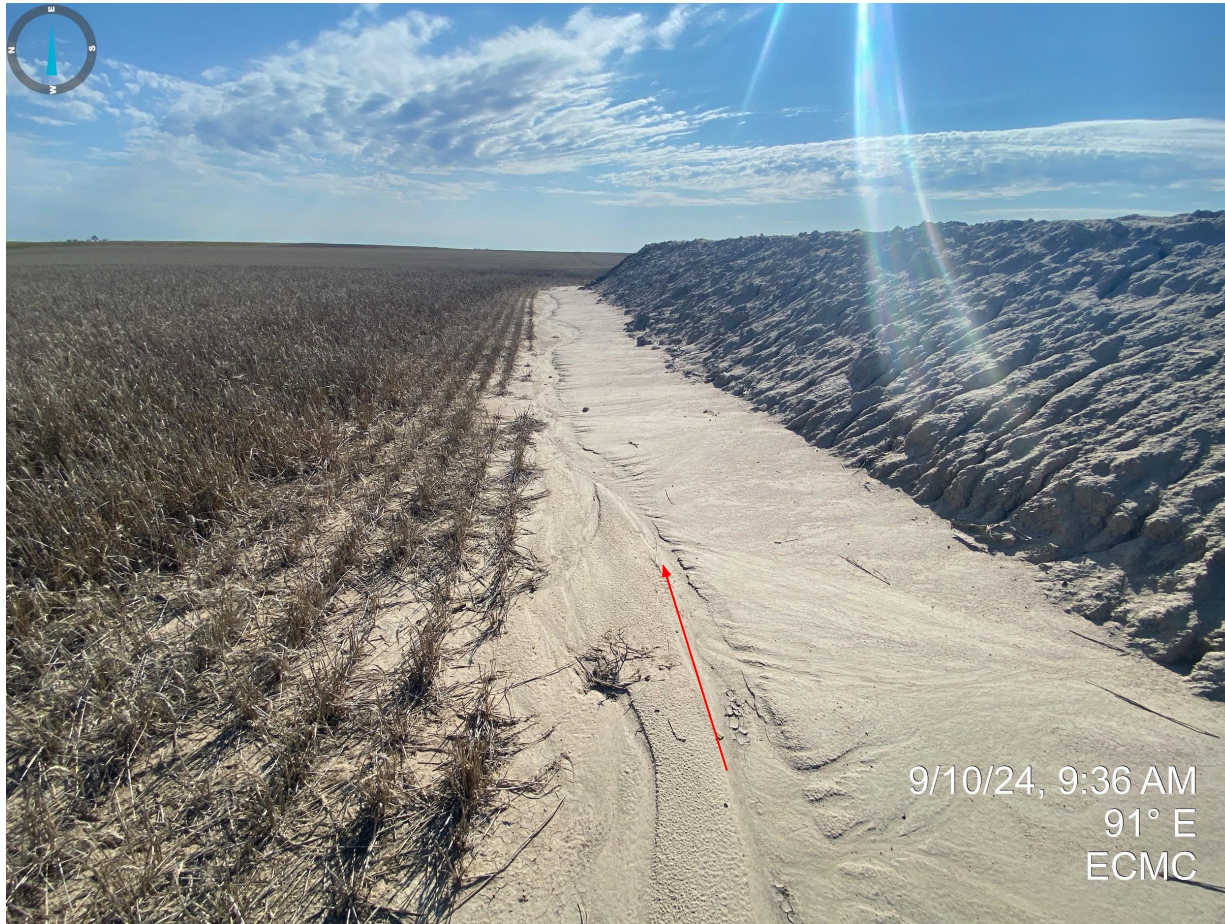
Photo 12. Erosion degradation and unstabilized pit berms on the northern portion of the pit.

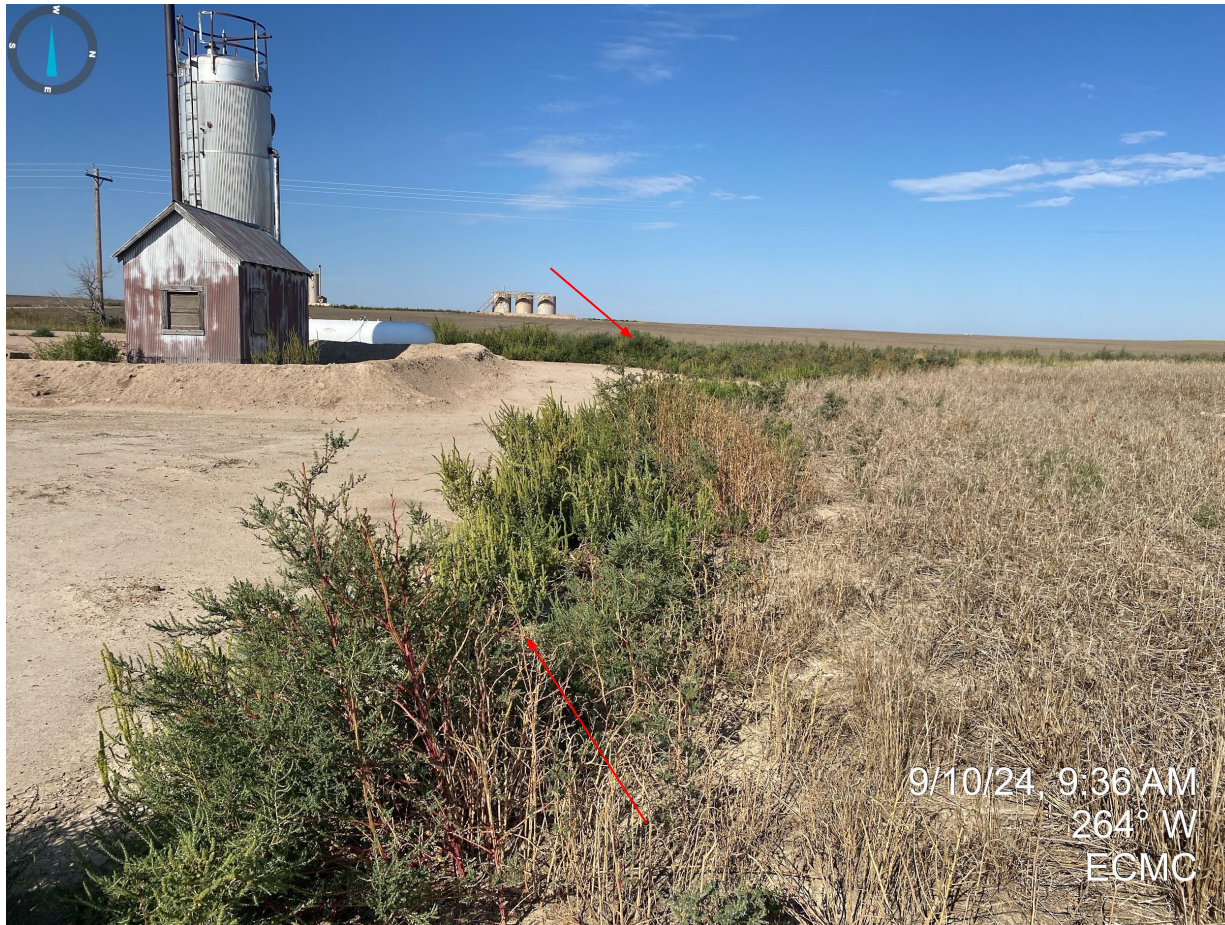
Photo 13. Undesirable vegetation observed throughout the production facilities.

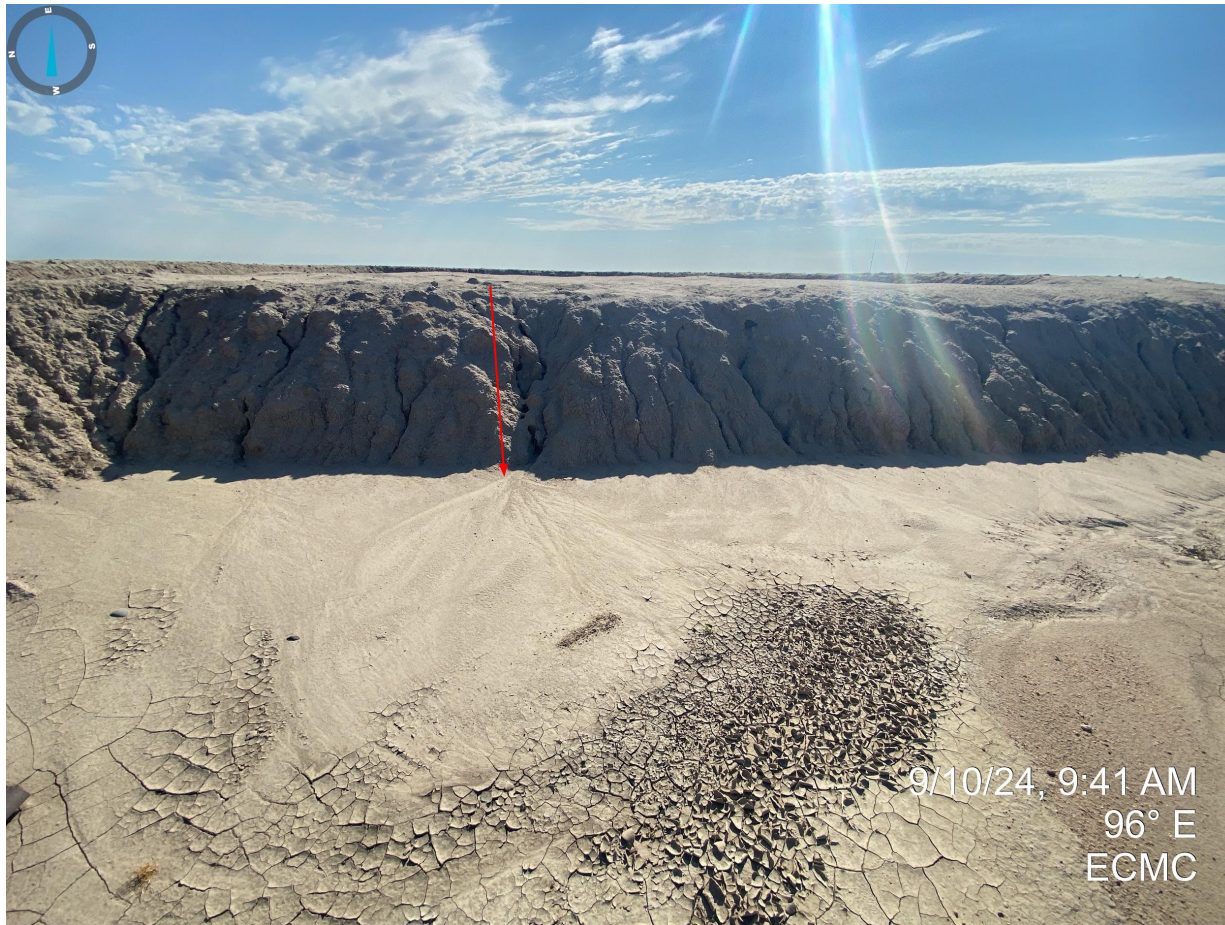
Photo 14. Erosion degradation and unstabilized pit berms on the western portion of the pit

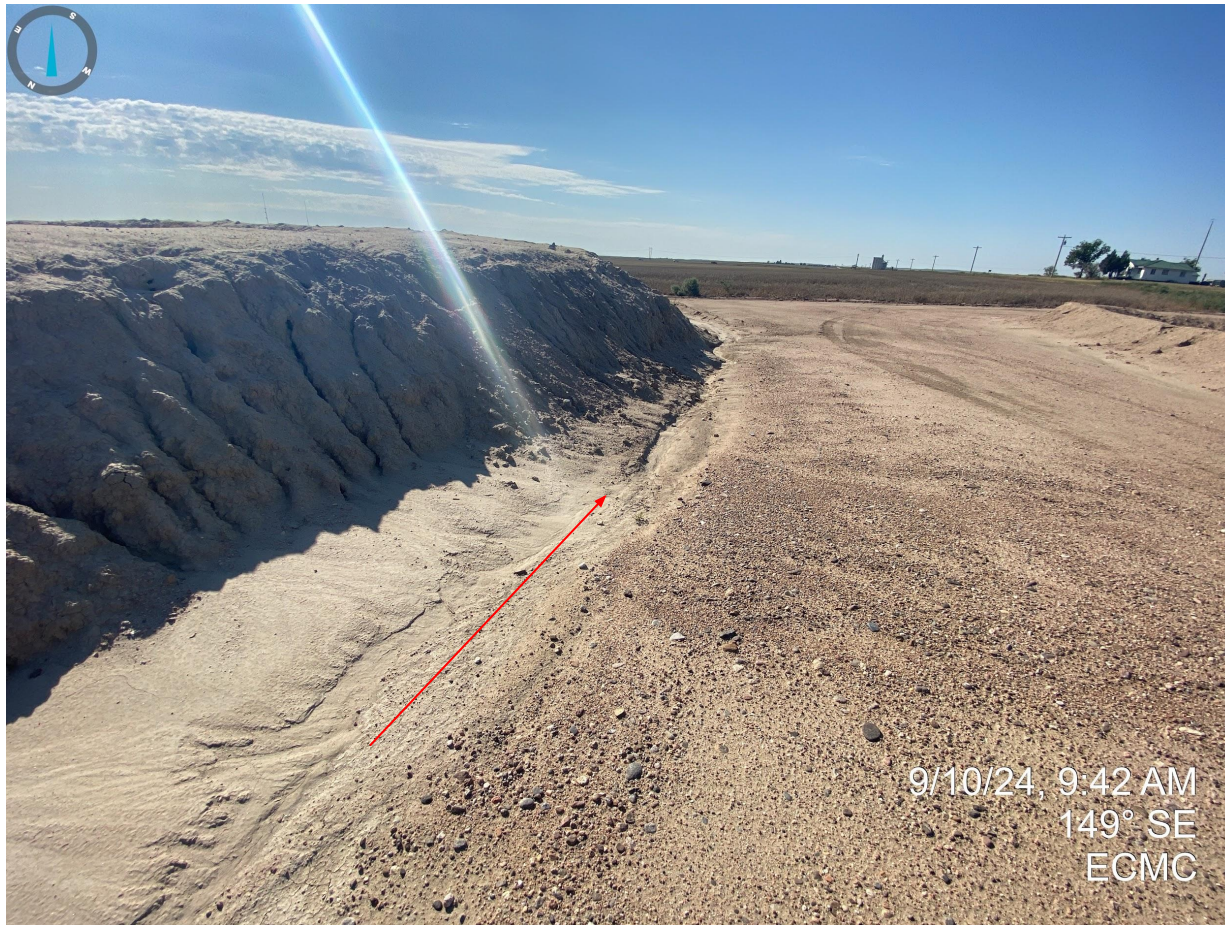
Photo 15. Continued from Photo 14; Erosion degradation observed on the western portion of the pit.

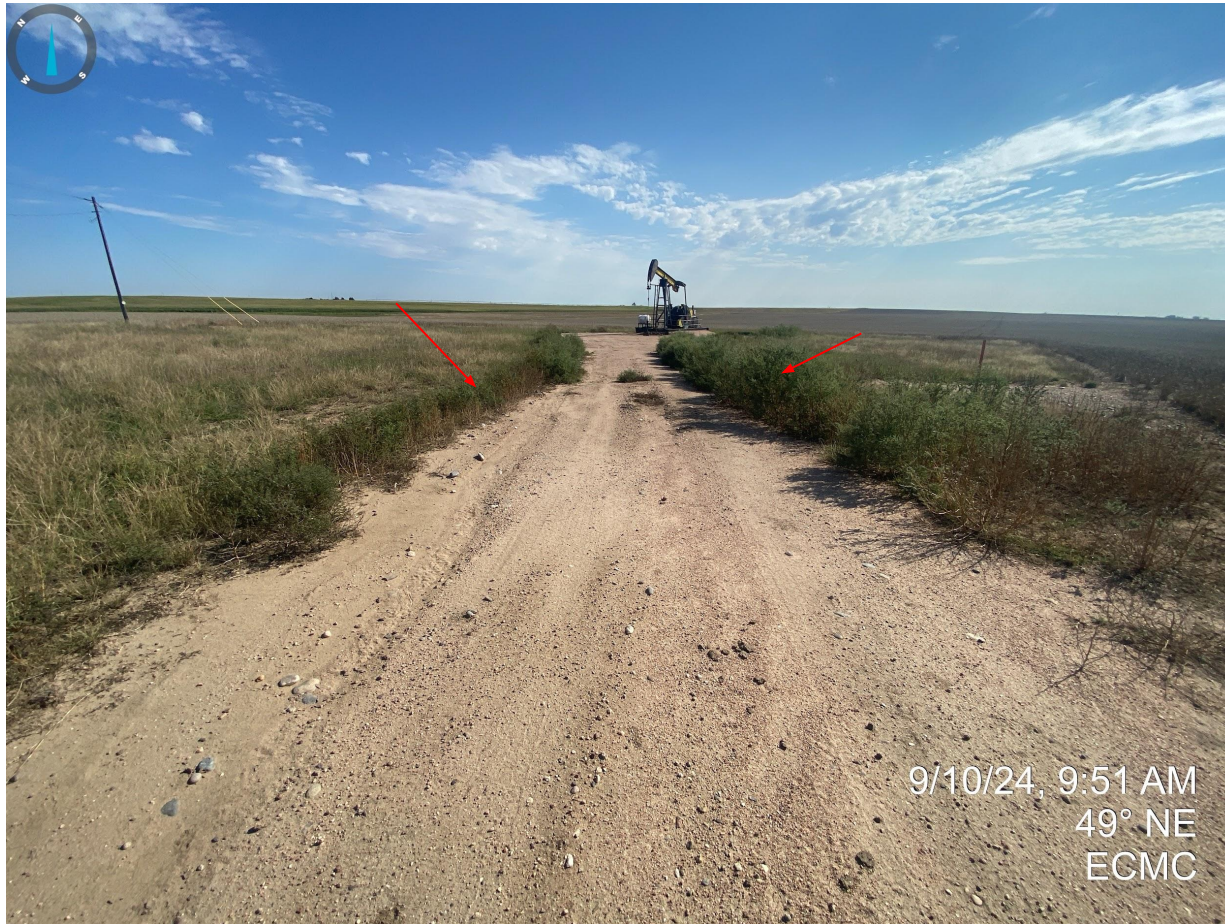
Photo 16. Undesirable vegetation observed along the access road to the well.

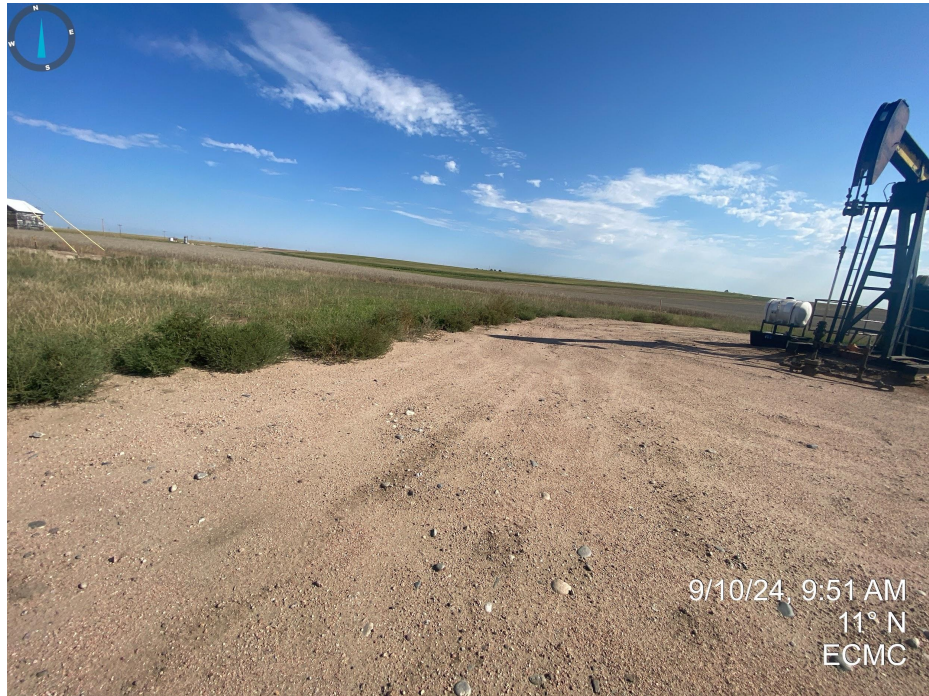
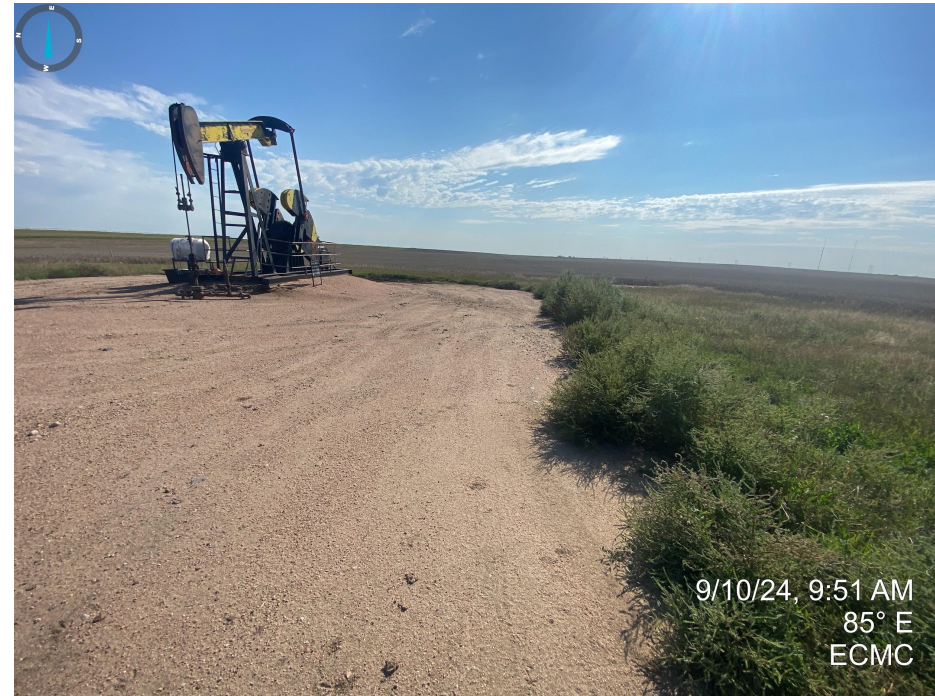
Photos 17 & 18. Undesirable vegetation observed around the well location.
