## Inspection Photos

Location Name: TEP Rocky Mountain LLC GIBSON GULCH UNIT 3-31B Pad

Location # 311685

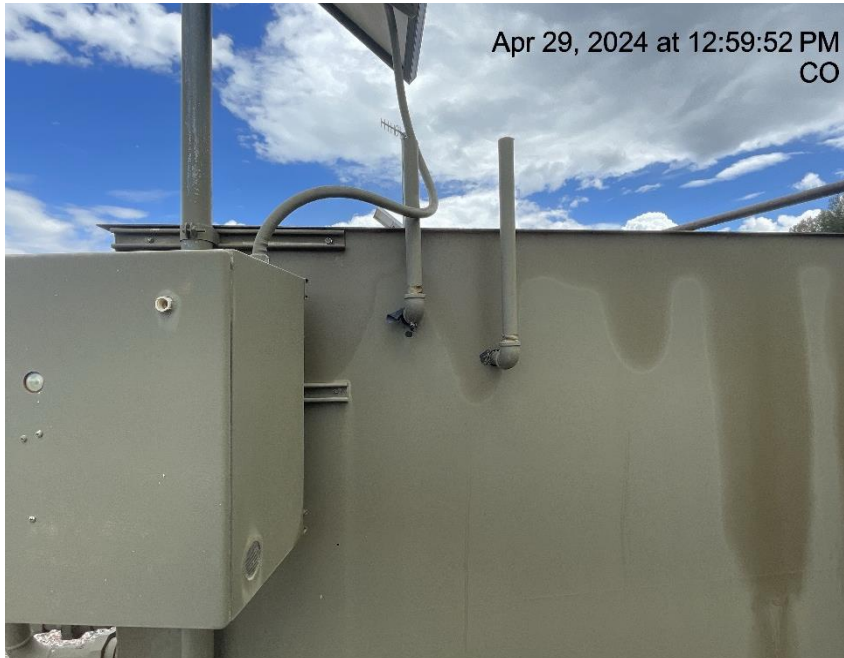
**Photo # 5373 From inspection 708903672 conducted on 04/29/2024 PRV & rupture disc vent lines do not comply with CECMC pressure safety device rules**

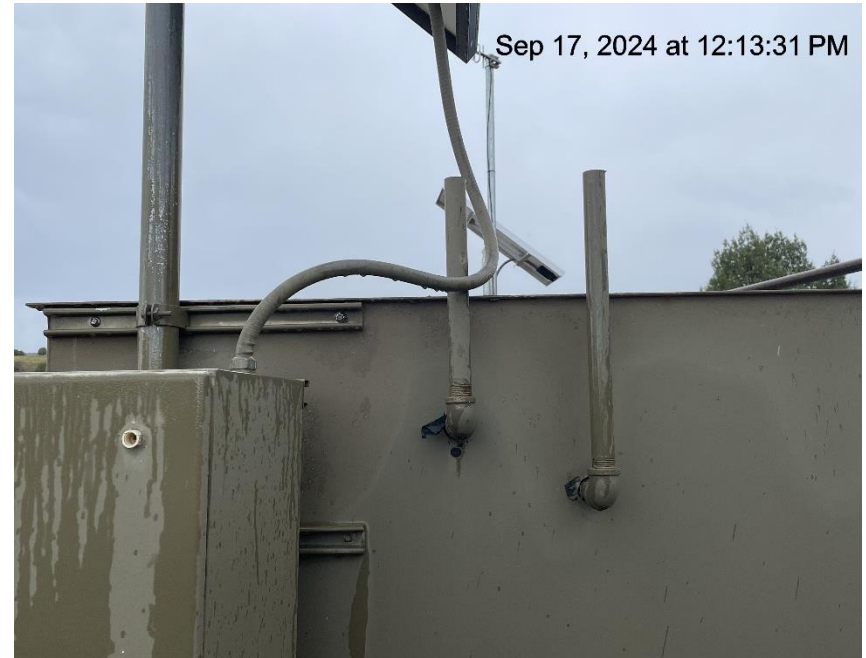
**Photo # 666 PRV & rupture disc vent lines do not comply with CECMC pressure safety device rules**

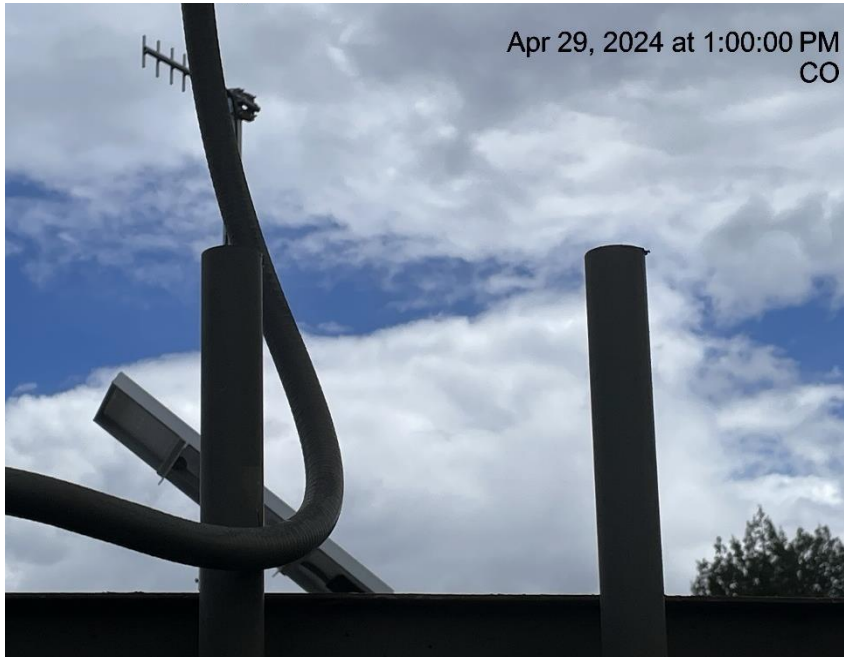
**Photo # 5374 From inspection 708903672 conducted on 04/29/2024 PRV & rupture disc vent lines do not comply with CECMC pressure safety device rules**

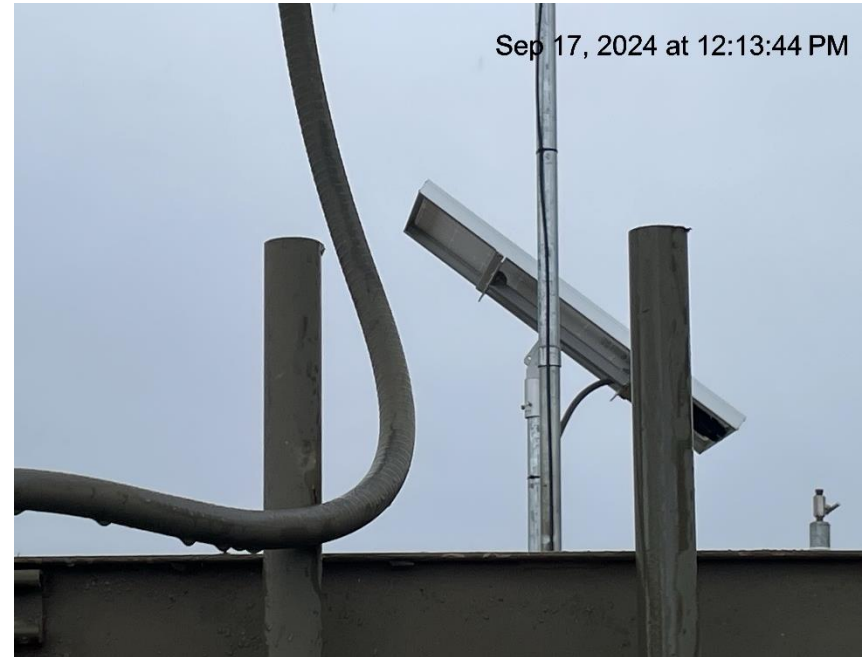
**Photo # 667 PRV & rupture disc vent lines do not comply with CECMC pressure safety device rules**

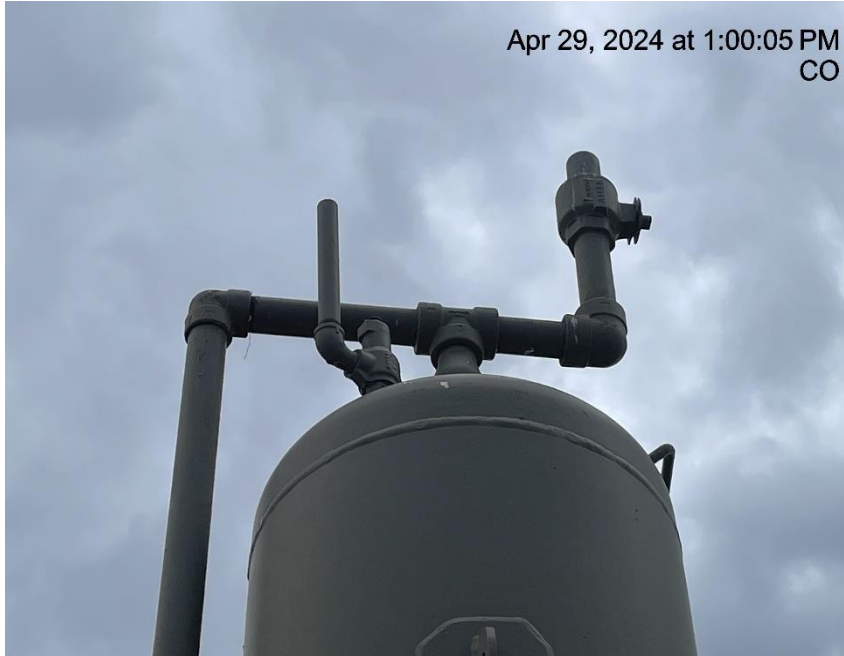
**Photo # 5375 From inspection 708903672 conducted on 04/29/2024 PRV vent line does not comply with CECMC pressure safety device rules**

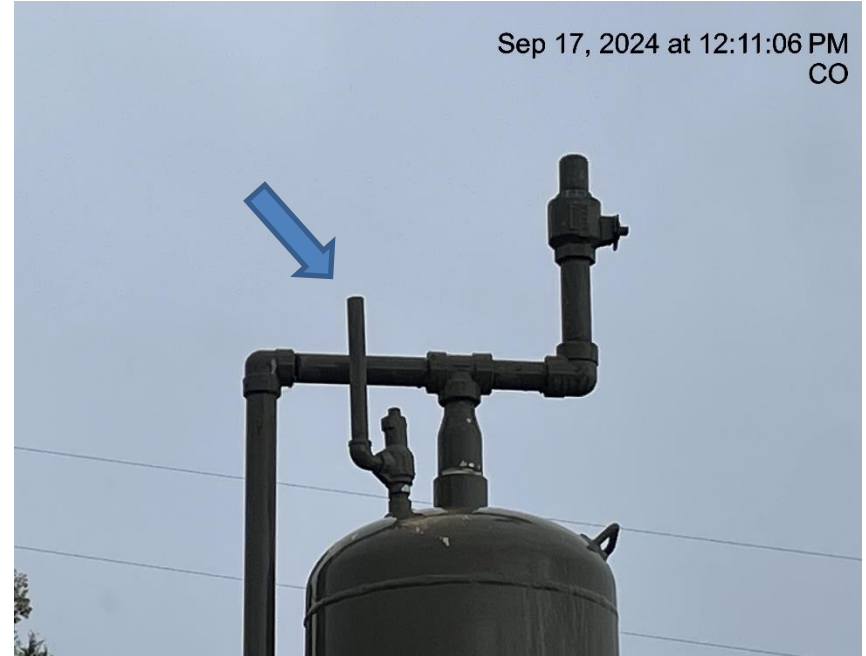
**Photo # 668 PRV vent line does not comply with CECMC pressure safety device rules**
