**Operator:** CPR

**Location Name:** CHAPIN 61N65W / 4 SESE

**Loc ID:** 331608

**Inspection:** 708201512

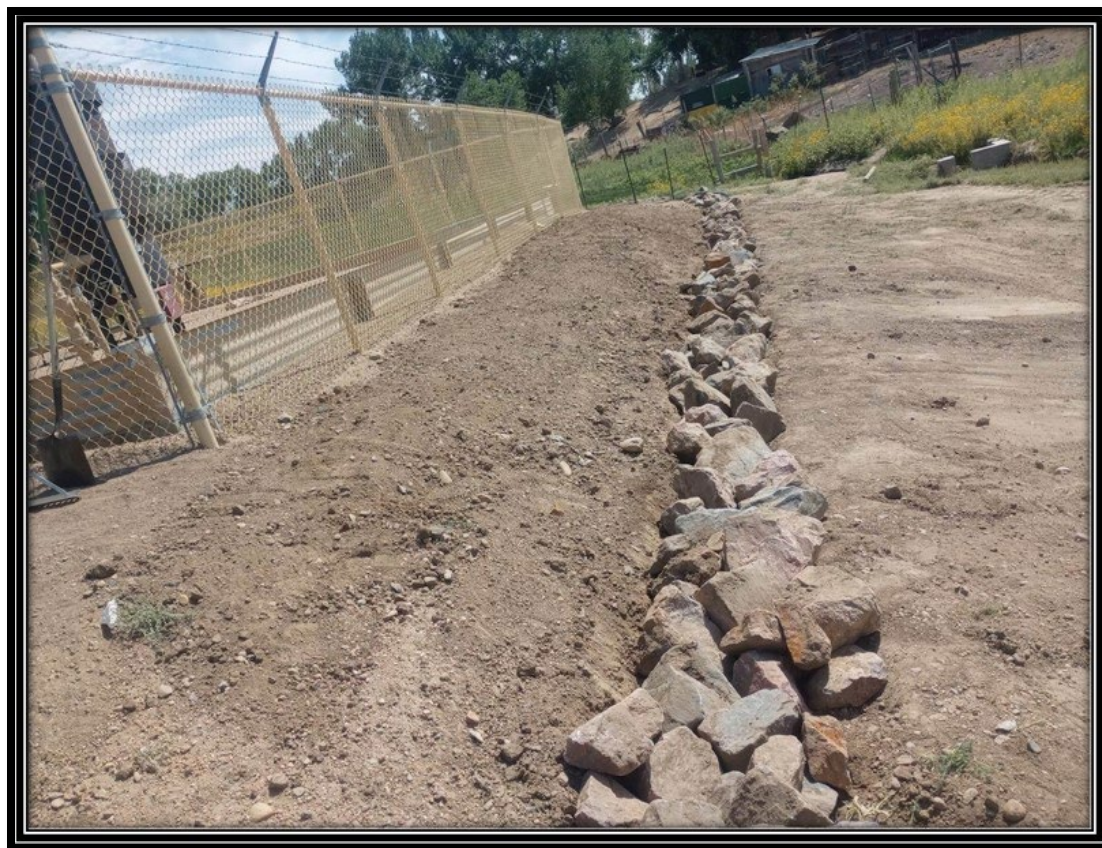
**CA:** This location does not comply with Rule 1003. During this inspection, it was observed that the interim areas do not appear to be progressing towards Rule 1003 regulations and standards with undesirable vegetation (Russian thistle) and CO ist B Noxious Weed (Russian olive) observed to be growing throughout. Additionally, production areas do not appear to be properly stabilized with erosion degradation observed (refer to Stormwater Section for additional information). Refer to attached inspection photos. Perform reclamation in accordance with Rule 1003. Establish vegetation with total perennial, non-invasive uniform plant cover of at least eighty (80) percent of reference area levels. se a seed mixture requested by the surface owner, or a mixture prescribed by the local county NRCS. Ensure erosion controls are implemented to stabilize the seeded soil and continue to monitor and manage this site until the location meets Rule 1003 standards.

**CA Resolution:** Operator has reported that the location has also been mowed, line trimmed. It has also been noted that the road base removal and seeding has been scheduled.

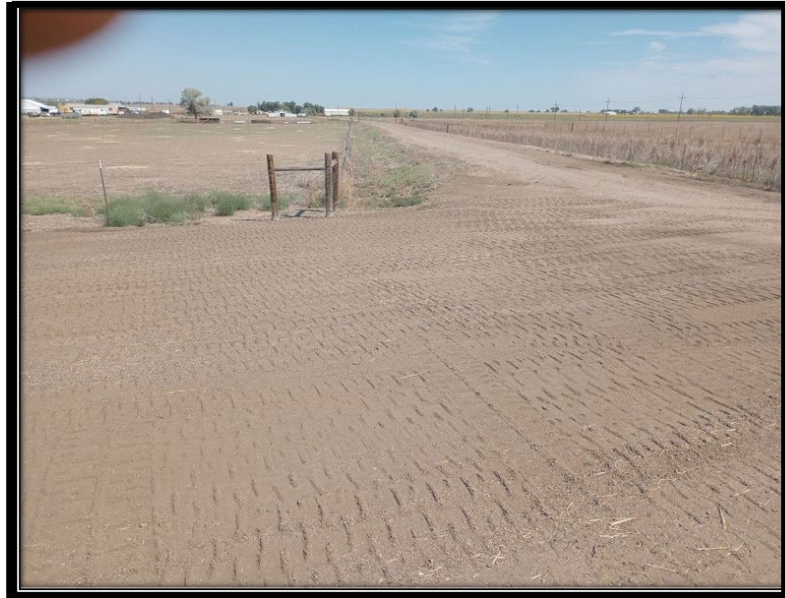
**CA:** This location does not comply with Rule 1002.f. During this inspection, it was observed that the western portions of the pad are experiencing erosion degradation (e.g. gullyng) with evidence of sediment deposition outside of the location. The pad seems to have been extended beyond the original well footprint and has not been reclaimed since the well was plugged and abandoned. Once final reclamation activities are completed for the former well location, the area will need to have adequate stormwater BMPs to manage stormwater for the reclaimed portions. Refer to attached inspection photos. Comply with Rule 1002.f.

**CA Resolution:** Operator has reported that identified areas of erosion have been appropriately stabilized and riprap refreshed to comply with Rule 1002.f.
