Inspection Photos

Operator: Hilcorp Energy Company - 10133

Location ID: 325820

Inspection Photos
Location Name: Huber Burkett 1-25
Location ID: 325820

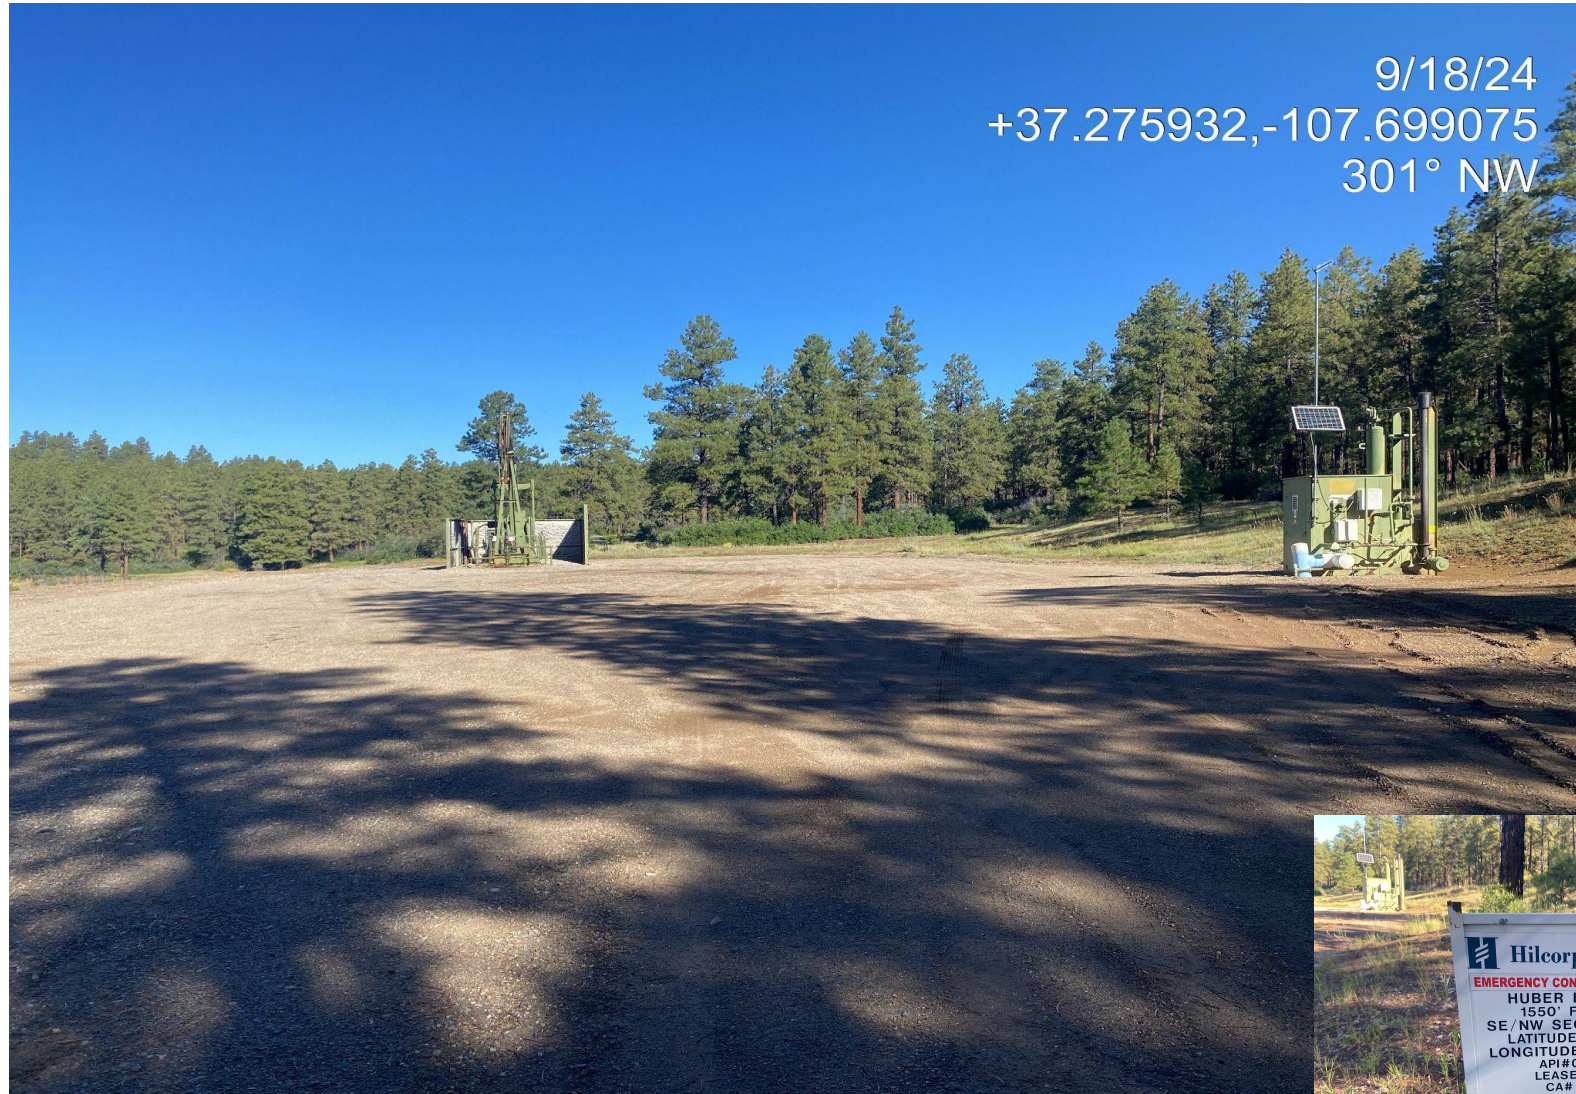
Photo 1. View of the well pad taken from the access point facing center.

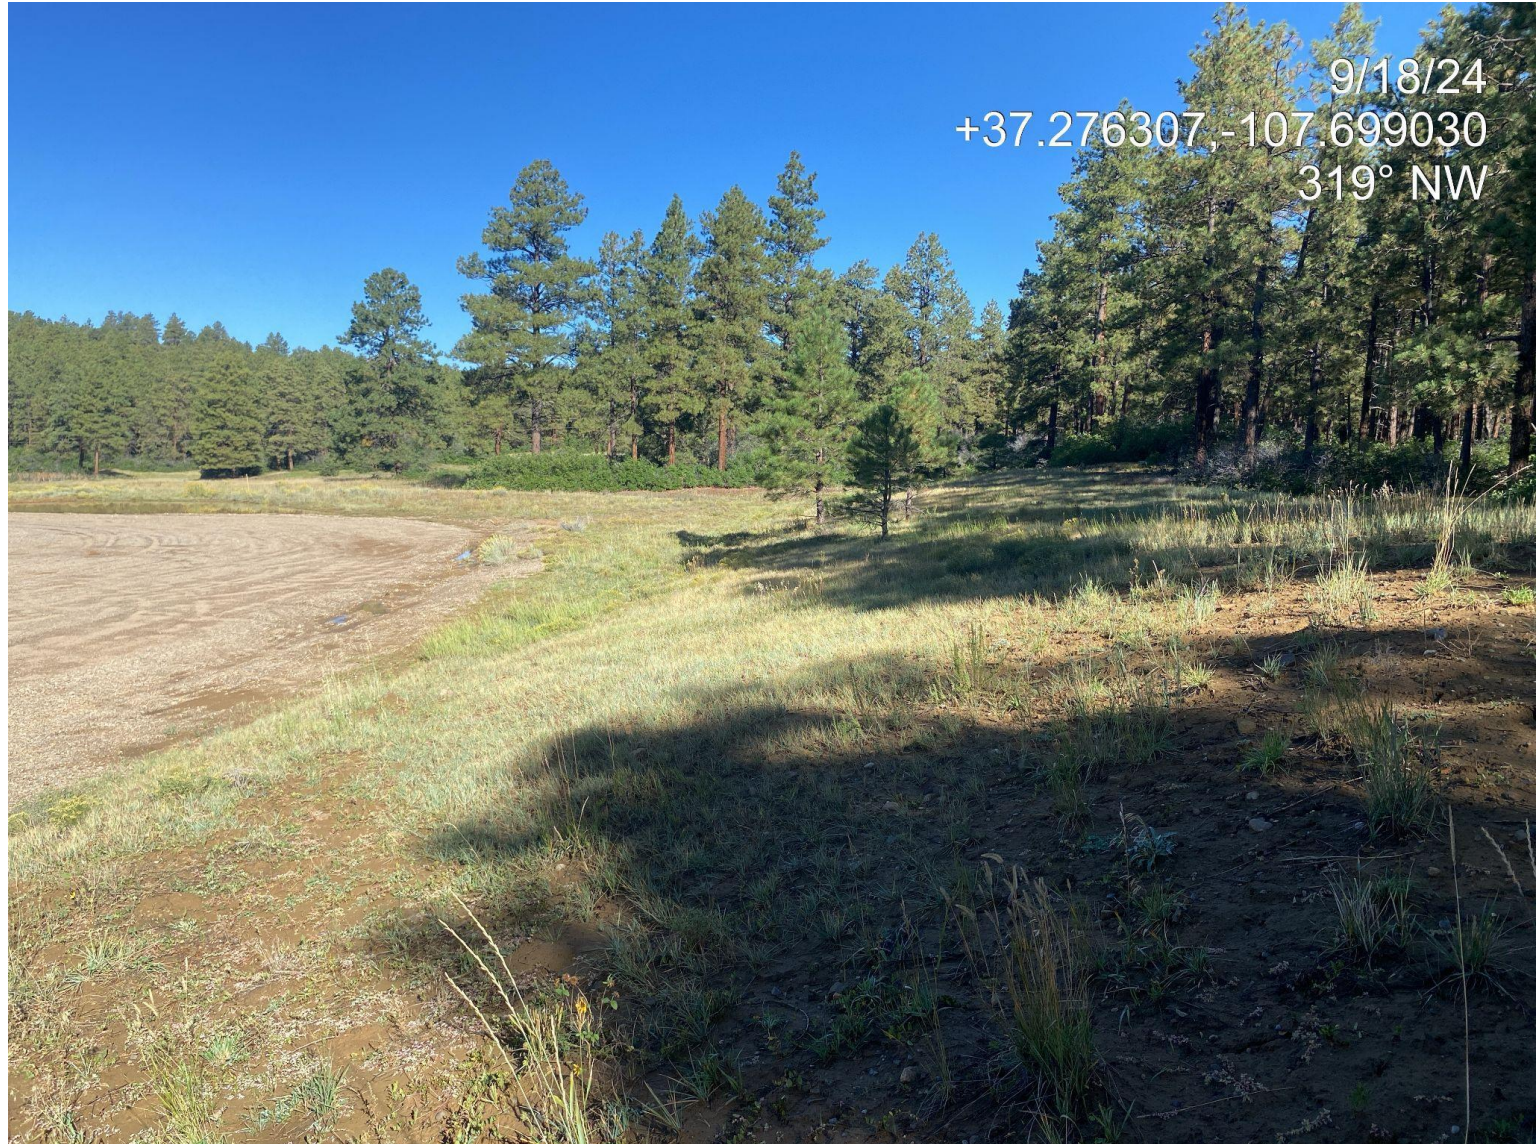
Photo 2. View of the northern interim reclamation area facing northwest.

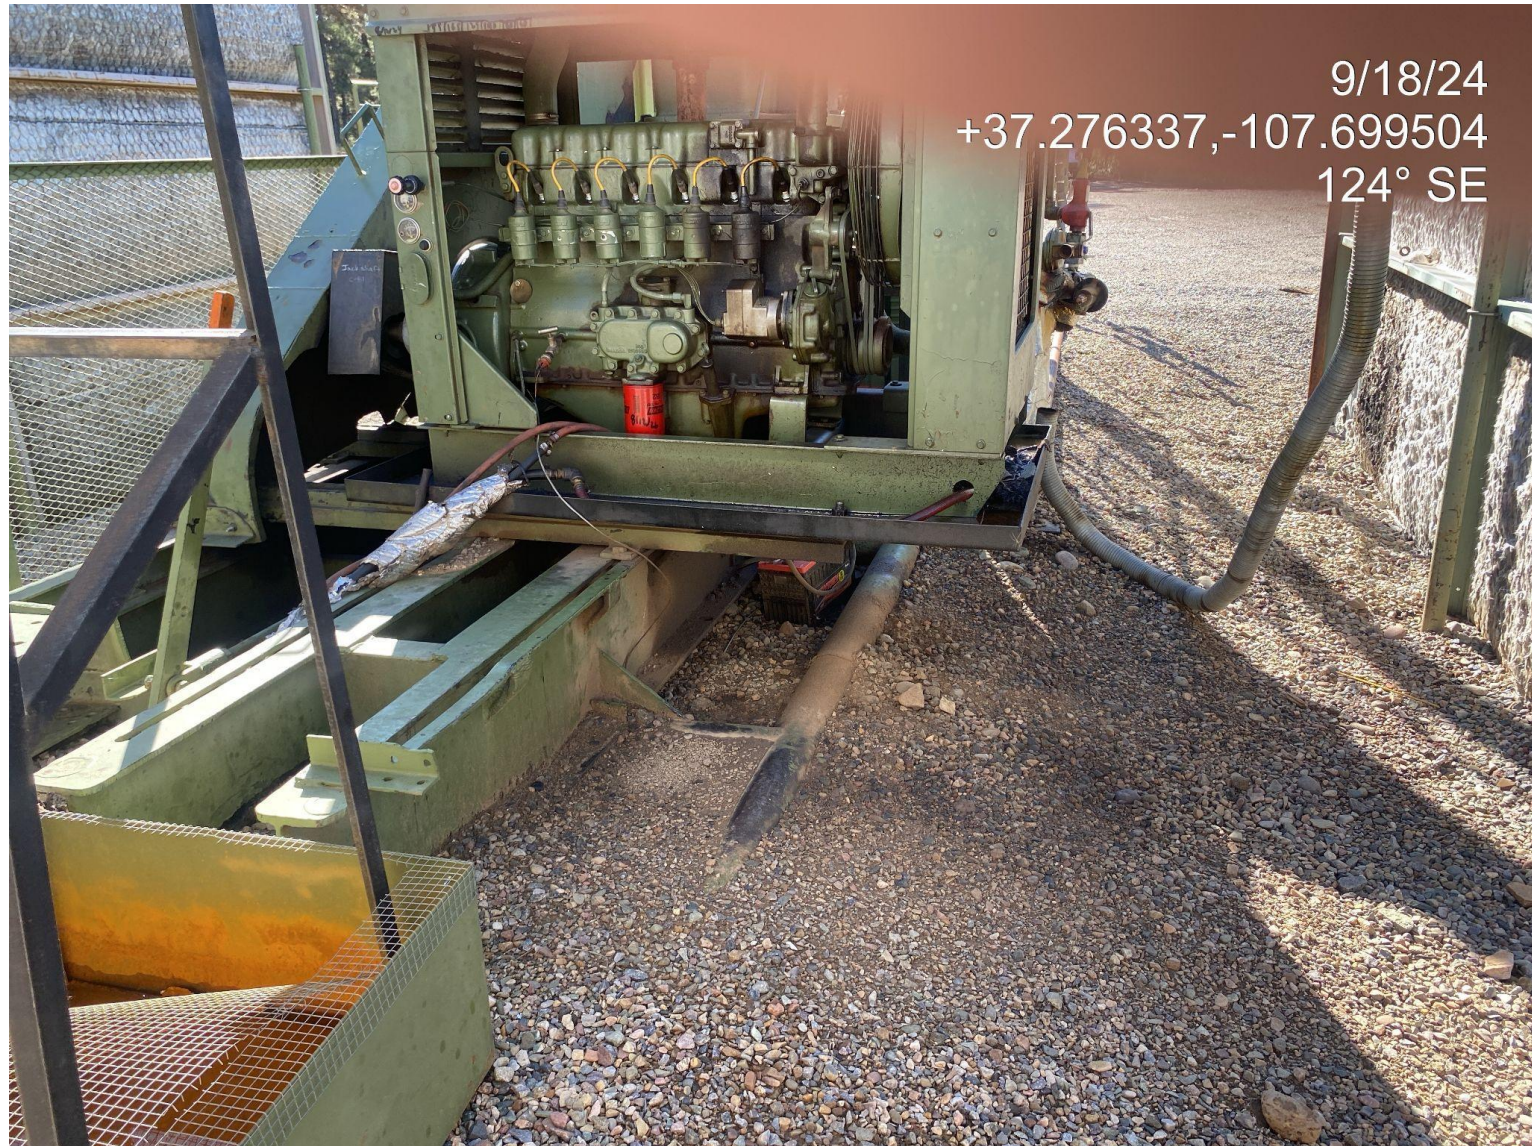
Photo 3. Impacted surface material corrective action identified in the previous inspection doc #690204344 has been addressed/resolved.

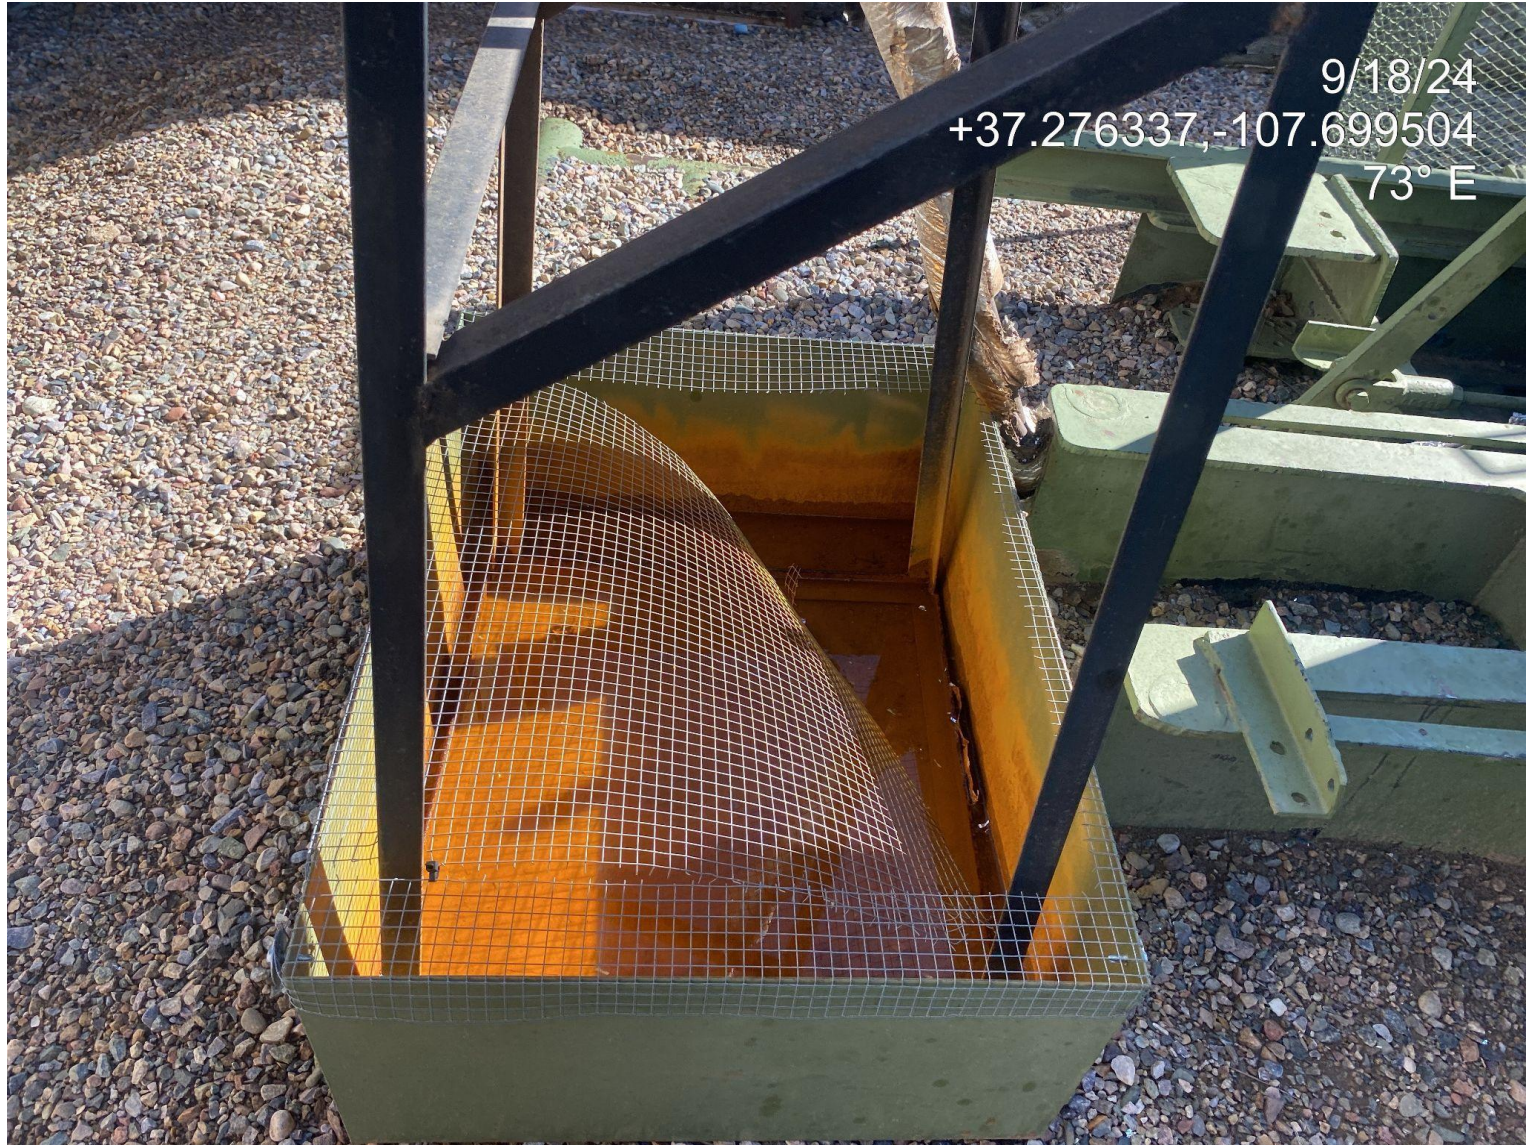
Photo 4. Wildlife BMP at chemical tank secondary containment is damaged and no longer functioning, maintenance is needed.

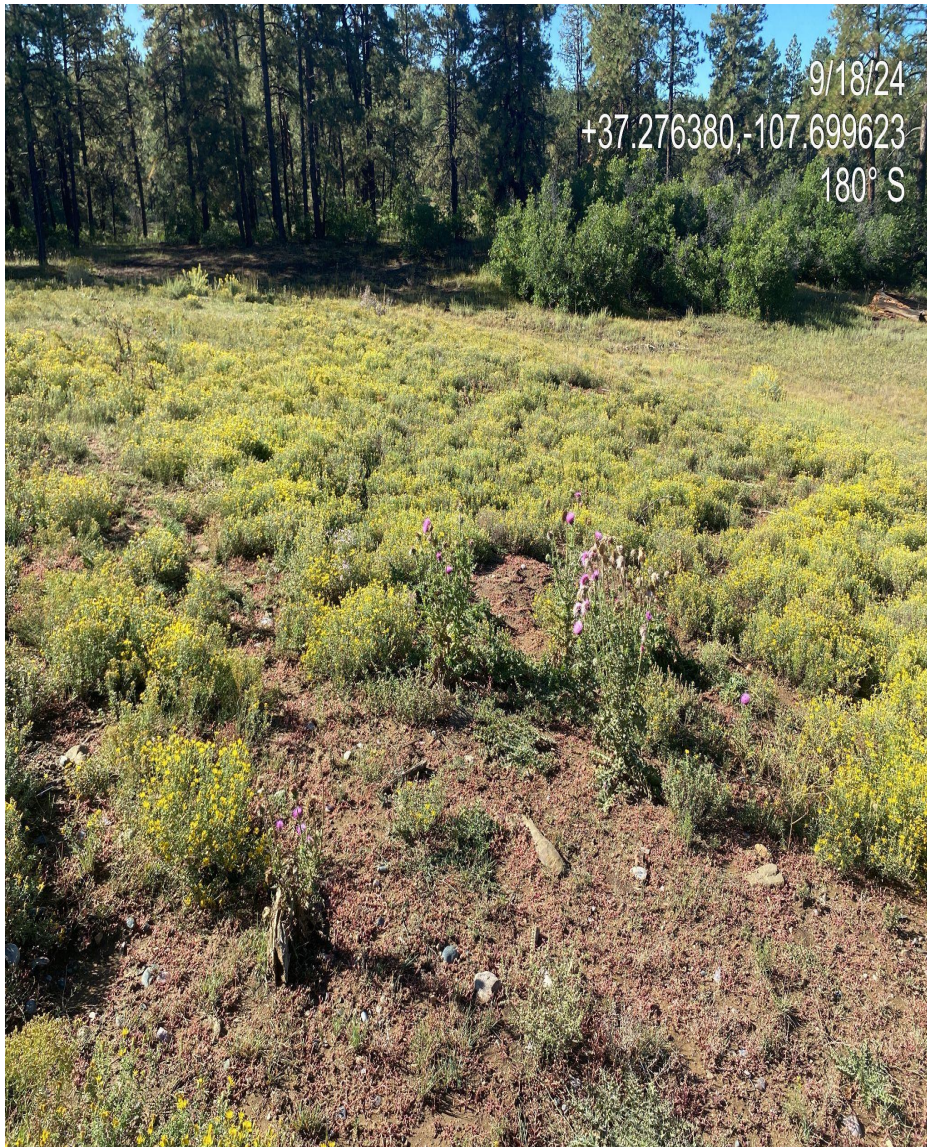
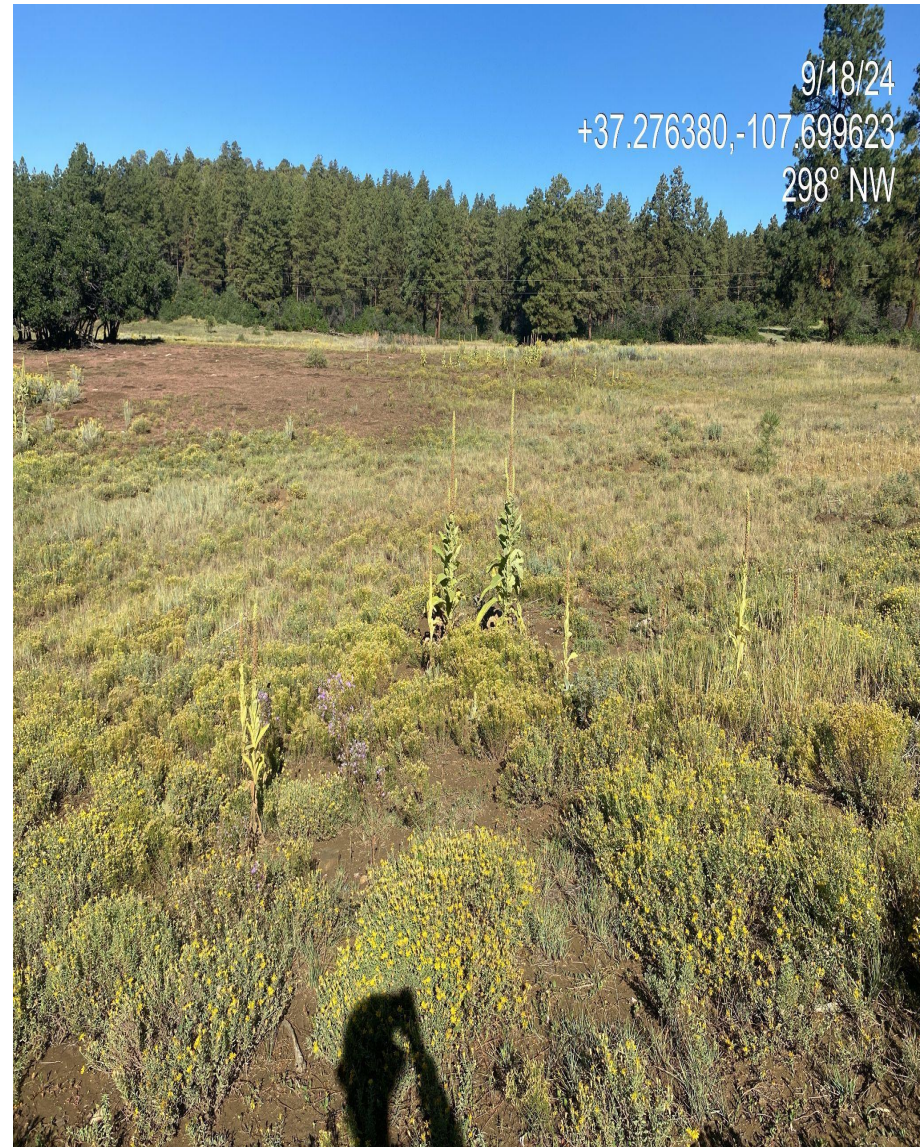
Photo 5. View of flowering Muks thistle and Mullein observed in the southern interim reclamation area.

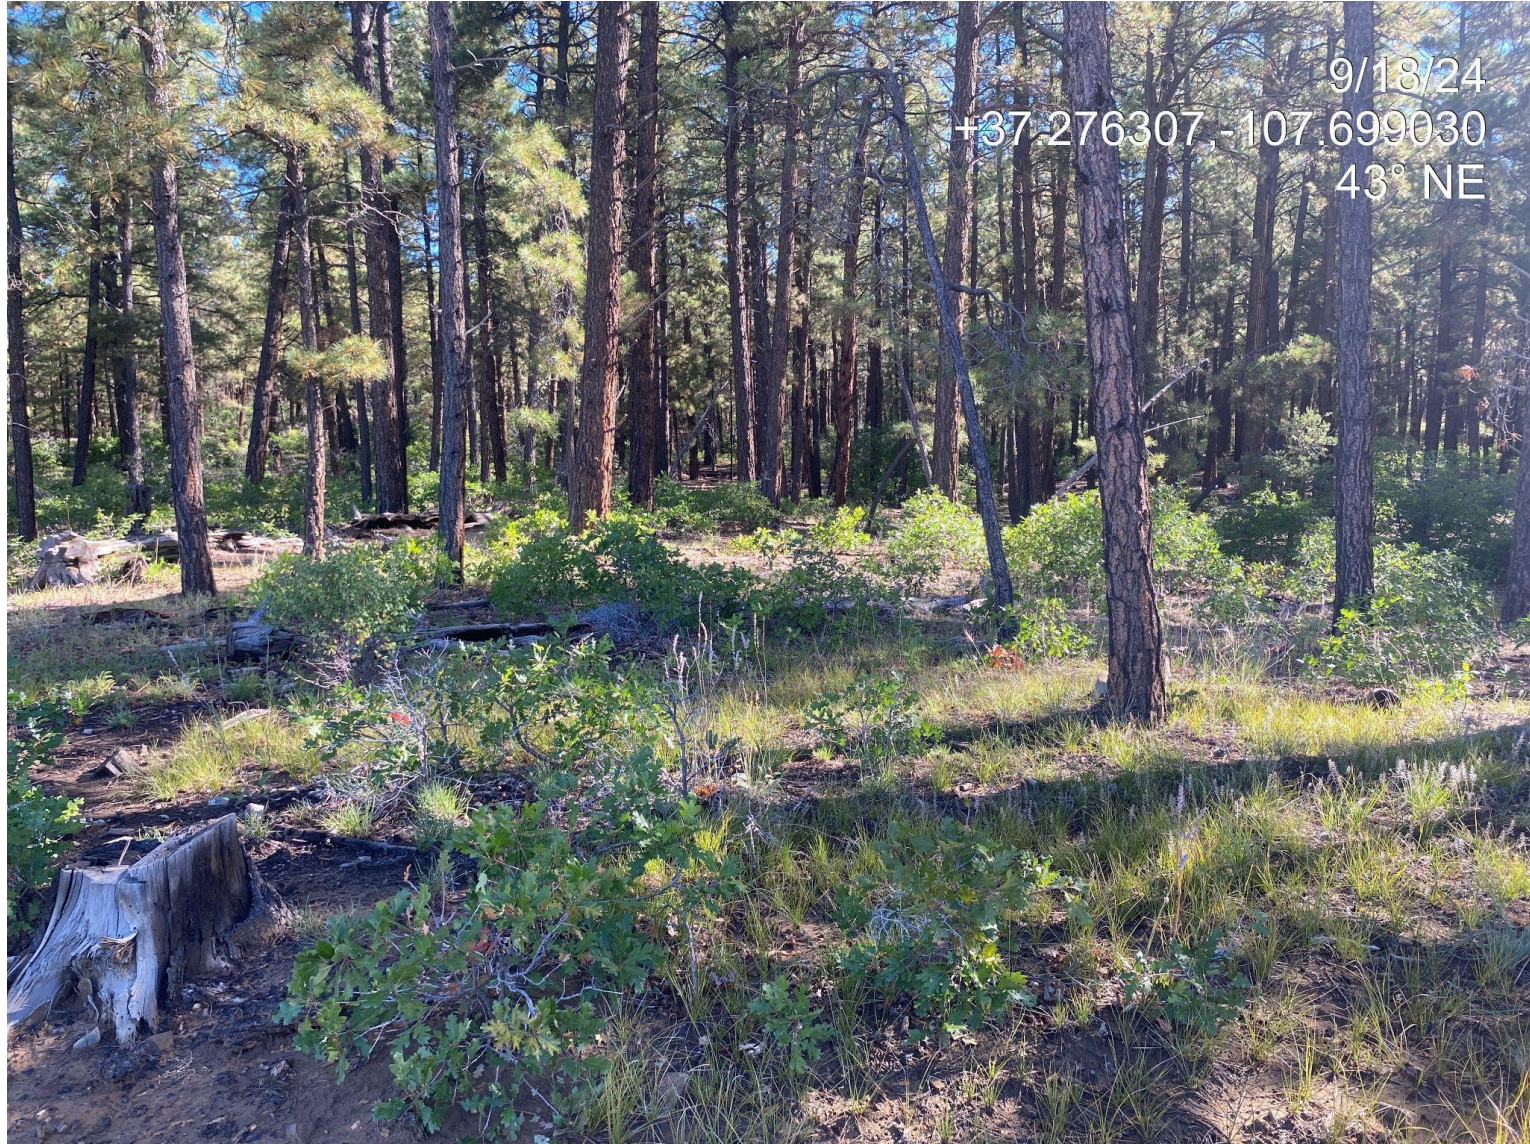
Photo 6. Reference area comprised of Gambel oak, Pine and Squirrel tail.
