Inspection Photos

Operator: Hilcorp Energy Company - 10133

Location ID: 326512

Inspection Photos
Location Name: Huber Burkett 3-25
Location ID: 326512

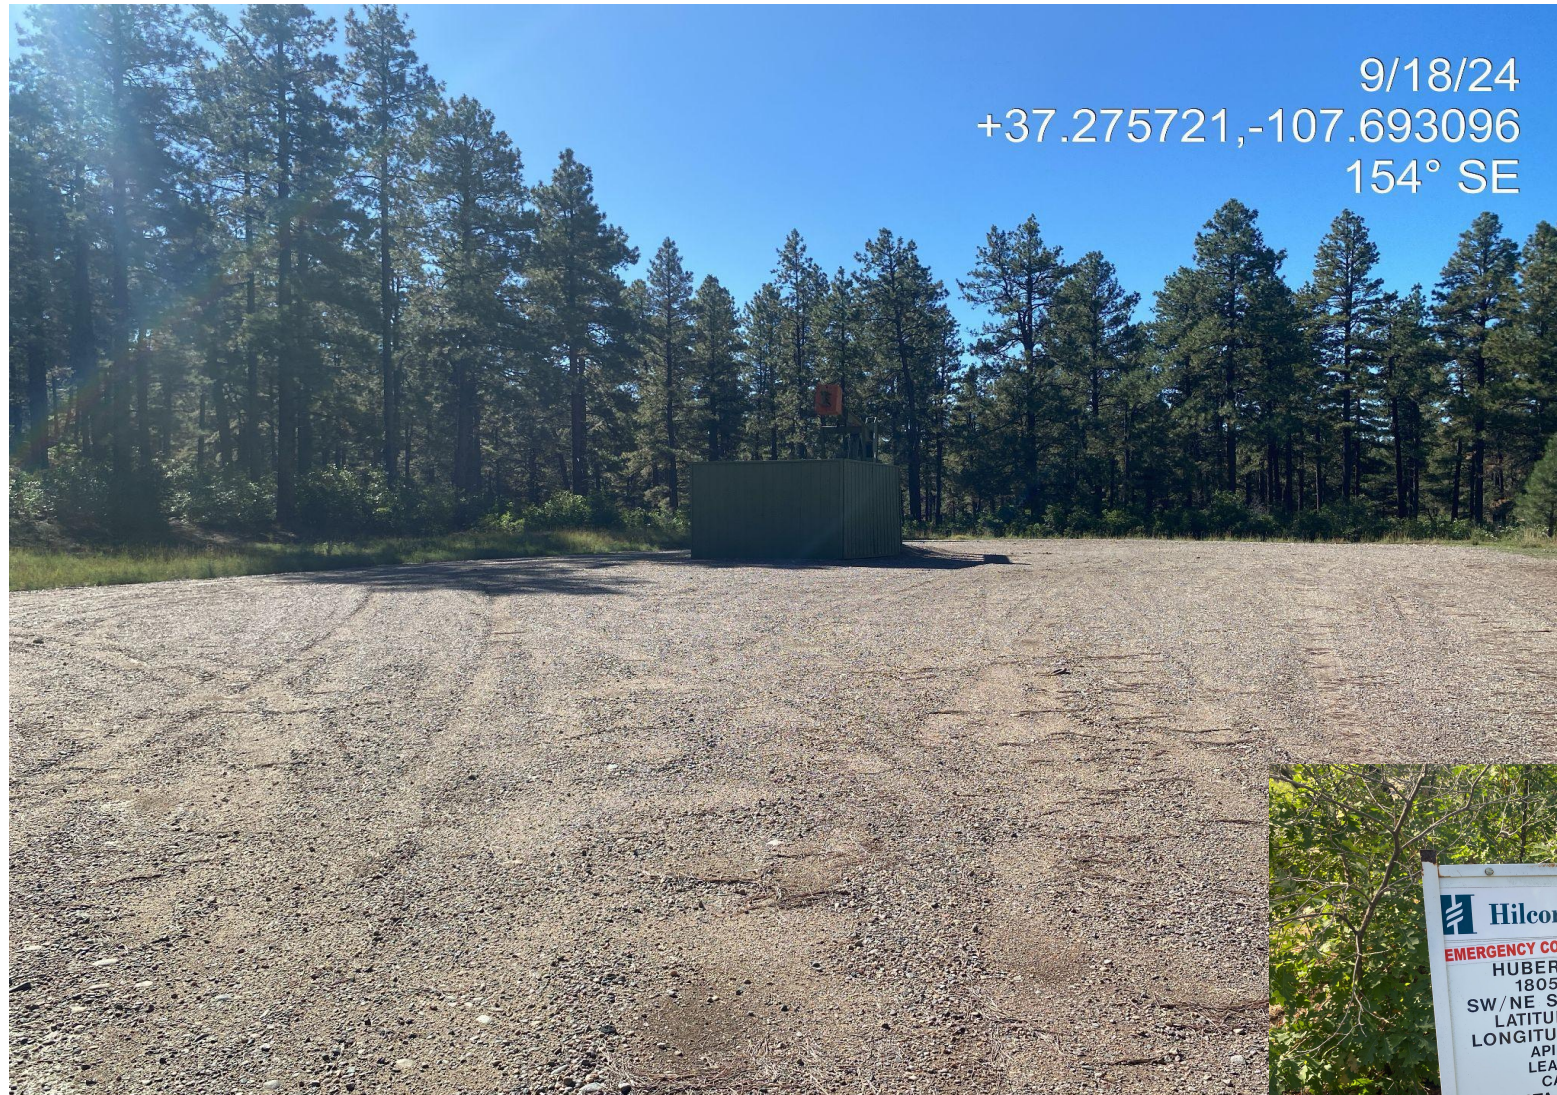
Photo 1. View of the well pad taken from the access point facing center.

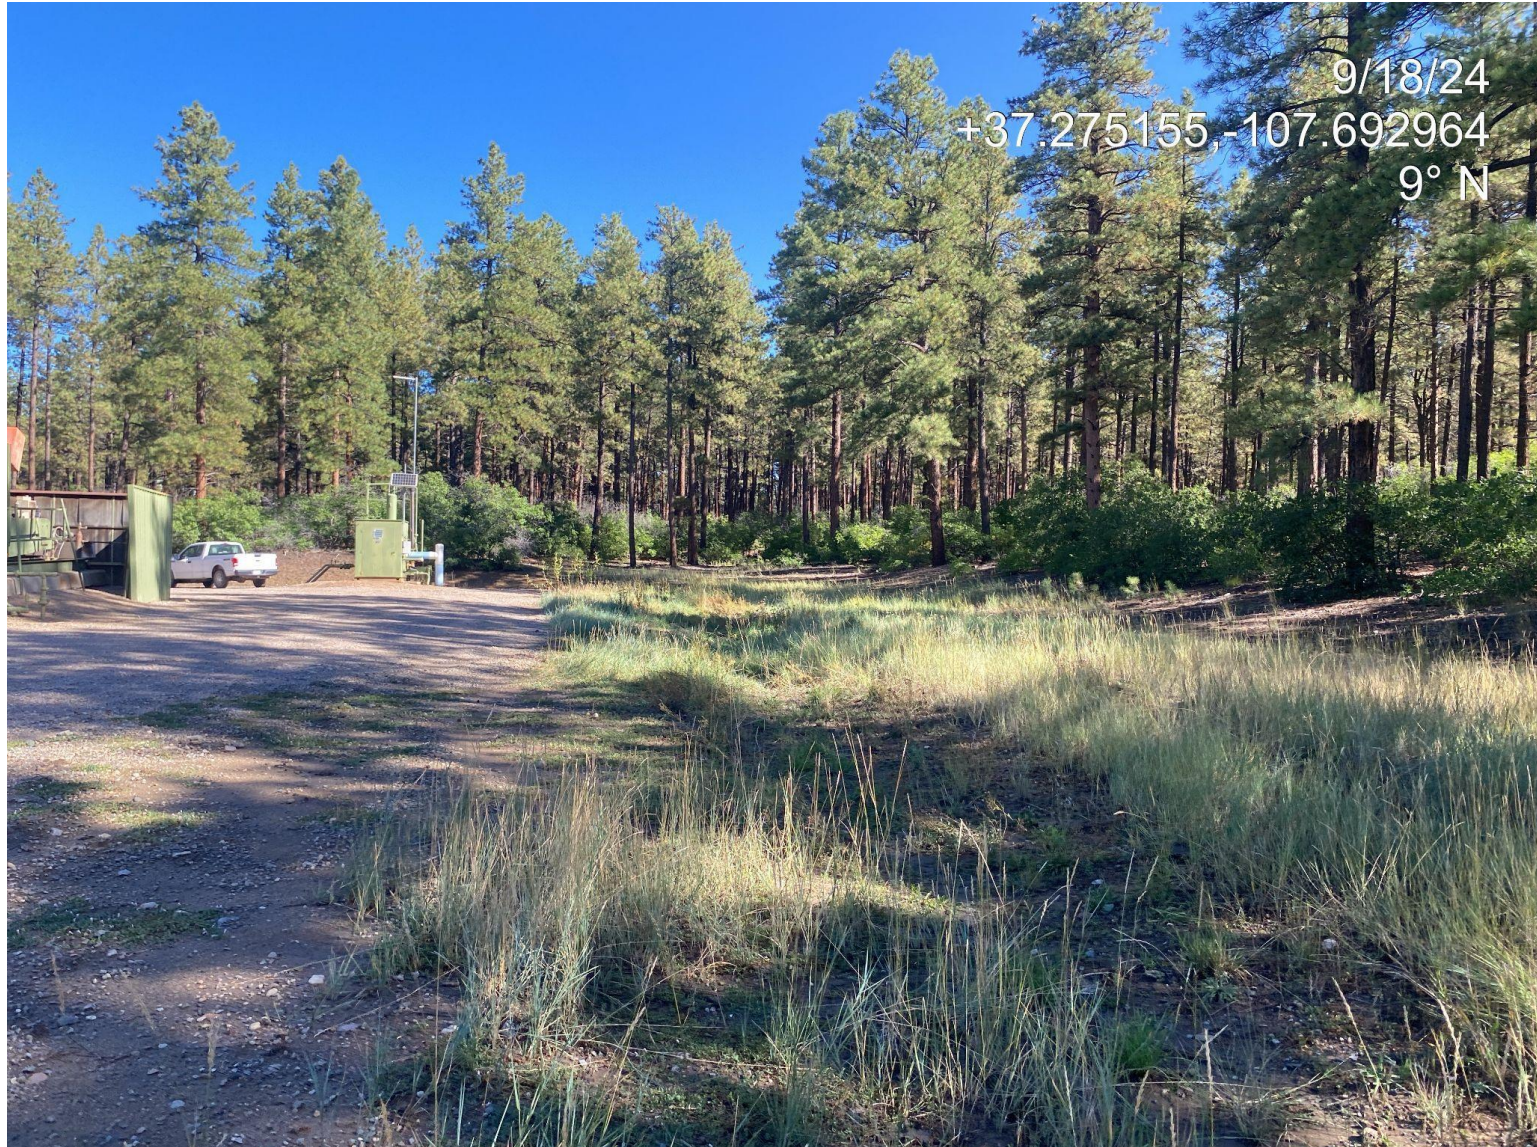
Photo 2. View of the eastern interim reclamation area facing north.

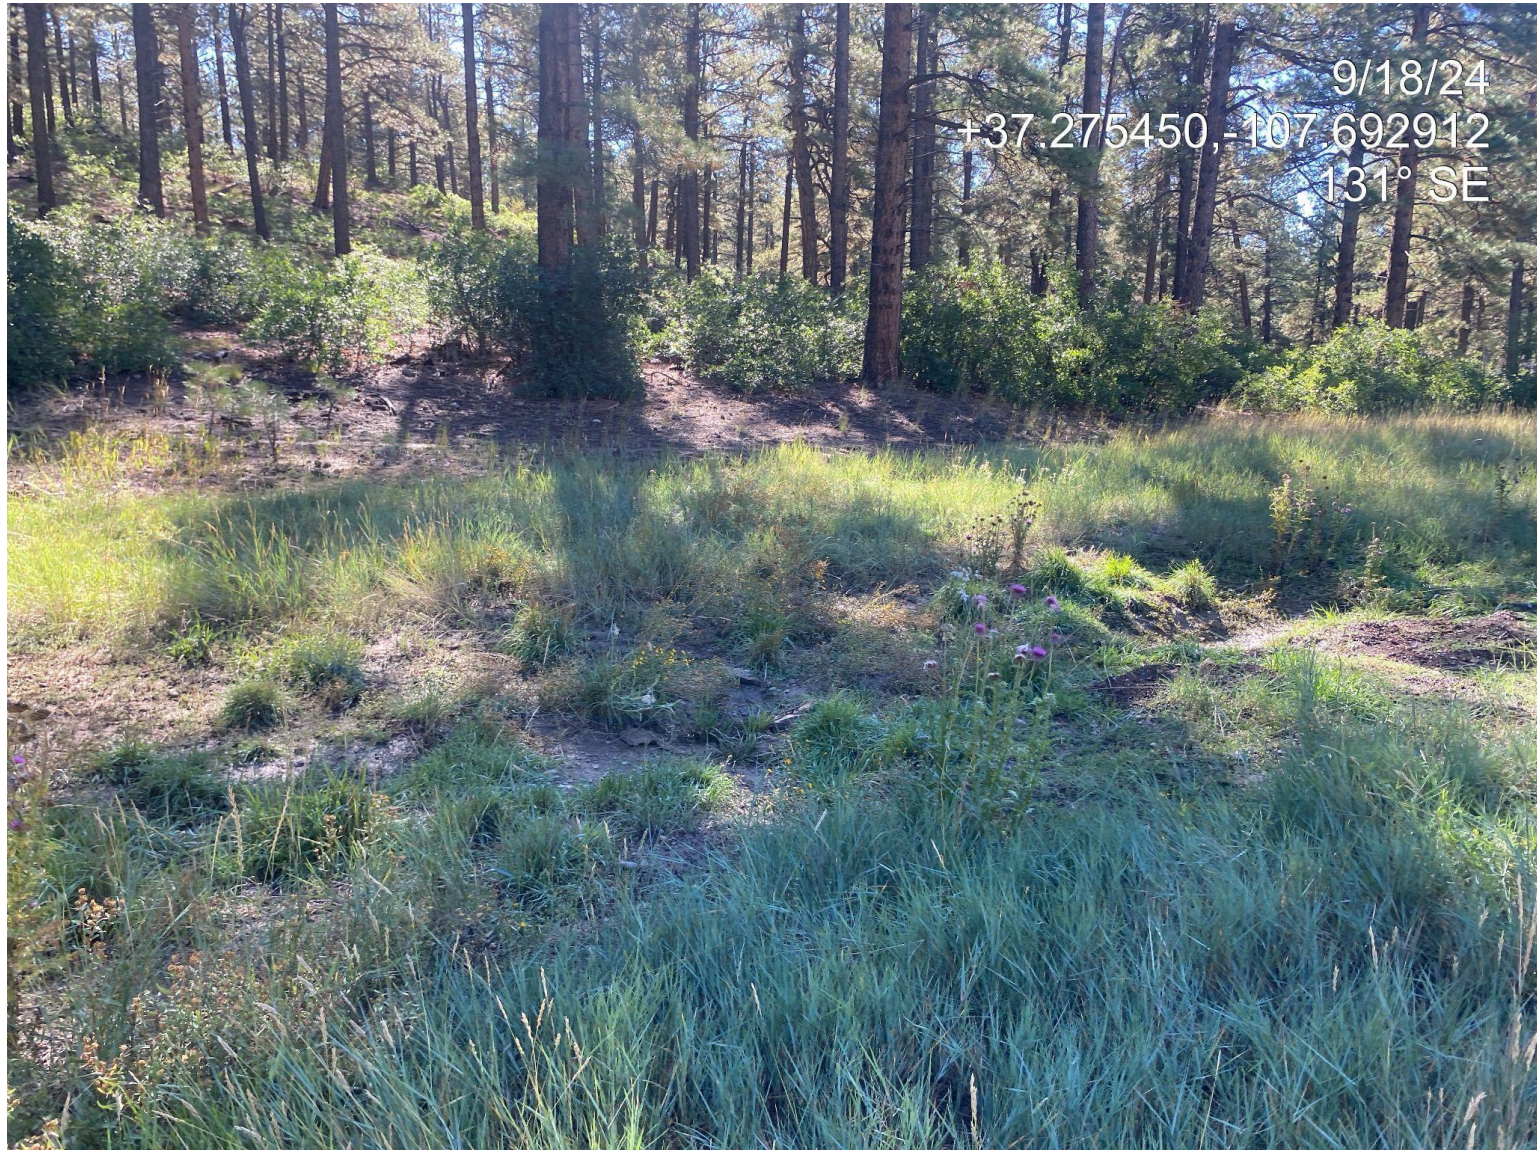
Photo 3. Patch of flowering Musk thistle observed in the southern interim reclamation area.

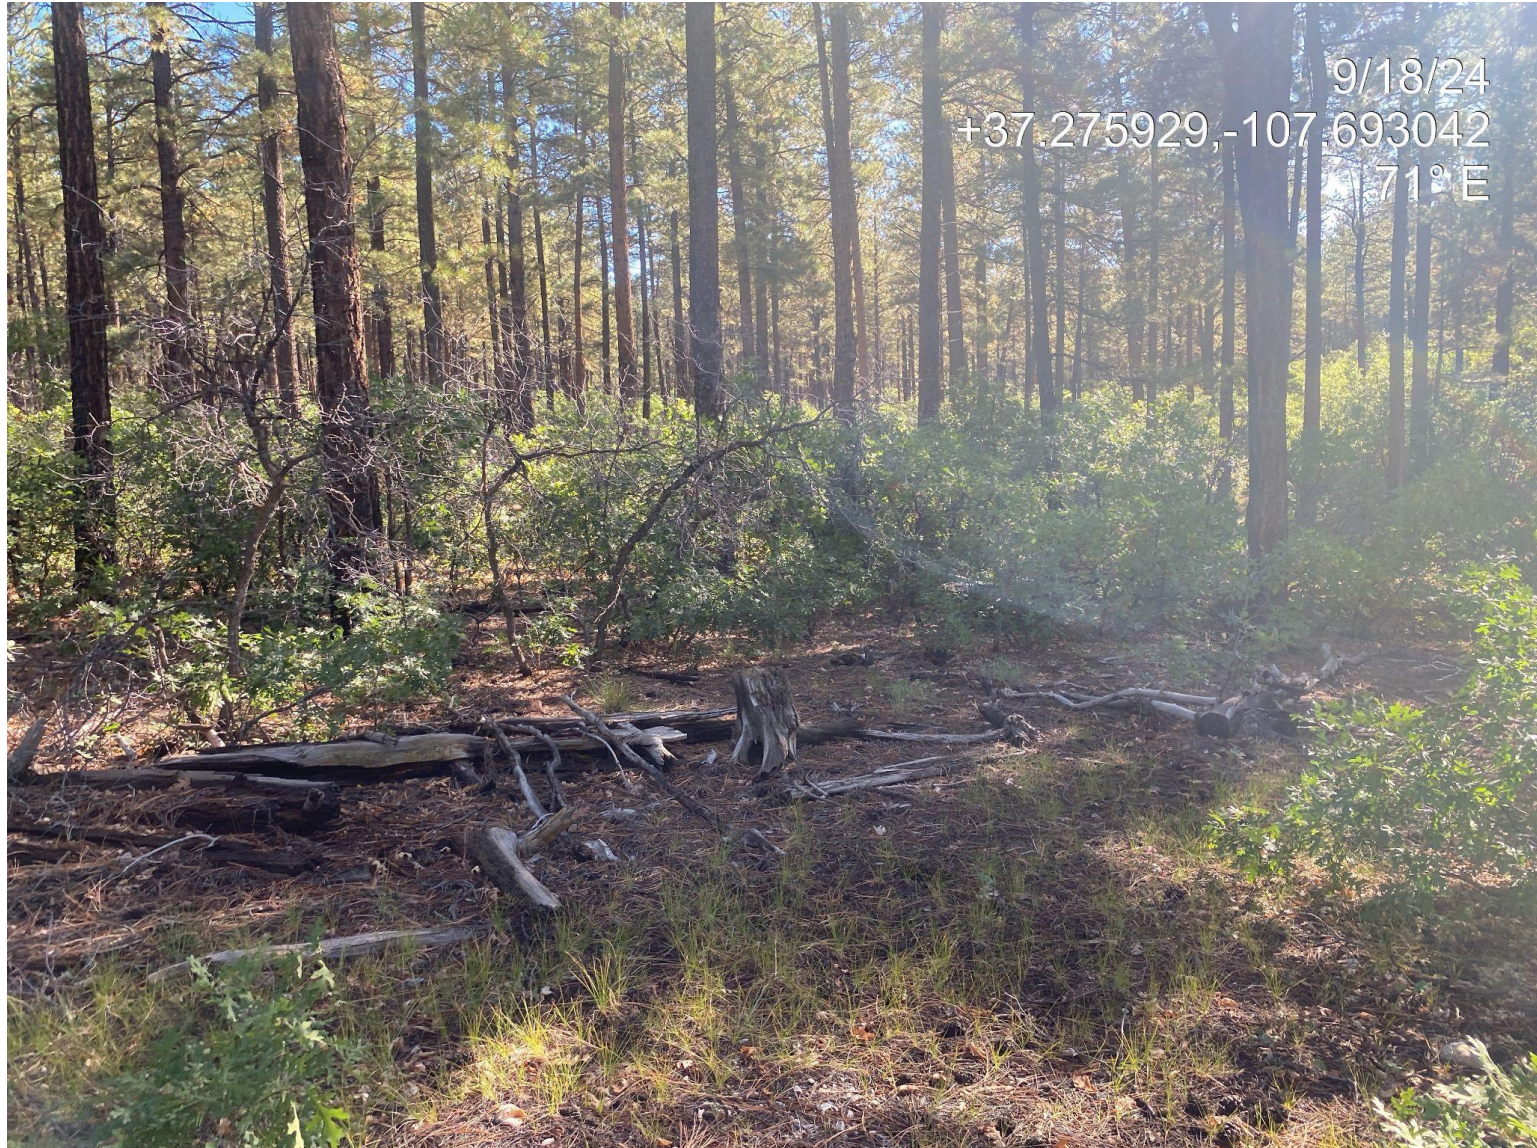
Photo 5. Reference area comprised of Gambel oak, Pine and Squirrel tail.
