Interim Reclamation and Stormwater Inspection

Date: 9/16/24

Operator: PDC Energy Inc - 69175

Location ID: 484682

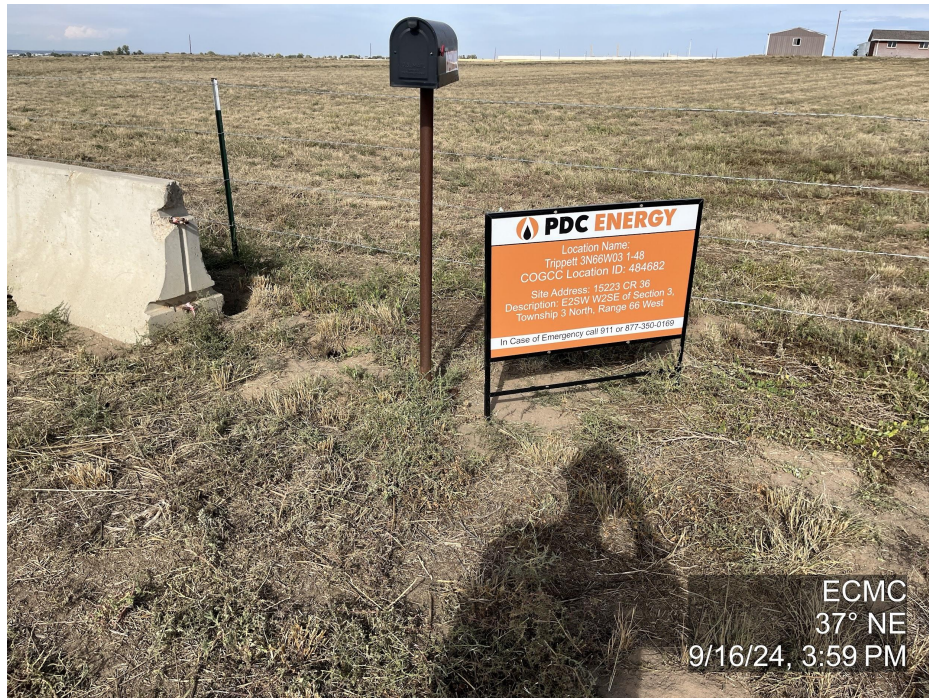
Photo 1. The photo was taken at the well location facing Northeast. The photo illustrates the Operator location sign and forms mailbox.

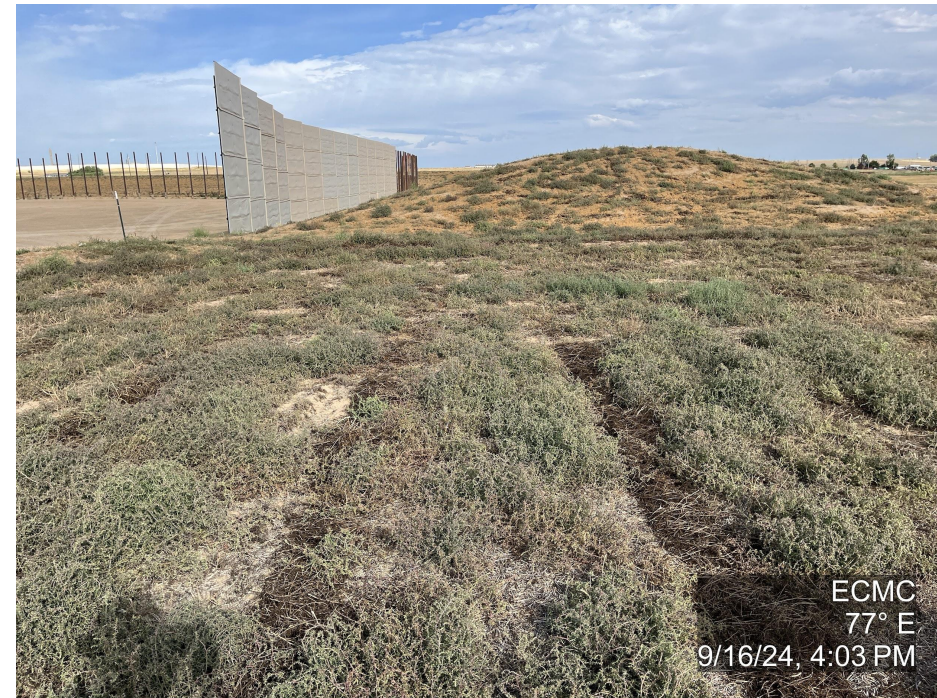
Photo 2. The photo was taken at the well location facing East. The photo illustrates the topsoil stockpile and other areas of disturbance outside of the drilling pad are dominated by Russian thistle, Kochia and puncturvine.

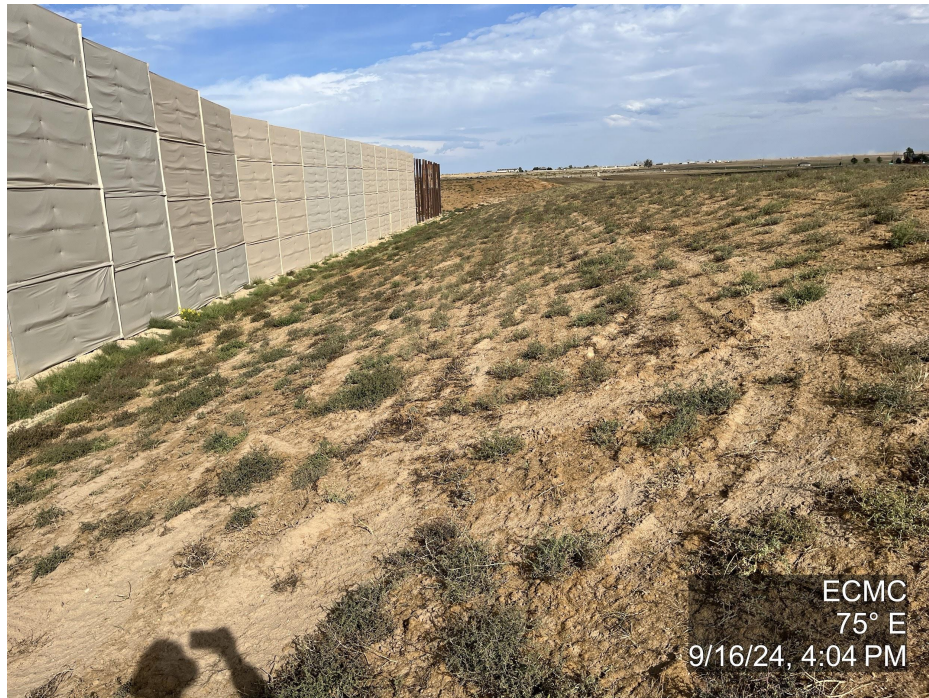
Photo 3. The photo was taken at the well location facing East. Refer to the comment for photo 2.

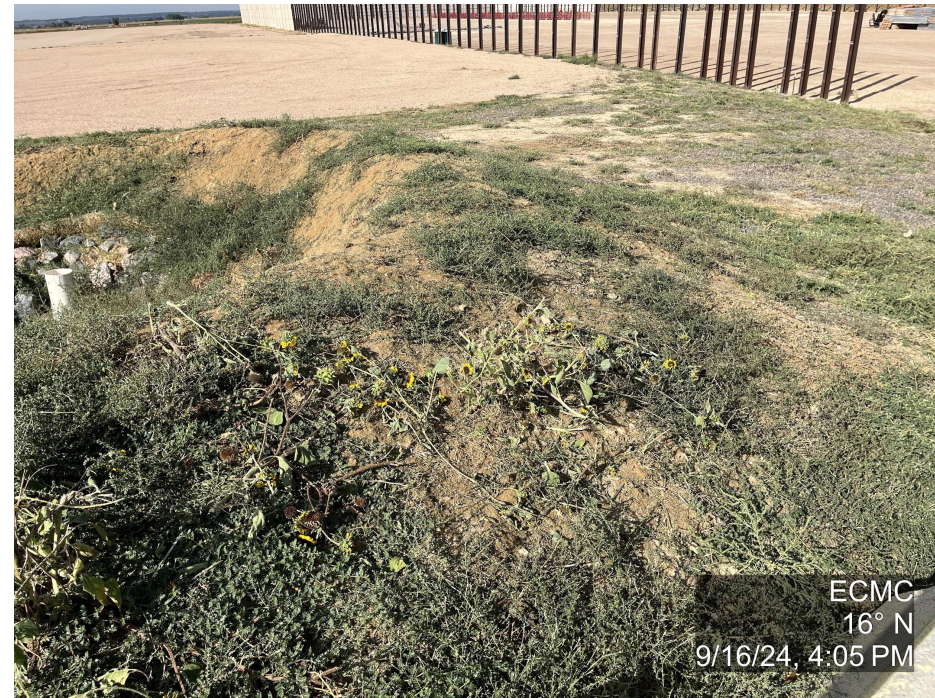
Photo 4. The photo was taken at the well location facing North. The photo illustrates puncturvine dominates areas of previously bare soil around the sediment trap on the South side of the location.

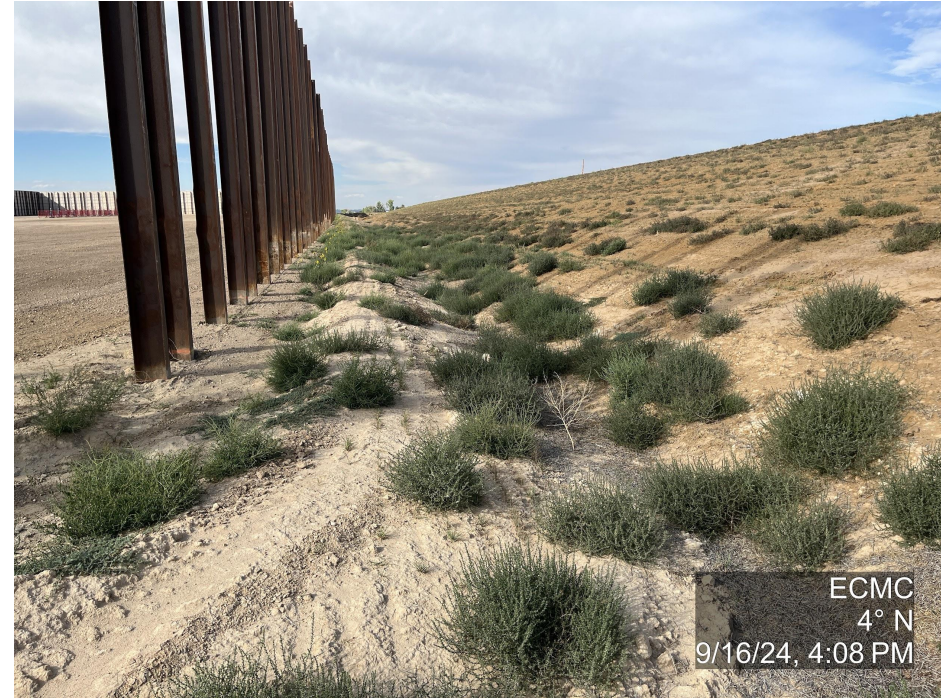
Photo 6. The photo was taken at the well location facing North.
Refer to the comment for photo 2.

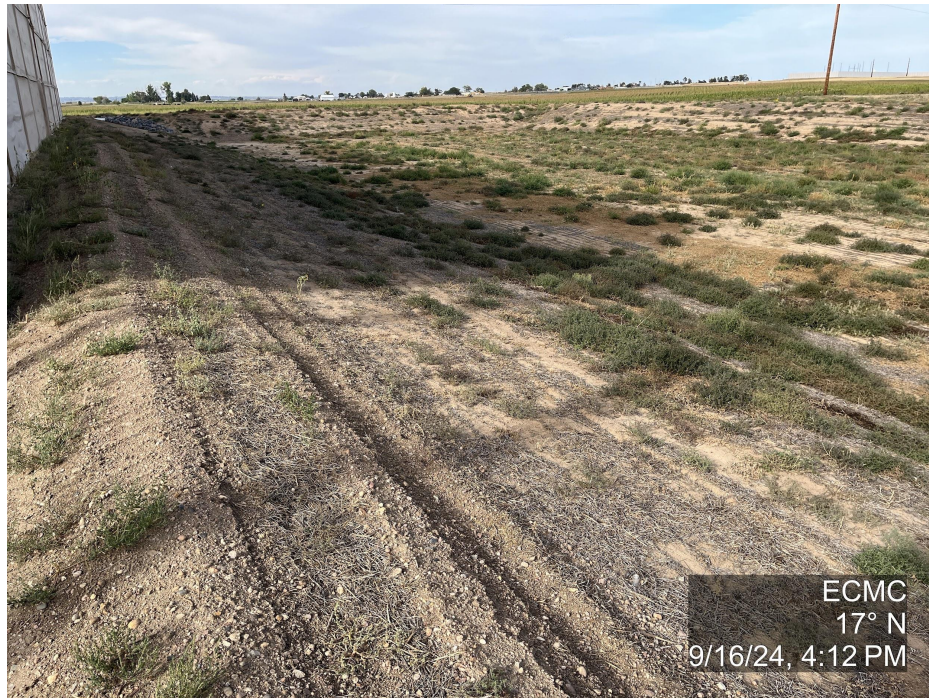
Photo 7. The photo was taken at the well location facing North. Refer to the comment for photo 2.

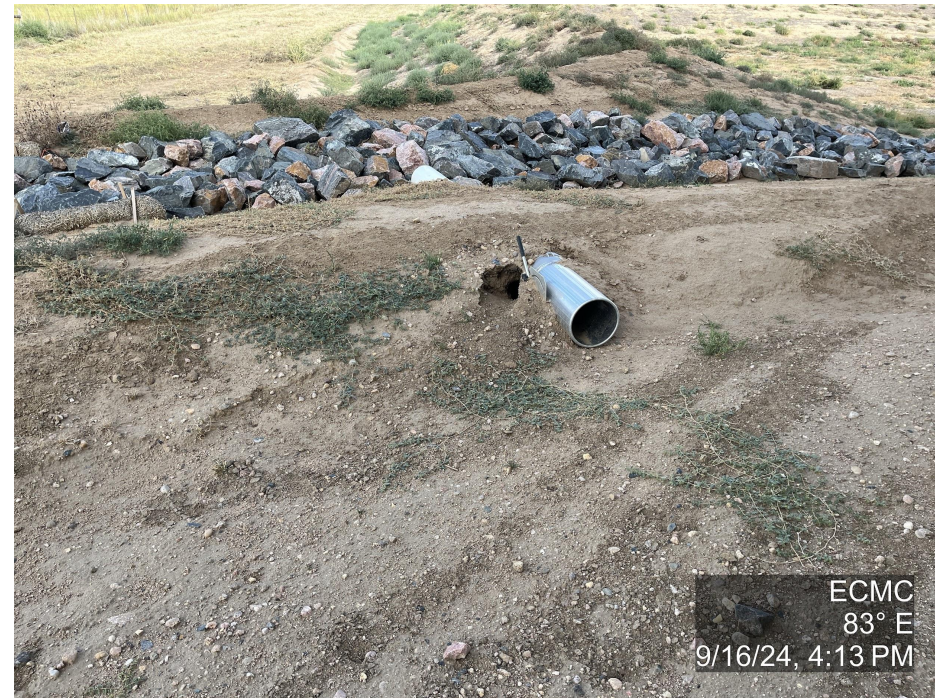
Photo 8. The photo was taken at the well location facing East. The photo illustrates wildlife burrowing through the berm near the controlled drain as well as puncturevine growing throughout.

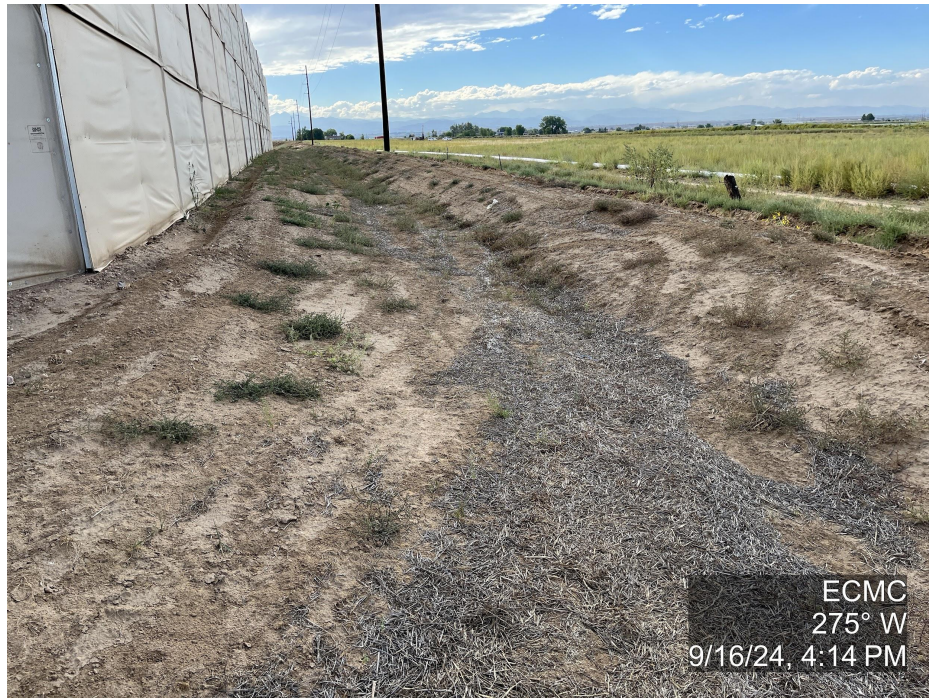
Photo 9. The photo was taken at the well location facing West. Refer to the comment for photo 2.

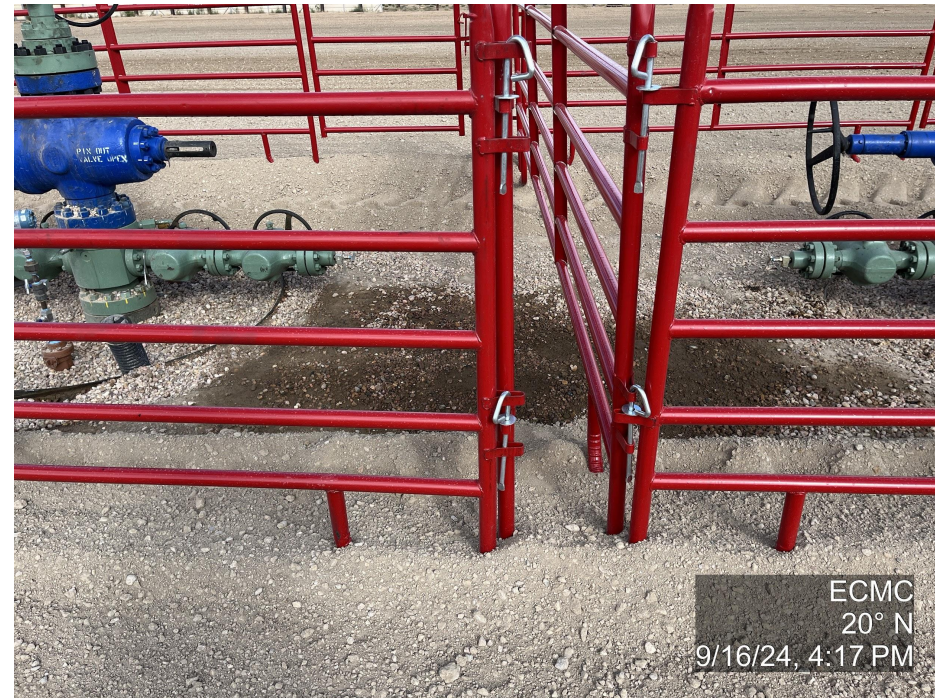
Photo 10. The photo was taken at the well location facing North. The photo illustrates stained soil around the wells.

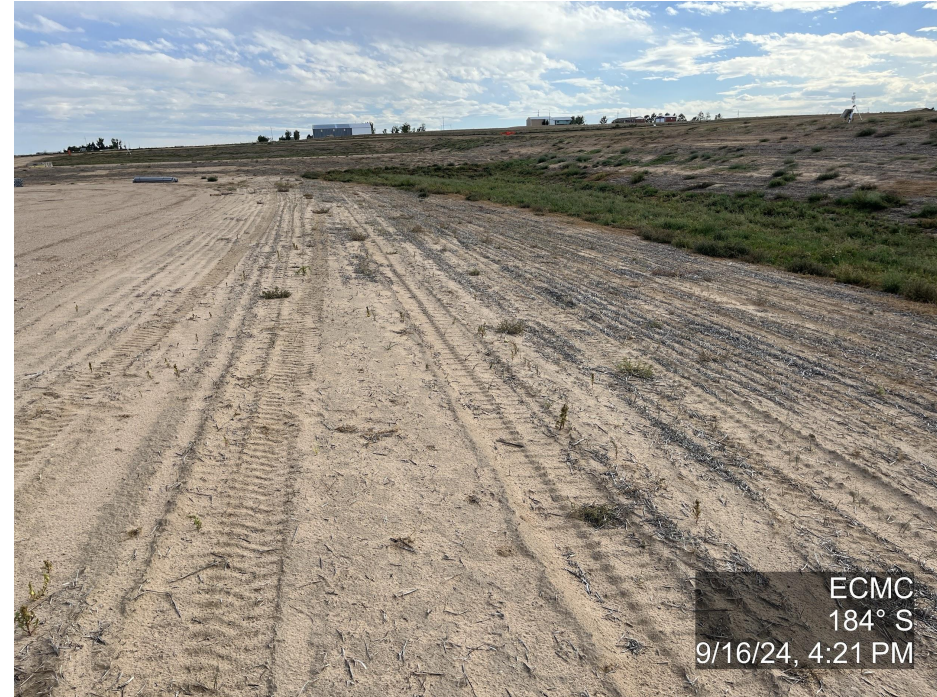
Photo 11. The photo was taken at the well location facing South. Refer to the comment for photo 2.

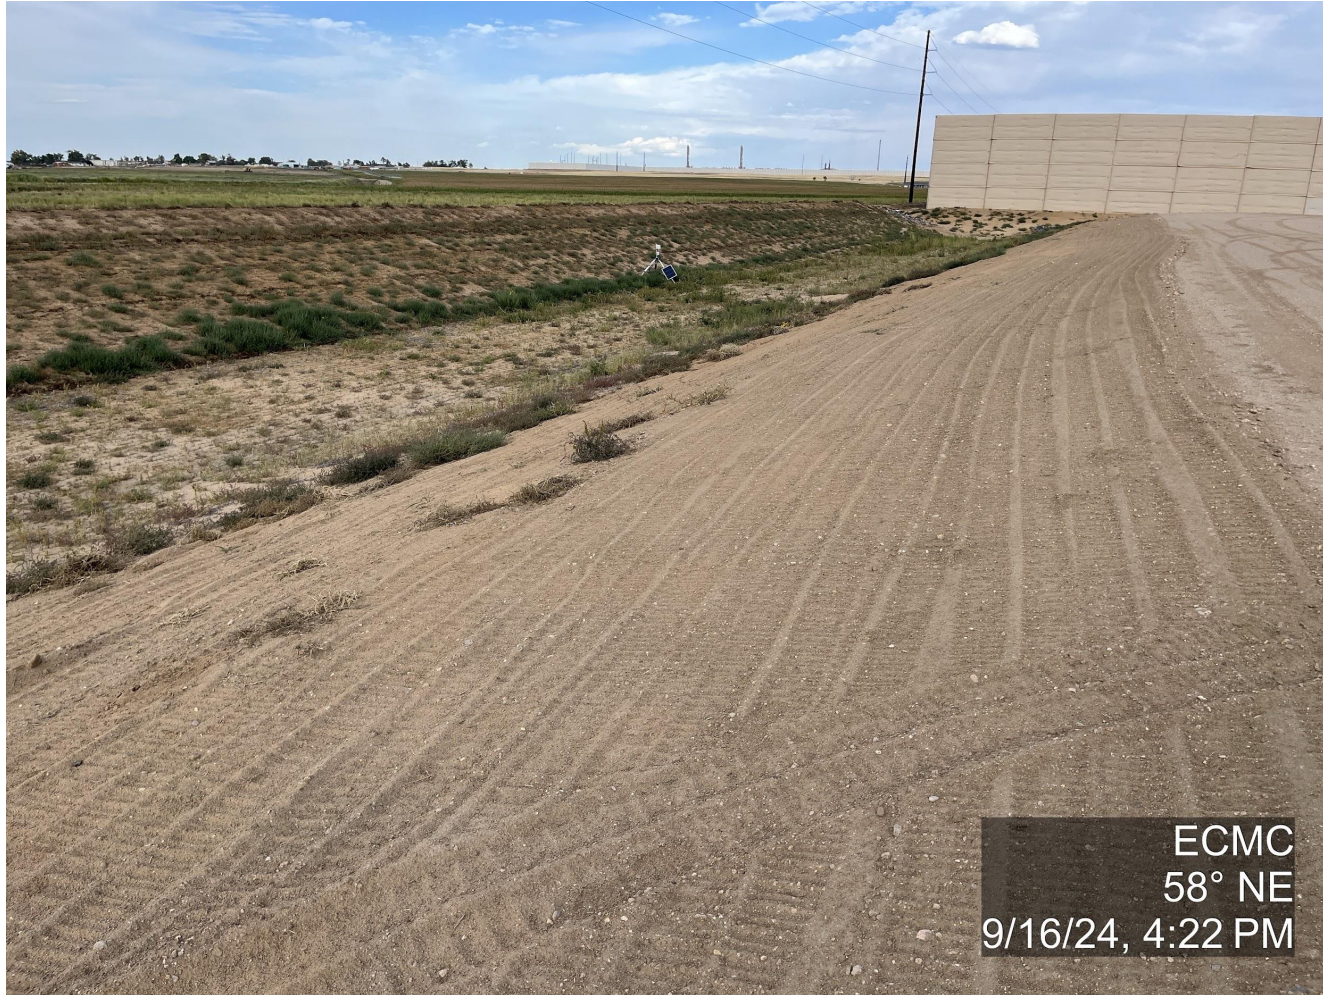
Photo 12. The photo was taken at the well location facing Northeast. Refer to the comment for photo 2.

Note - The tracking along the sediment trap slopes are tracked the incorrect direction.
