Inspection Photos

Location Name: TEP ROCKY MOUNTAIN LLC DIAZ RWF 42-25 Pad

Location ID: 335504

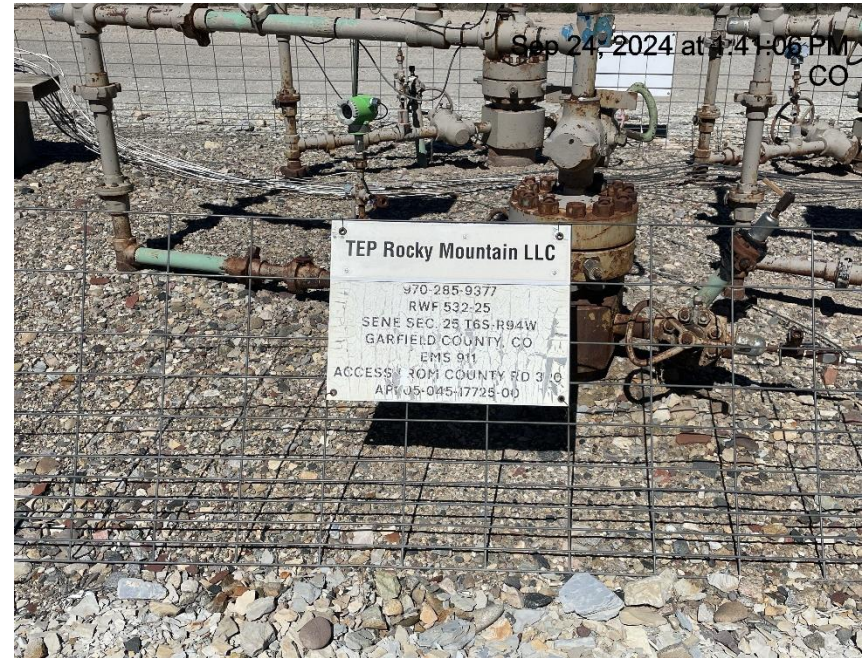
Photo # 1696 RWF 532-25 wellhead sign weathered, cracking & peeling/some info is starting to become illegible

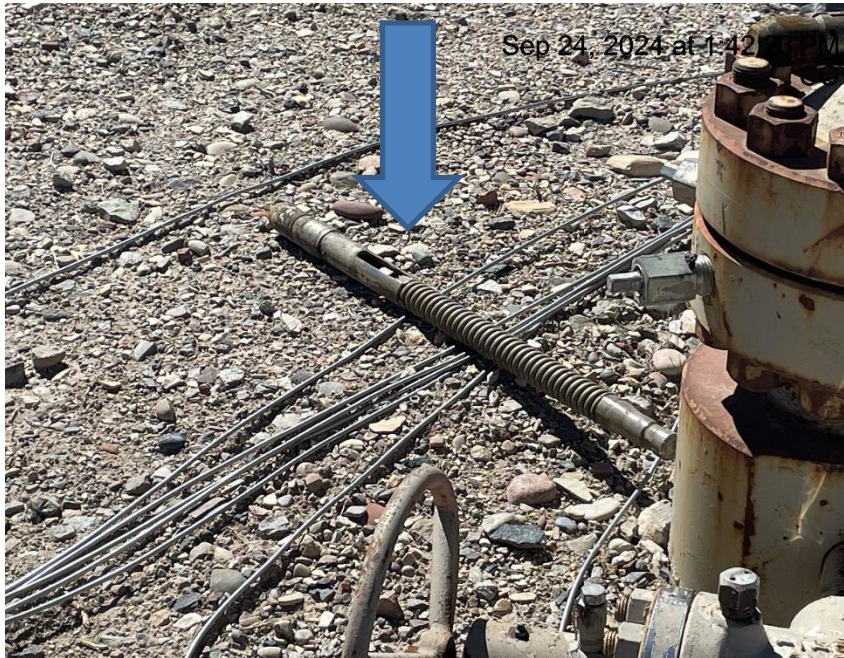
Photo # 1697 Debris

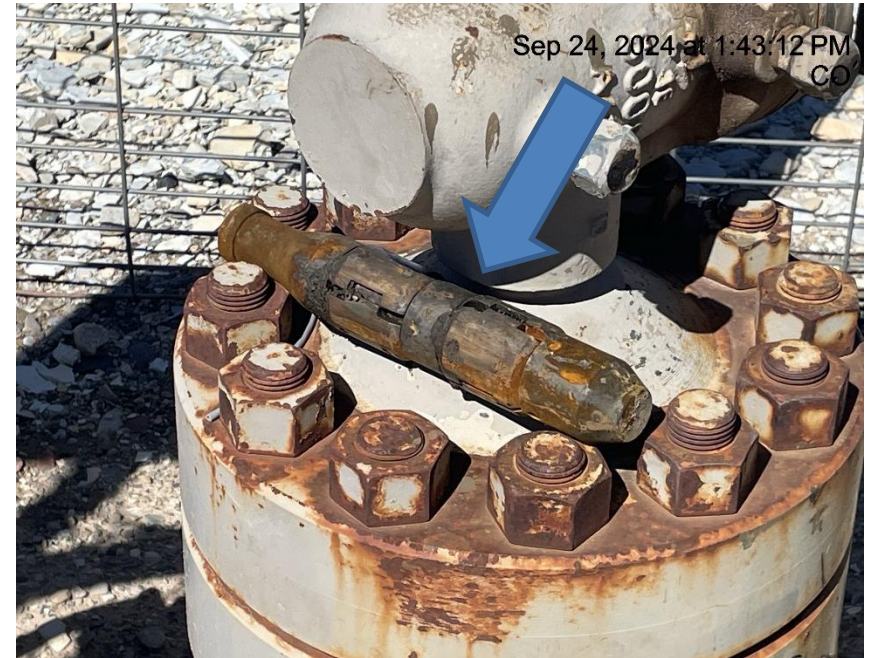
Photo # 1698 Debris

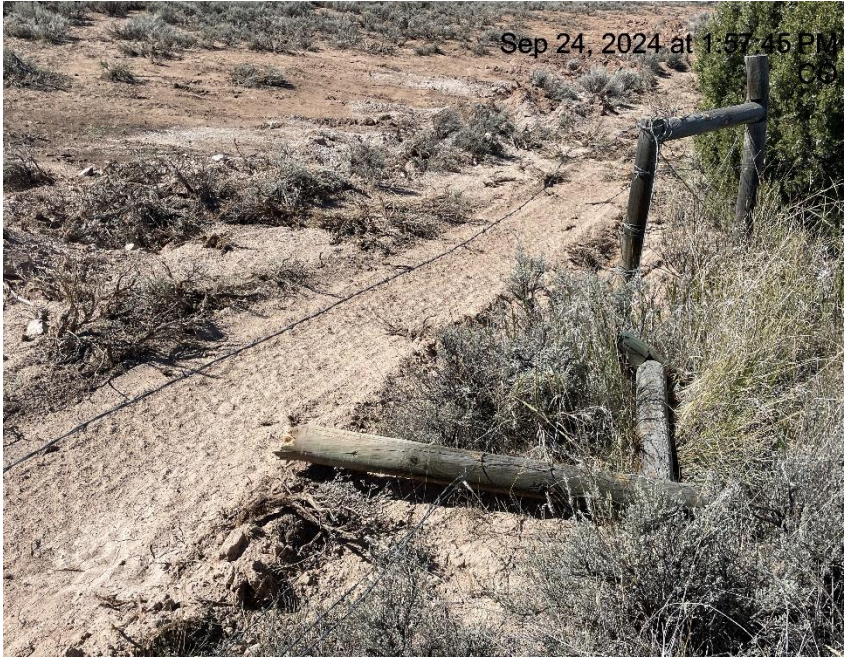
Photo # 1699 Barbed wire fence around location needs maintenance/wildlife hazard (S/SW area of location)

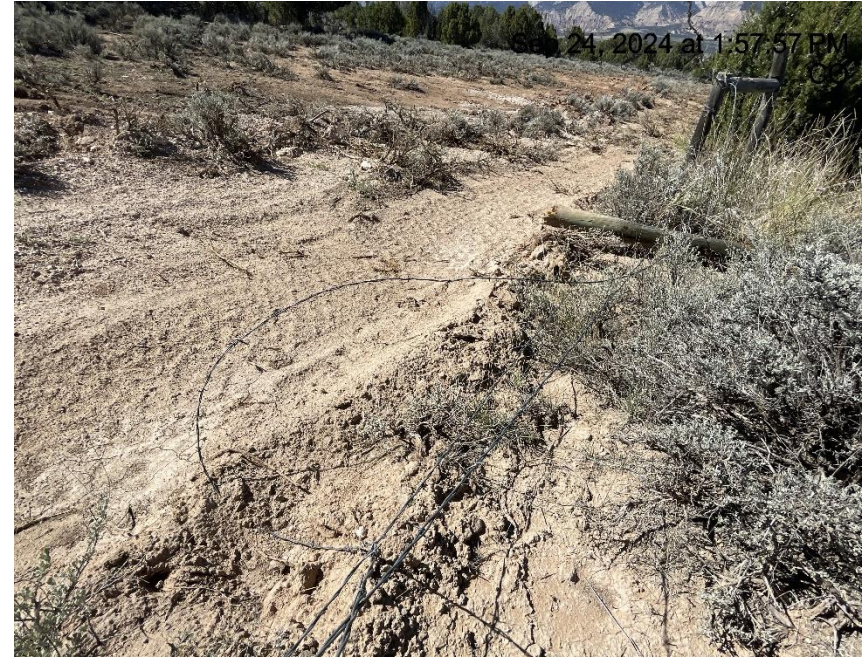
Photo # 1700 Barbed wire fence around location needs maintenance/wildlife hazard (S/SW area of location)

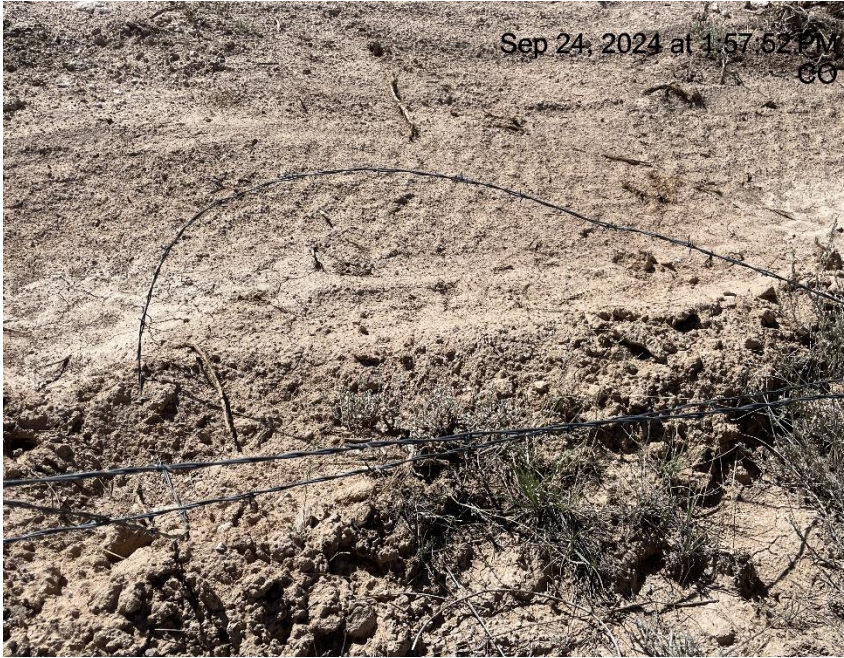
Photo # 1701 Barbed wire fence around location needs maintenance/wildlife hazard (S/SW area of location)
