Inspection Photos

Loc: 307766

Operator: WAPITI OPERATING LLC

Inspection Date: 9/23/2024

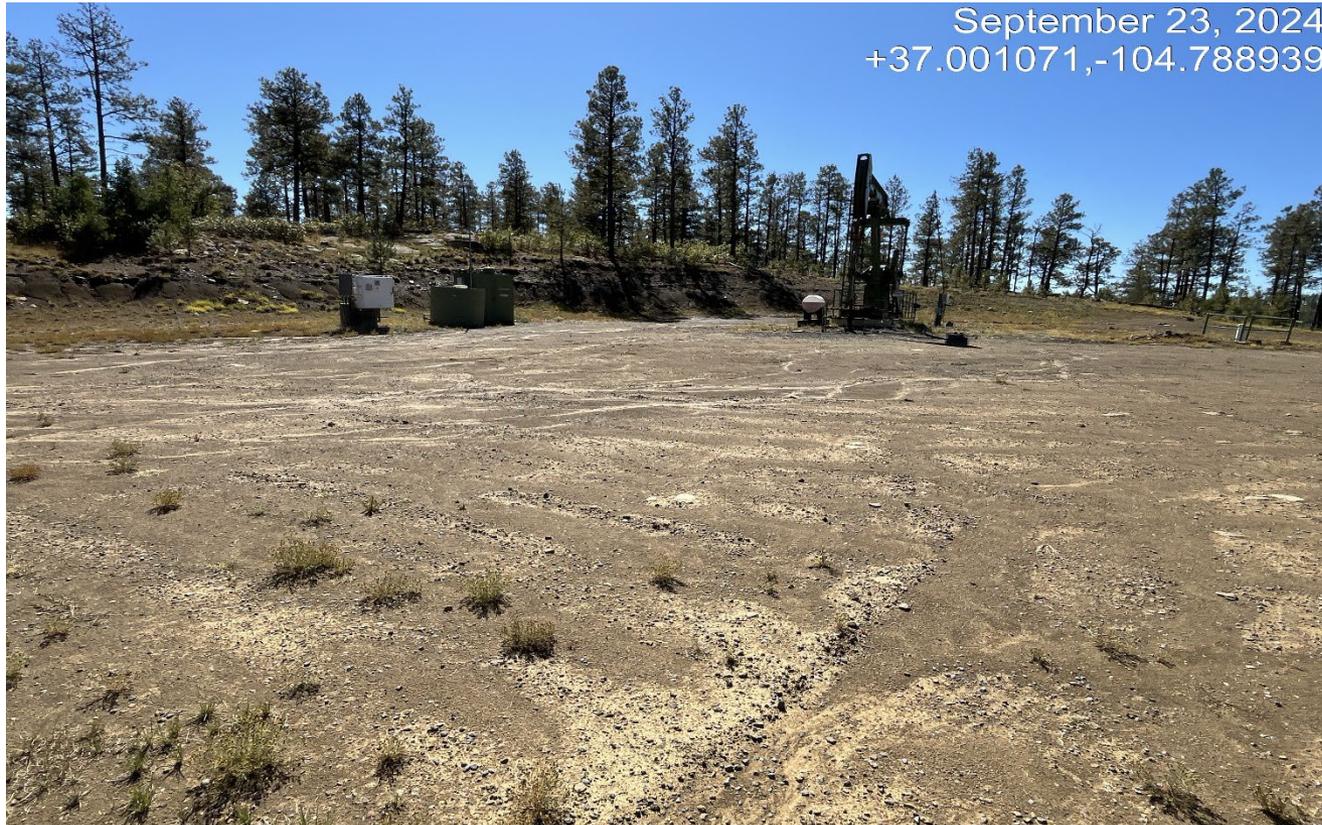
Photo 1. Facing southeast toward the wellsite.

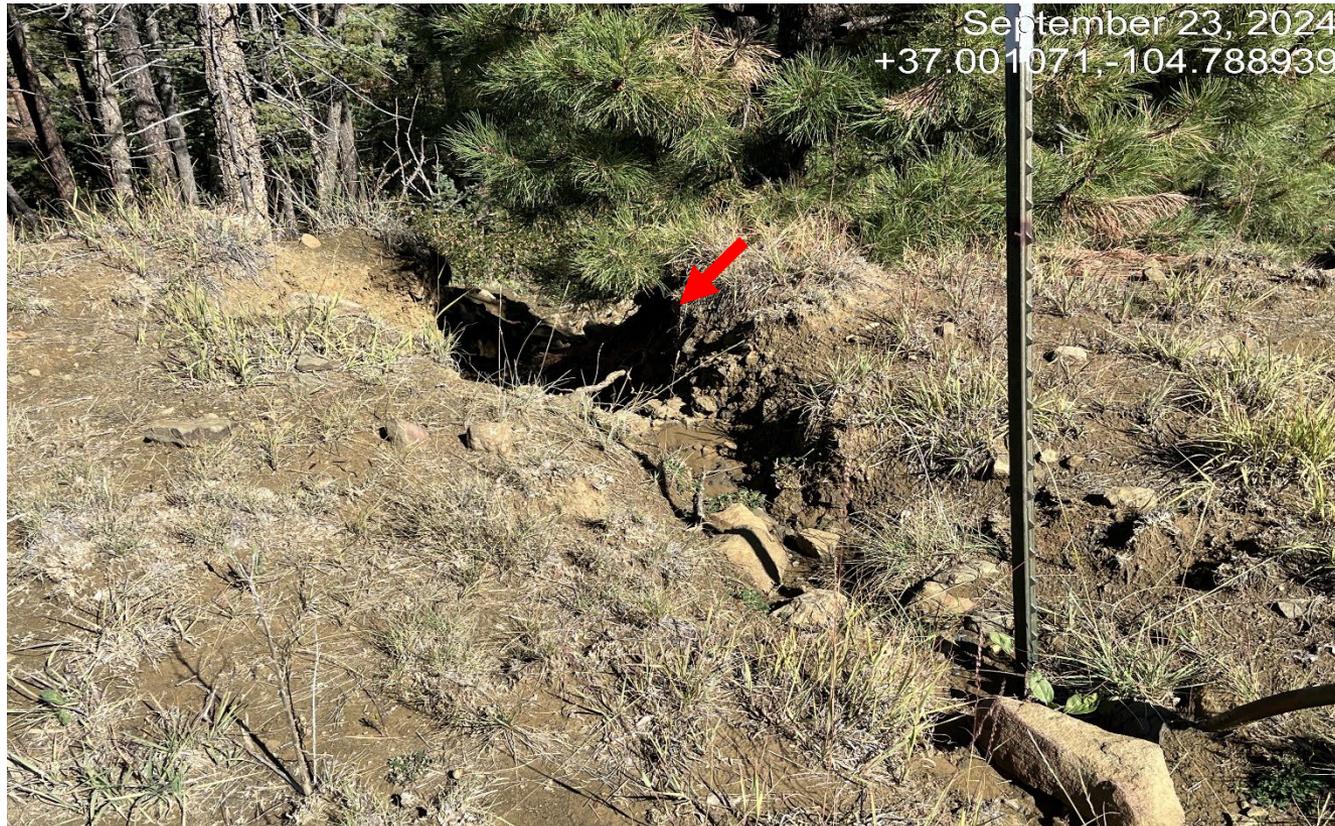
Photo 2. There is an erosion channel at the northwest side of the location that needs to be repaired. Previous CA was not completed.

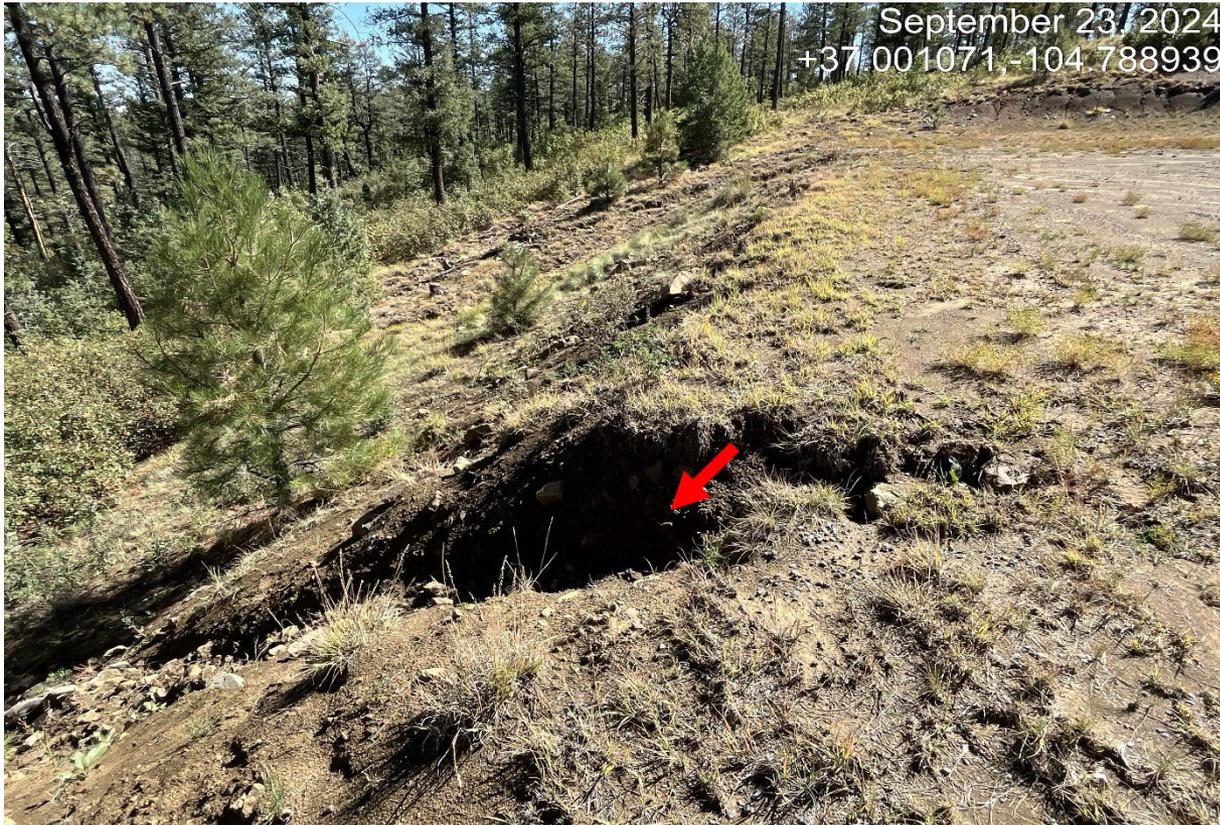
Photo 3. There are other erosion channels along the cut slope that have not been repaired.

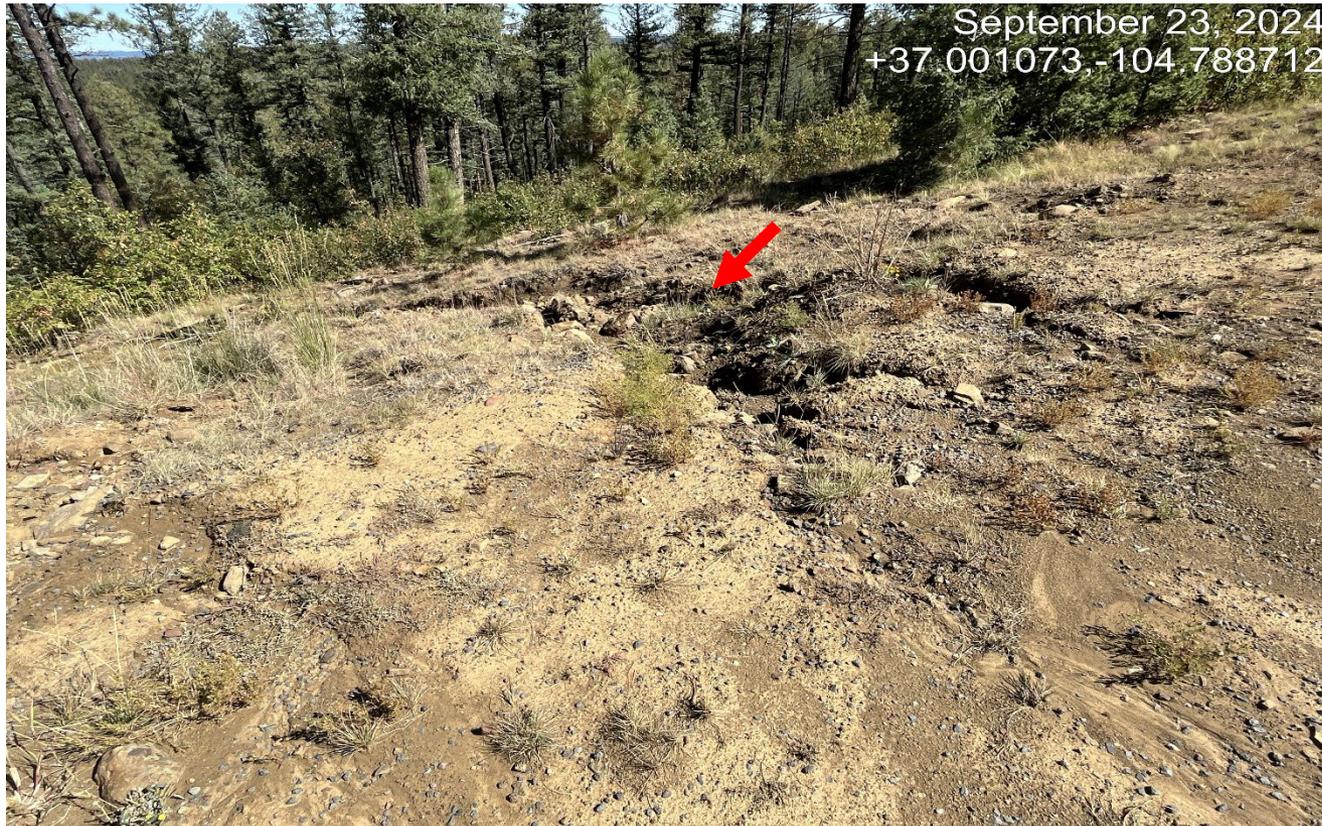
Photo 4. There is an erosion channel at the northeast side of the location that needs to be repaired. Previous CA was not completed.
