# Inspection Photos

API: 071-06970

Operator: WAPITI OPERATING LLC

Inspection Date: 9/23/2024

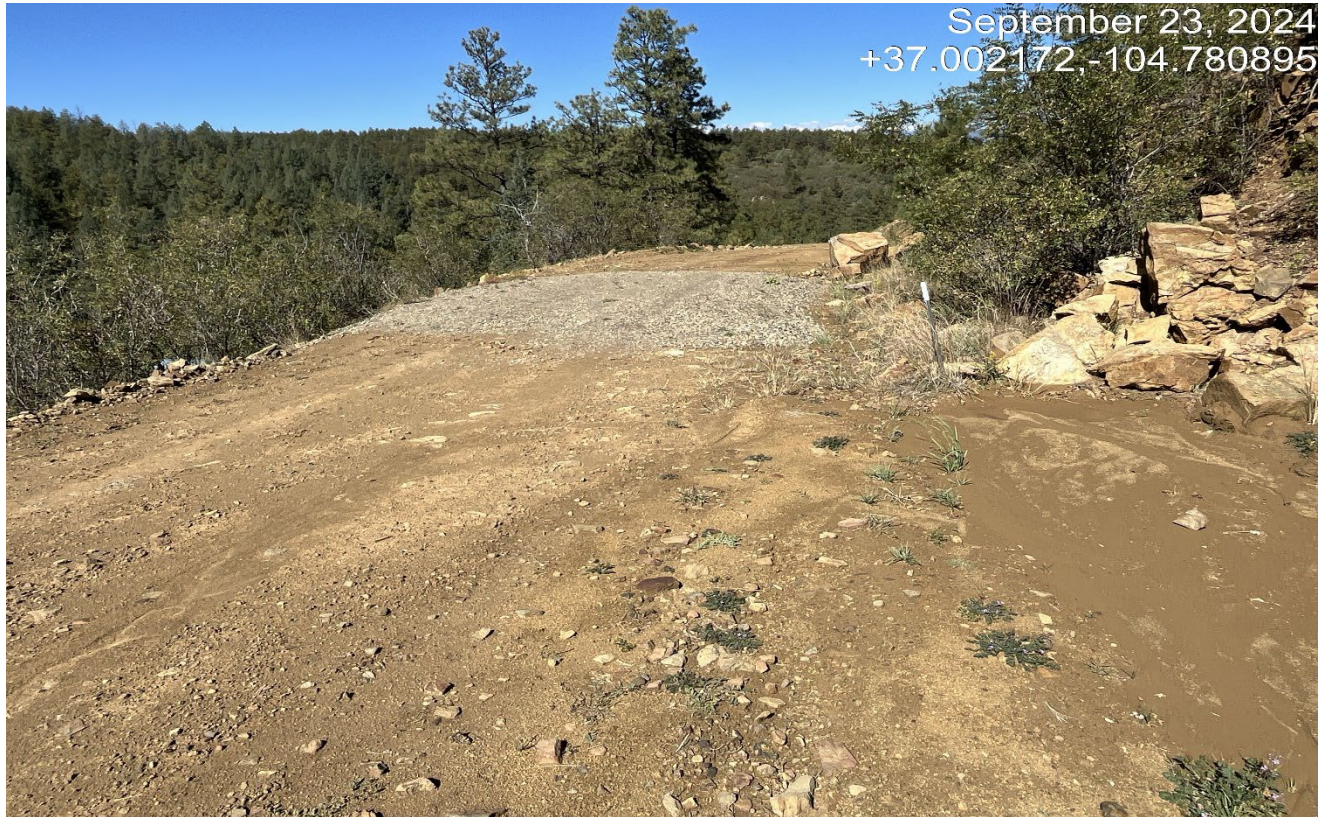
**Photo 1.** Facing northeast along the access road. The culvert has filled in with sediment and needs to be cleaned out. Previous CA was not completed.

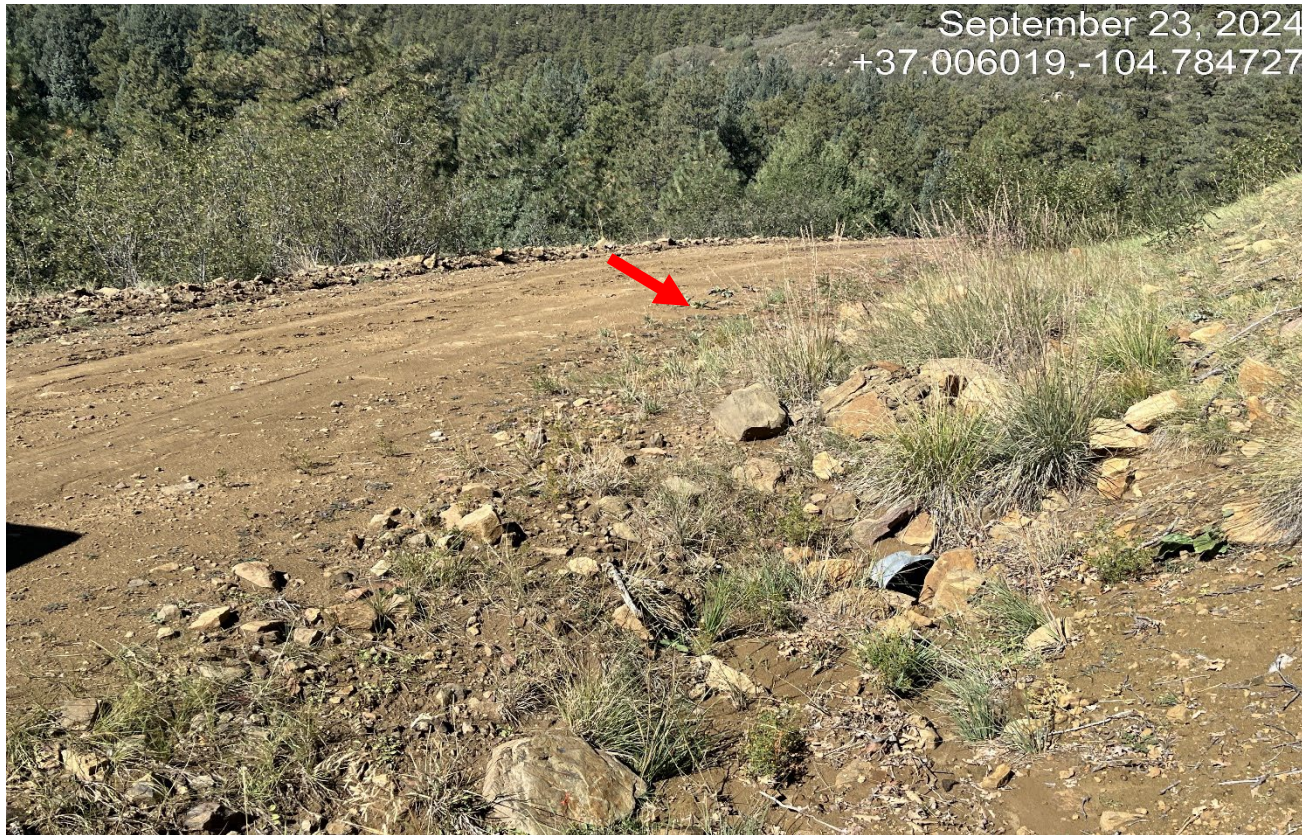
**Photo 2.** Facing northeast along the road. There are noxious weeds that need to be controlled. Houndstongue., This culvert is mostly filled in and needs to be cleaned out.

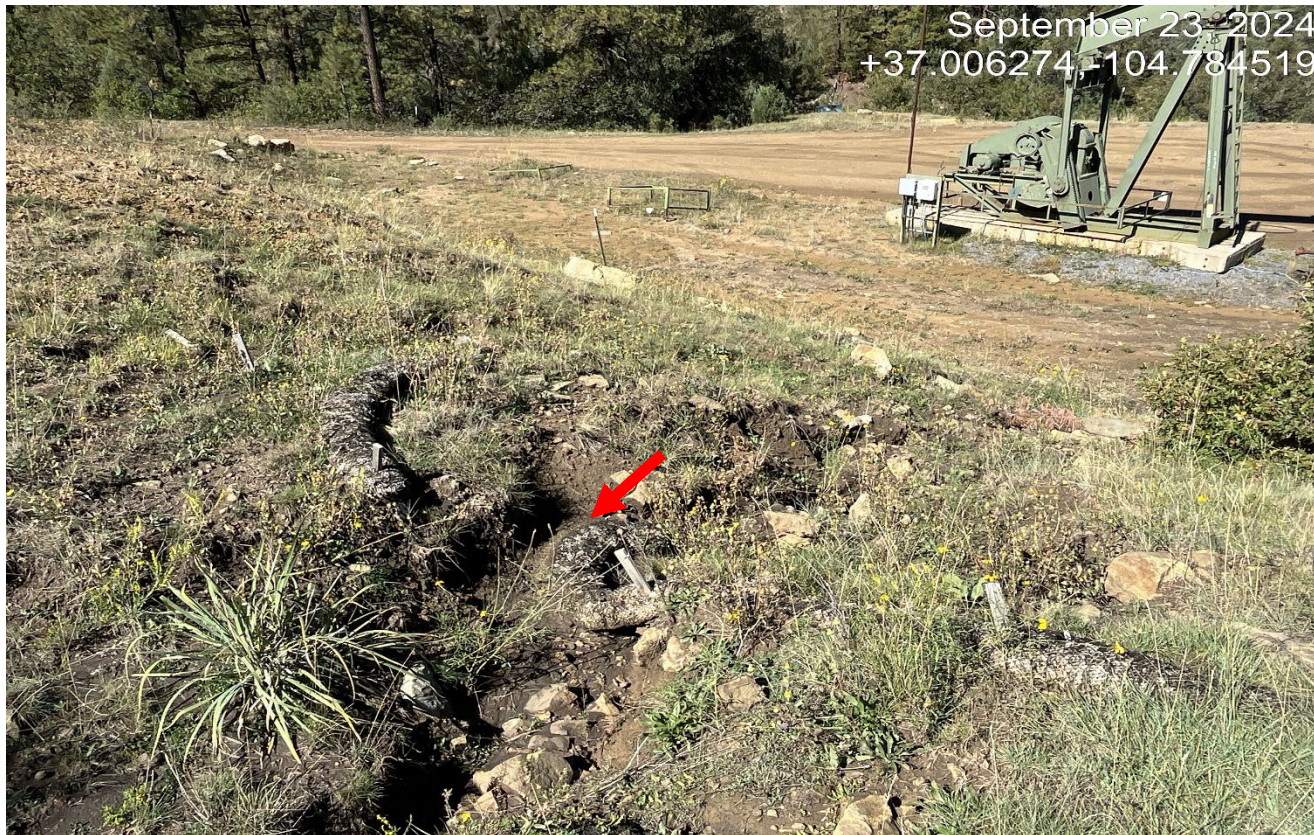
**Photo 4.** Facing northwest the cut slope. There are erosion channels that need to be repaired. The wattles at red arrow has failed. Previous CA was not completed.

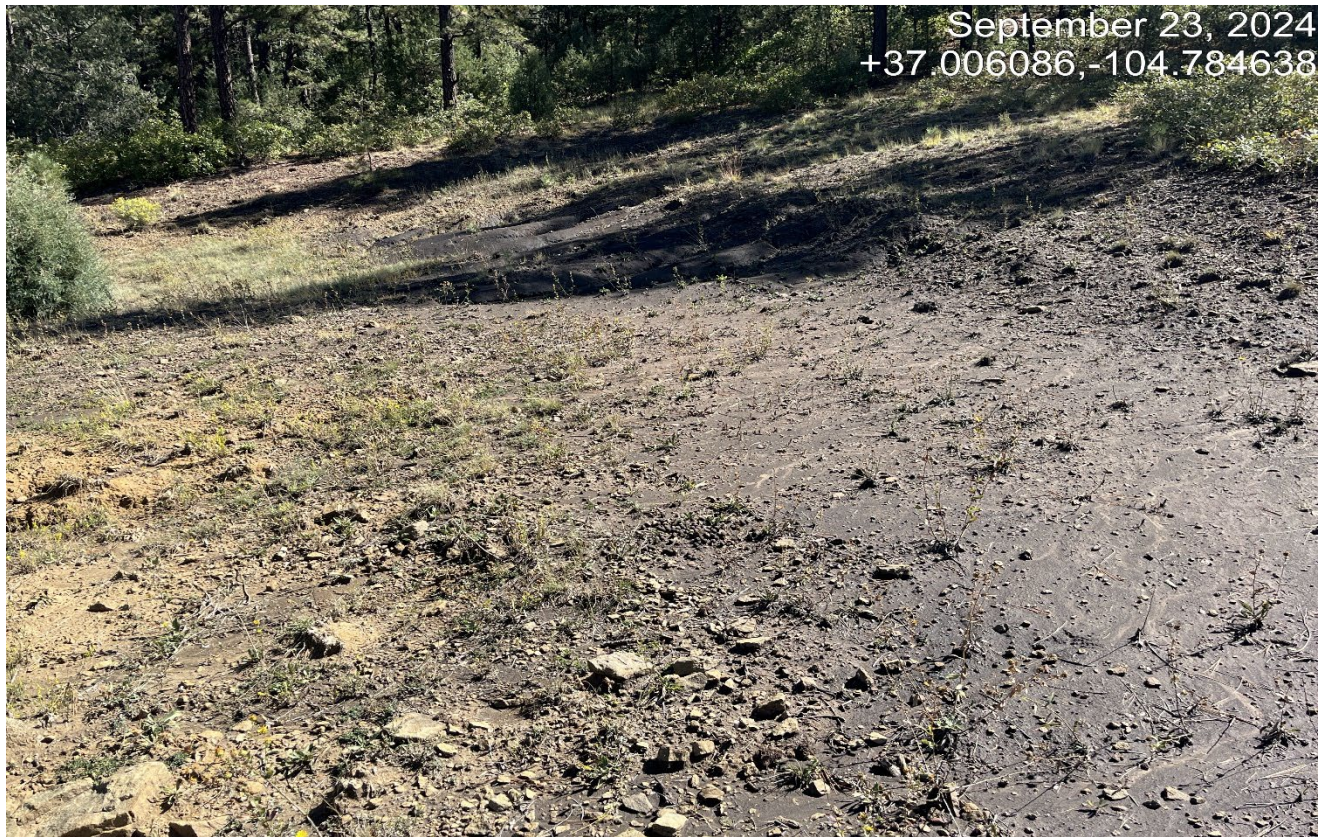
**Photo 5.** The top of the cut slope need to be stabilized and may require a run-on ditch or other BMP's.

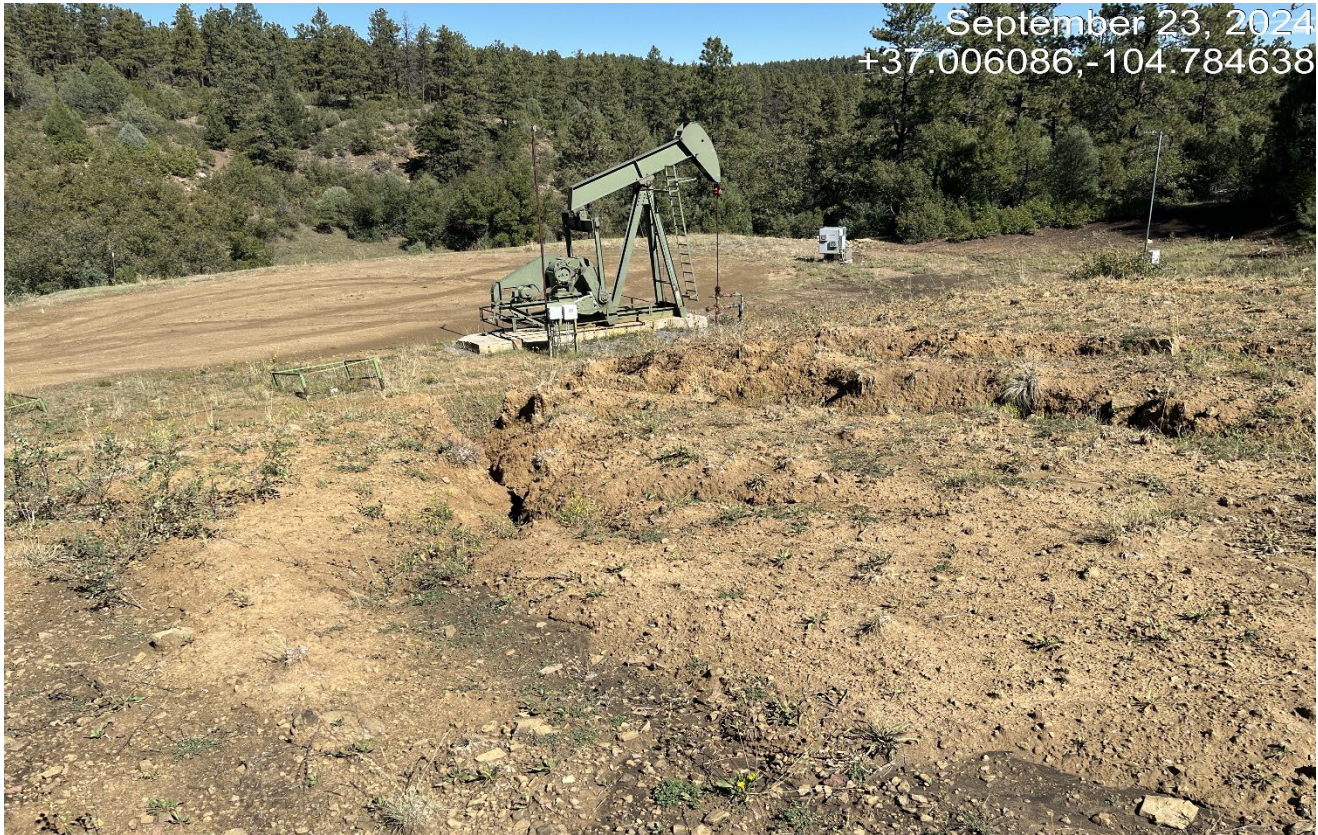
**Photo 6.** Facing northwest along the cut slope. There are erosion channels that must be repaired and stabilized. Previous CA was not completed.
