# Inspection Photos

ID: 444661

Operator: STRACHAN EXPLORATION INC

Inspection Date: 9/24/2024

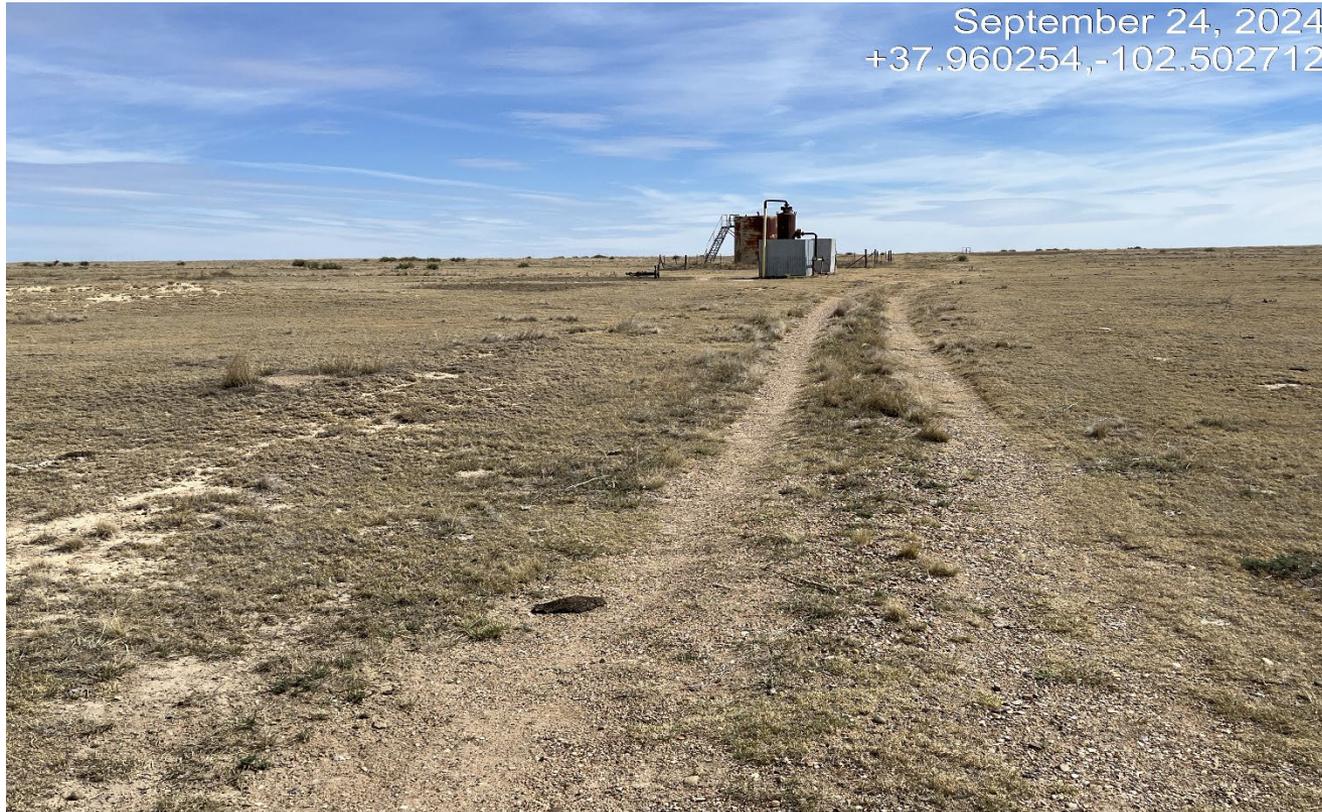
**Photo 1.** Facing east toward the compressor facility.

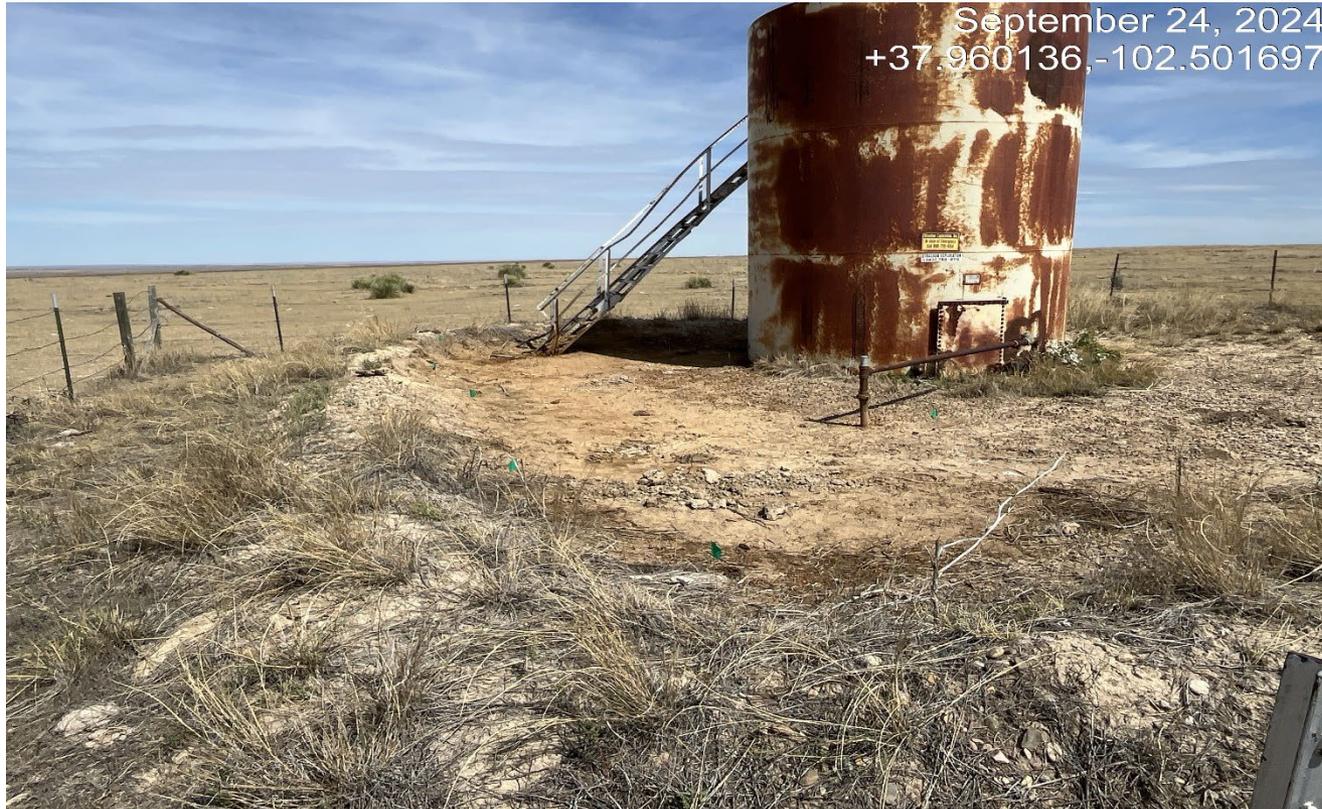
**Photo 2.** Facing northeast toward the tank. The leak that had occurred was not cleaned up. There is insufficient labeling and signage at the tank. Previous corrective action was not completed.

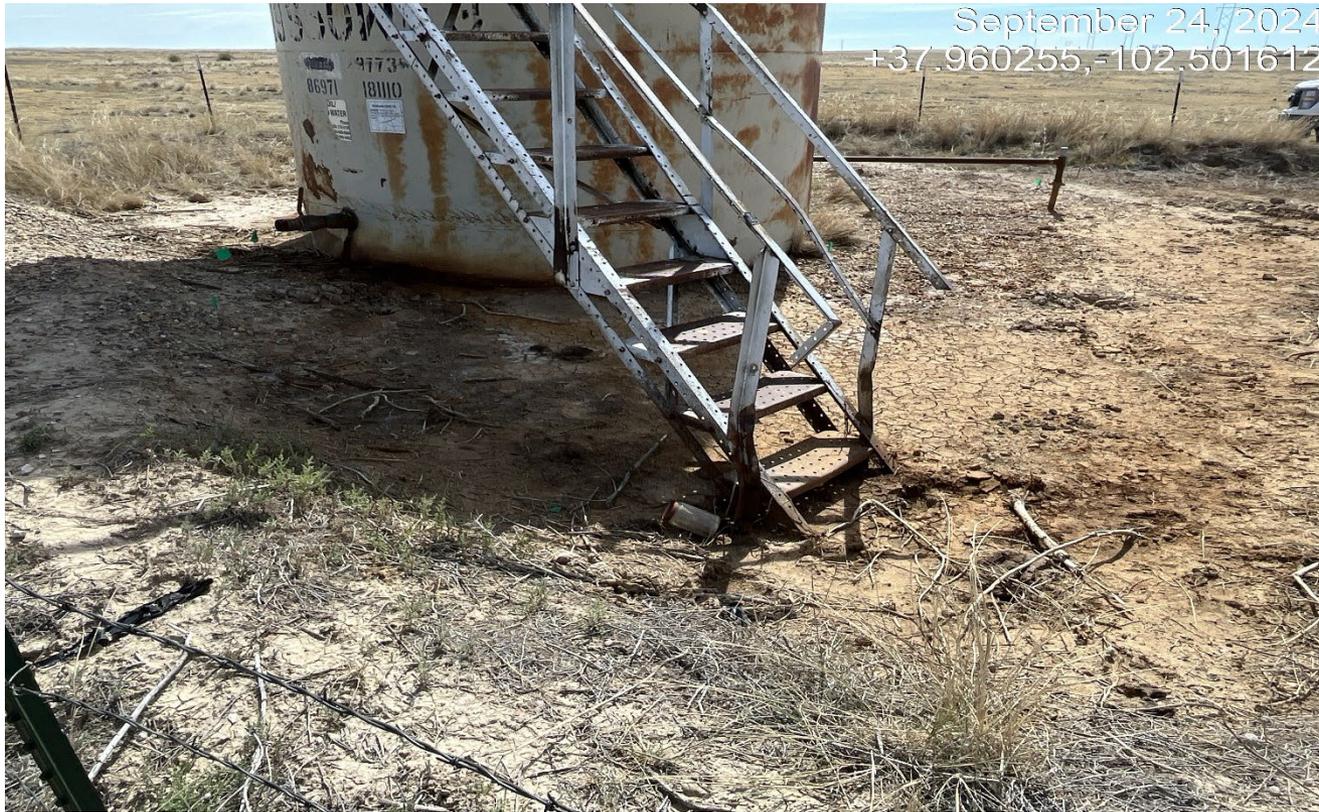
**Photo 3.** Facing east toward the tank. The leak that had occurred was not cleaned up. There is insufficient labeling and signage at the tank . Previous corrective action was not completed.

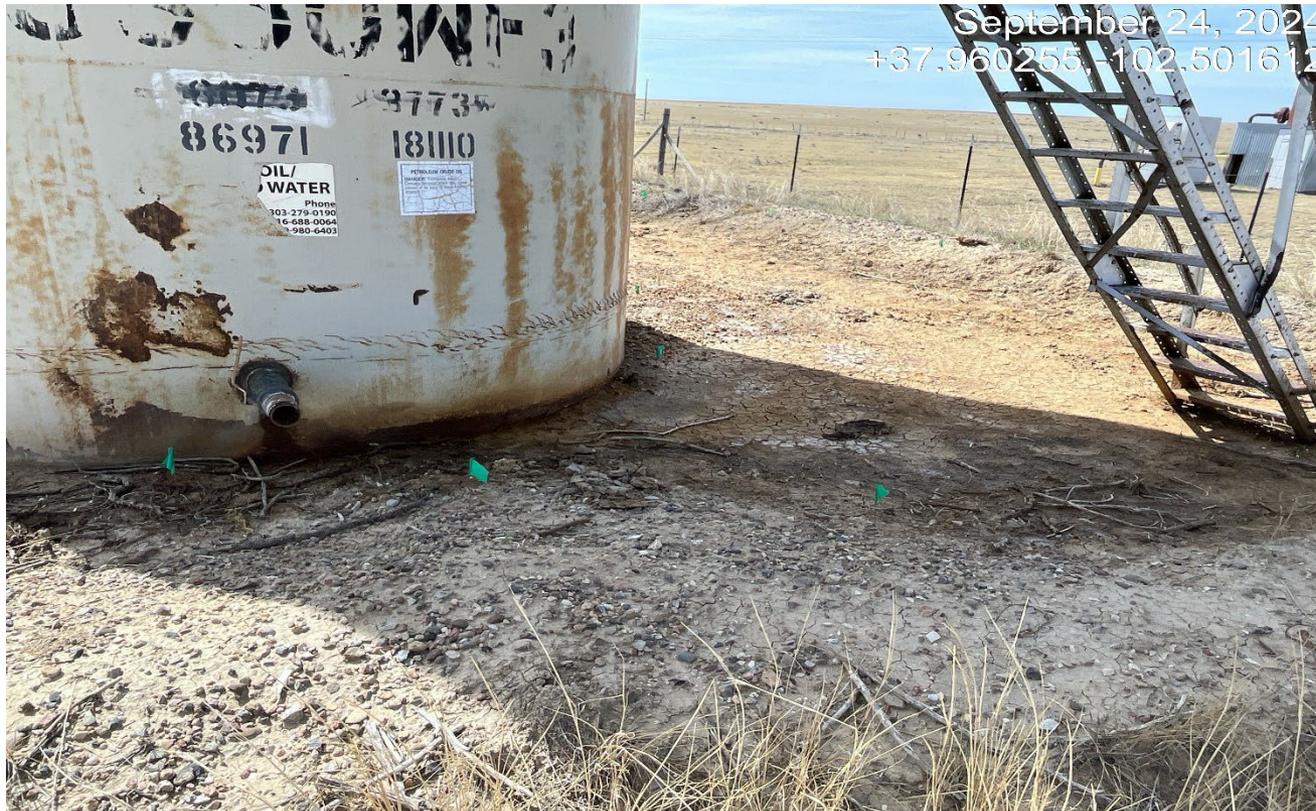
**Photo 4.** There is stained soils still observed inside the secondary from the previous spill. There are green flags put around the impacted area.
