Inspection Photos

API: 099-06872

Operator: STRACHAN EXPLORATION INC

Inspection Date: 9/24/2024

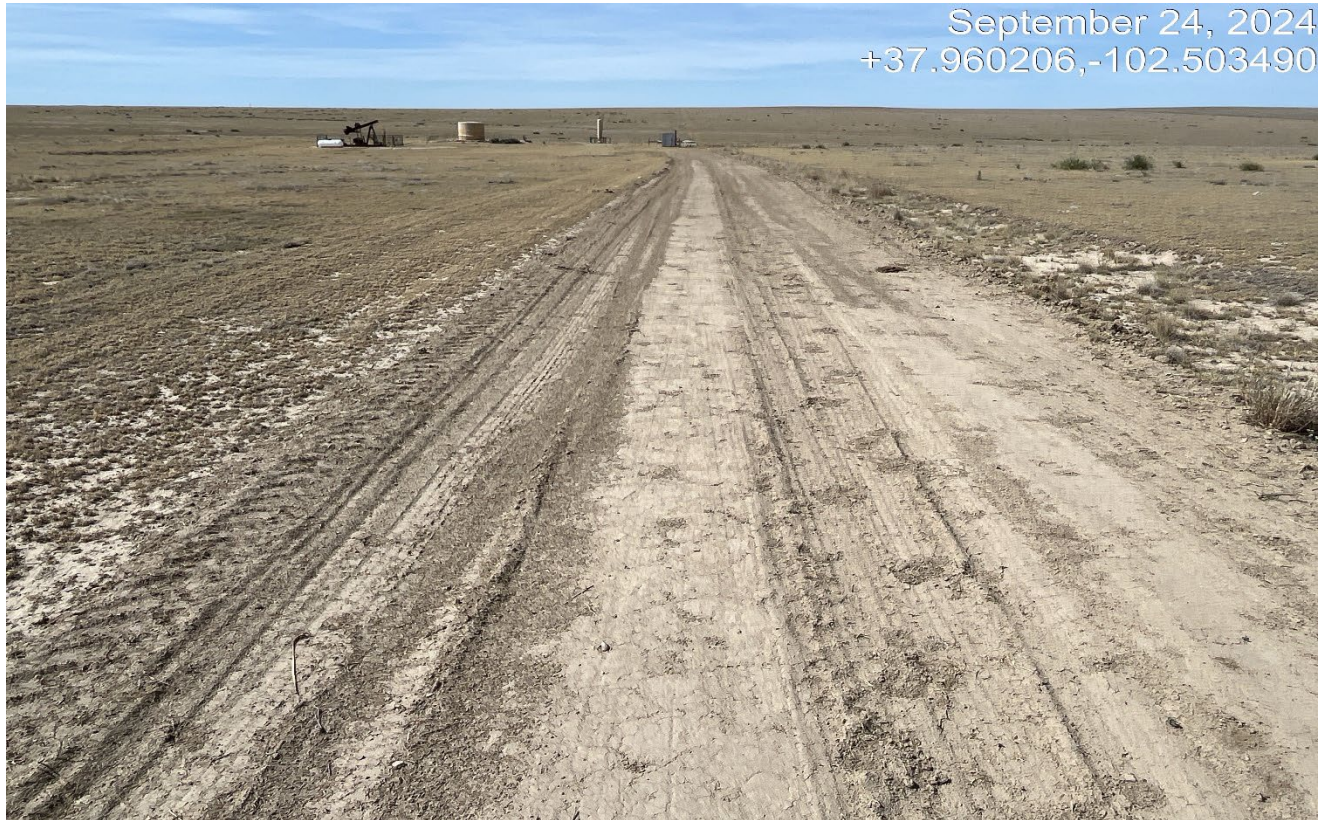
Photo 1. Facing east along the access road. The ruts along the road have been repaired but no stabilization was performed to prevent erosion reoccurrence.

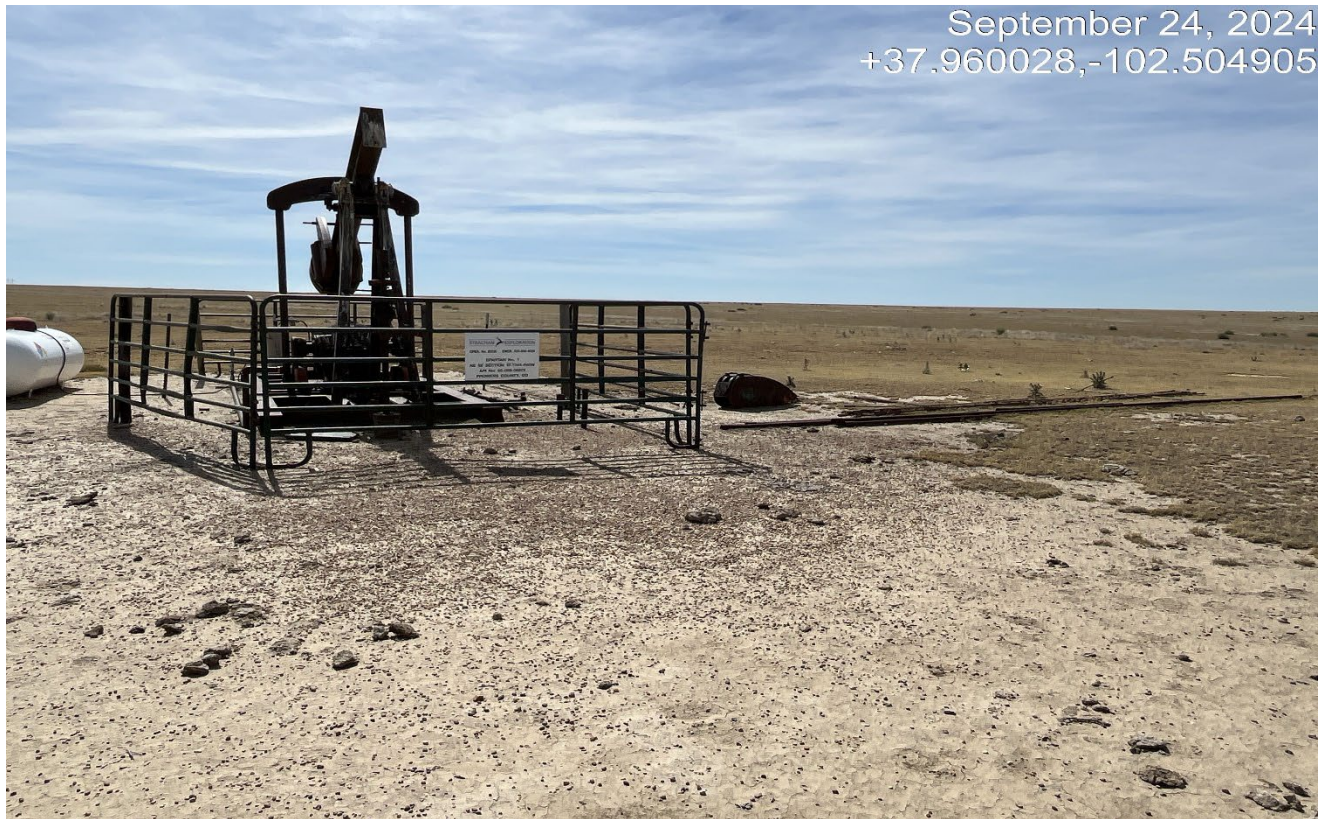
Photo 2. Facing southwest at the wellsite. Sign is posted at the wellhead.

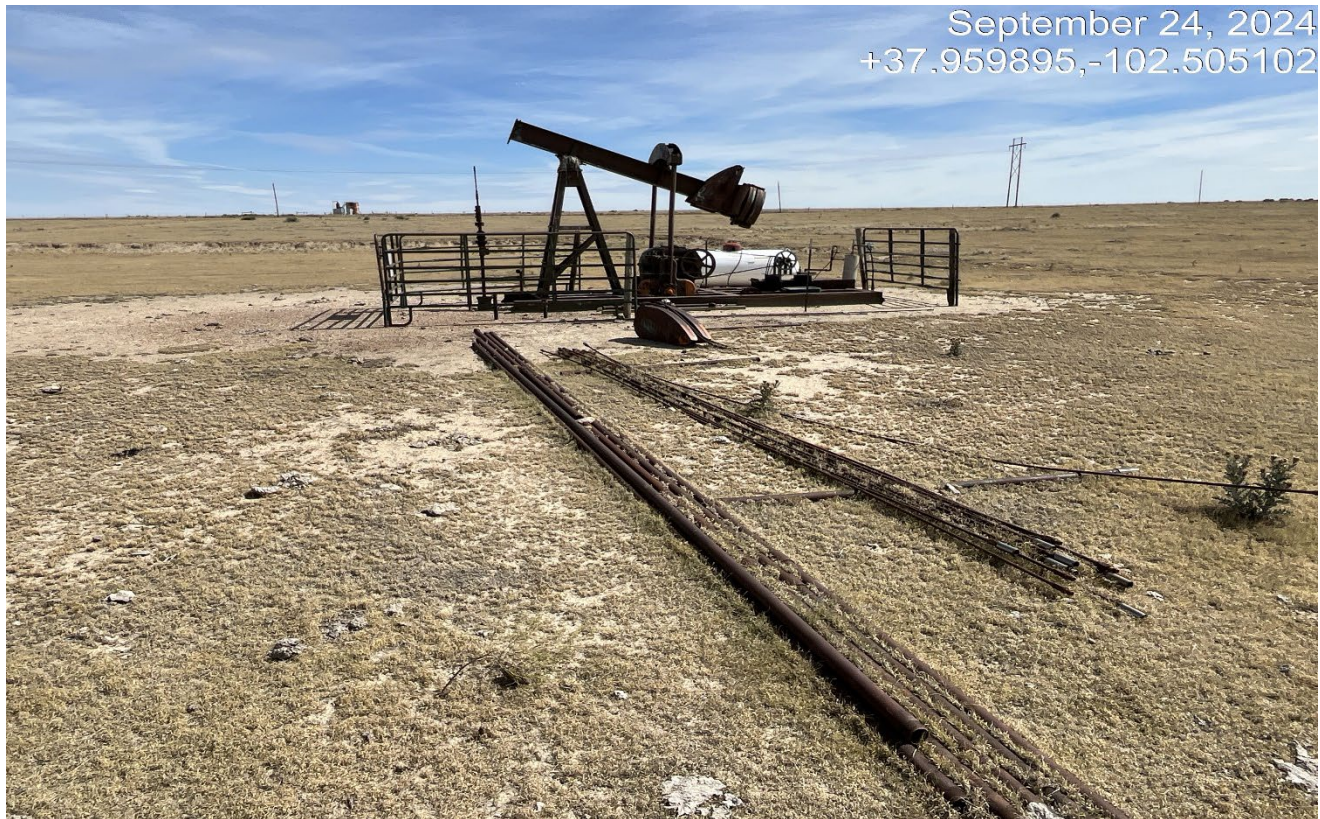
Photo 3. Facing southwest by the well. There is unused equipment and drilling pipe that needs to be removed. Previous corrective action was not completed.

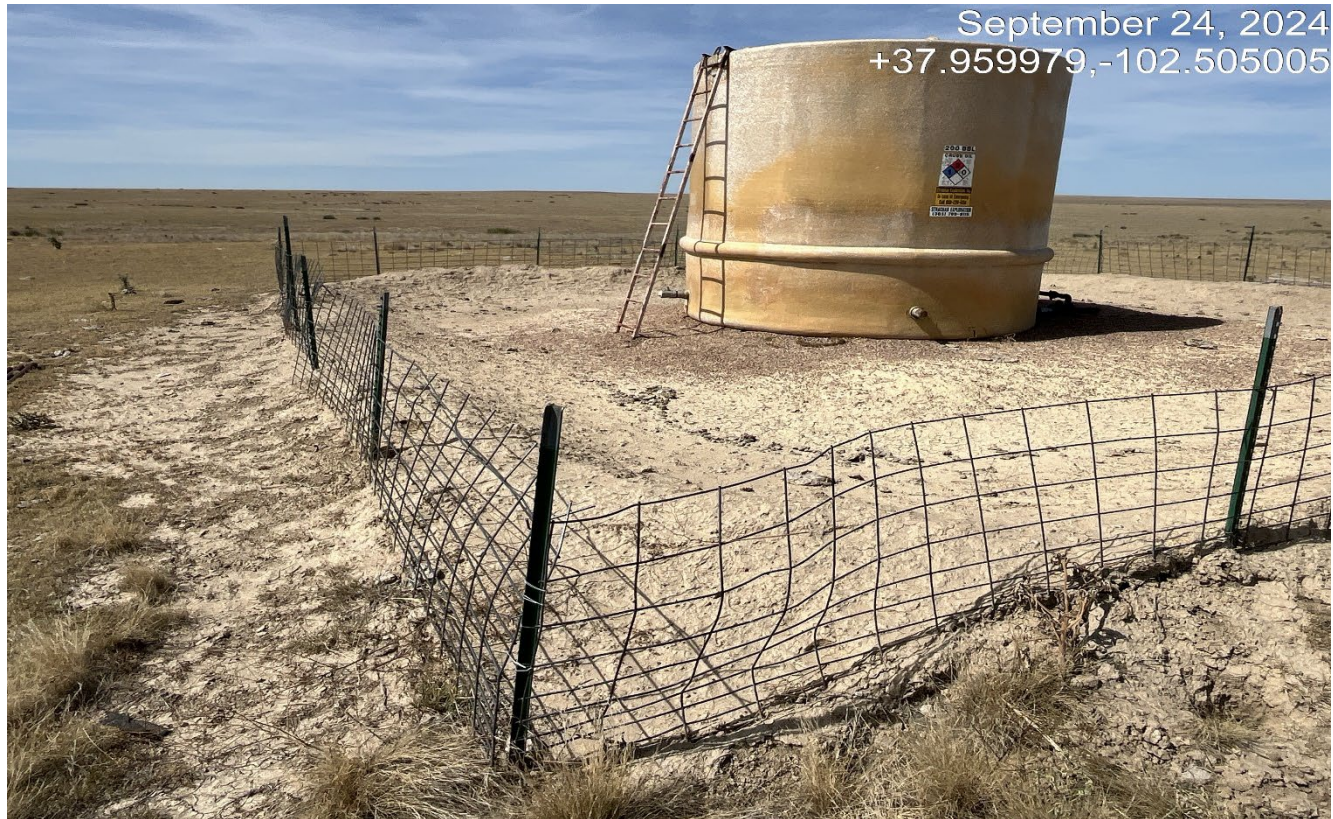
Photo 4. Facing toward the fiberglass tank. The fence has been repaired.
