Interim Reclamation and Stormwater Inspection

Date: 09/10/2024

Operator: DENOVA SEQUESTRATION LLC - 10790

Location ID: 483817

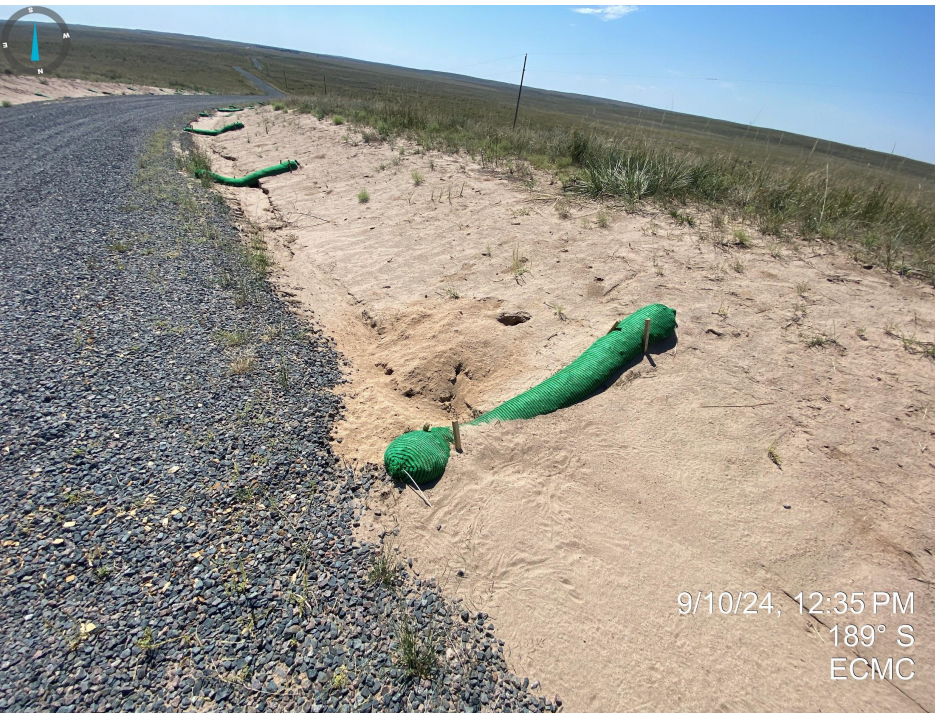
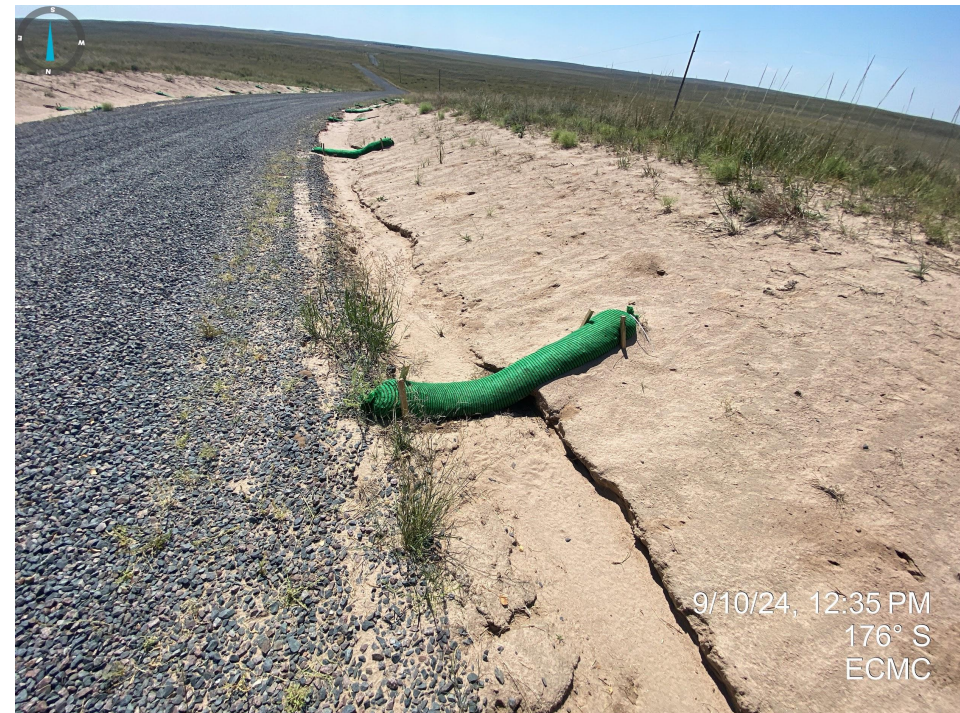
Photos 1 & 2. Erosion degradation evident with inadequate stormwater control measures observed along the access road. Additional maintenance and/or more robust control measures required.

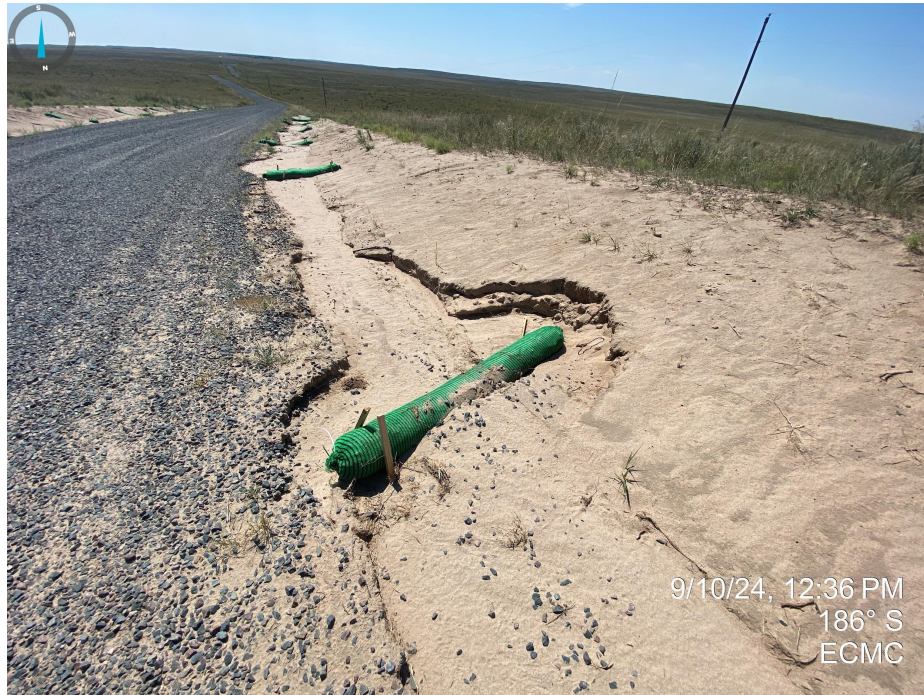
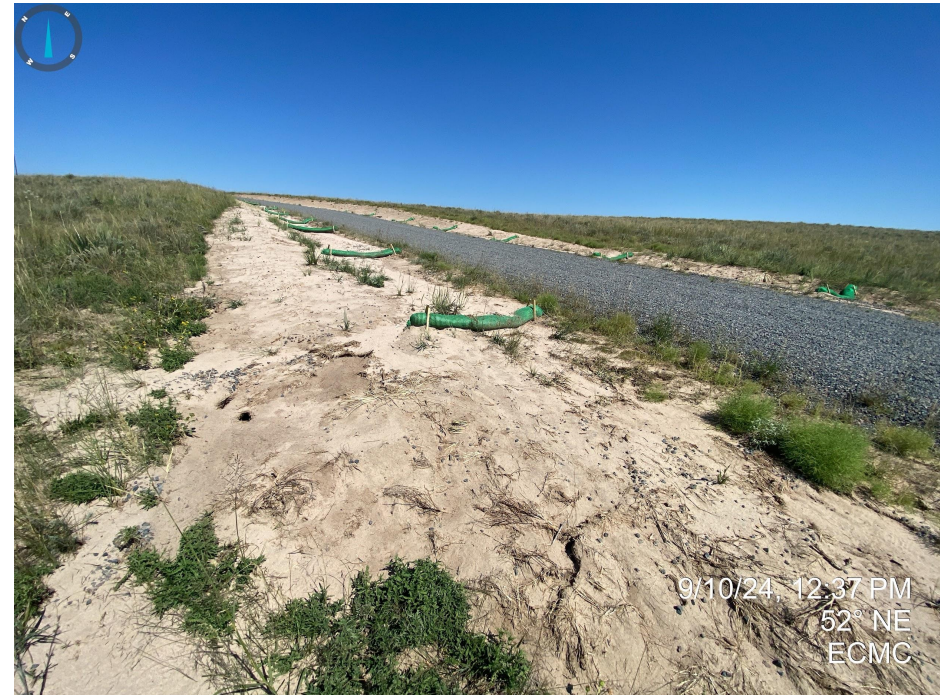
Photos 3 & 4. Taken along the access road; see comments in Photo 1 & 2.

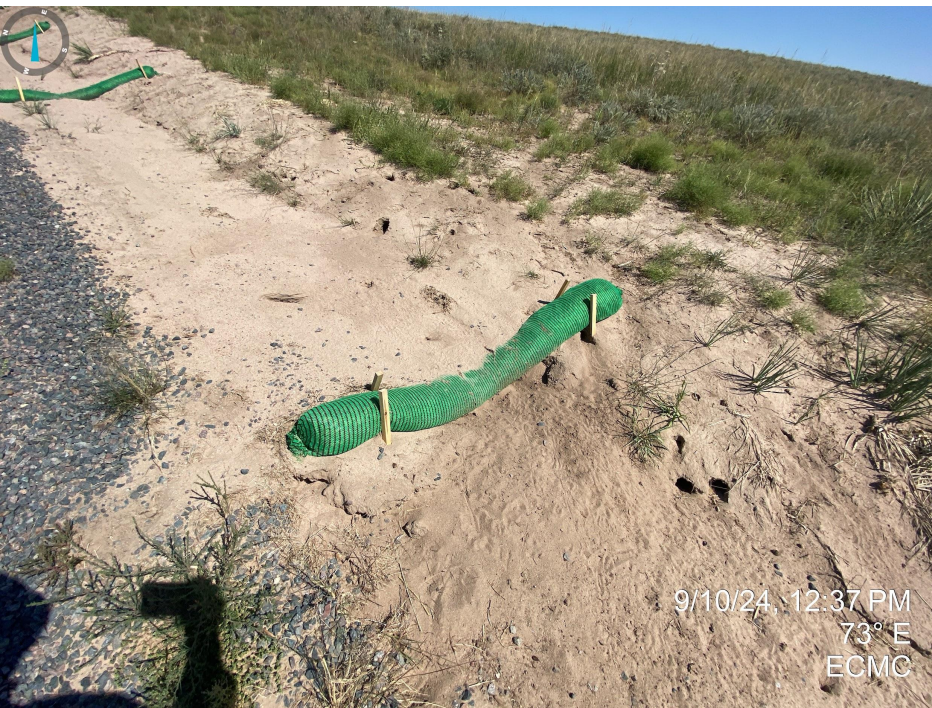
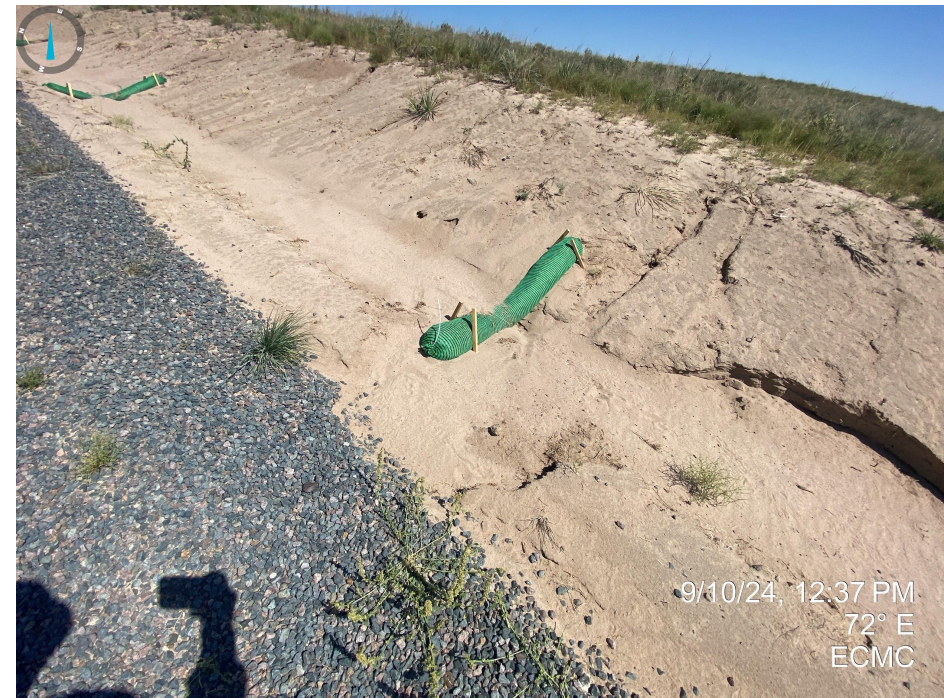
Photos 5 & 6. Taken along the access road; see comments in Photo 1 & 2.

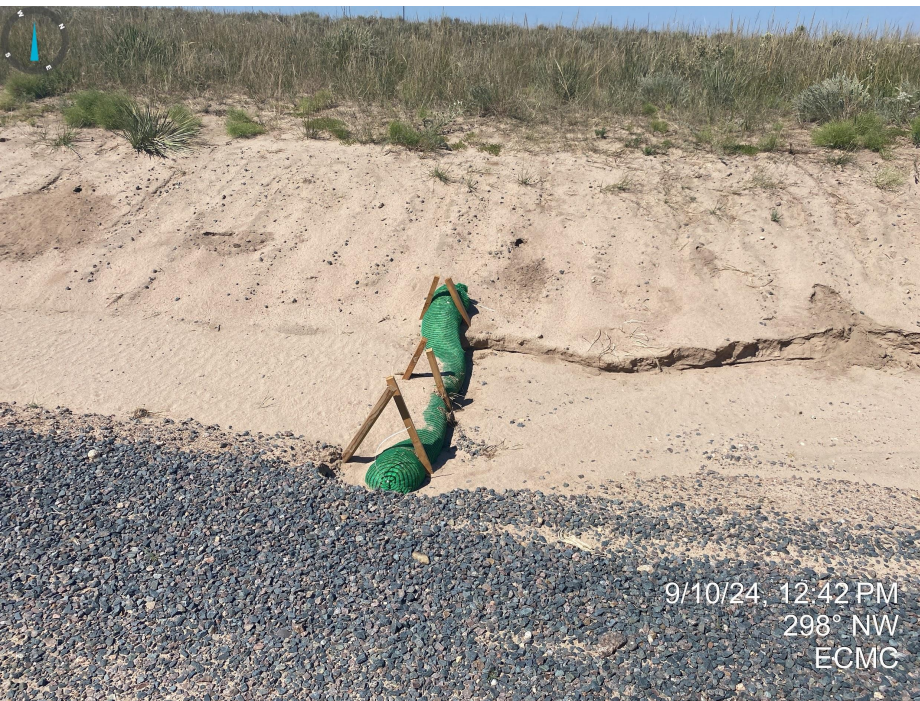
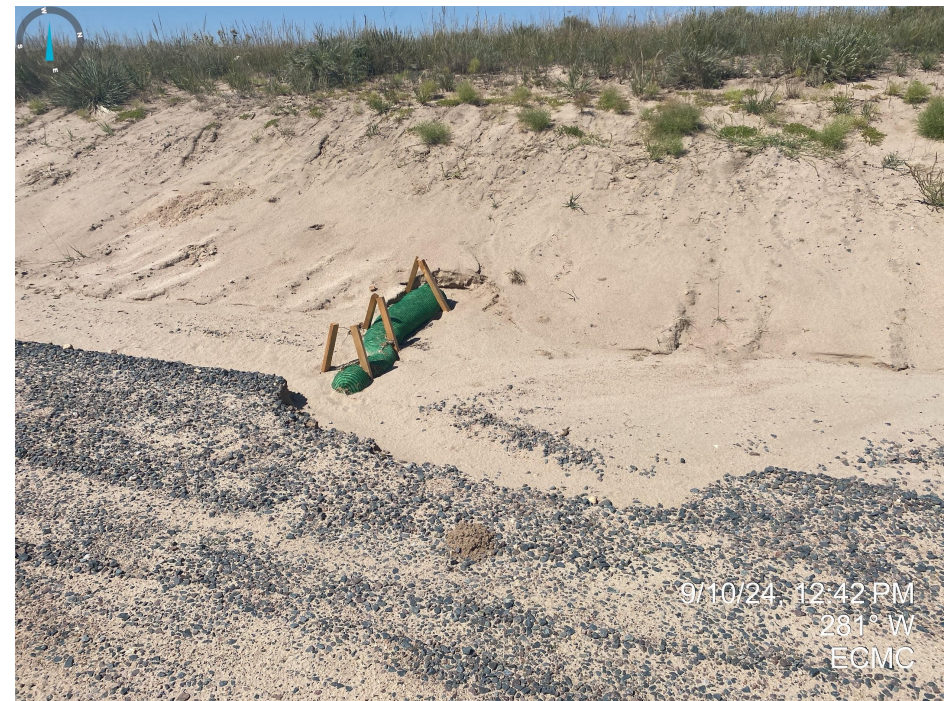
Photos 7 & 8. Taken along the access road; see comments in Photo 1 & 2.

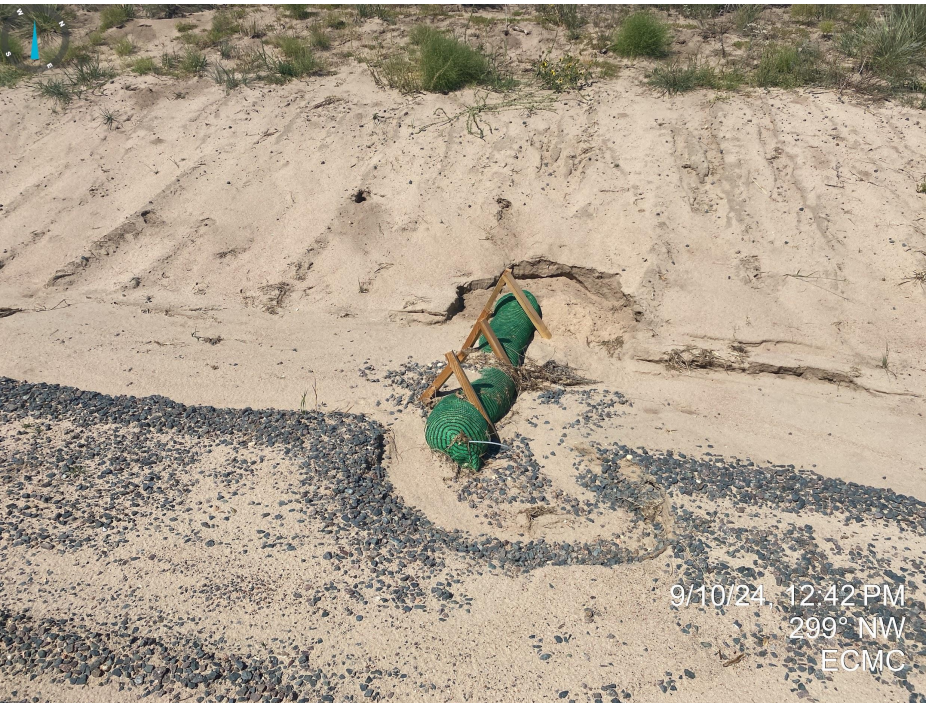
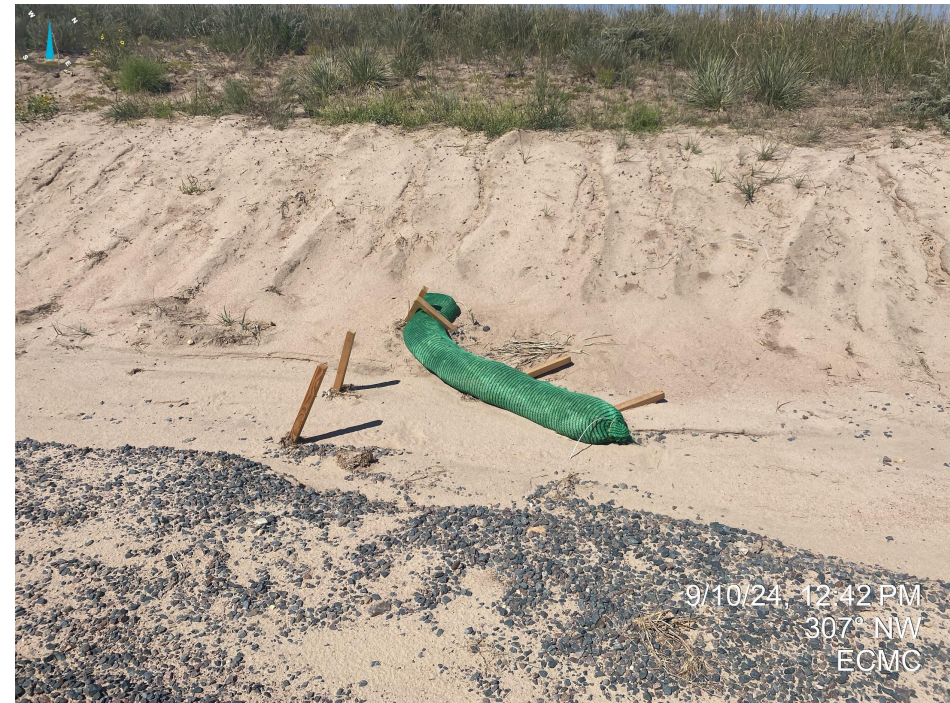
Photos 9 & 10. Taken along the access road; see comments in Photo 1 & 2.

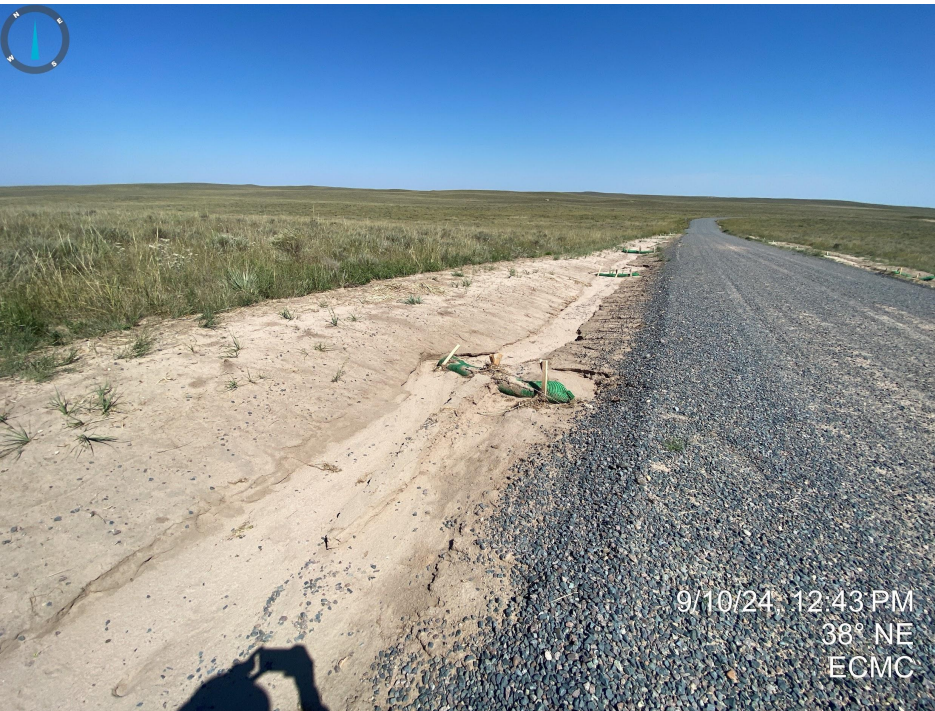
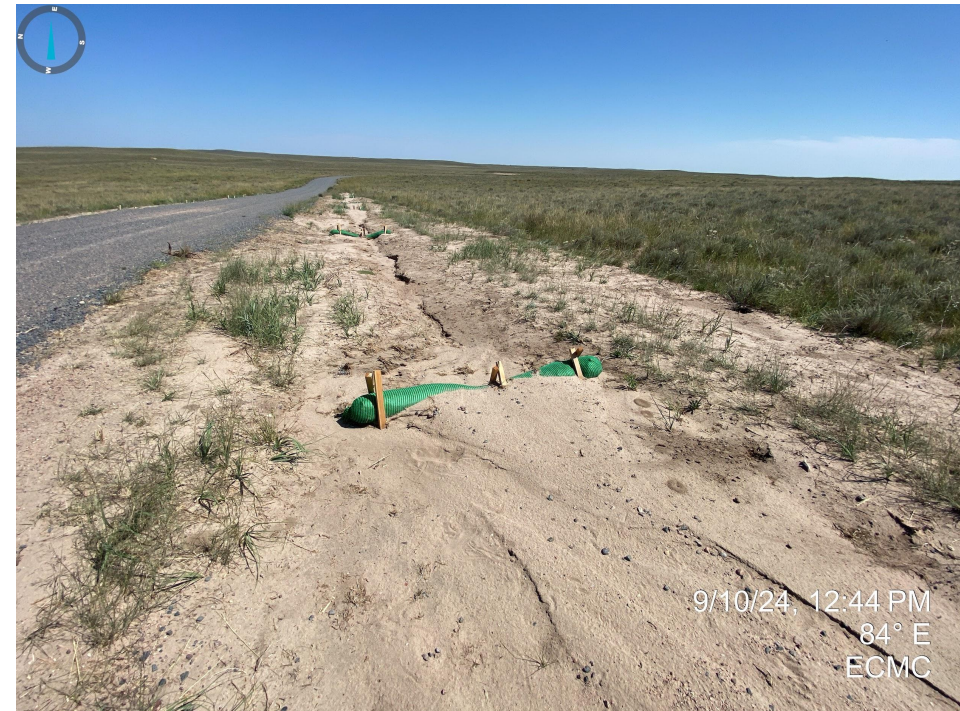
Photos 11 & 12. Taken along the access road; see comments in Photo 1 & 2.

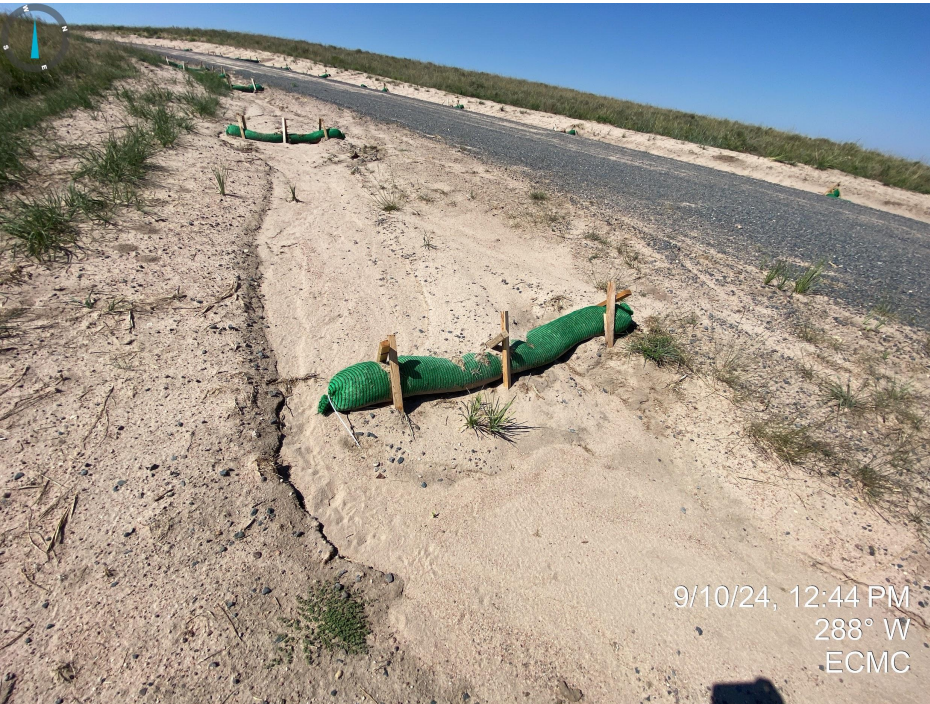
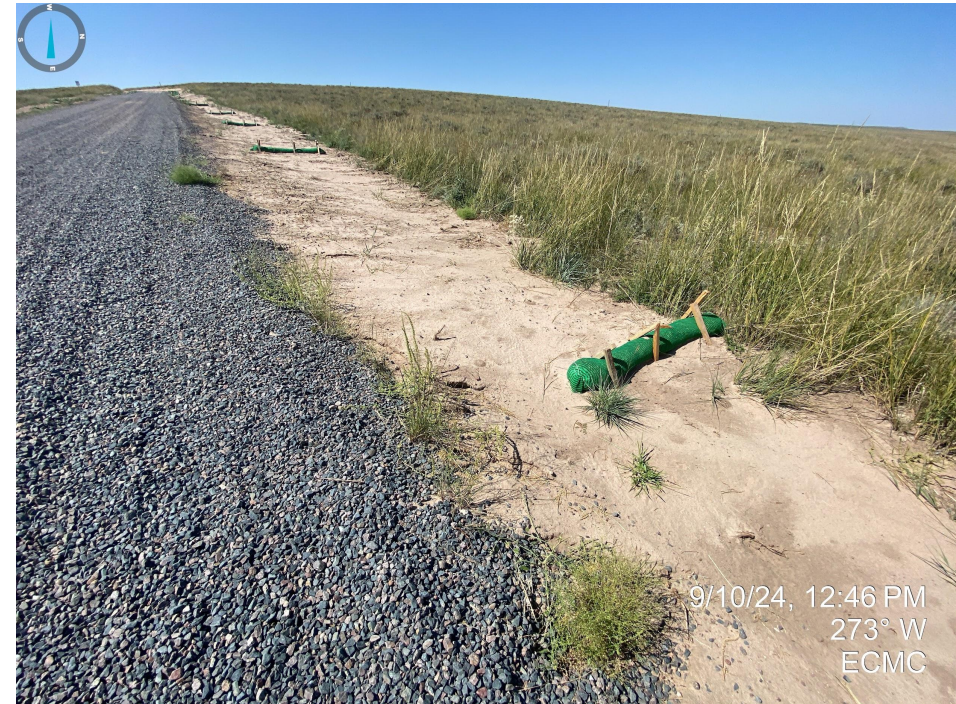
Photos 13 & 14. Taken along the access road; see comments in Photo 1 & 2.

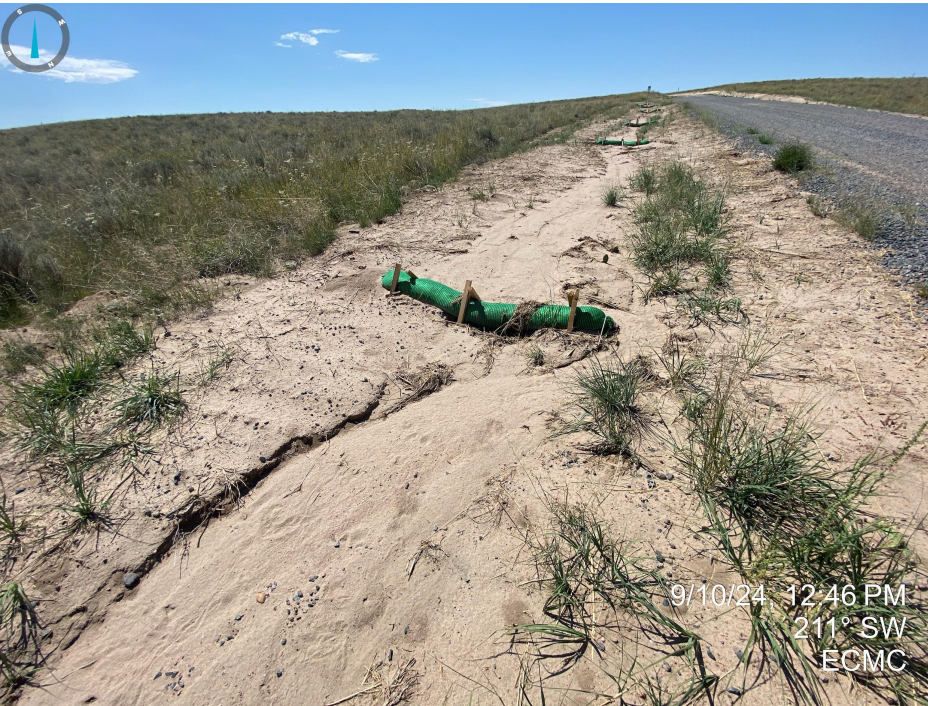
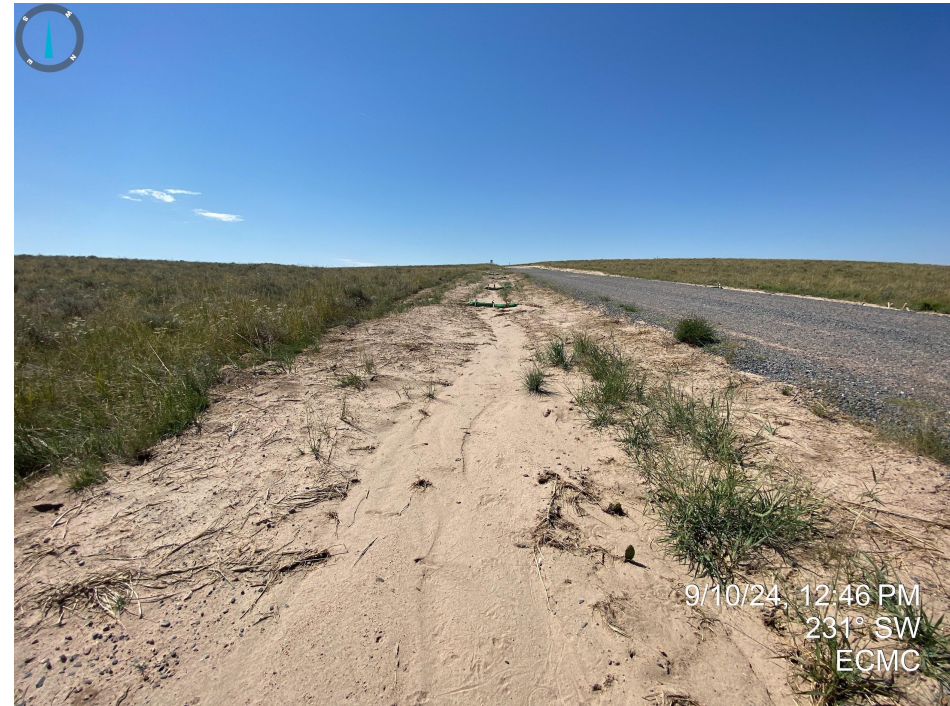
Photos 15 & 16. Taken along the access road; see comments in Photo 1 & 2.

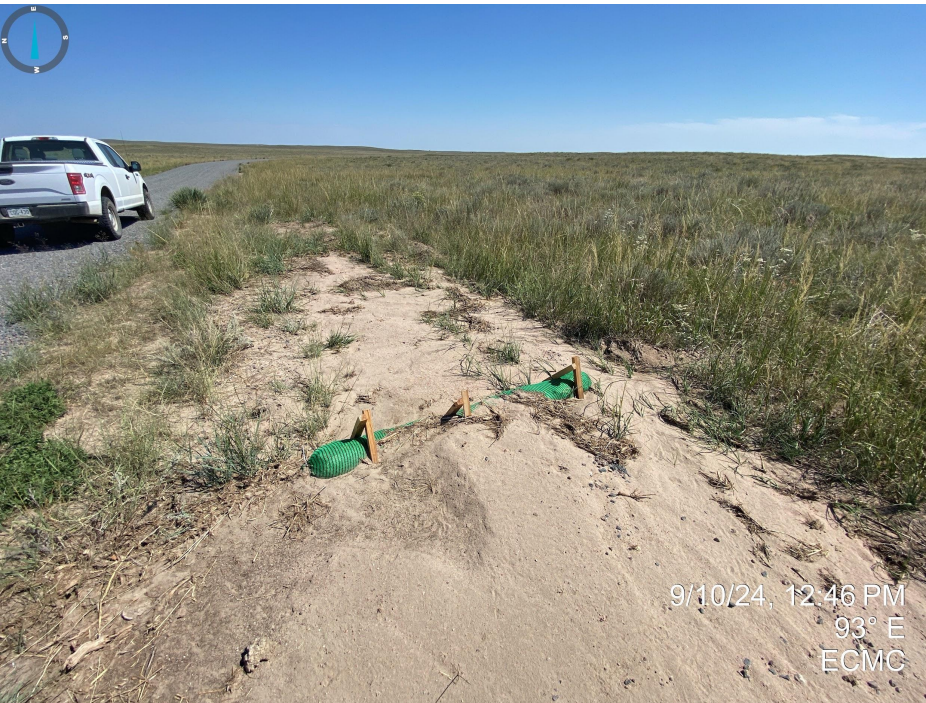
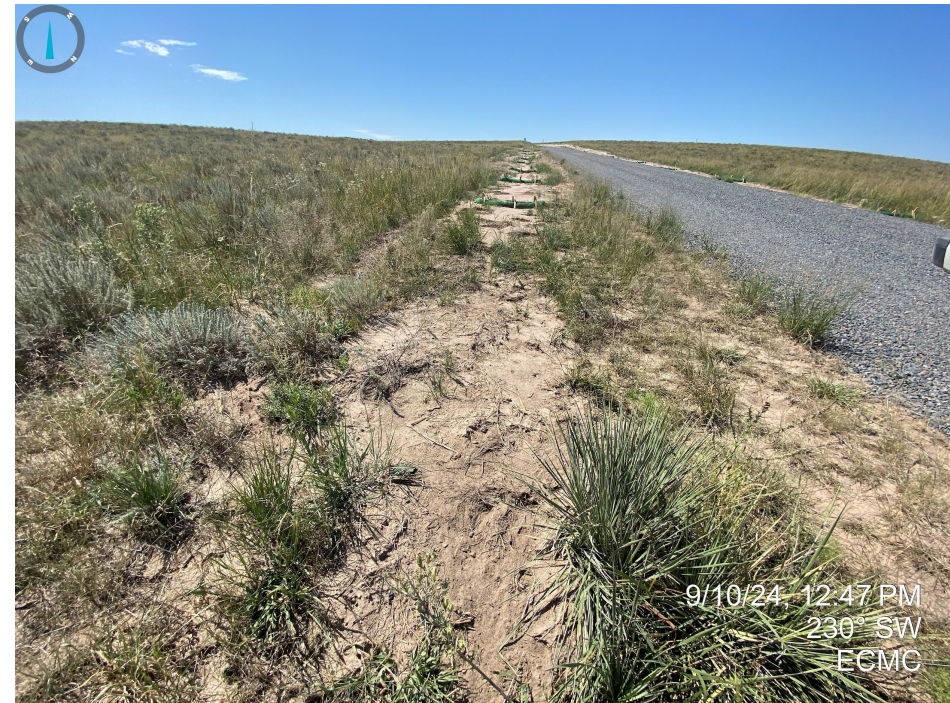
Photos 17 & 18. Taken along the access road; see comments in Photo 1 & 2.

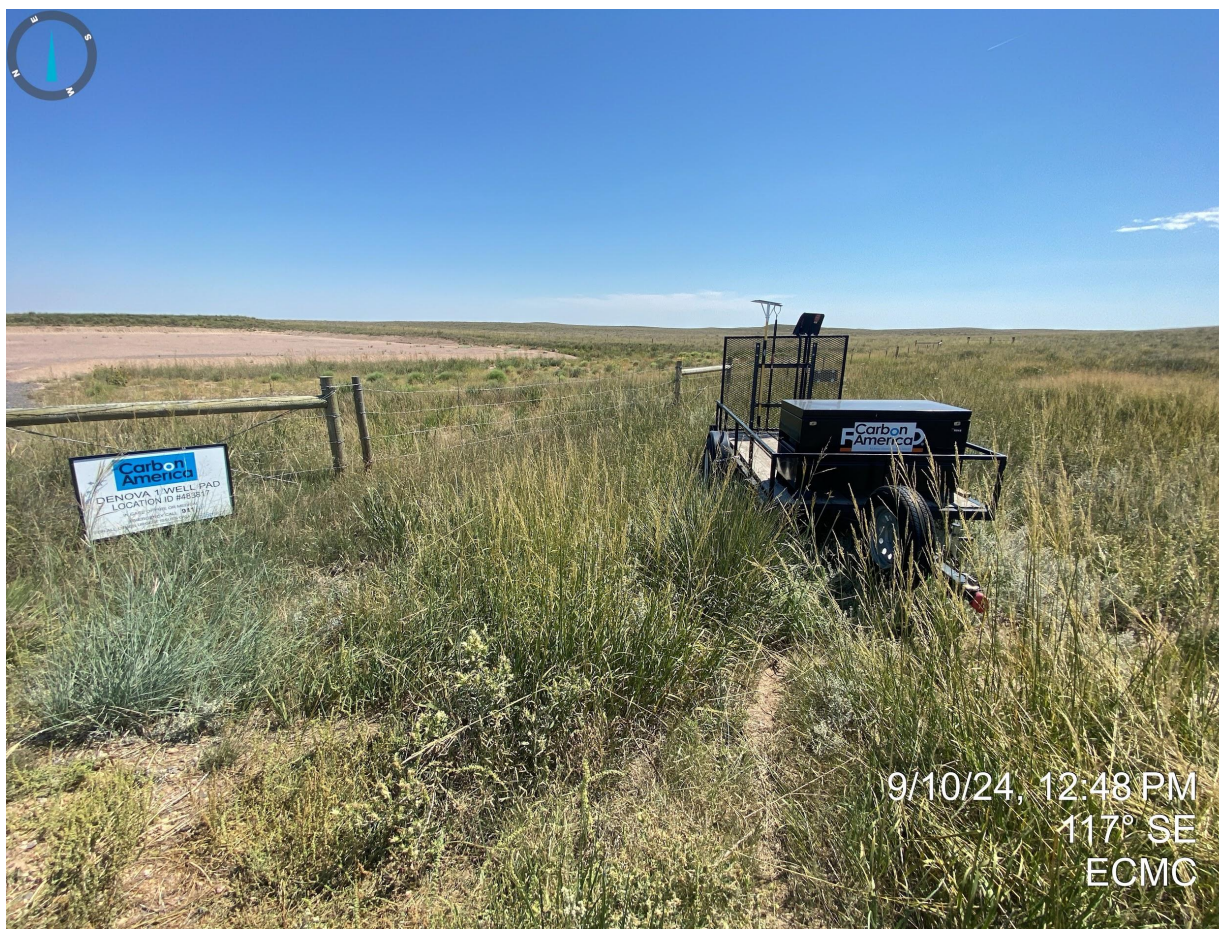
Photo 19. Emergency contact number has been updated with larger font and the unused equipment has been moved off location. Operator will need to submit documentation of permission to store equipment on adjacent landowner.

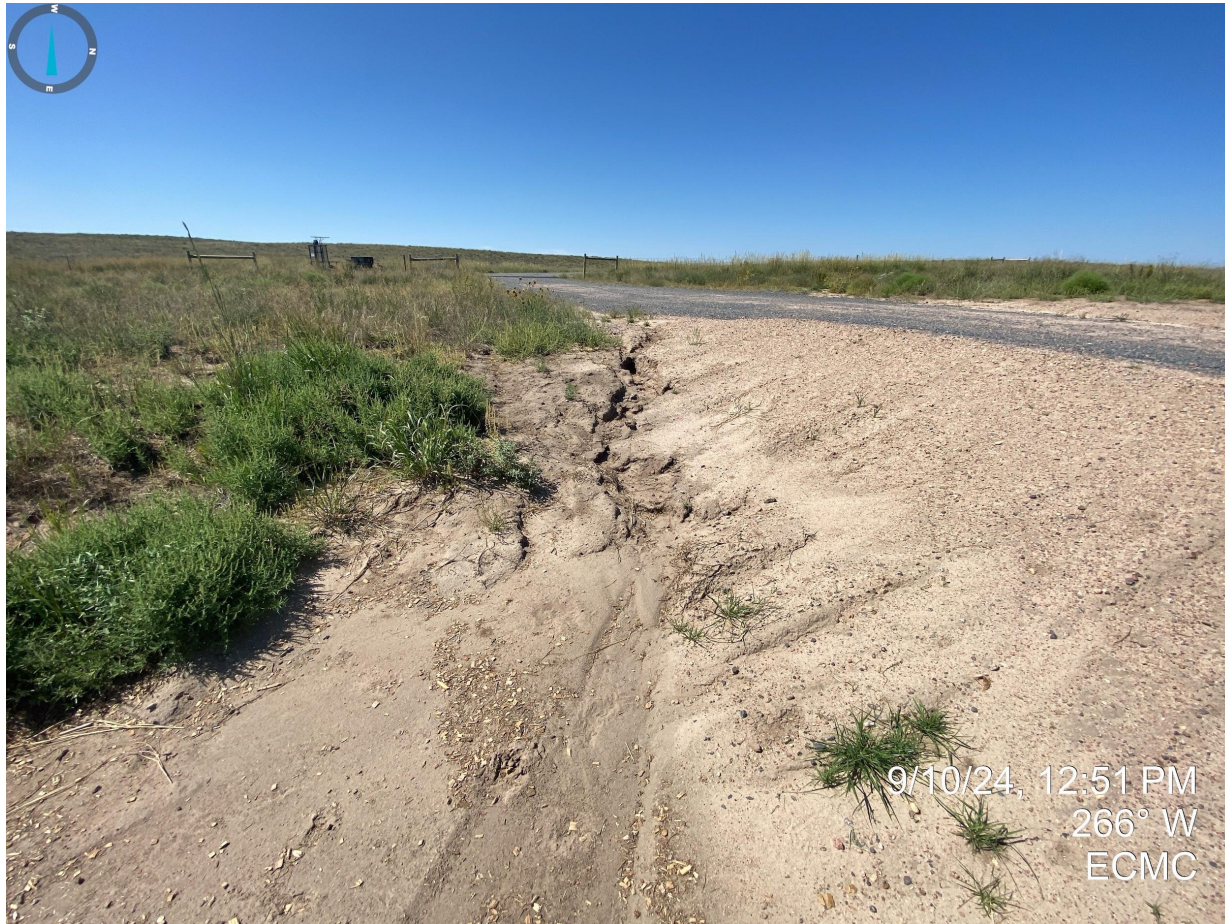
Photo 20. Erosion degradation observed near the entrance to the drilling pad.

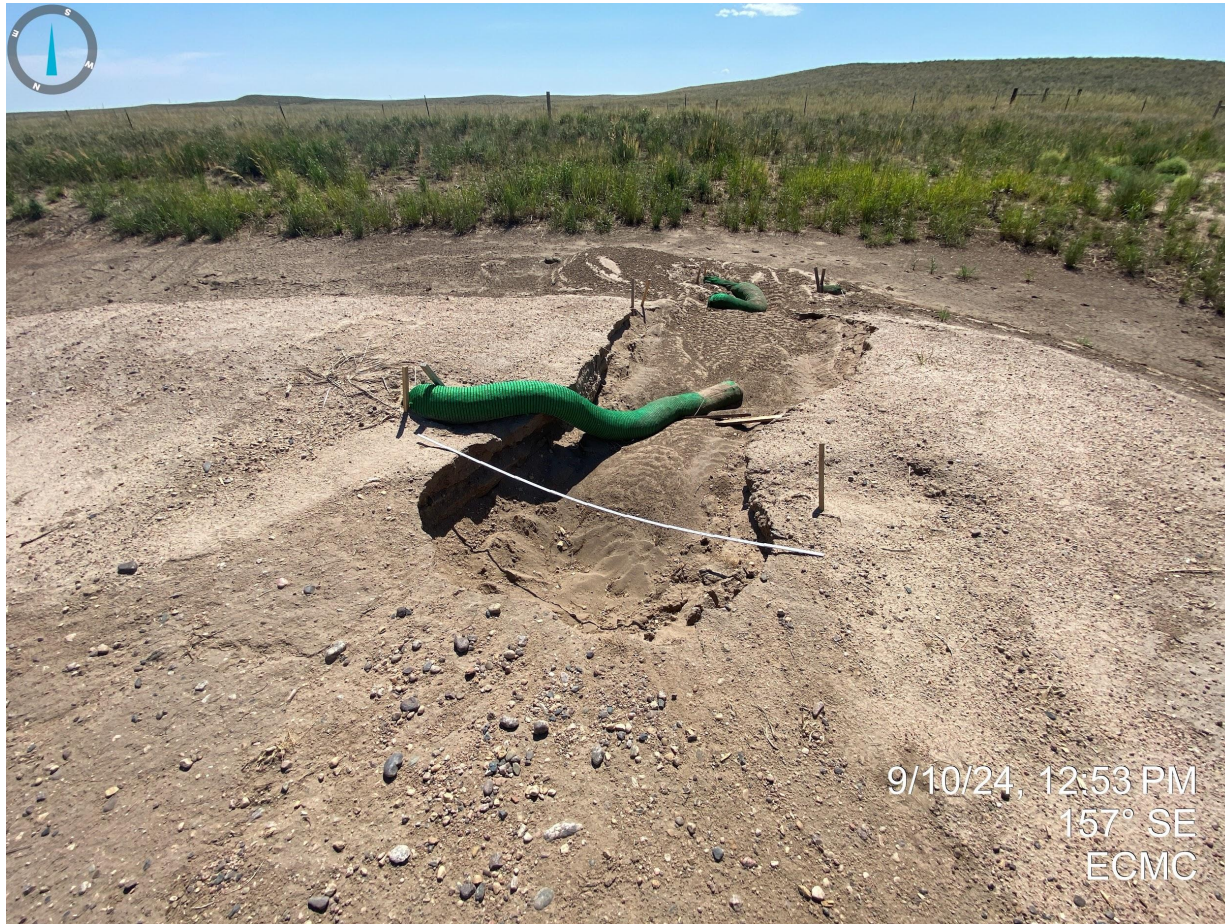
Photo 21. Erosion degradation near the southwest corner of the drilling pad, near the sediment detention area.

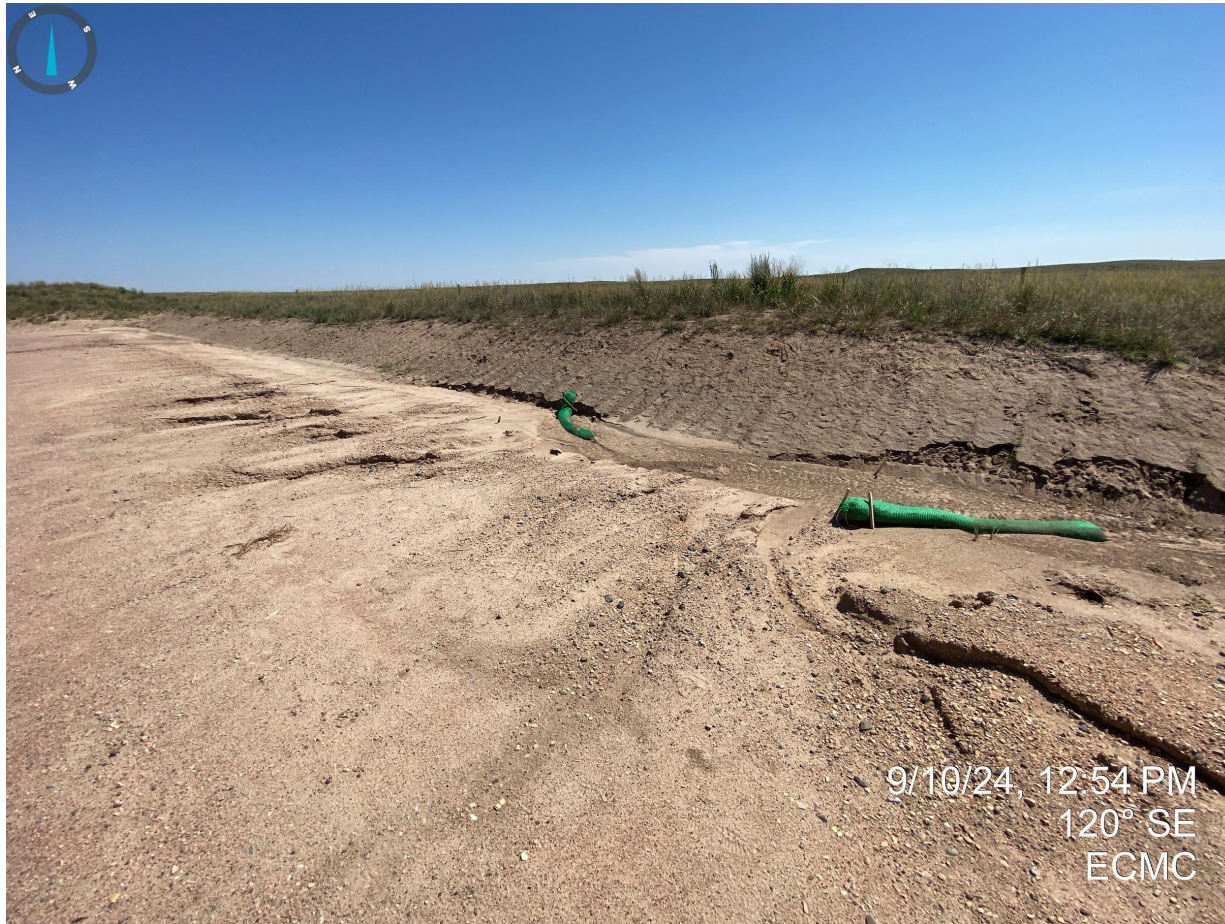
Photo 22. Erosion degradation observed on the southern portion of the drilling pad.

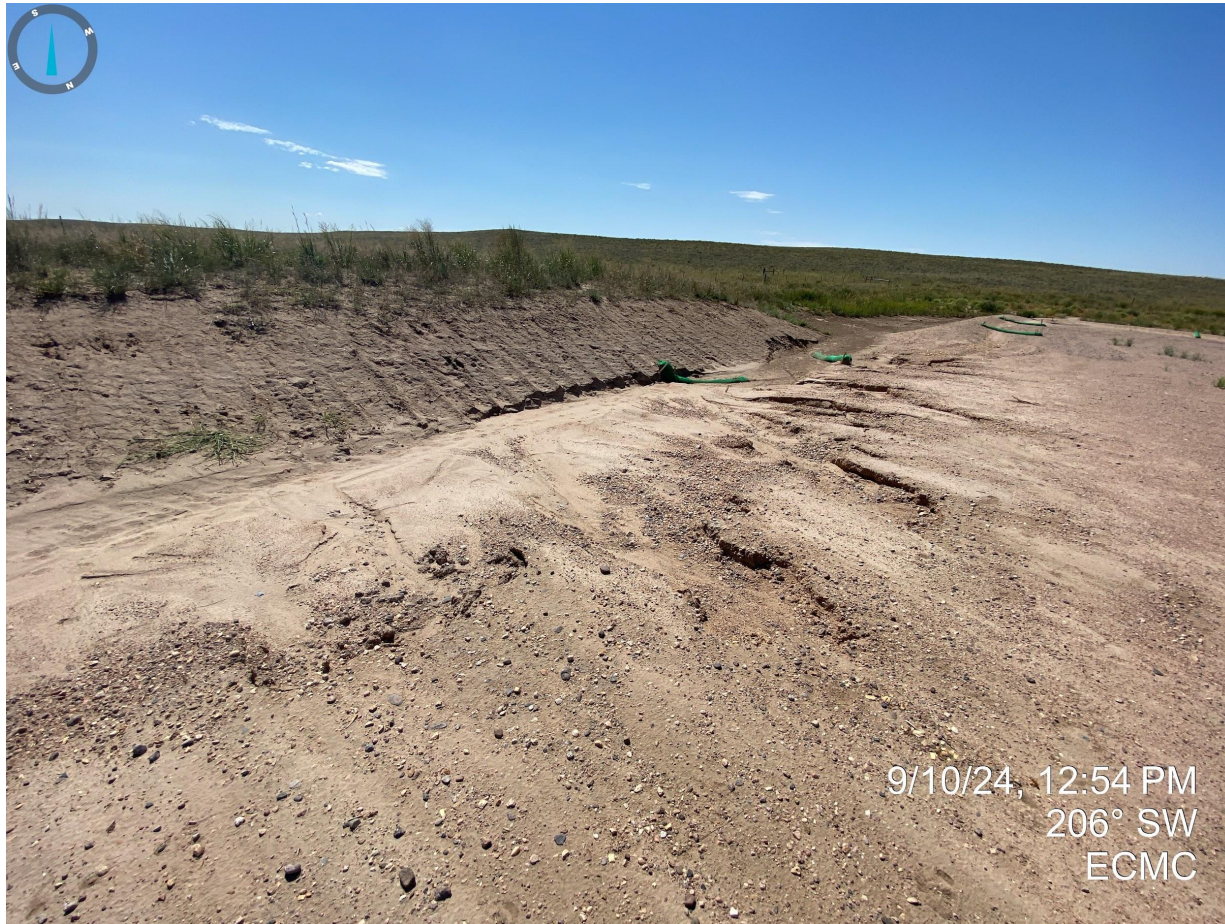
Photo 23. Erosion degradation observed on the southern portion of the drilling pad.

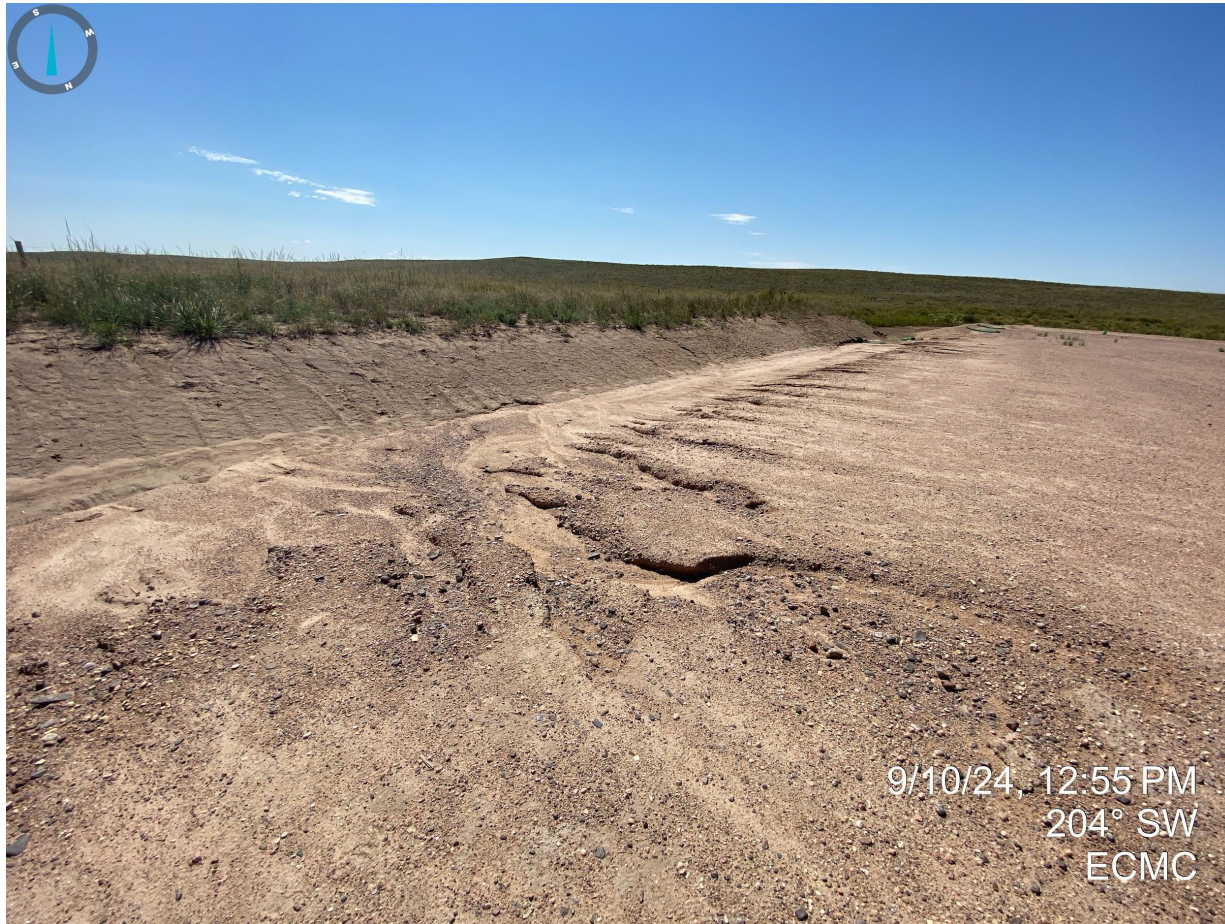
Photo 24. Erosion degradation observed on the southern portion of the drilling pad.

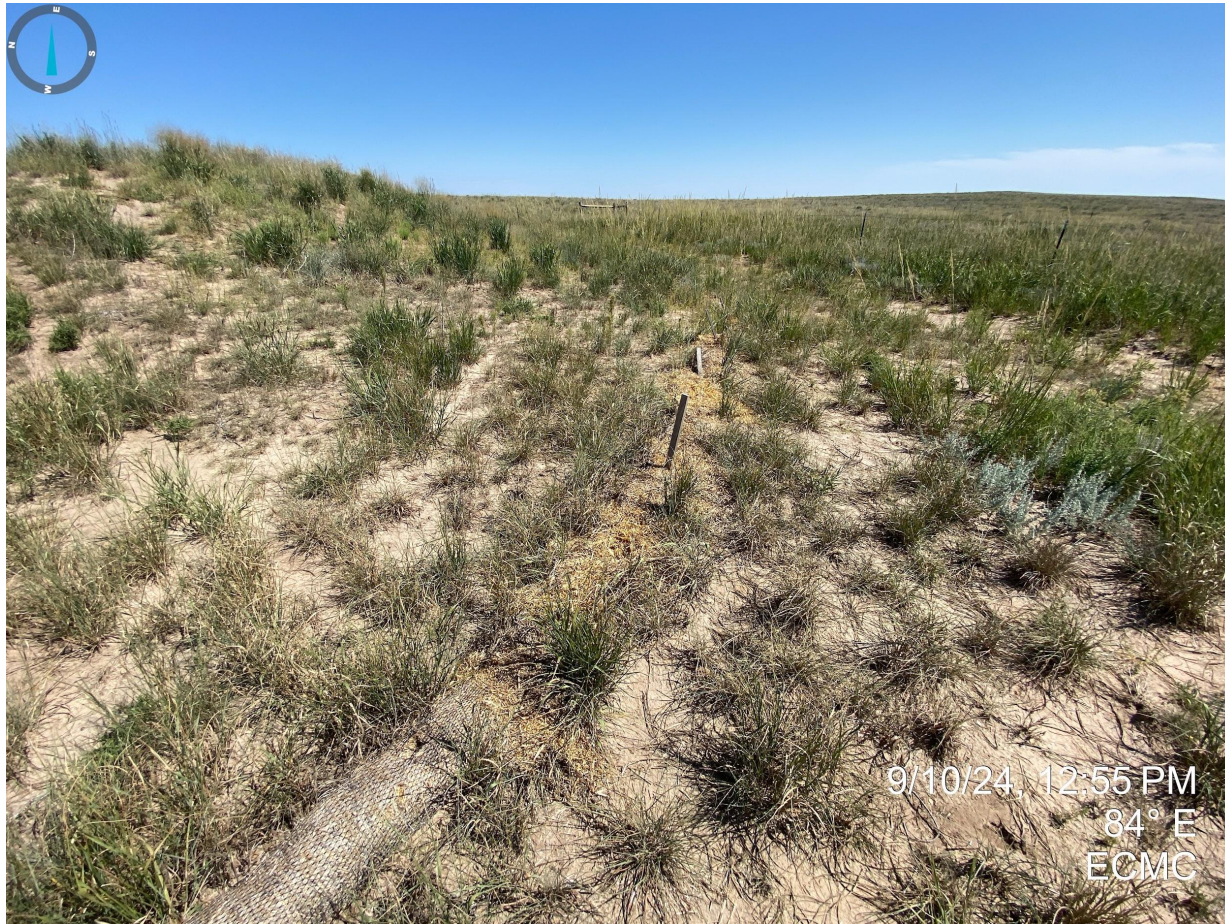
Photo 25. Degraded straw wattles around the topsoil stockpile need to be removed as it's considered debris.

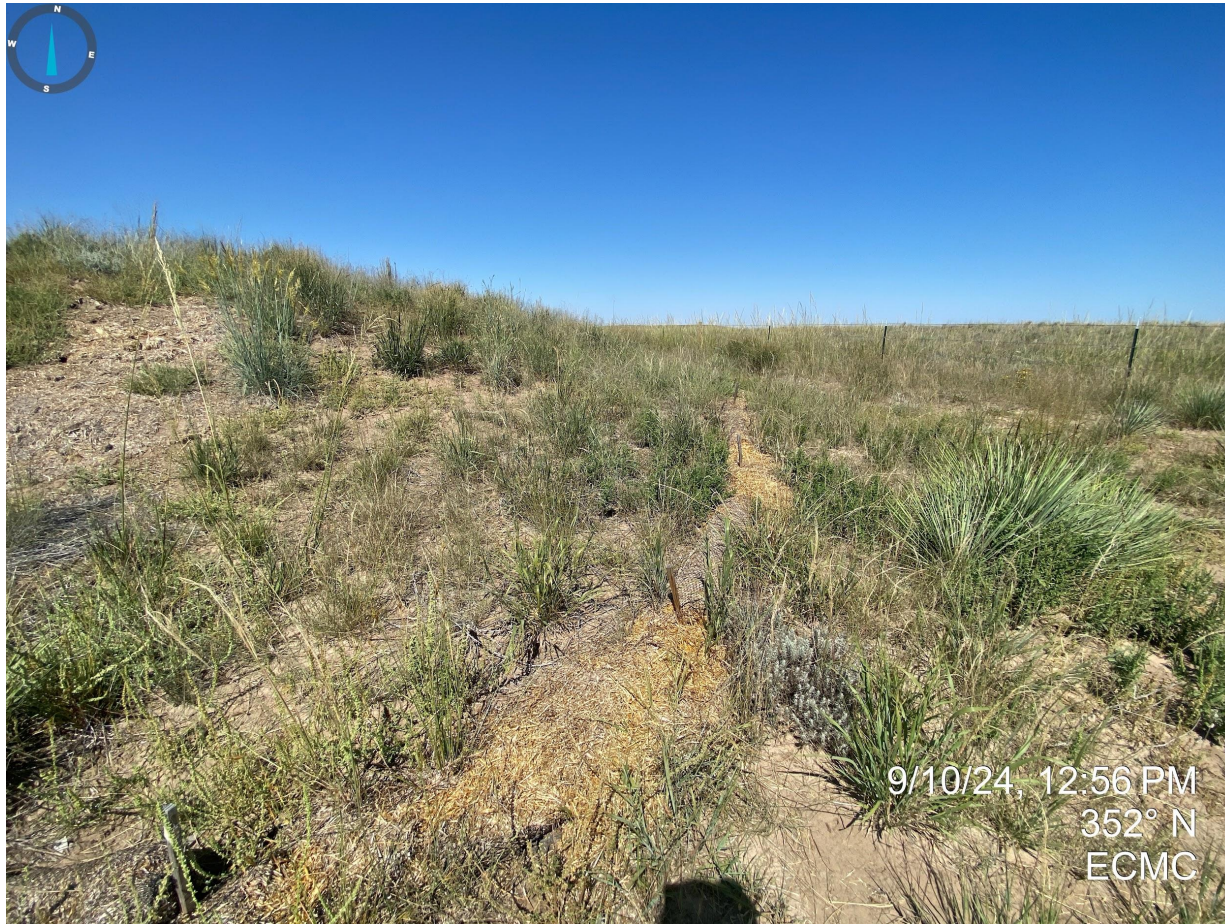
Photo 26. South side of topsoil stockpile; see comments in Photo 25.

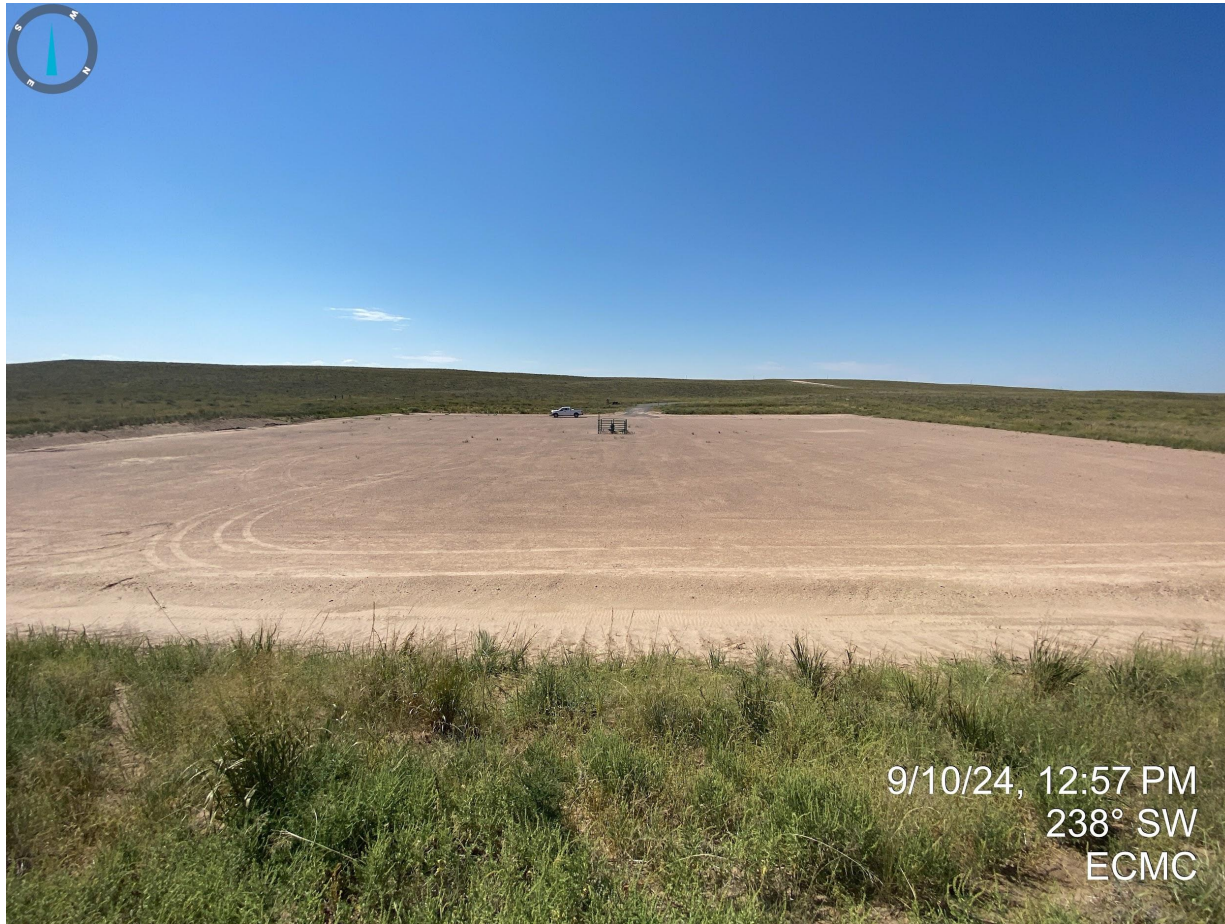
Photo 27. Facing southwest from on top of the topsoil stockpile. It does not appear that interim reclamation activities have been performed.
