Interim Reclamation and Stormwater Inspection

Date: 09/10/2024

Operator: DENOVA SEQUESTRATION LLC - 10790

Location ID: 483817

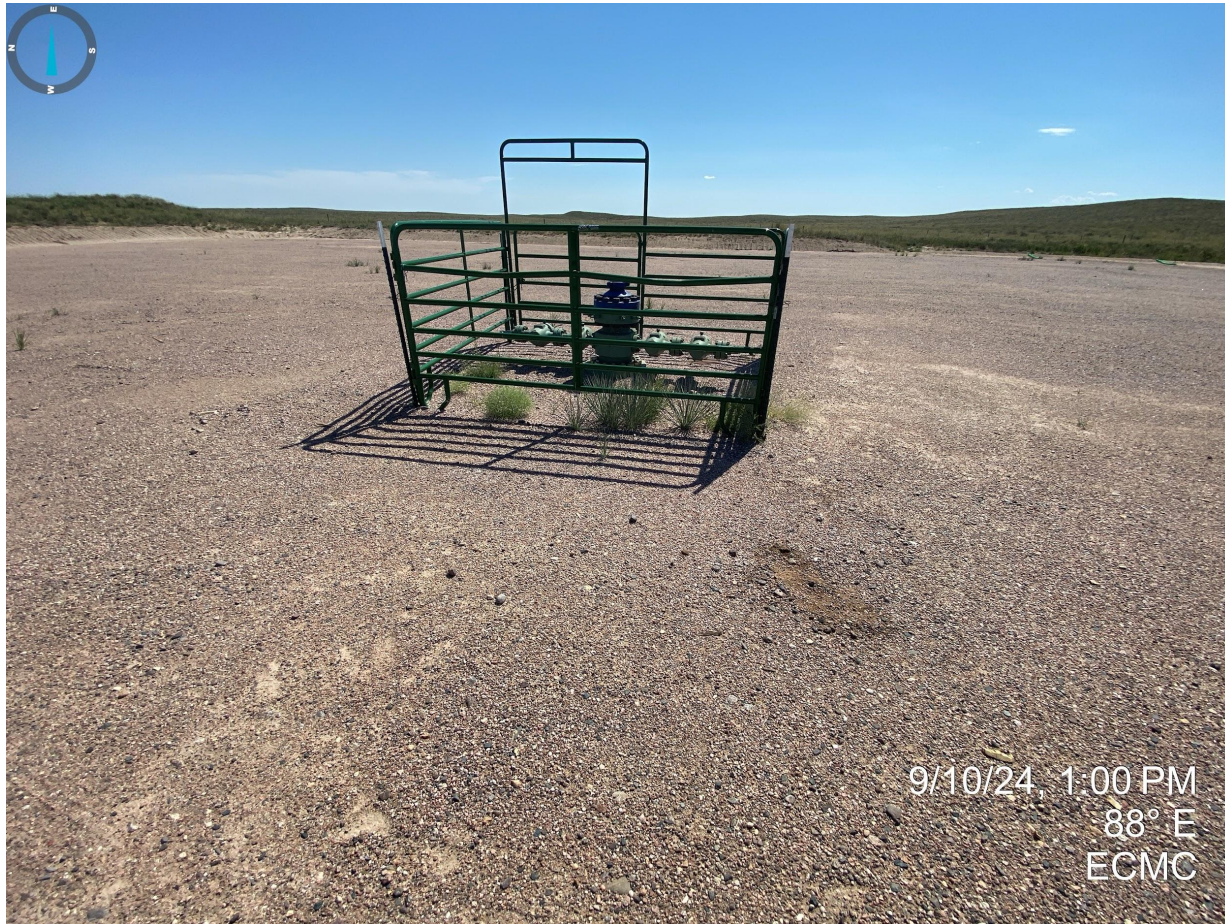
Photo 28. Stained soil around the wellhead appears to have been removed.

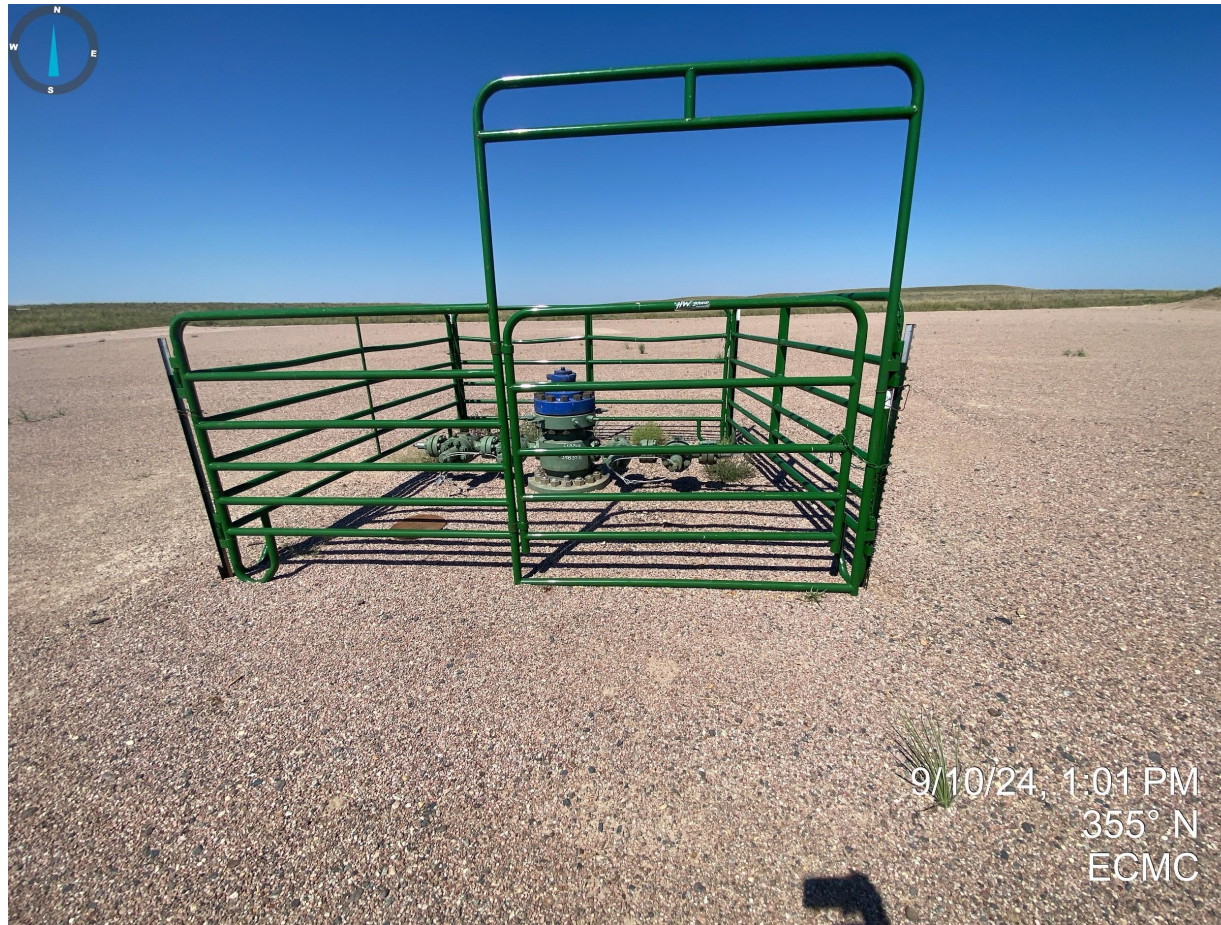
Photo 29. Stained soil around the wellhead appears to have been removed.

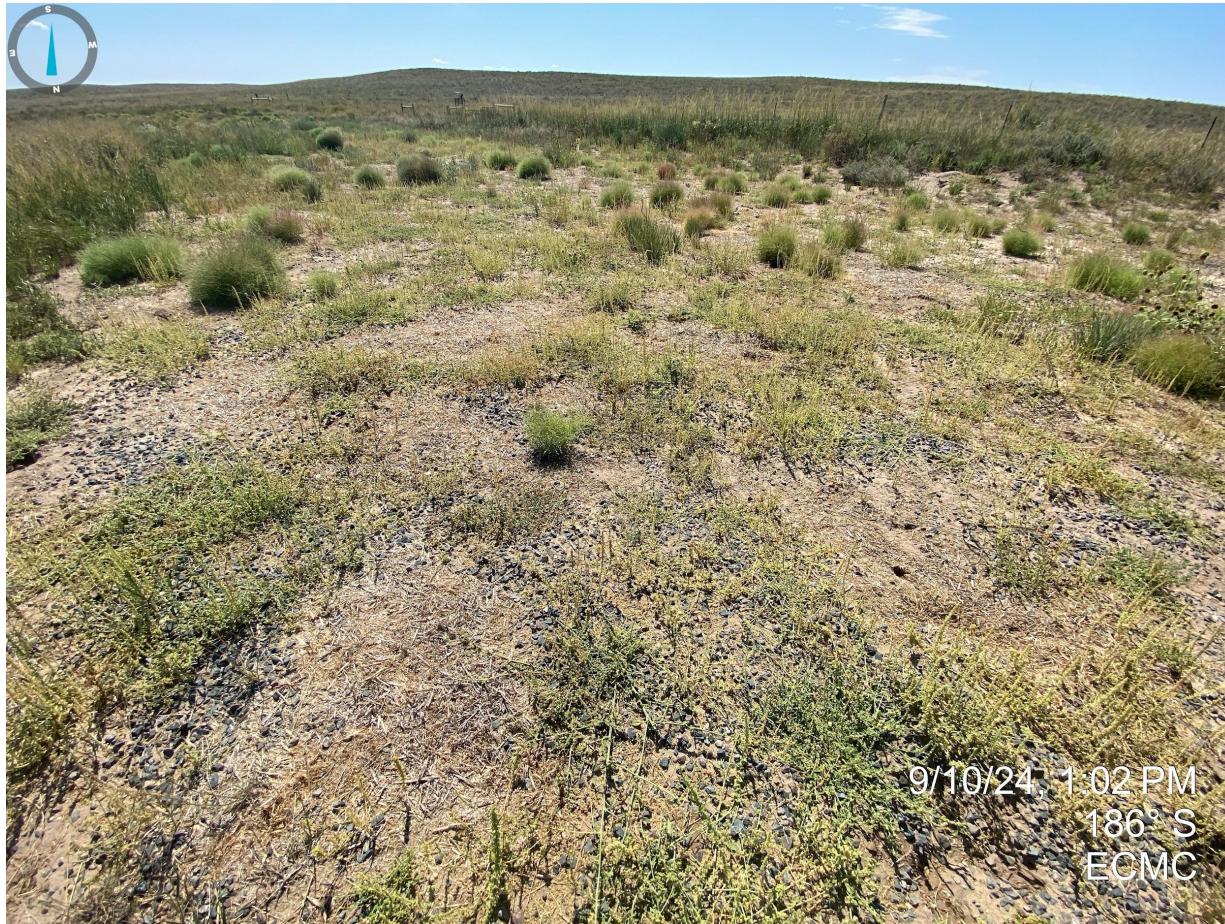
Photo 30. Northern parking areas do not appear to have been reclaimed.

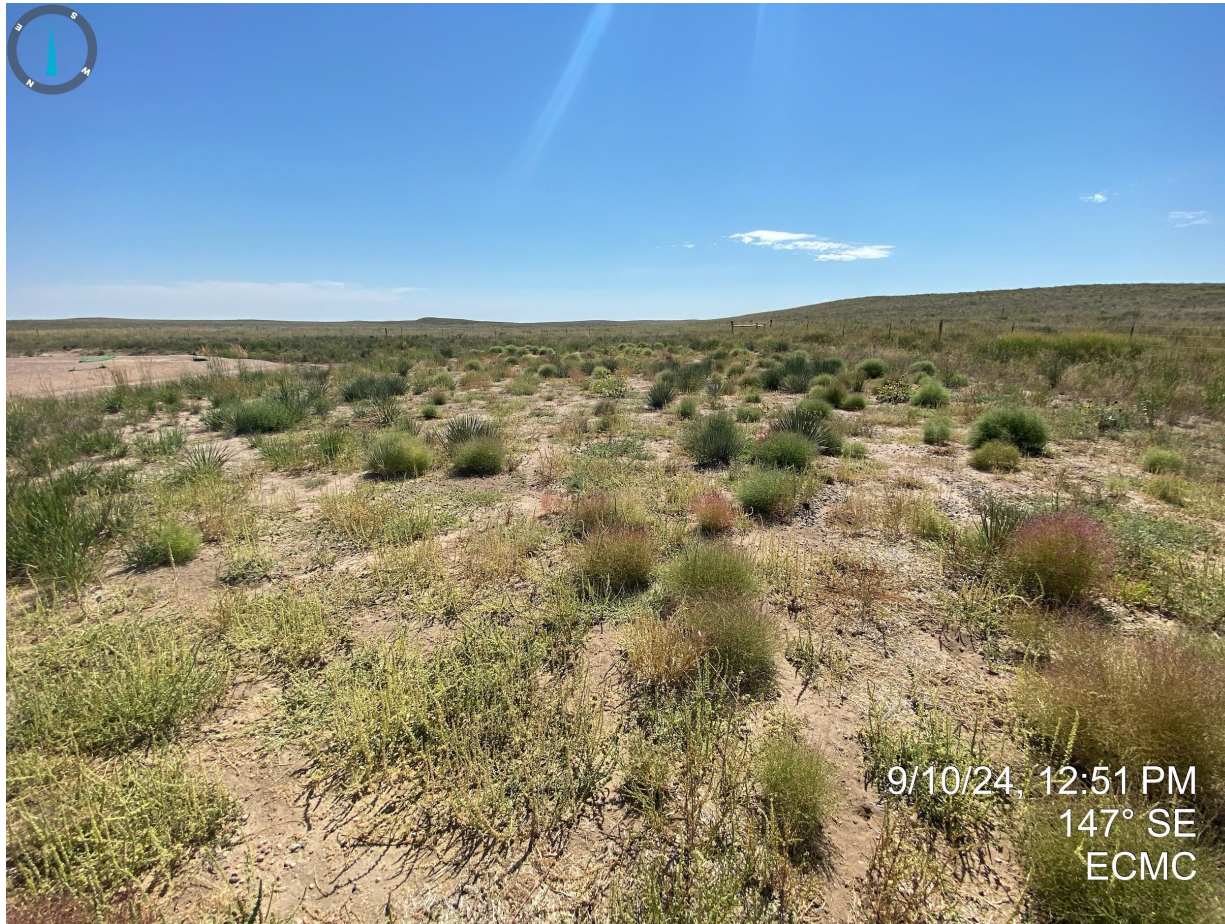
Photo 31. Southern parking areas do not appear to have been reclaimed.
