Inspection Photos
Location: Hoffman Earl 1
Location ID: 321229
API # 05-011-06126

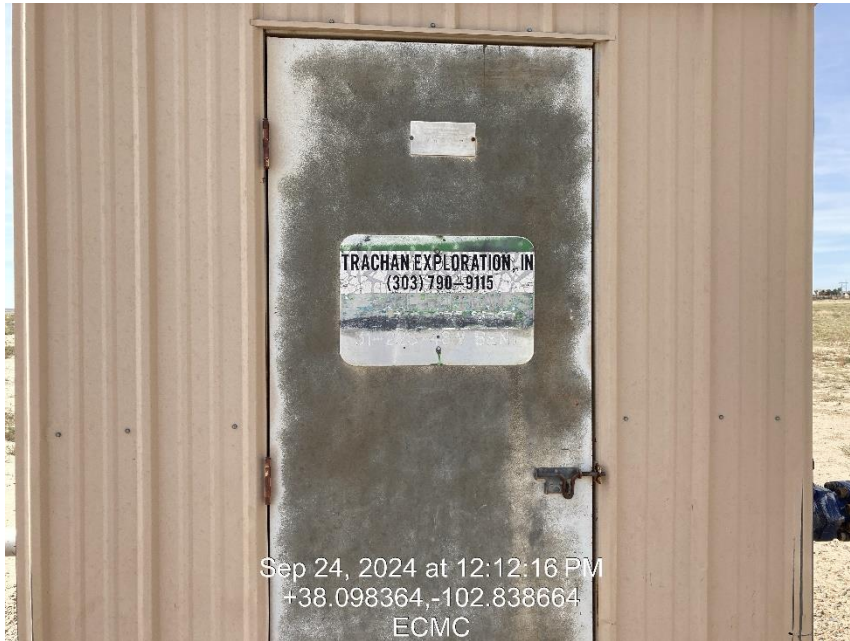
Photo 1 – Well placard on meter house, placard not legible

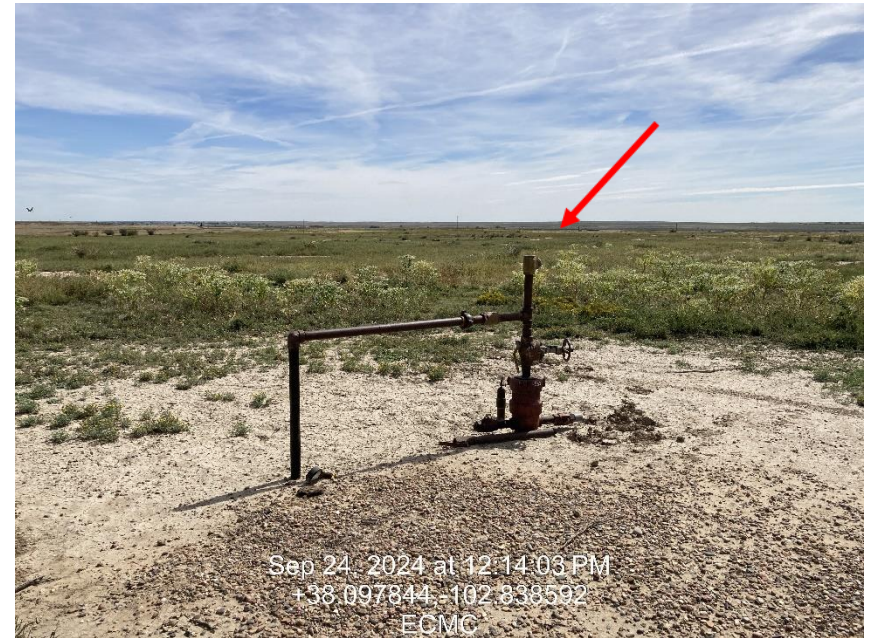
Photo 2 – Wellhead and equipment

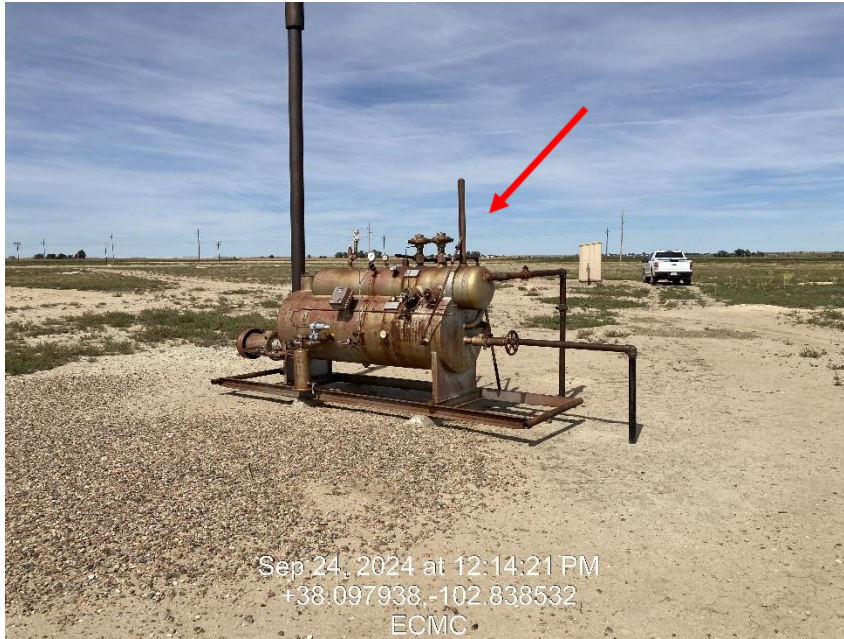
Photo 3 – Heater Treater

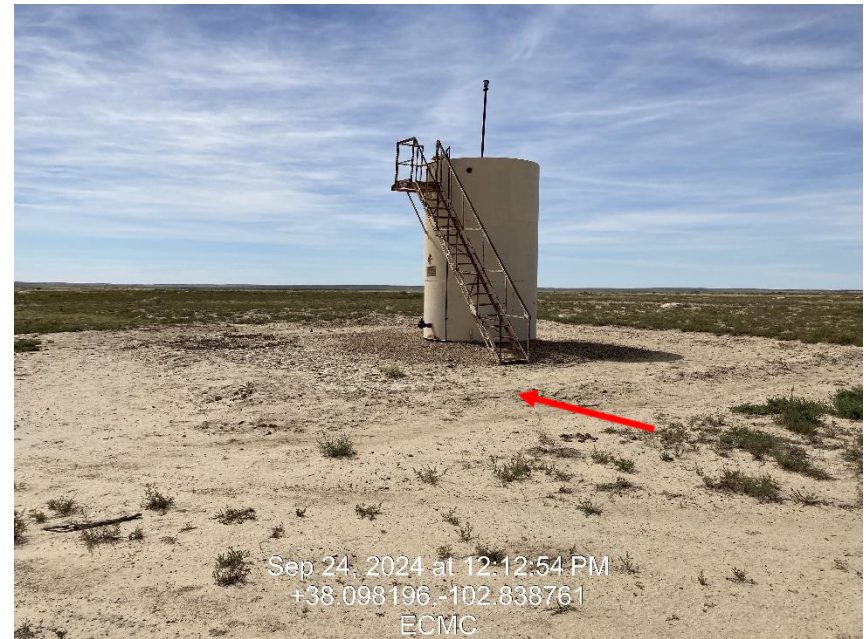
Photo 4 – Tank Battery, secondary containment not adequate

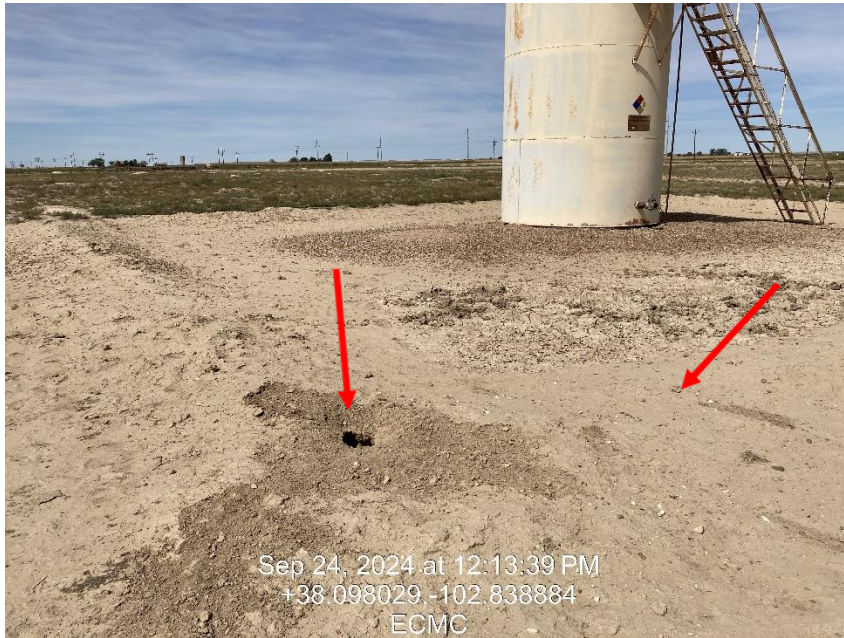
Photo 5 – Secondary Containment not adequate

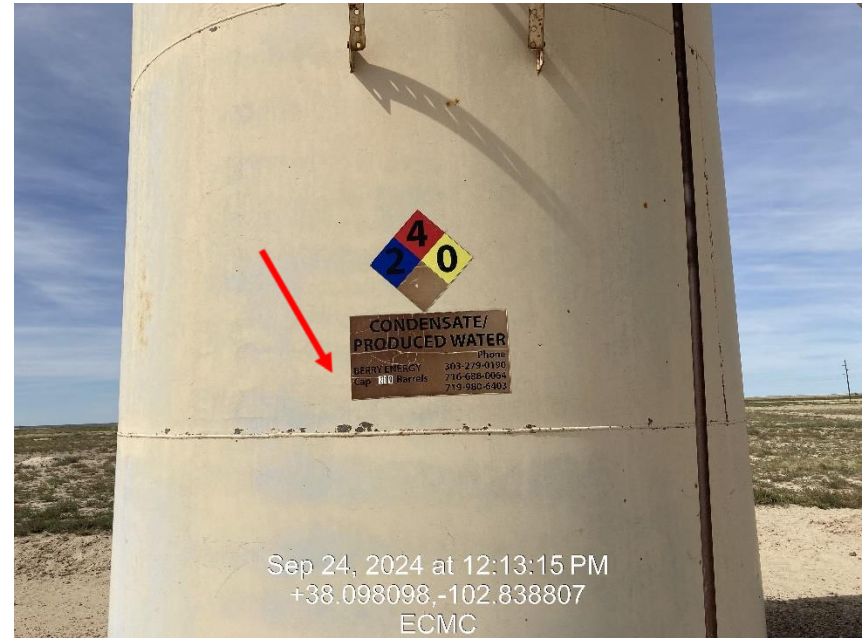
Photo 6 – Tank Placard does not reflect current Operator
