**Inspection Photos**  
**Location: Bourne 1**  
**Location ID: 321213**  
**API # 05-011-06032**

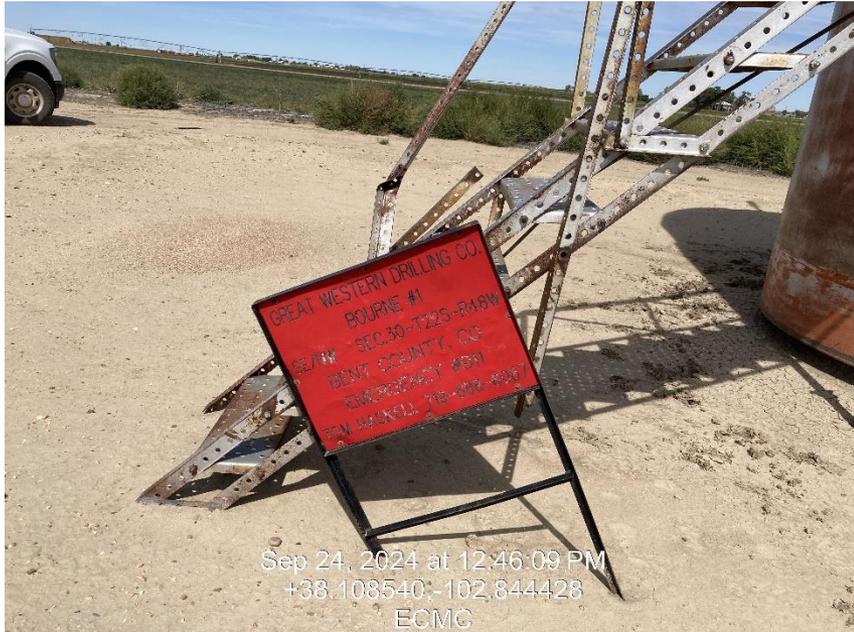
**Photo 1 –Well placard, incorrect Operator information**

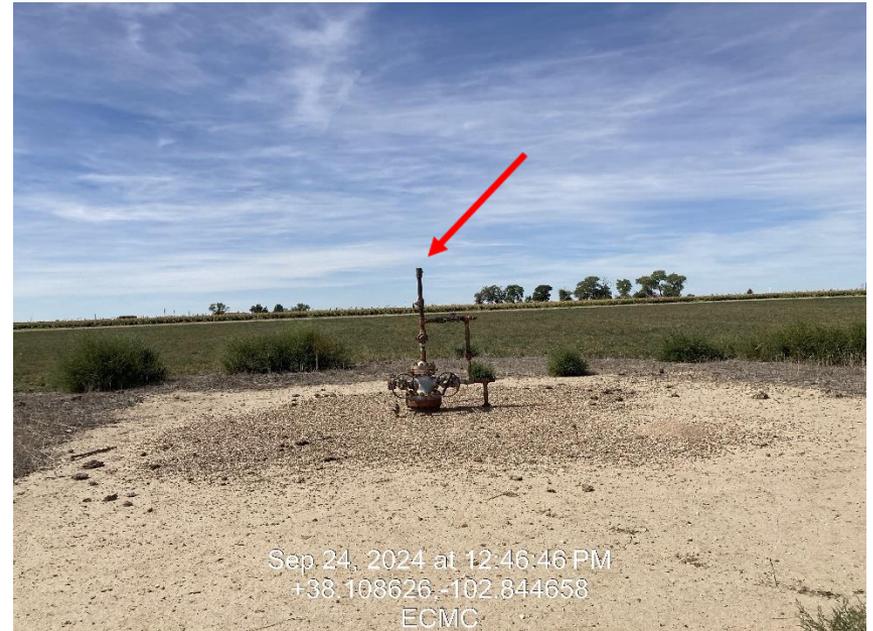
**Photo 2 – Wellhead and equipment**

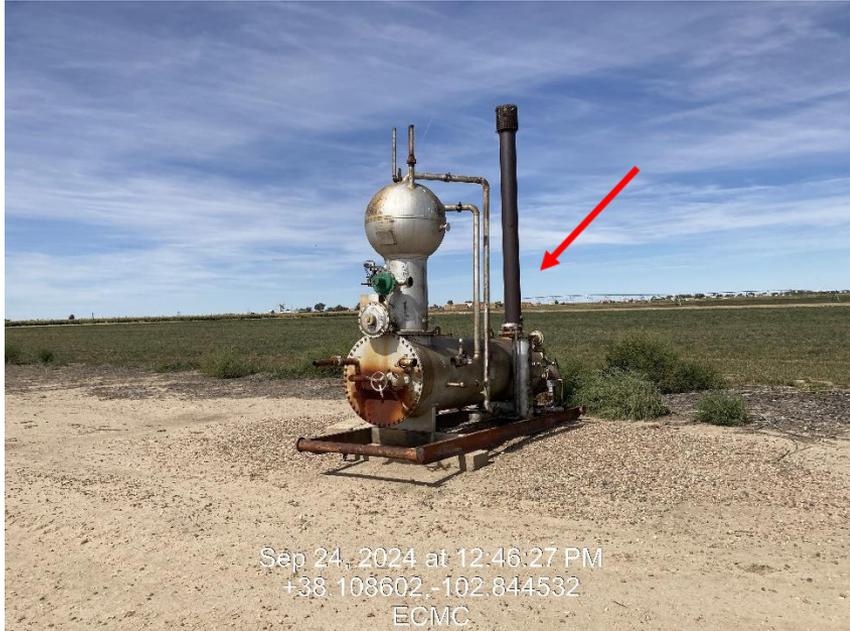
**Photo 3 – Heater Treater**

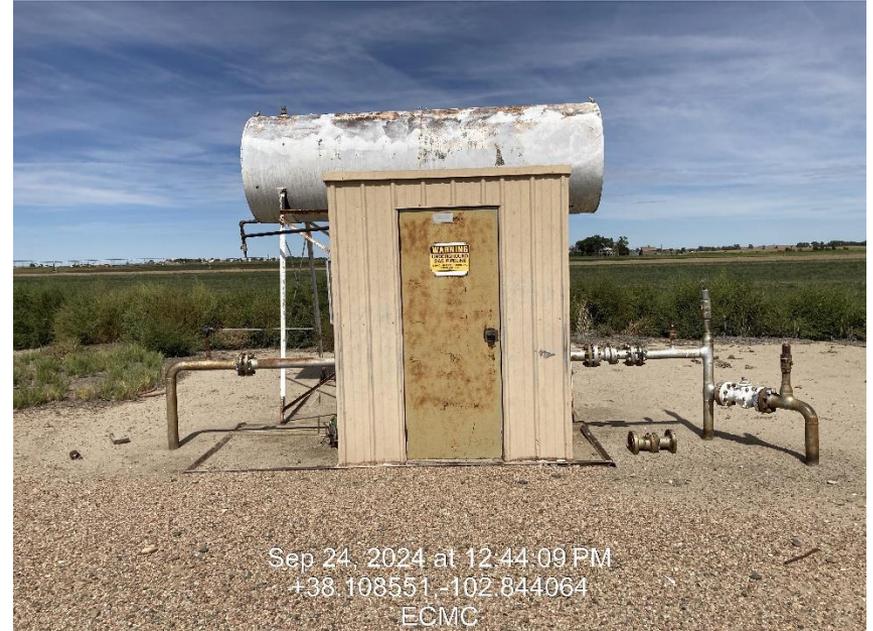
**Photo 4 – Meter House**

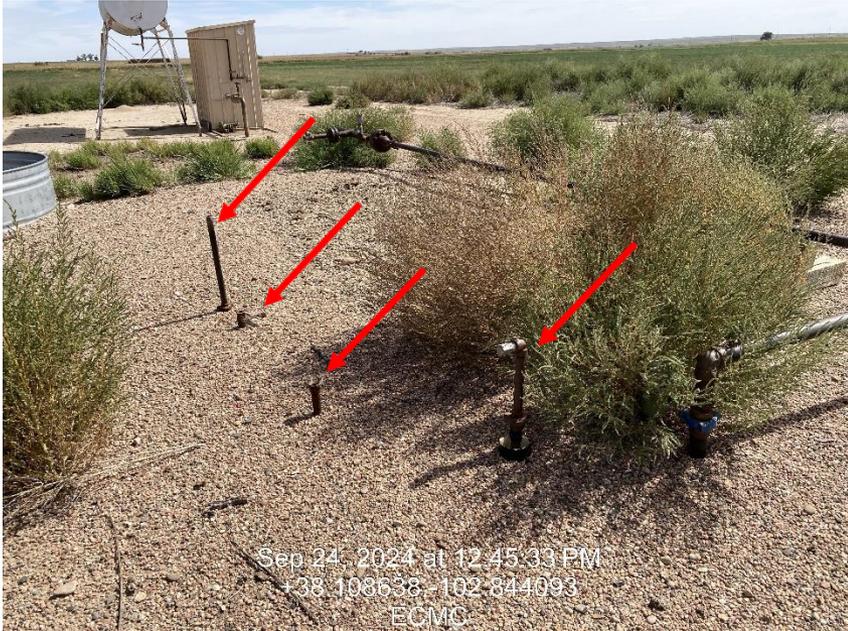
**Photo 5 – Pipe risers not capped and no OOSLAT**

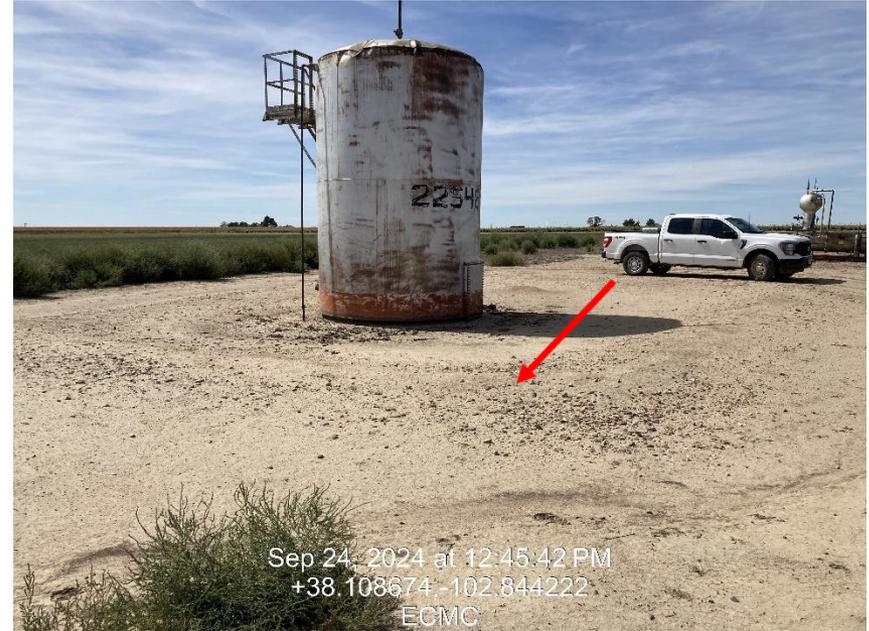
**Photo 6 – Tank Battery, Secondary Containment not adequate**

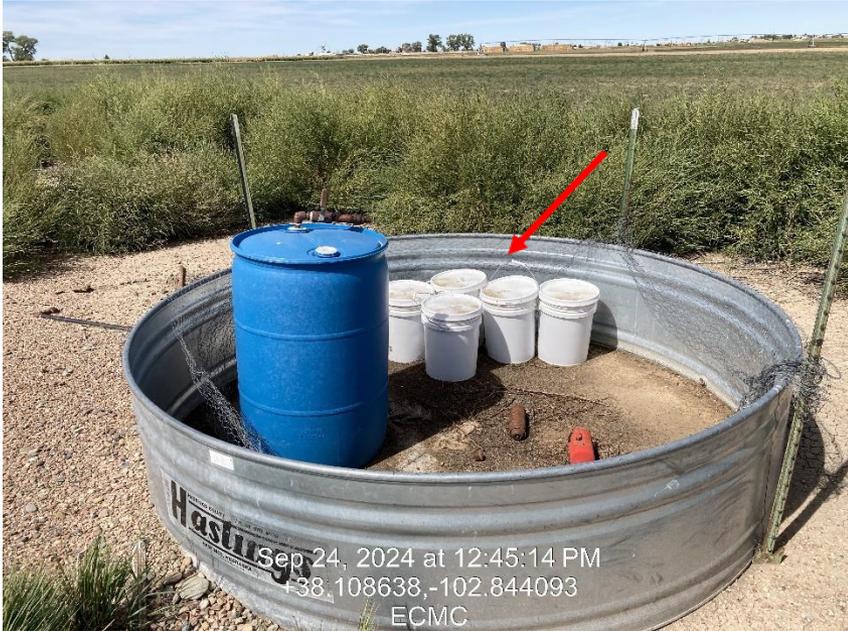
**Photo 7 – Secondary Containment with impacted soils stored in 5 gallon buckets**

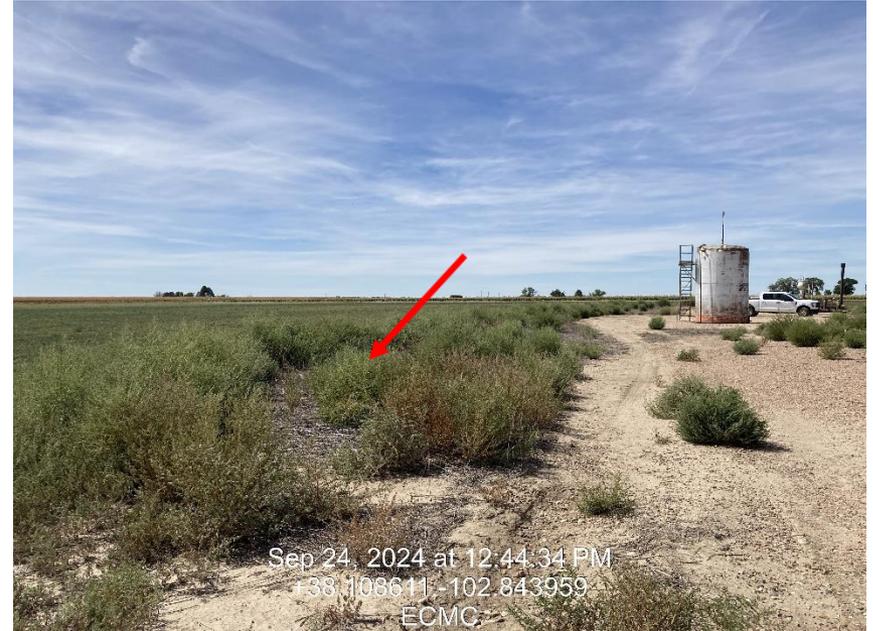
**Photo 8 – Undesirable weeds on location**

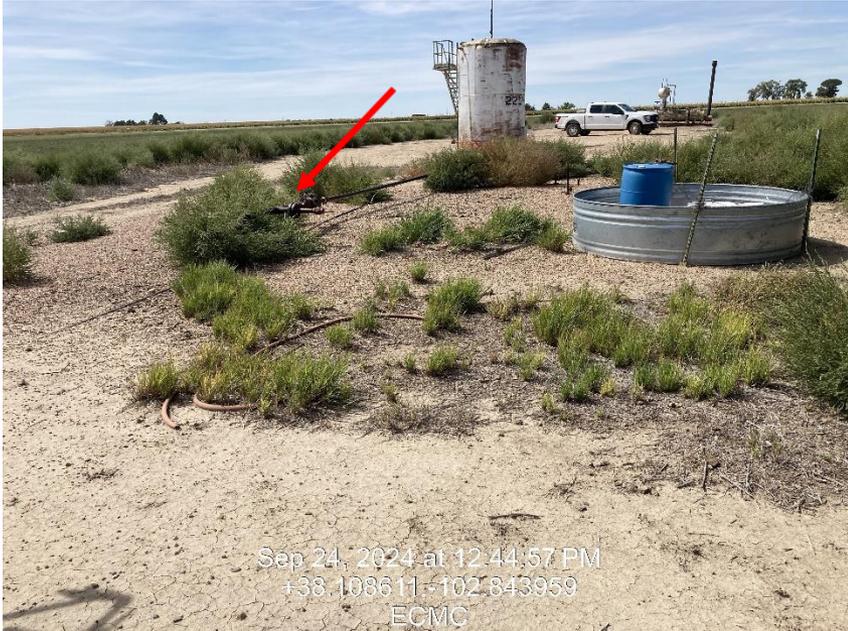
**Photo 9 – Undesirable weeds on location**

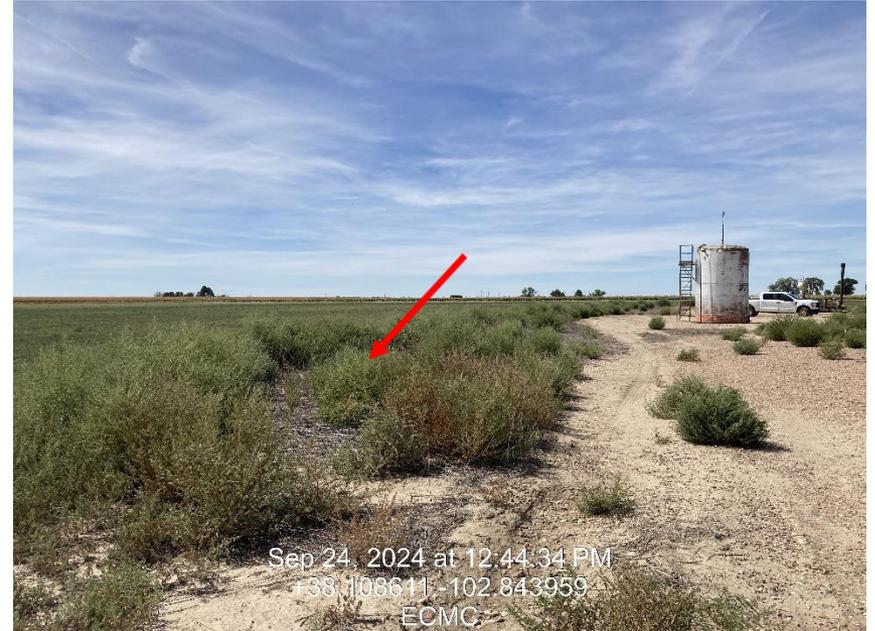
**Photo 10 – Undesirable weeds on location**
