Inspection Photos

Location: Wollert D 1

Location ID: 321230

API # 05-011-06138

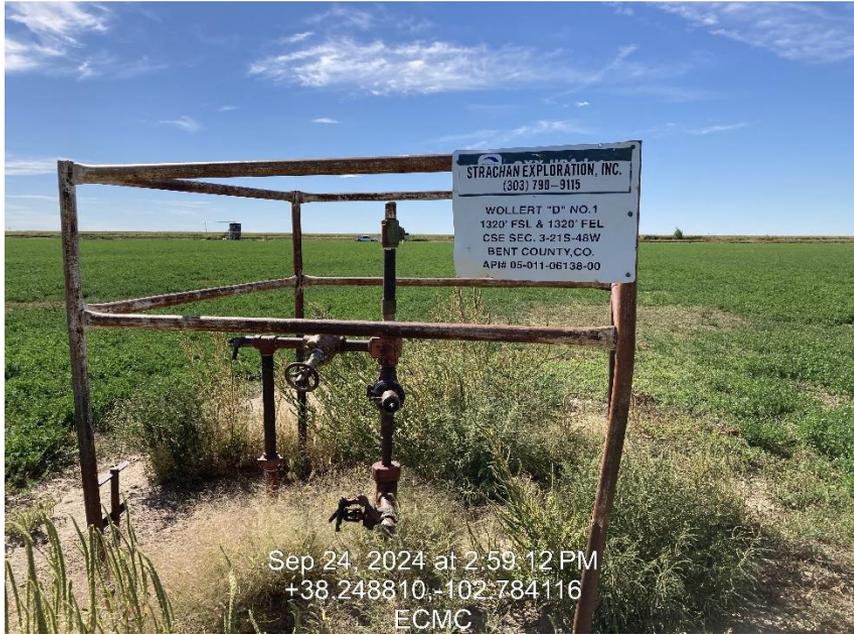
Photo 1 –Wellhead, well placard at wellhead

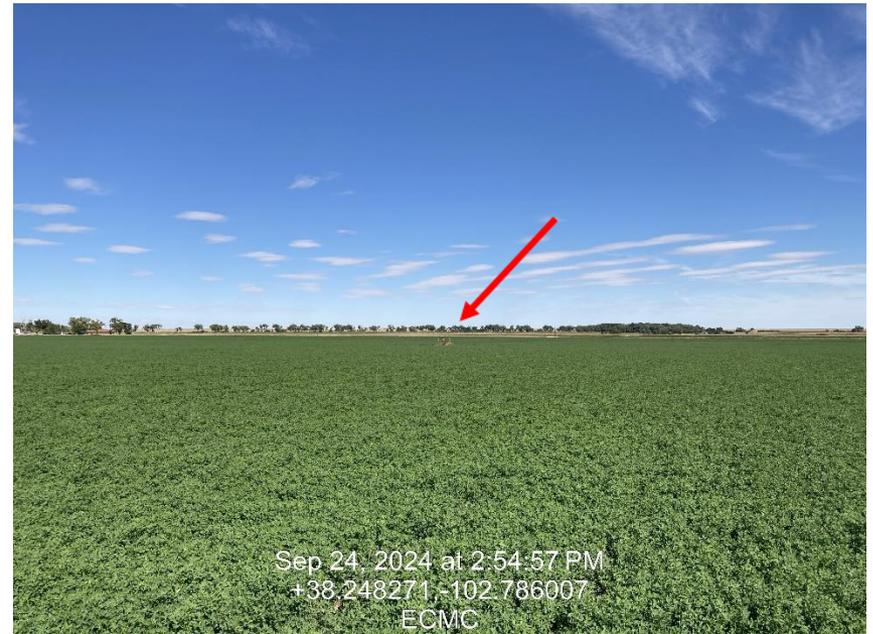
Photo 2 – Location looking east to wellhead from tank battery

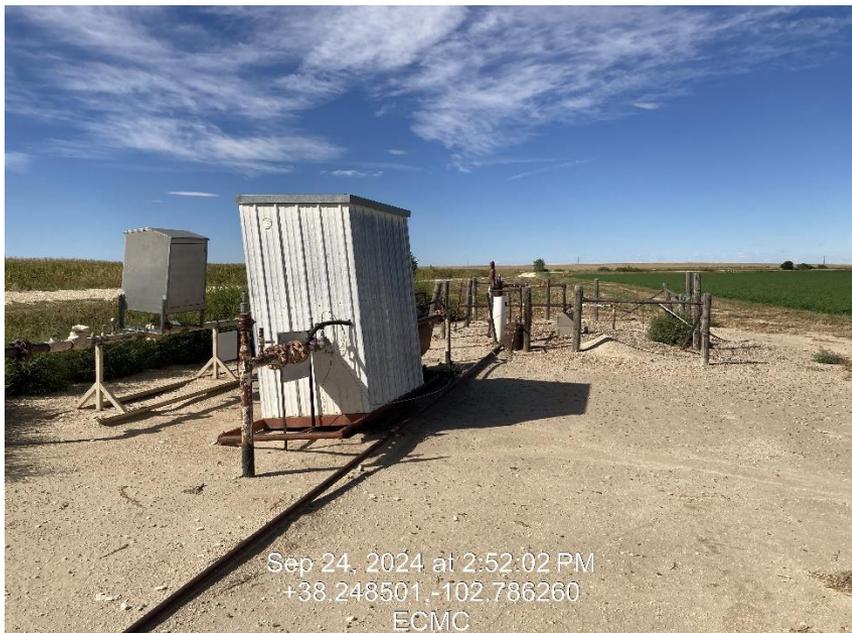
Photo 3 – Meter house and equipment

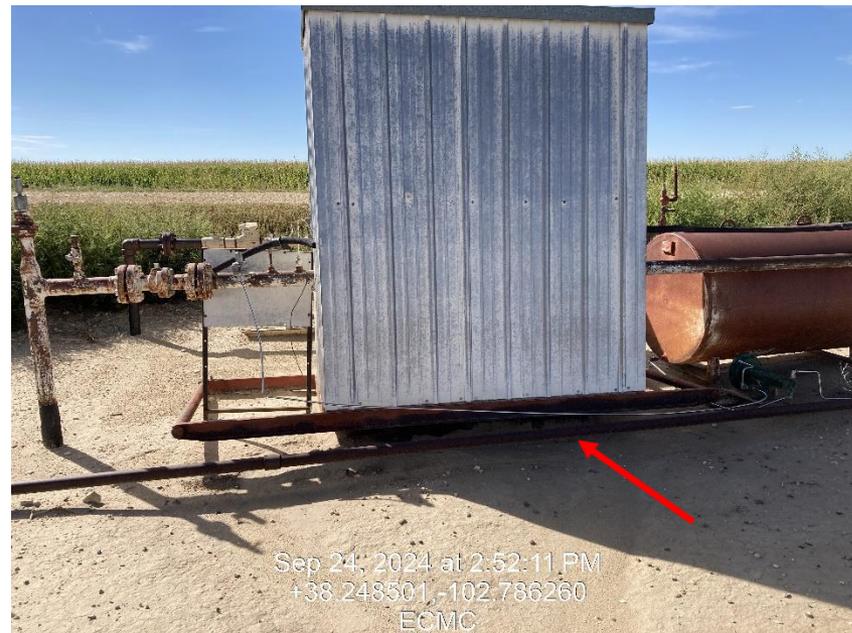
Photo 4 – Meter house settling

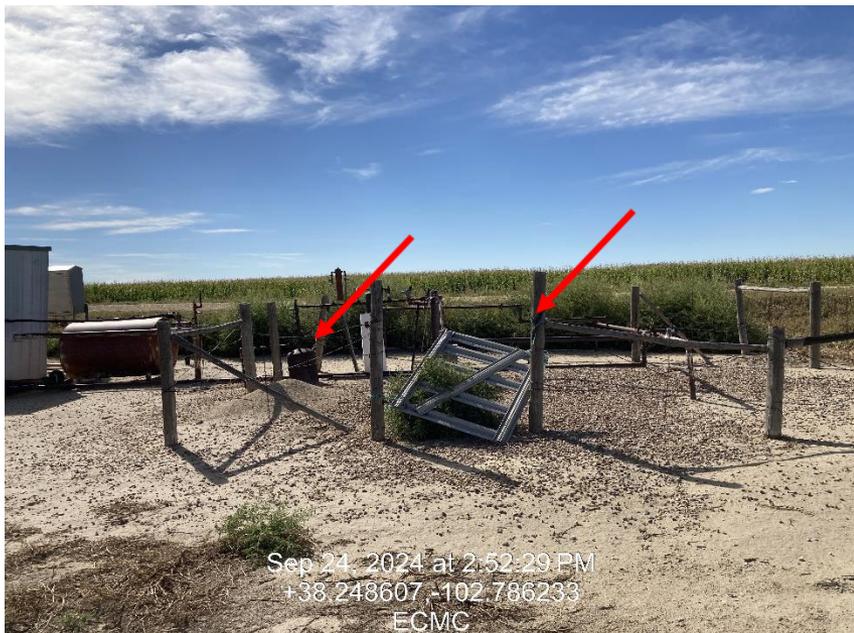
**Photo 5 – Partially Buried Separator and equipment,
Gate in disrepair**

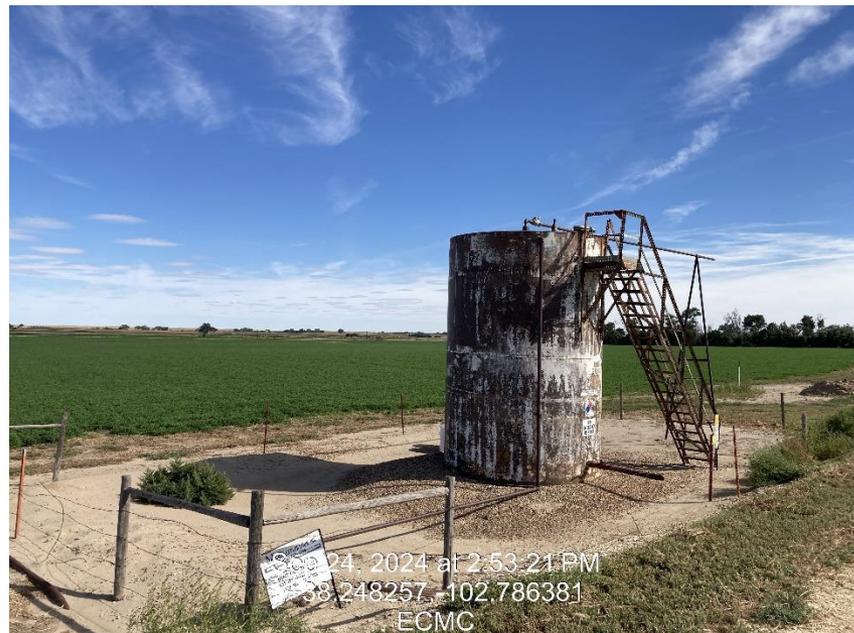
Photo 6 – Tank Battery

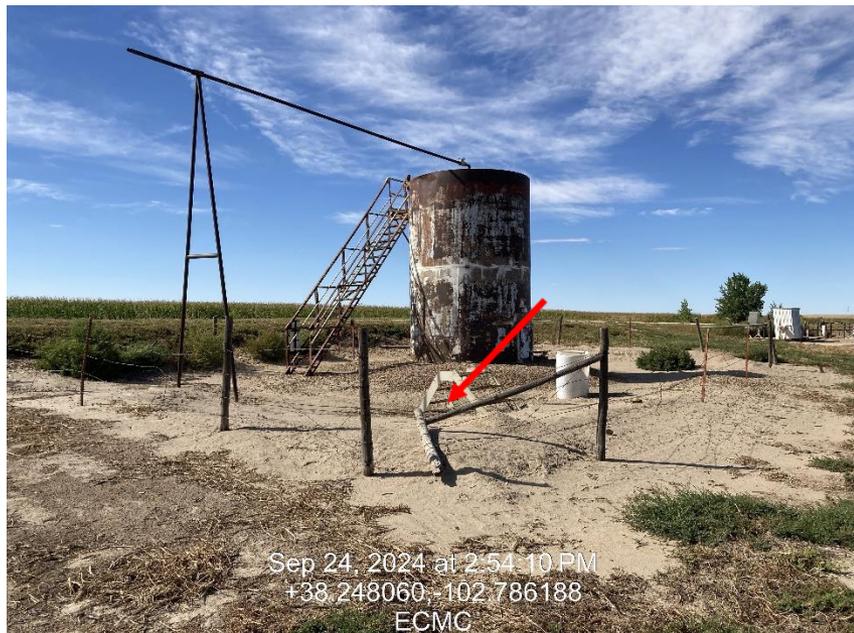
Photo 7 – Tank Battery fencing in disrepair

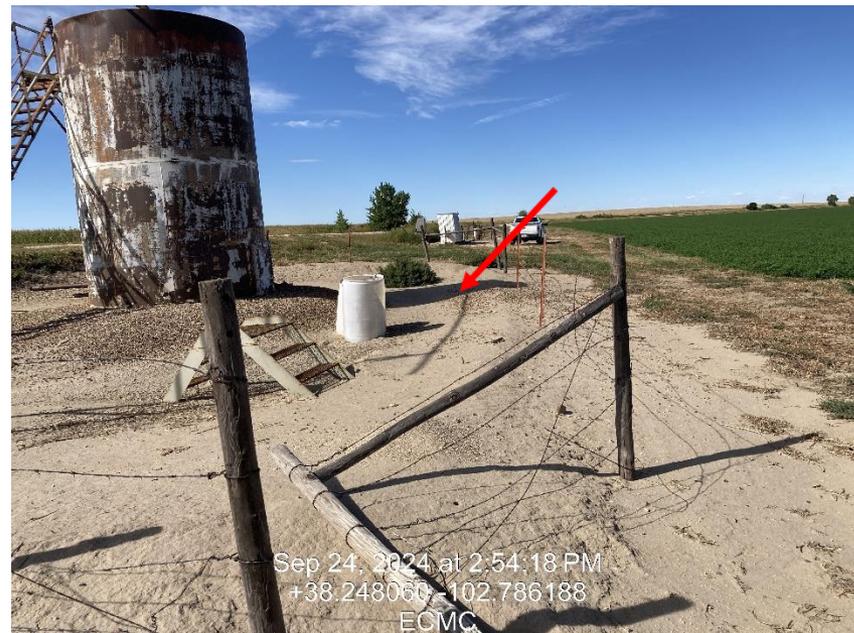
Photo 8 – Secondary Containment inadequate

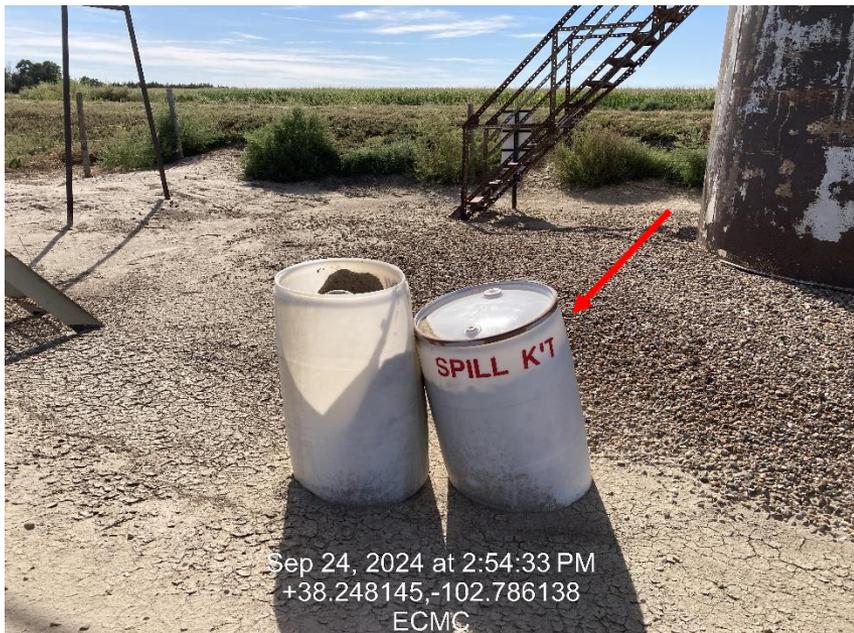
Photo 9 – Spill Kit

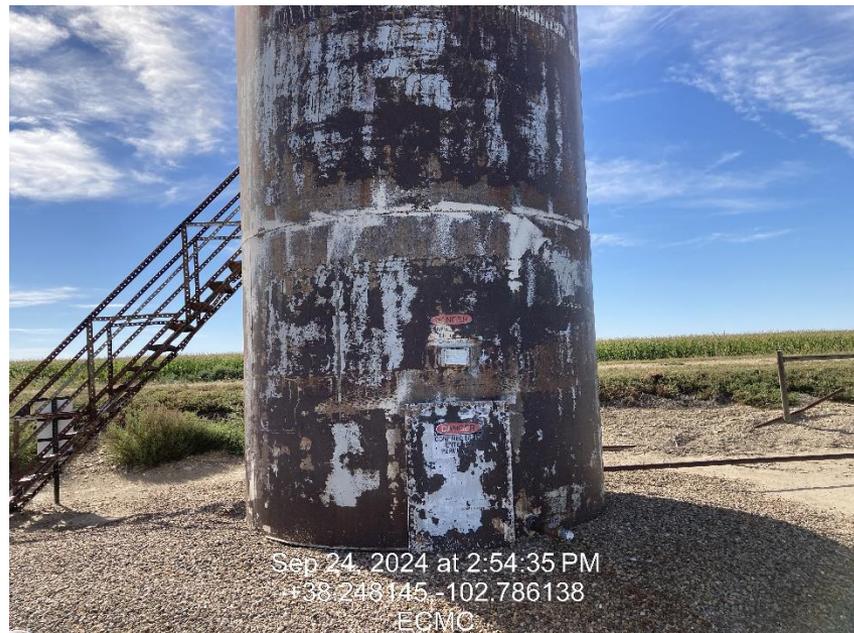
Photo 10 – AST
