Interim Reclamation and Stormwater Inspection

Date: 9/19/24

Operator: Fritzler Resources Inc - 31257

Location Name: West Fork Unit

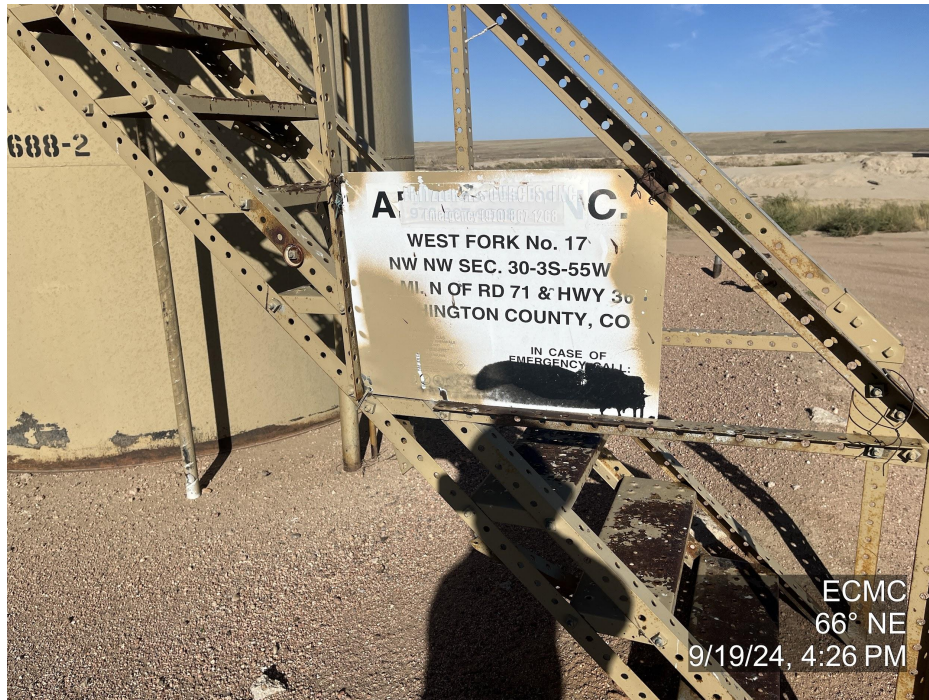
Photo 1. The photo was taken at the tank battery location facing Northeast. The photo illustrates the Operator location sign has been painted covering the emergency contact number and other pertinent operator information.

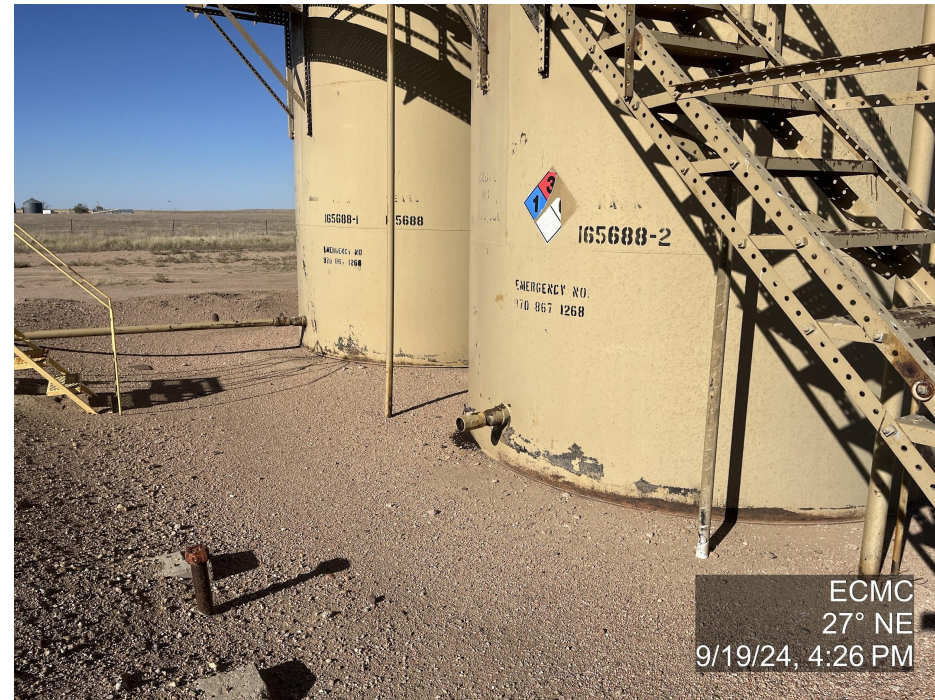
Photo 2. The photo was taken at the tank battery location facing Northeast. The photo illustrates the tank placards on the location need replaced.

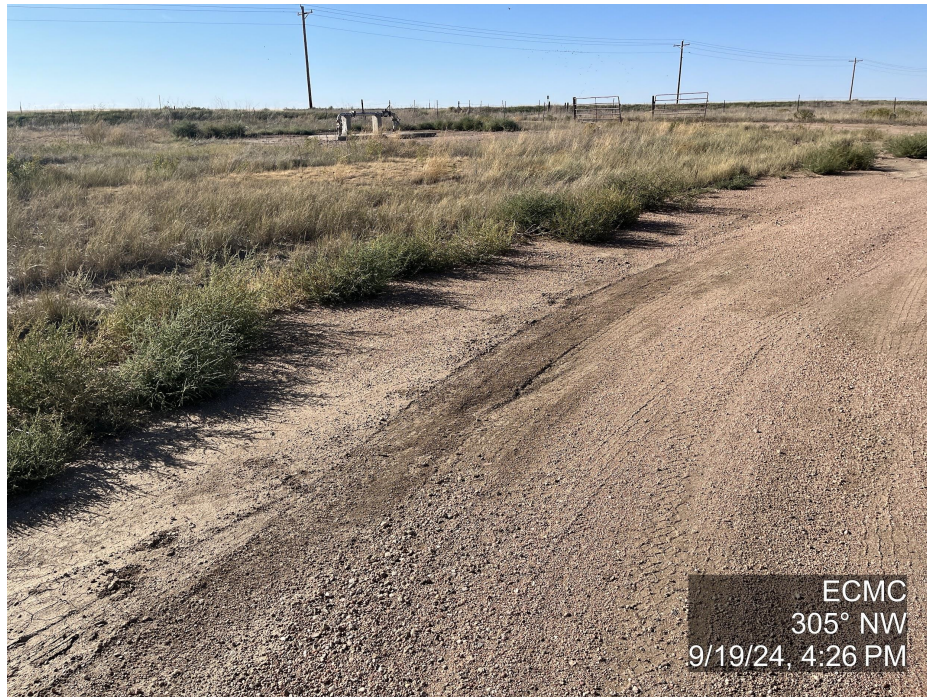
Photo 3. The photo was taken at the tank battery location facing Northwest. The photo illustrates the interim areas have some perennial grass growth with some tumbleweeds, russian thistle and kochia, predominantly along the edges.

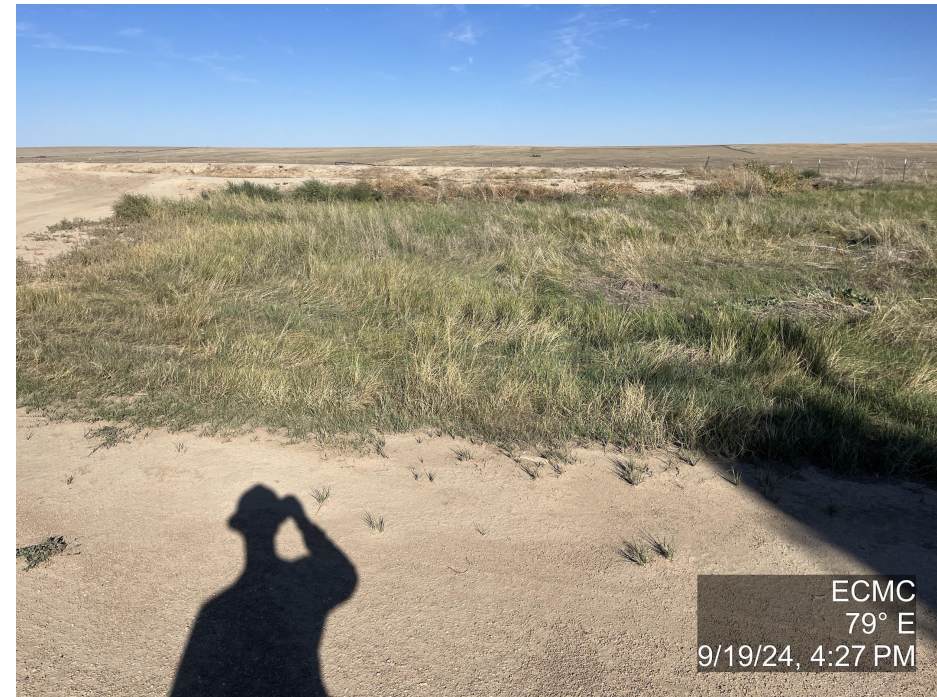
Photo 4. The photo was taken at the tank battery location facing East. Refer to the comment for photo 3.

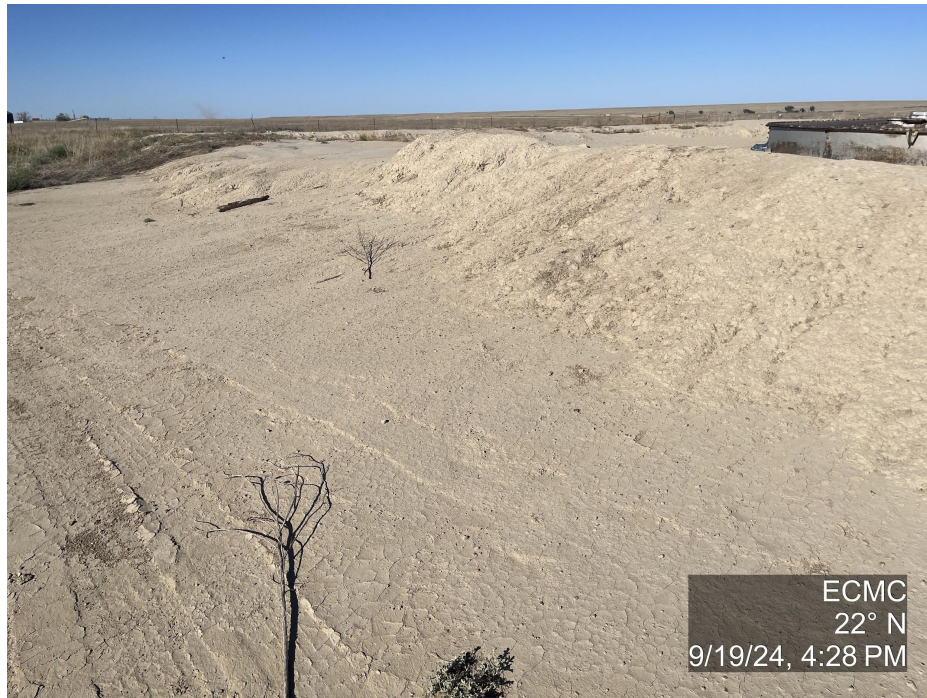
Photo 5. The photo was taken at the tank battery location facing North. The photo illustrates the West pit wall is eroding.

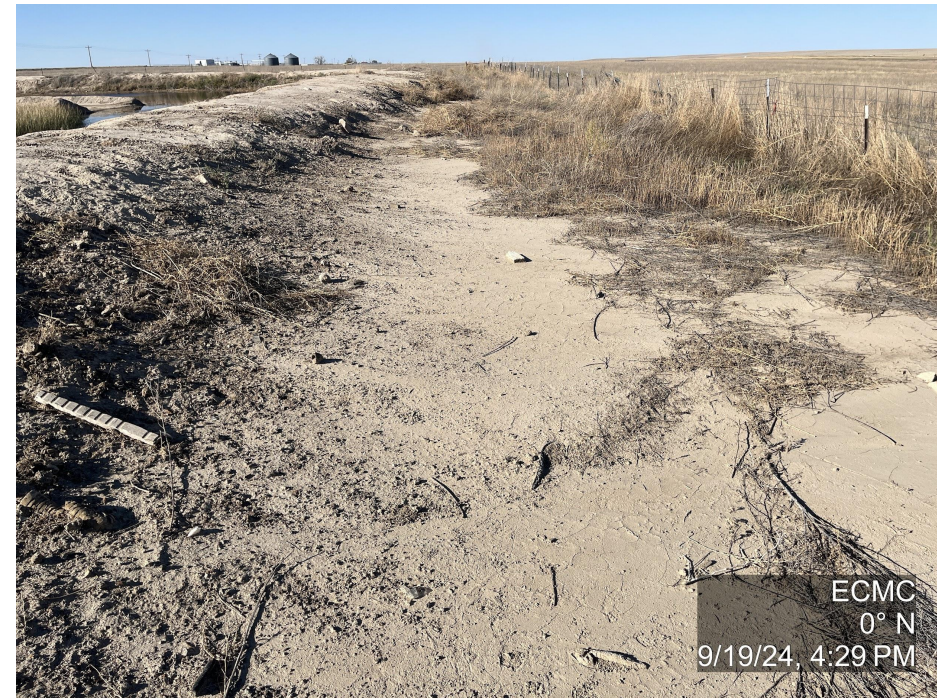
Photo 6. The photo was taken at the tank battery location facing North. The photo illustrates the East pit wall is eroding.

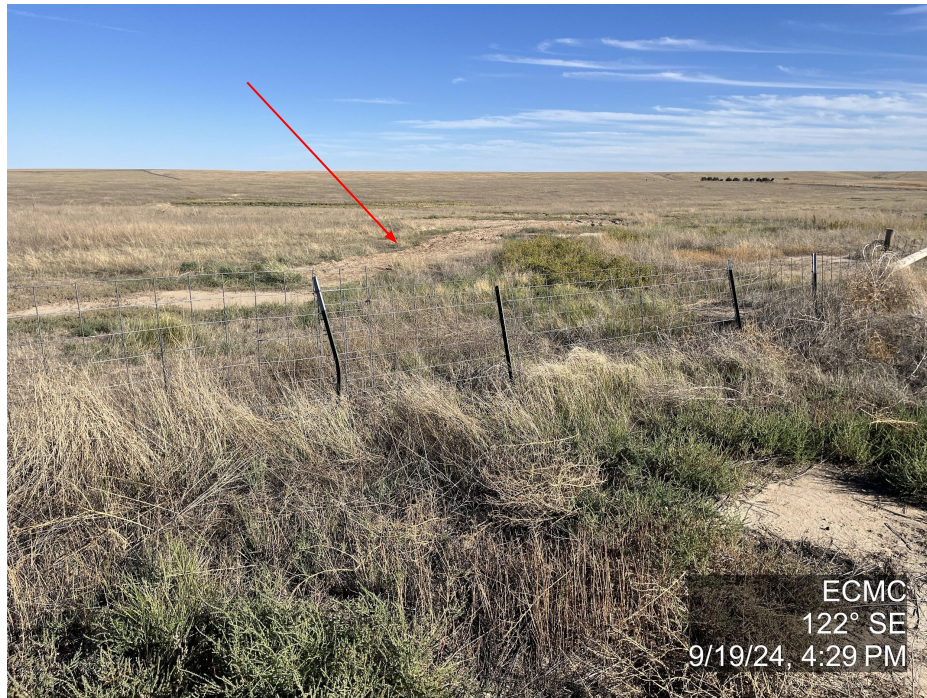
Photo 7. The photo was taken at the tank battery location facing Southeast. The photo illustrates additional disturbance associated with Remediation Project #9126.

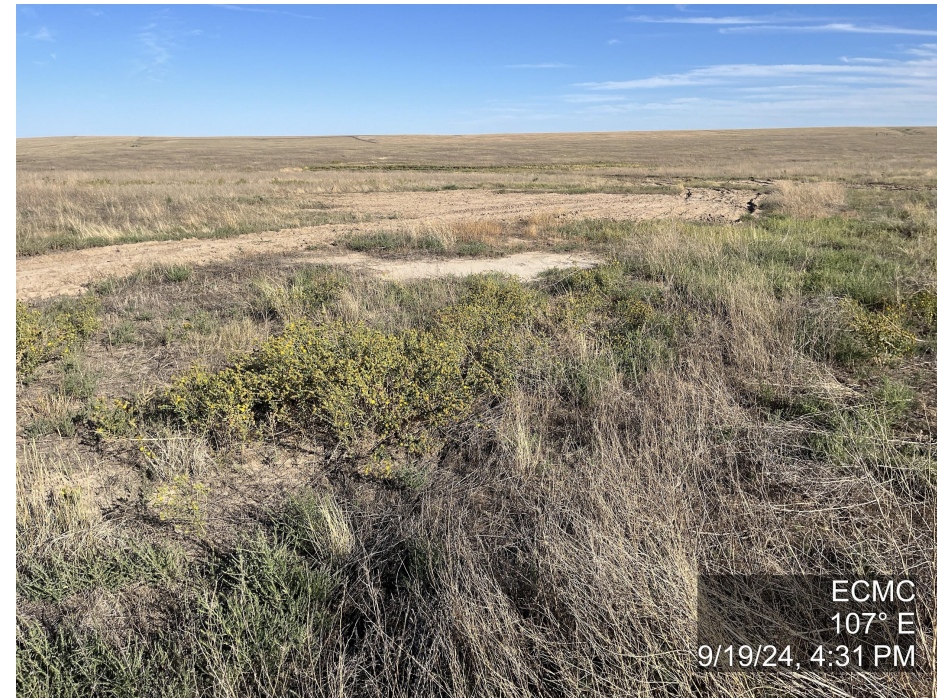
Photo 8. The photo was taken Southeast of the tank battery location facing East. Refer to the comment for photo 7.

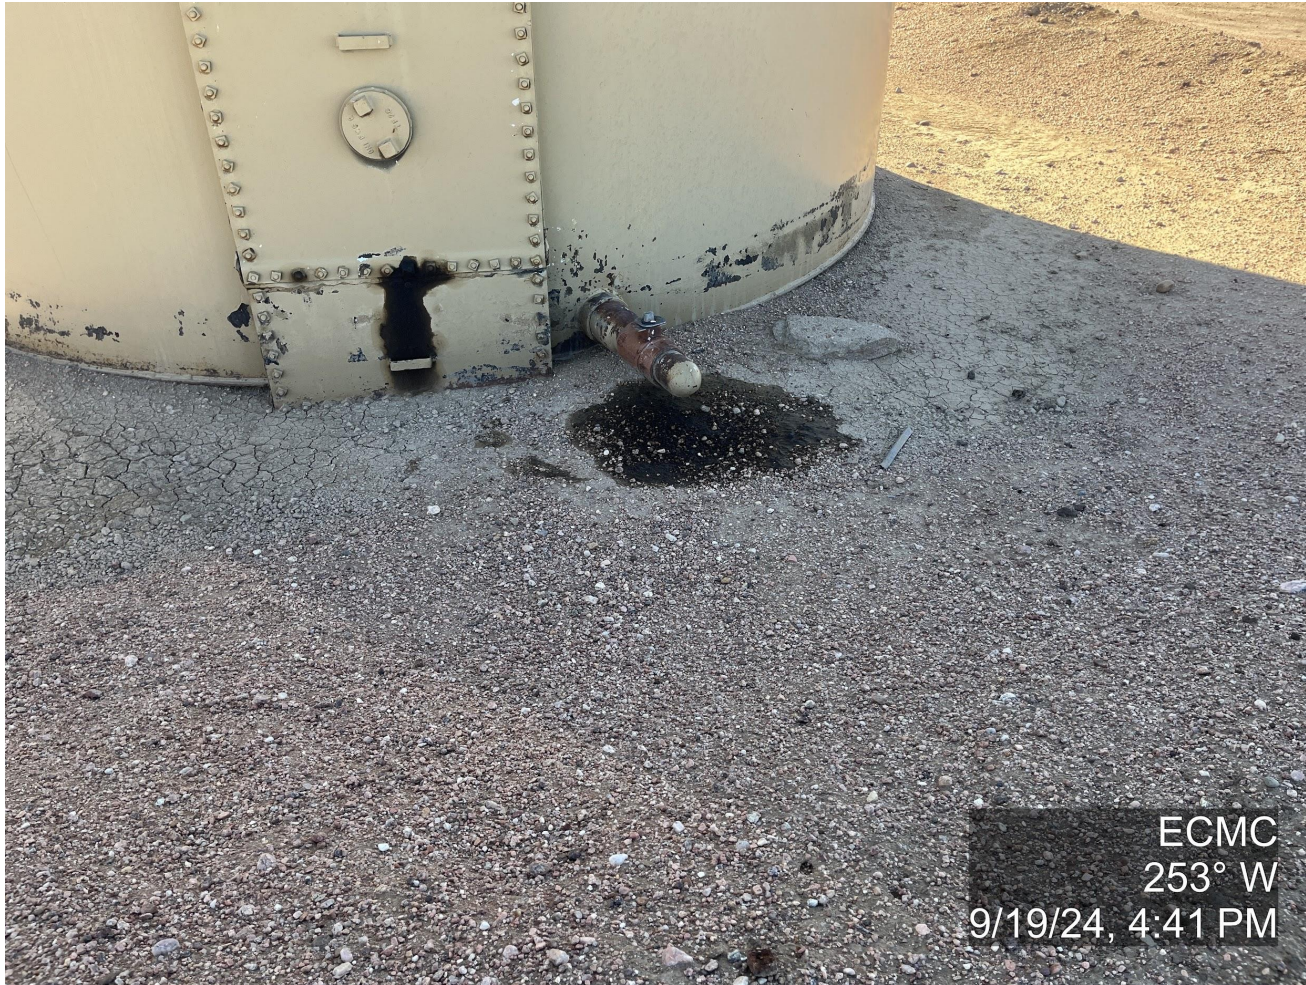
Photo 9. The photo was taken at the tank battery location facing West. The photo illustrates stained soil within secondary containment at the tanks.
