Inspection Photos

Operator: American Helium Operating - 10841

Location ID: 381617

Inspection Photos
Location Name: Pribble A1
Location ID: 381617

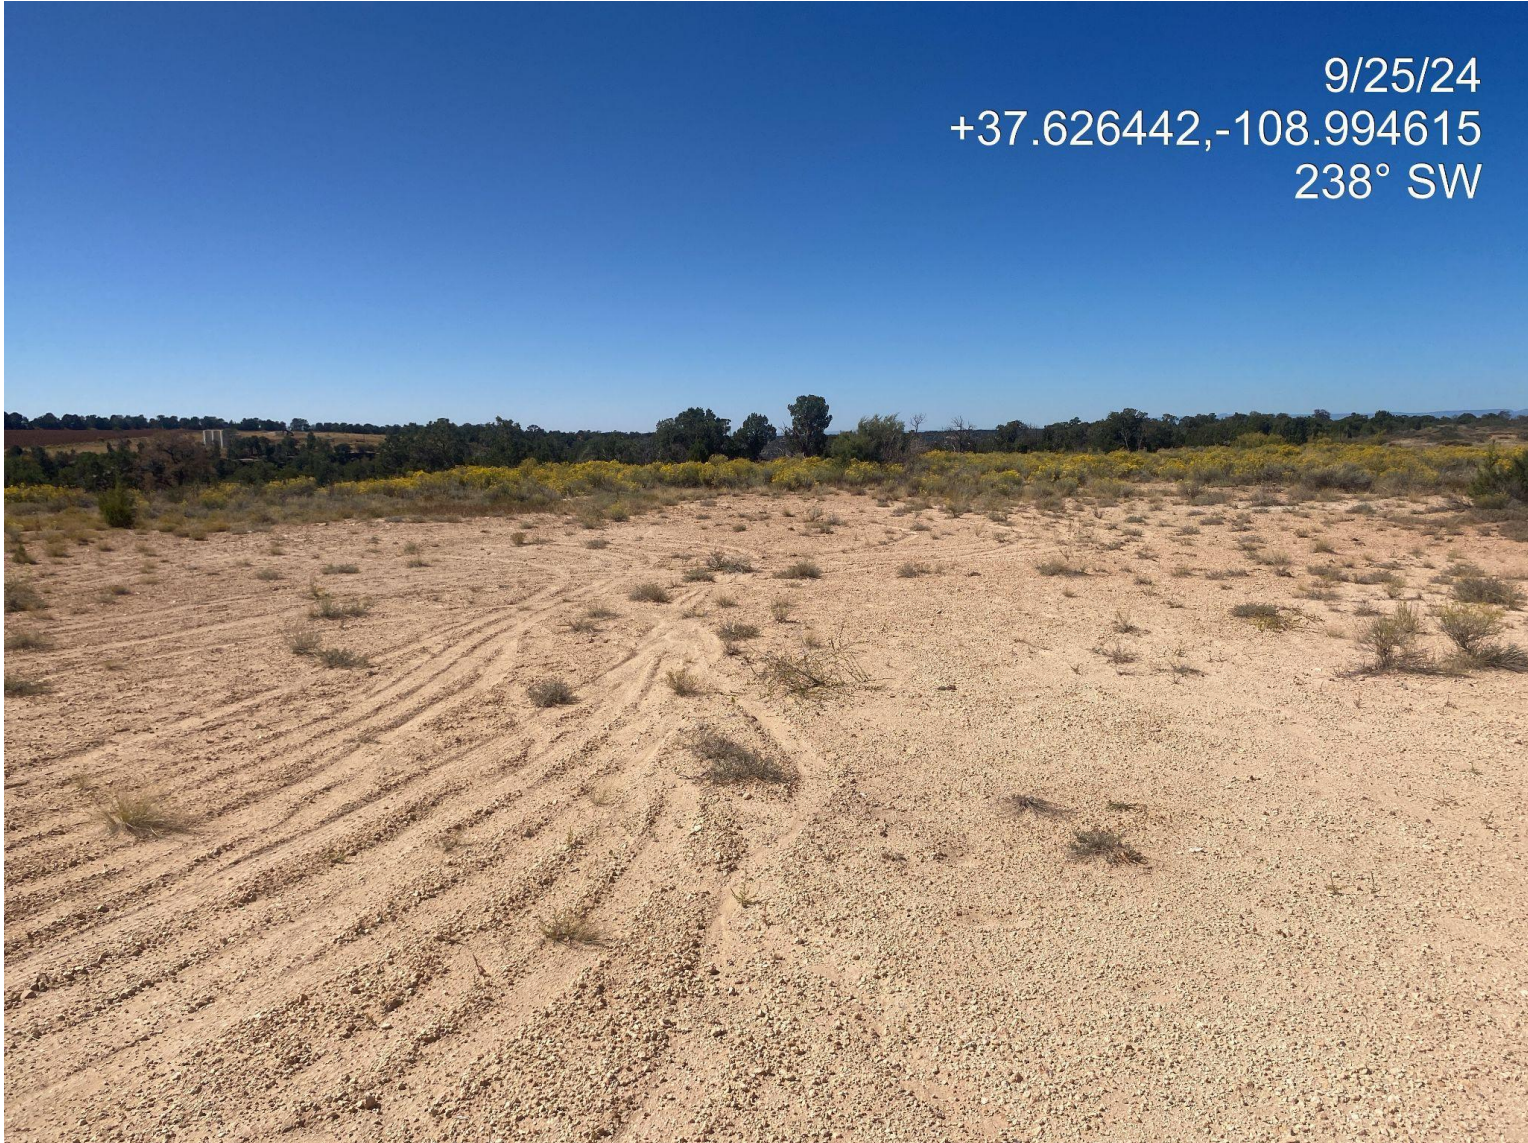
Photo 1. View of the eastern portion of the disturbance facing center. Note: Large area that has not been reclaimed per 1004 rules. Area shows little to no vegetation establishment and remnant gravel.

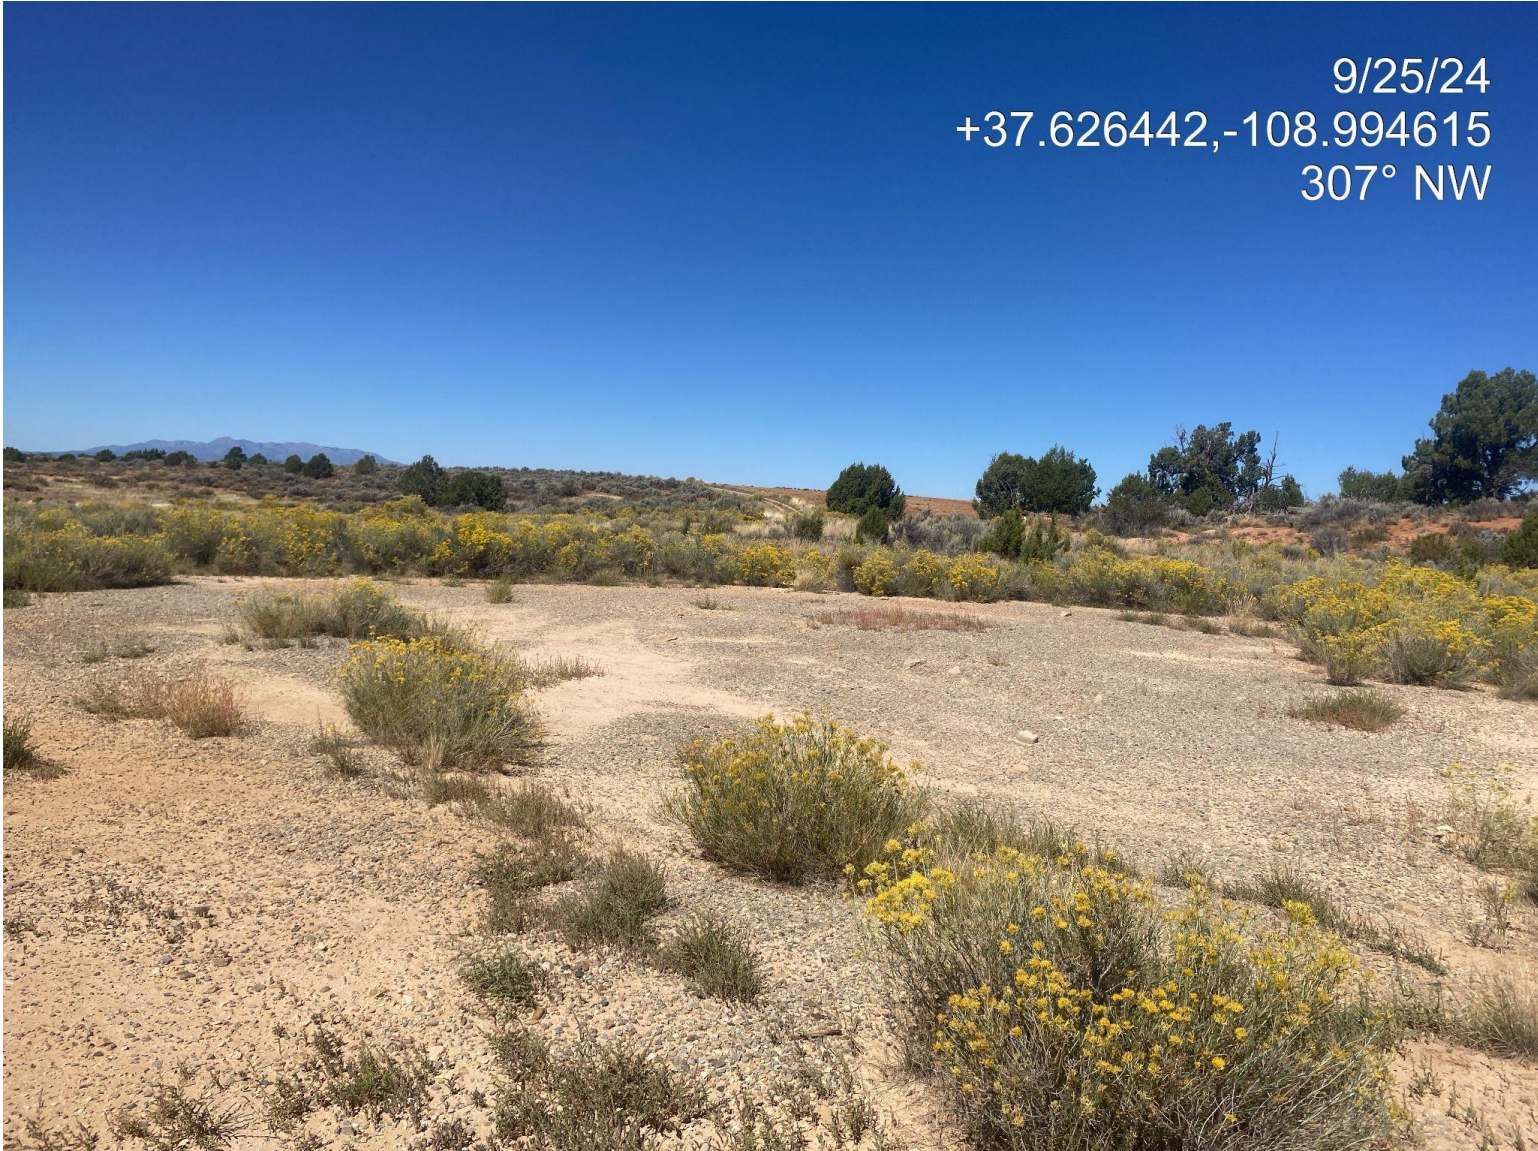
Photo 2. Area in towards center of project area that has not been reclaimed properly. Minimal vegetation establishment observed with remnant gravel.

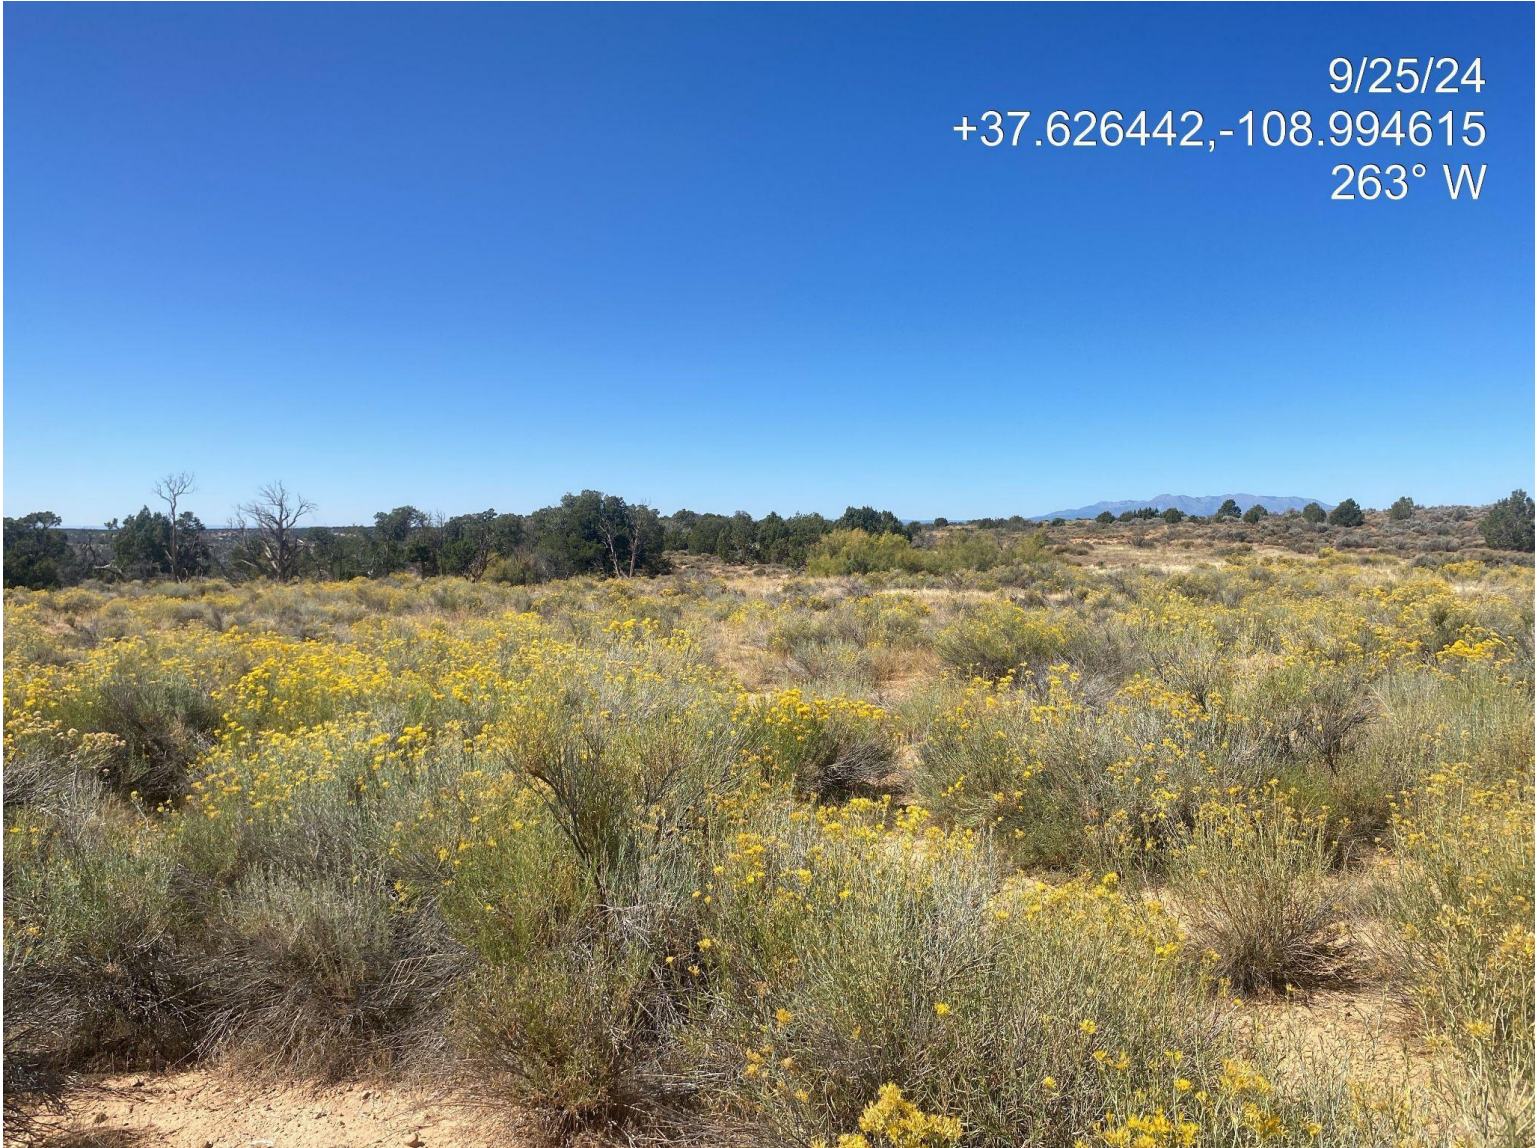
Photo 3. Adjacent reference area comprised predominantly of Rabbitbrush and Broom snakeweed.
