Inspection Photos
Operator: Dover Atwood/Envex Baca
Location Name: Thompson 1-24 API: 009-05200

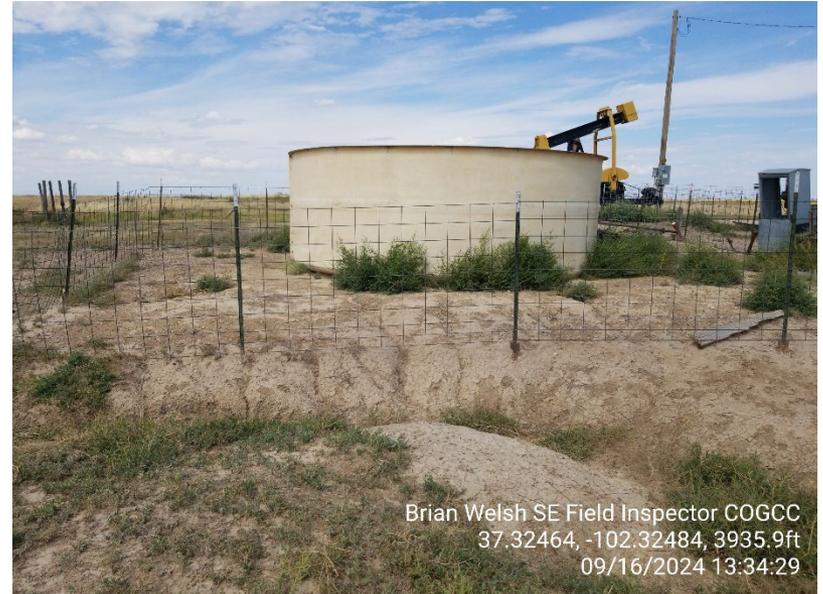
2. Erosion on south side of location around water tank

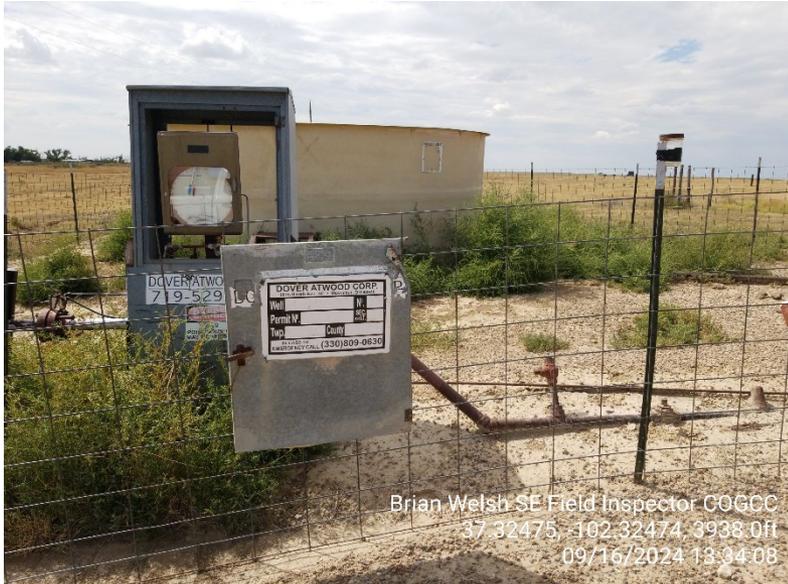
3. Lease sign mounted to meter run door isn't legible

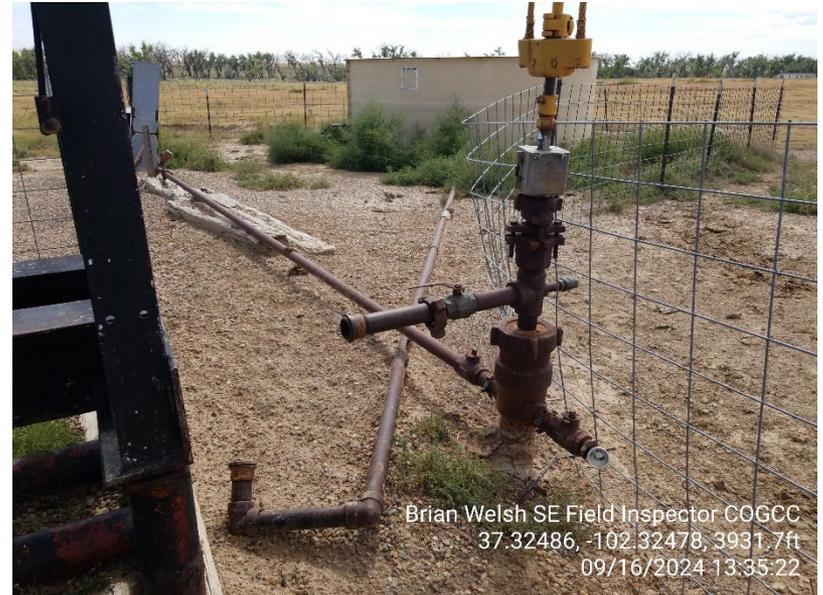
4. Wellhead with water leg disconnected
