**Emissions Monitoring Report
ECMC Orphaned Well Program**

Monitoring Site: Silver King Pan Am Hayes #5-27 (OWP)
API #: 05-103-07199
ECMC Location ID: 397405
Well Status: Post-Plugging
Lat 40.107267 Long -108.825874
SWSE Sec 27 T2N R102W 6th PM, Rio Blanco, CO

Monitoring Result: NON-DETECT

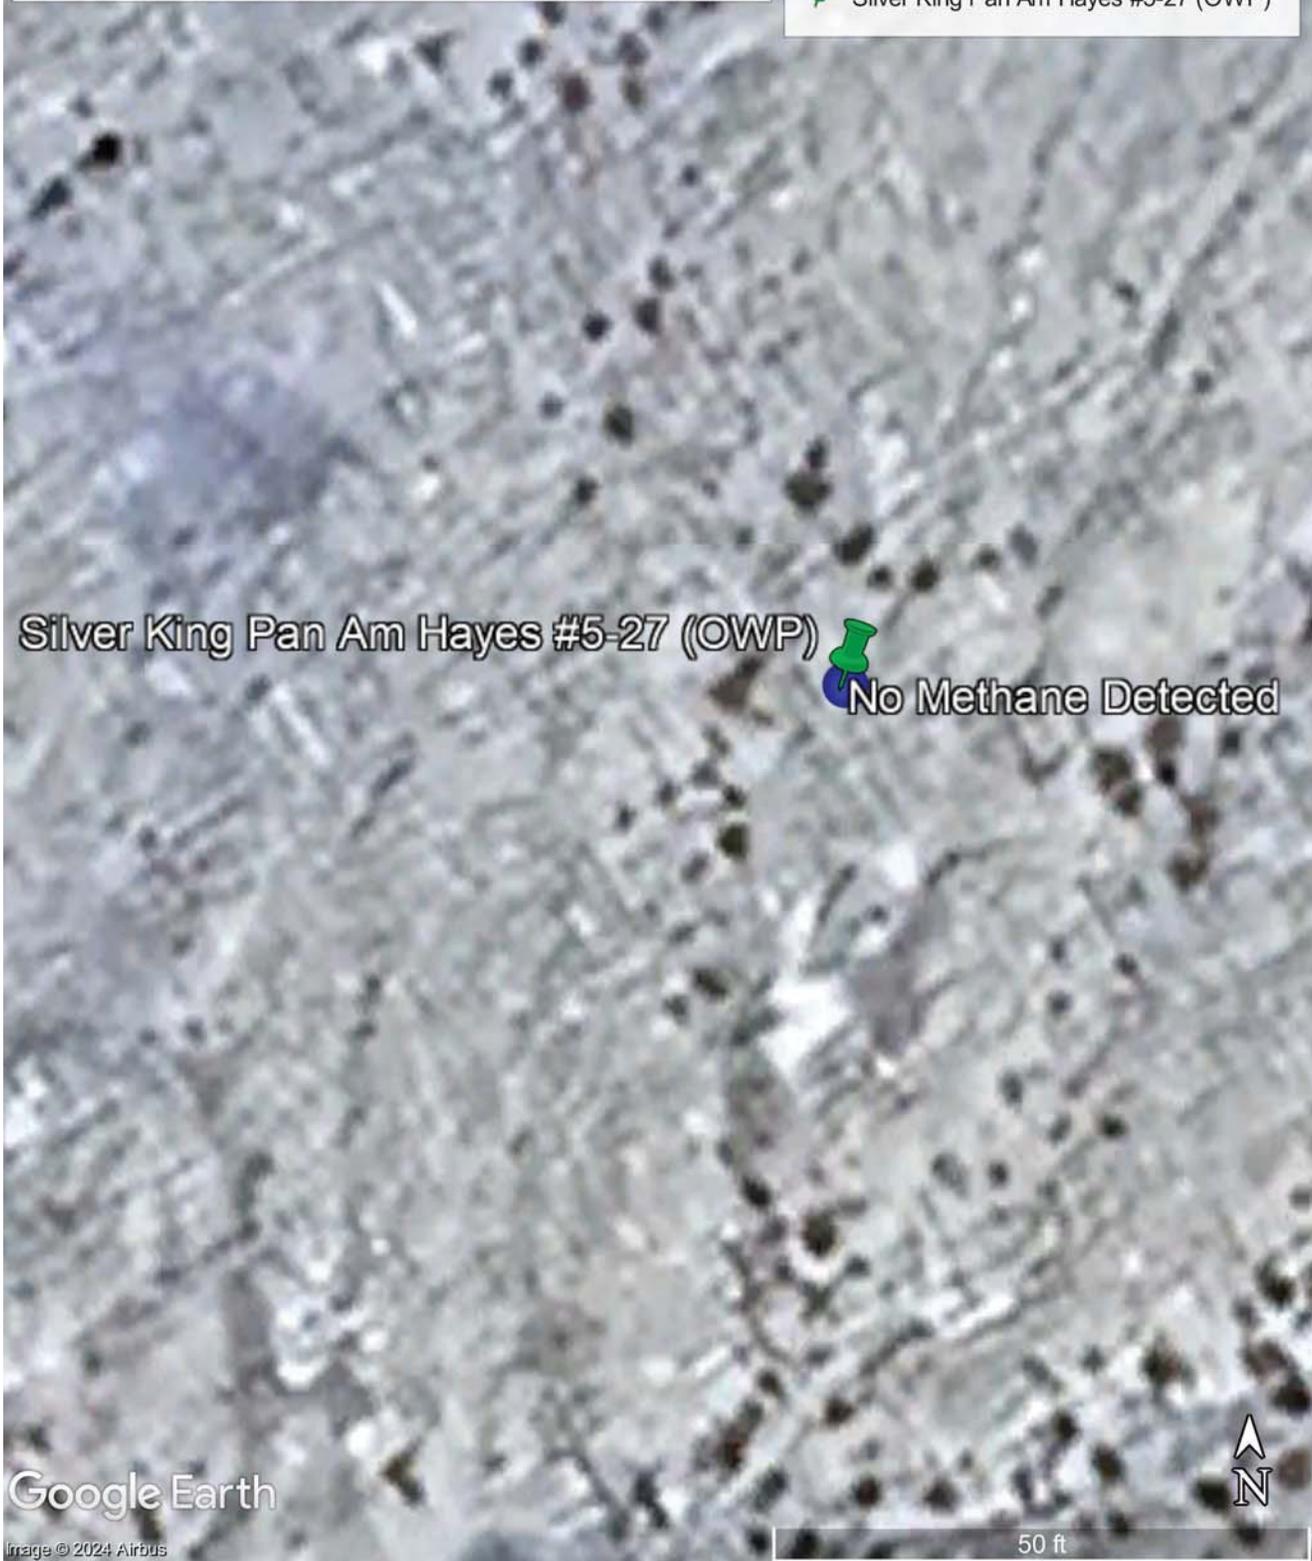
Figure 1
Silver King Pan Am Hayes #5-27 (OWP) Map
Post-plugging Methane Assessment
Colorado Energy & Carbon
Management Commission

No methane emissions were detected from the Silver King Pan Am Hayes #5-27 (OWP) P&A wellhead.

Notes: Post-plugging methane assessment conducted 6/5/2024. No methane detected.

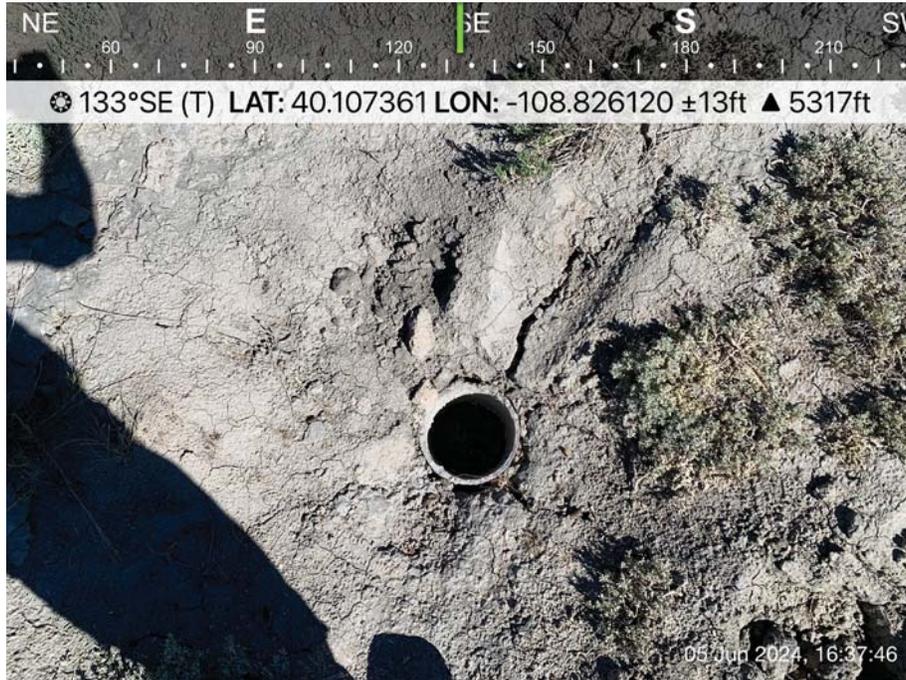
Photo 1: Silver King Pan Am Hayes #5-27 (OWP) P&A wellhead, no methane detected, view from above.

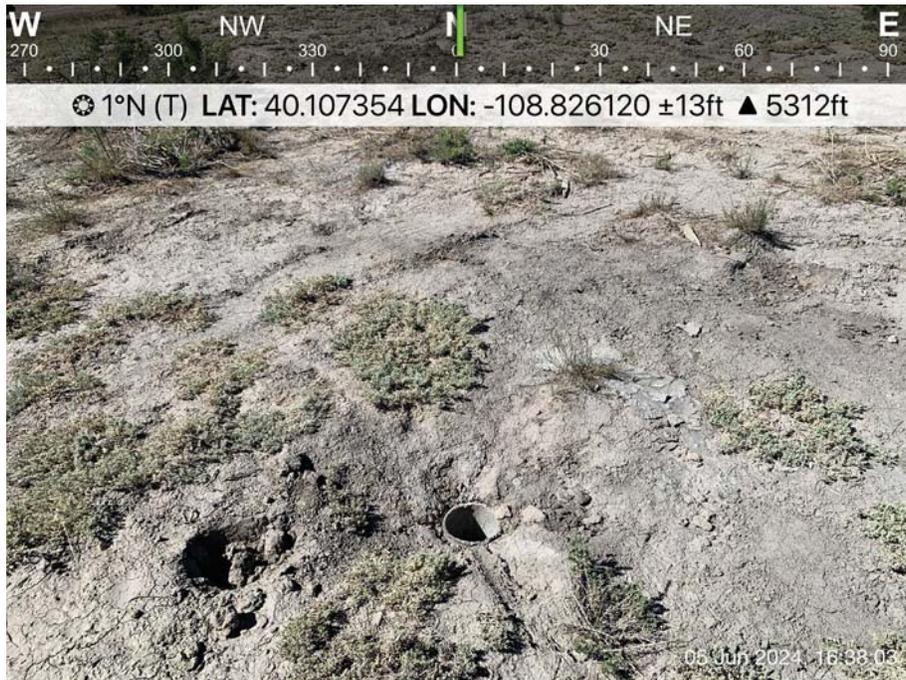
Photo 2: Silver King Pan Am Hayes #5-27 (OWP) P&A wellhead, no methane detected, view north.

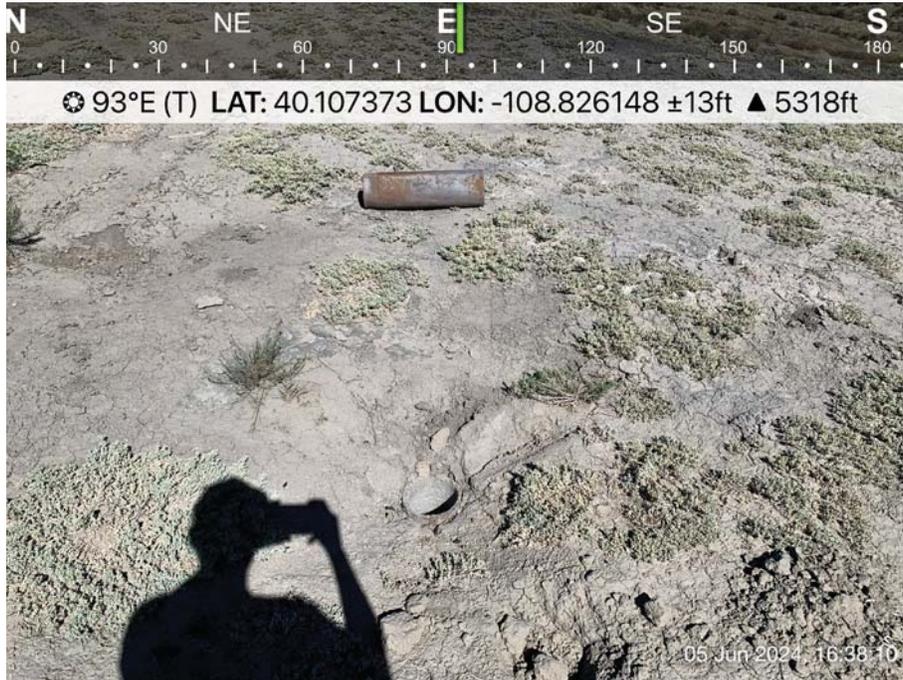
Photo 3: Silver King Pan Am Hayes #5-27 (OWP) P&A wellhead, no methane detected, view east.

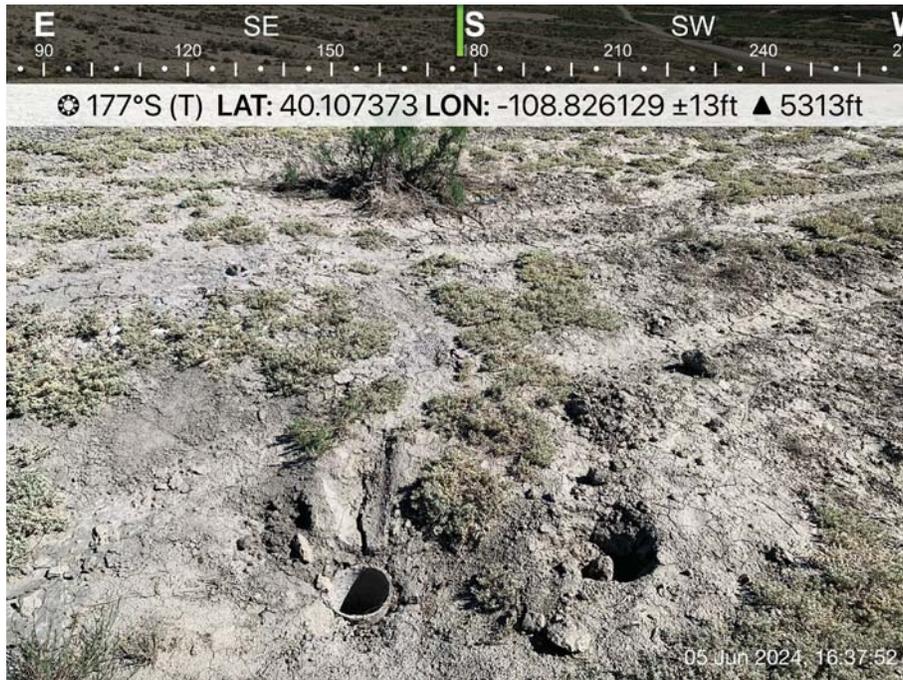
Photo 4: Silver King Pan Am Hayes #5-27 (OWP) P&A wellhead, no methane detected, view south.

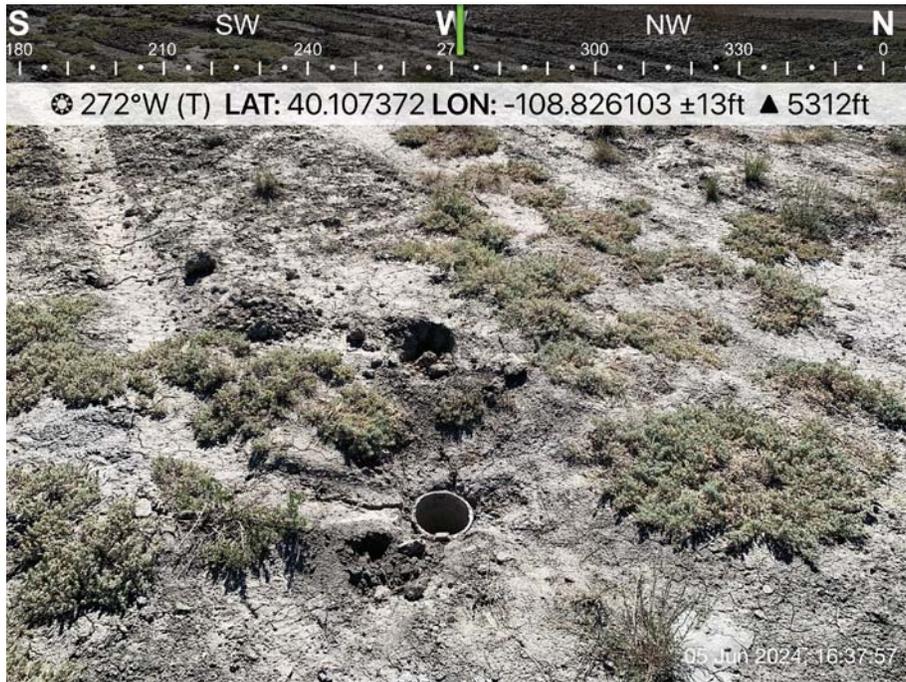
Photo 5: Silver King Pan Am Hayes #5-27 (OWP) P&A wellhead, no methane detected, view west.
