## Inspection Photos

Location Name: TEP ROCKY MOUNTAIN LLC JUHAN 14-26H Pad

Location ID: 323868

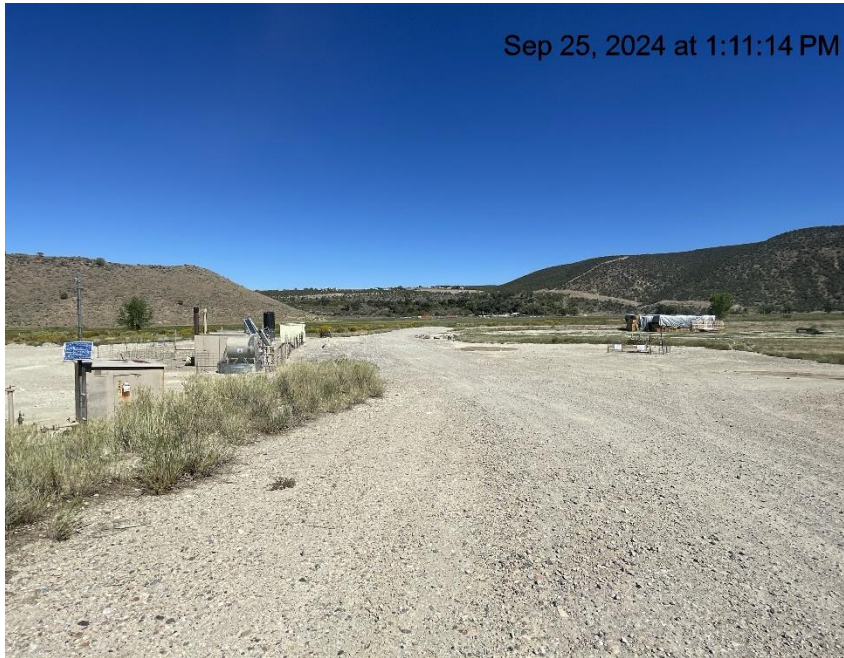
Photo # 1998 From entrance to location

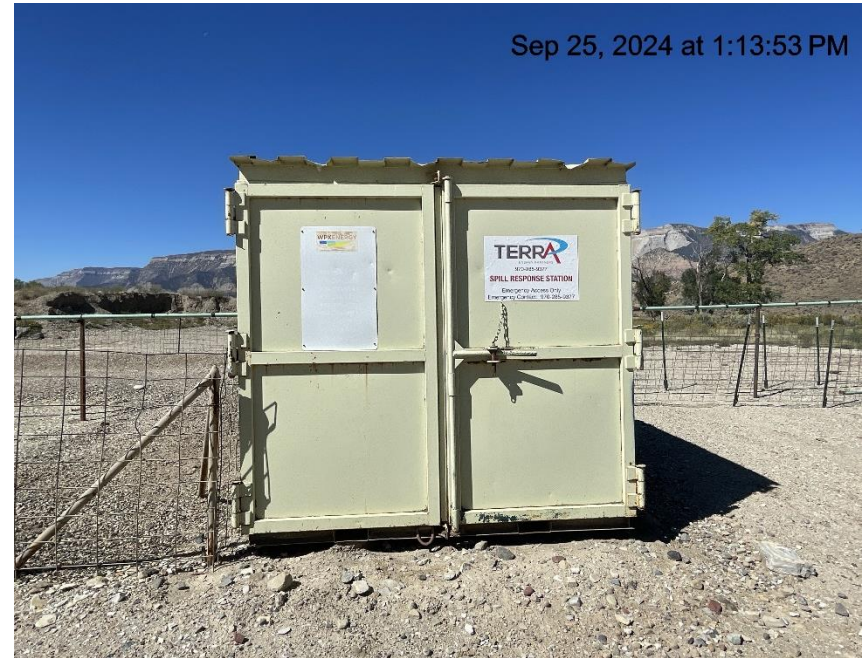
Photo # 2005 Spill response station

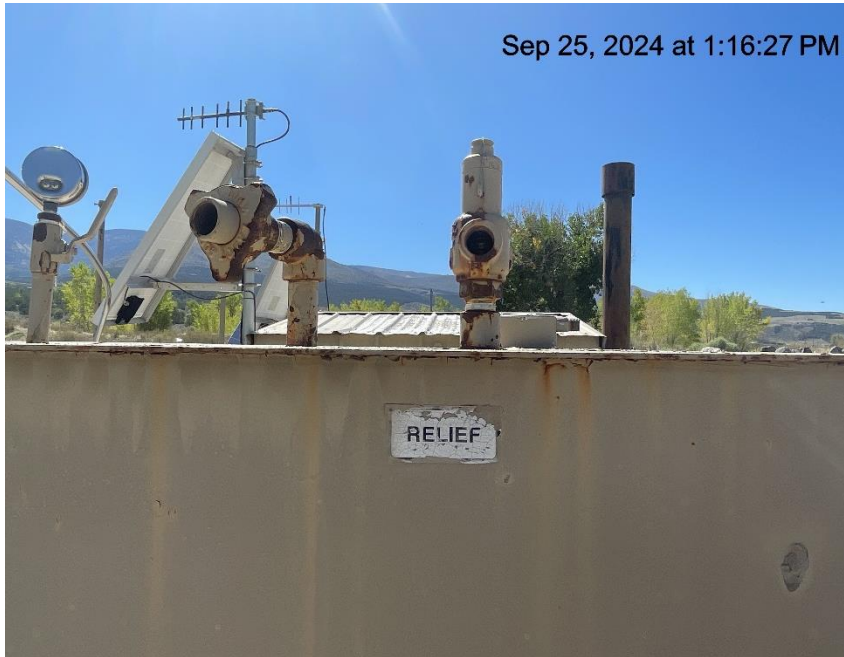
**Photo # 2006 PRV & rupture disc on separator unit do not comply with CECMC pressure safety device rules or CECMC general safety rules**

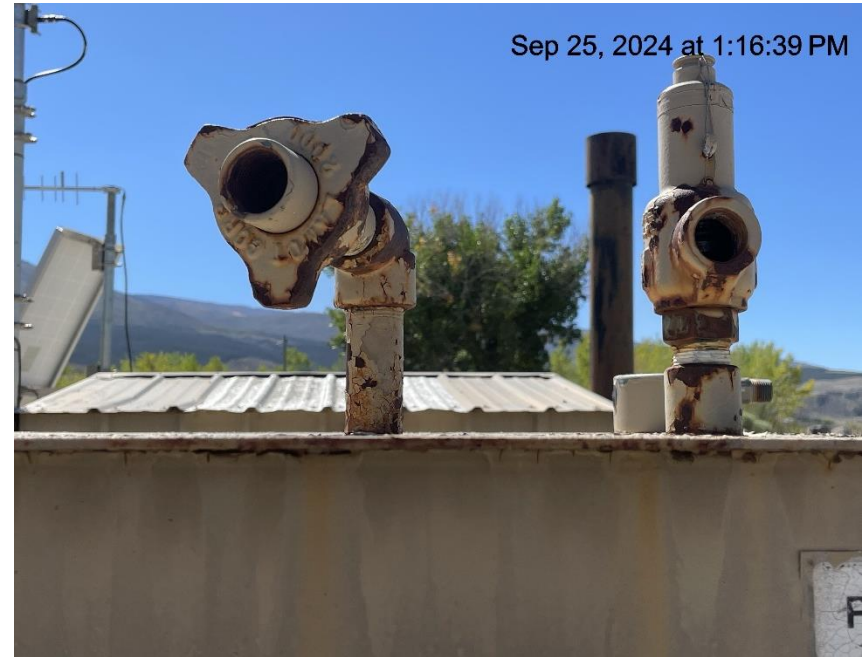
**Photo # 2007 PRV & rupture disc on separator unit do not comply with CECMC pressure safety device rules or CECMC general safety rules**
