Storm Water Management and Erosion control
Location Name: TEP ROCKY MOUNTAIN LLC Hoeppli RWF 33-36 Pad
Location ID: 335050

Section/Township/Range: 36 6S94W

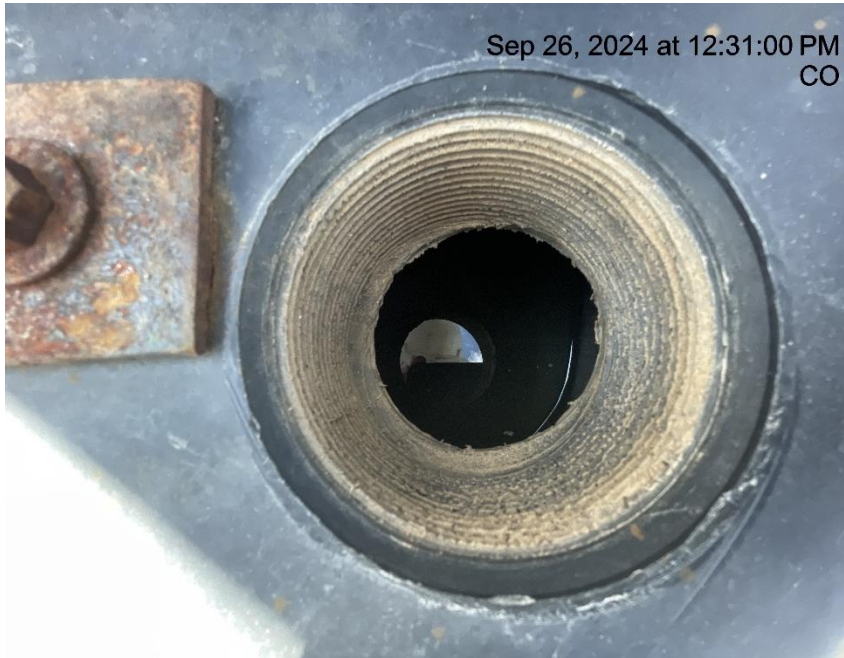
Photo # 2136 Failure to maintain chemical BMP/chemical tank containment approximately 3/4th full of fluid/BMP insufficient to contain possible spill

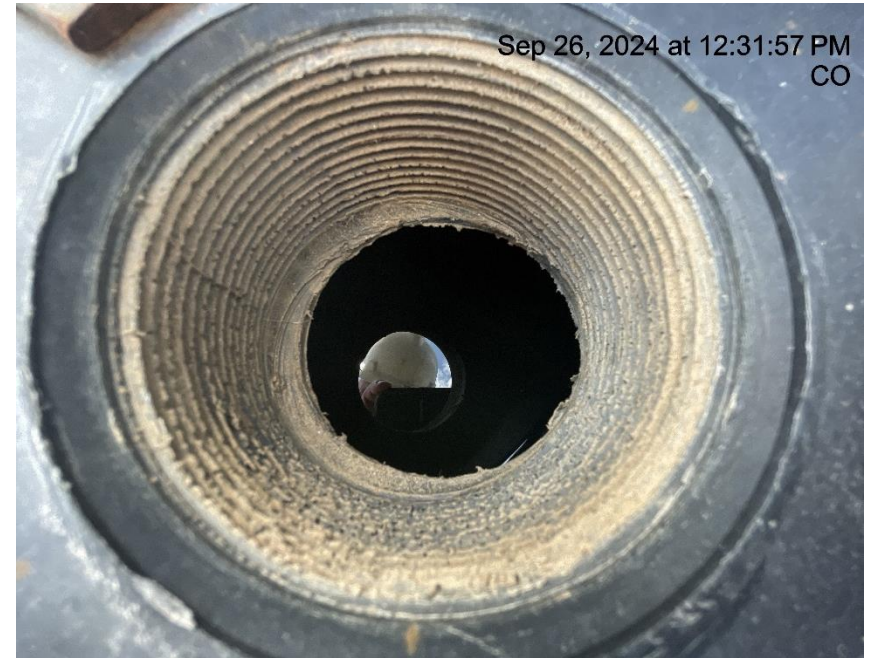
Photo # 2137 Failure to maintain chemical BMP/chemical tank containment approximately 3/4th full of fluid/BMP insufficient to contain possible spill

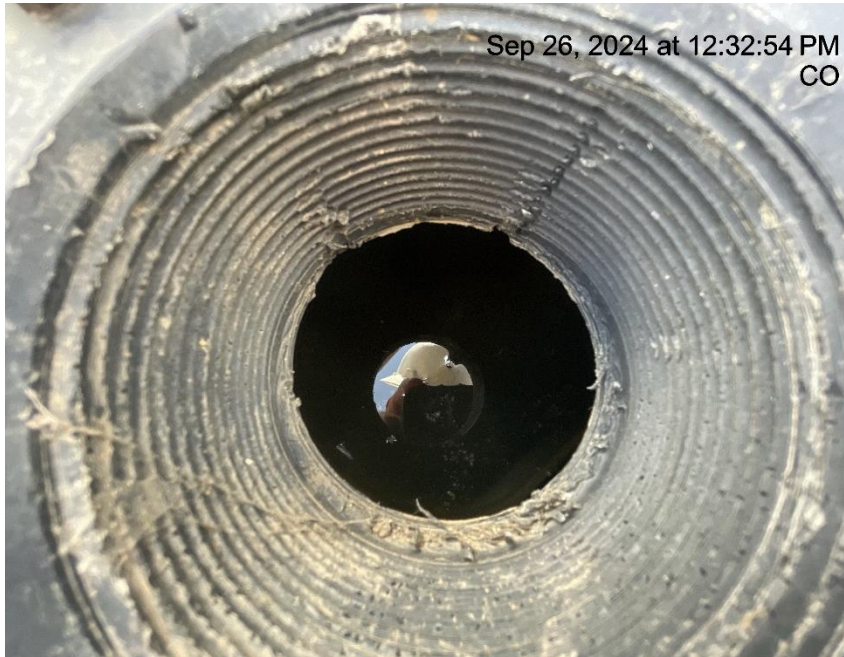
Photo # 2138 Failure to maintain chemical BMP/chemical tank containment approximately 3/4th full of fluid/BMP insufficient to contain possible spill

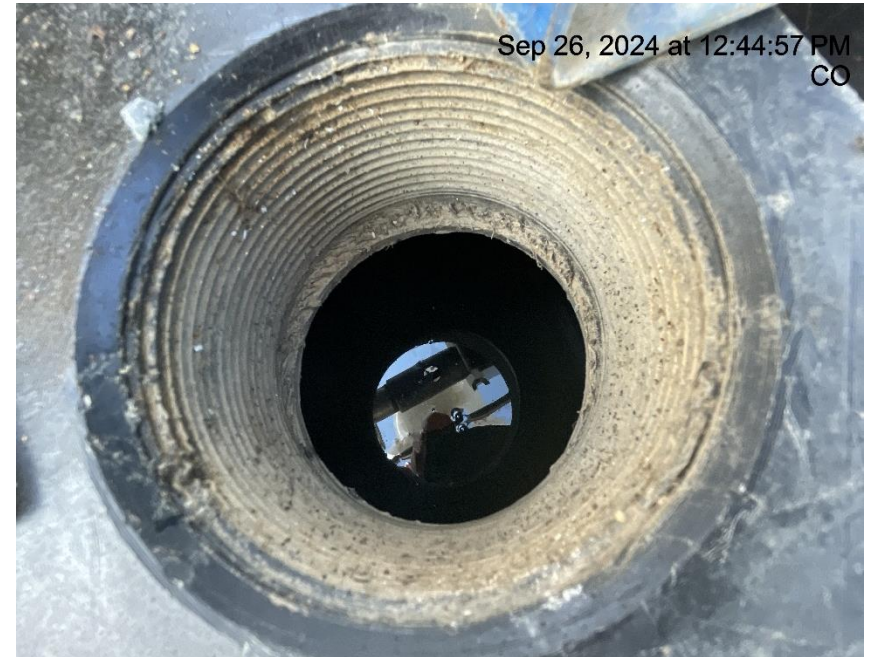
Photo # 2139 Failure to maintain chemical BMP/chemical tank containment approximately 3/4th full of fluid/BMP insufficient to contain possible spill
