Inspection Photos

Operator: MERRION OIL & GAS CORP - 56680
/ ANSCHUTZ EXPLORATION CORP - 3104

Location ID: 316731

Inspection Doc: 69620633

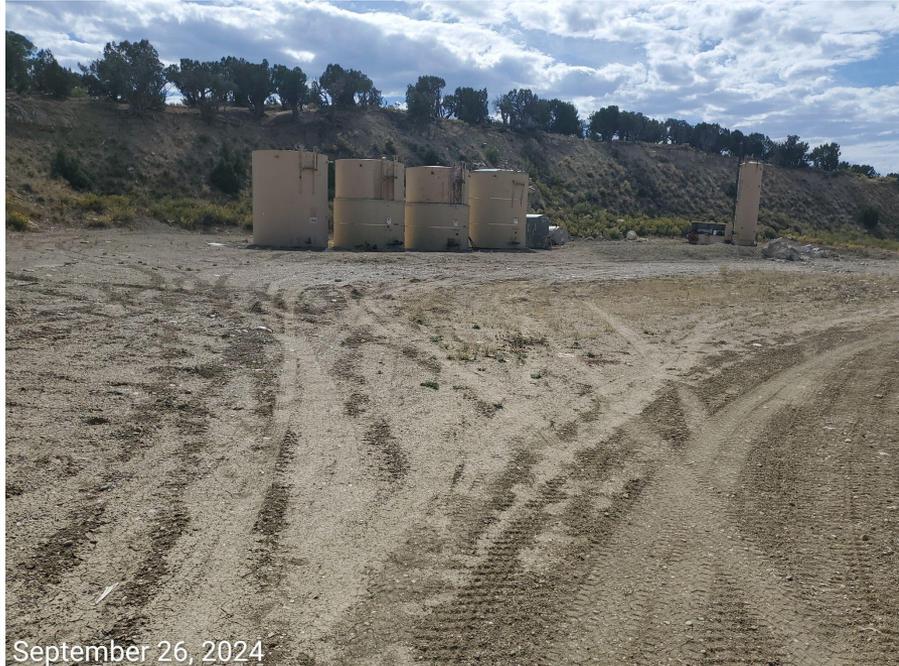
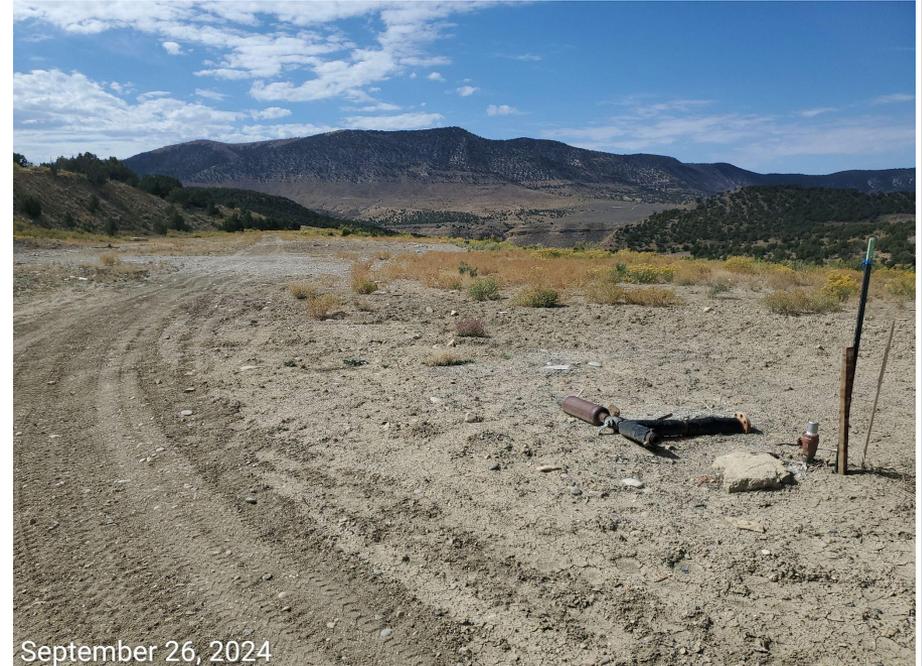
Photo 1: Photo taken from the north end of the Location facing southeast and southwest. Photos provide an overview of the Location. Photo also shows equipment (tanks, risers, etc...) have not been removed, and Location has not been reclaimed. Pursuant to Rule 1004 all equipment was required to be removed within 3 months, and reclamation complete within 12 months of plugging a well.

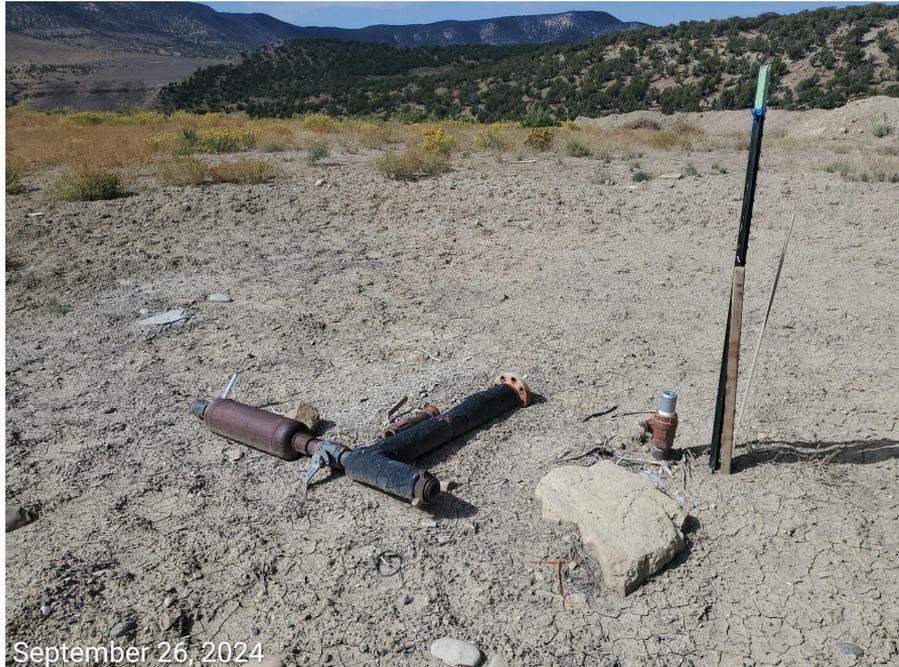
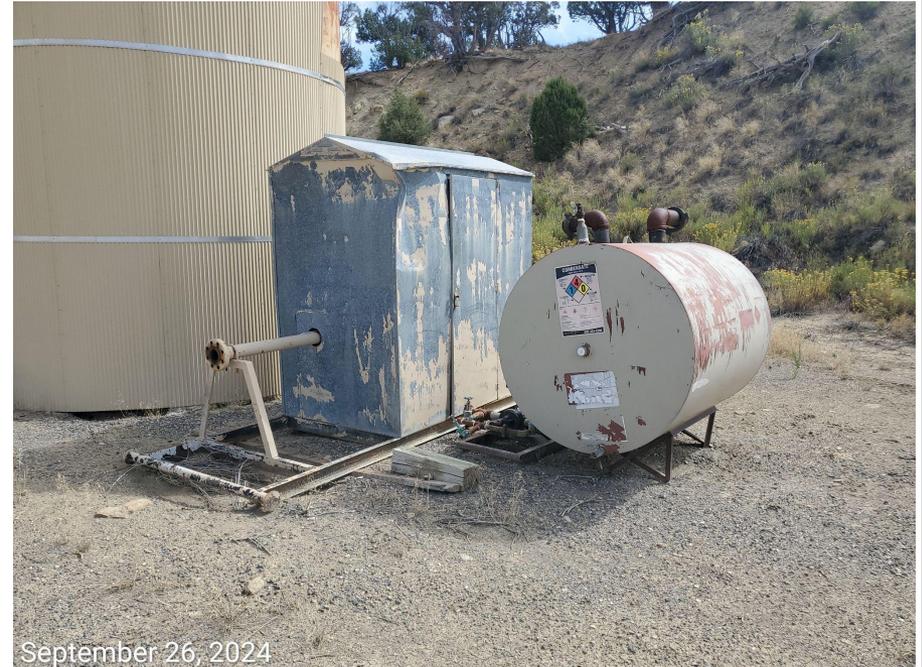
Photo 2: Photos examples showing equipment (tanks, risers, etc...) remaining on the Location. Pursuant to Rule 1004 all equipment, trash, debris, etc... was required to be removed within 3 months of plugging a well.

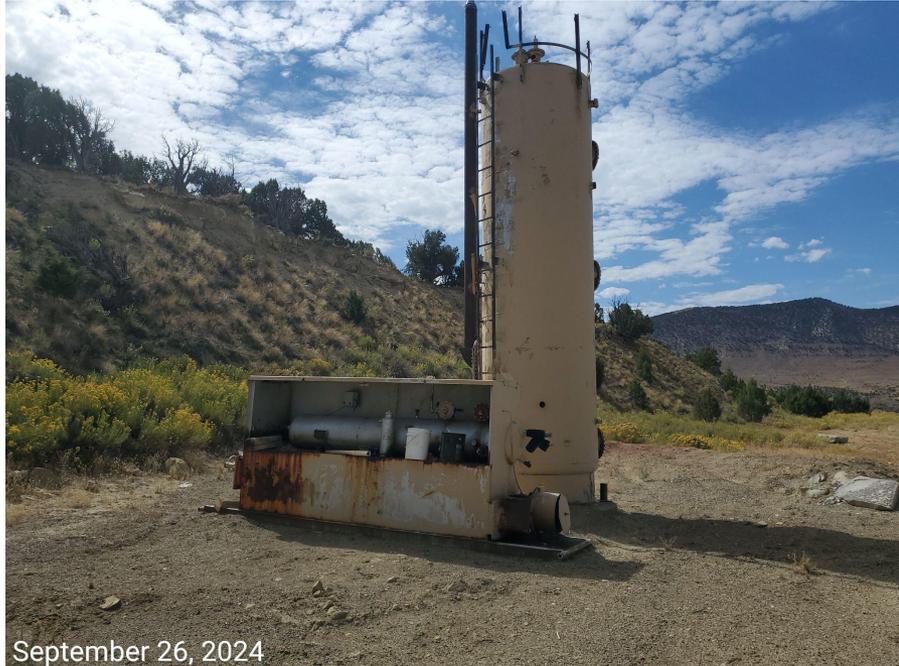
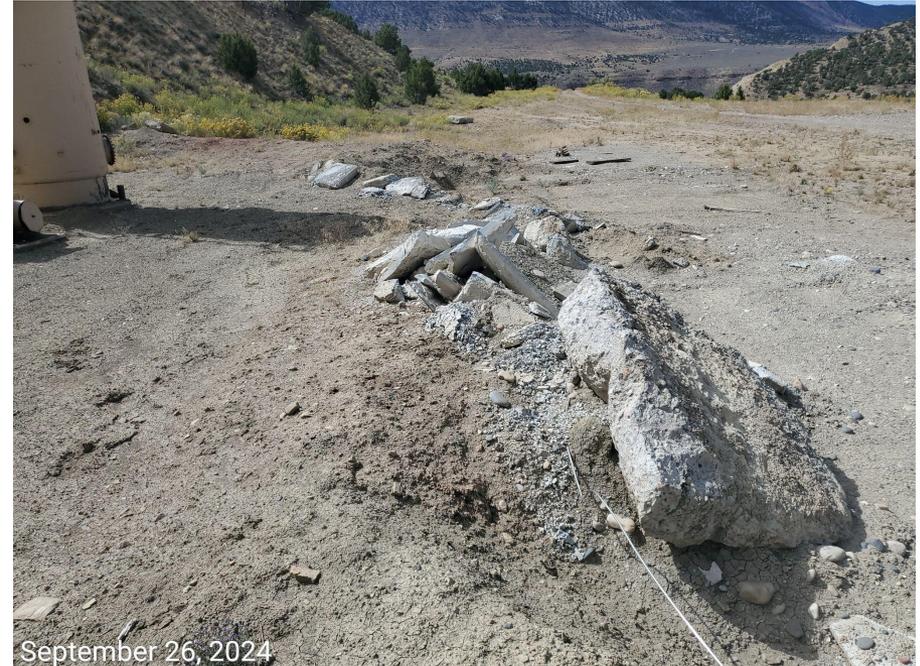
Photo 3: Photos examples showing trash/debris and equipment (tanks, risers, etc...) remaining on the Location. Pursuant to Rule 1004 all equipment, trash, debris, etc... was required to be removed within 3 months of plugging a well.

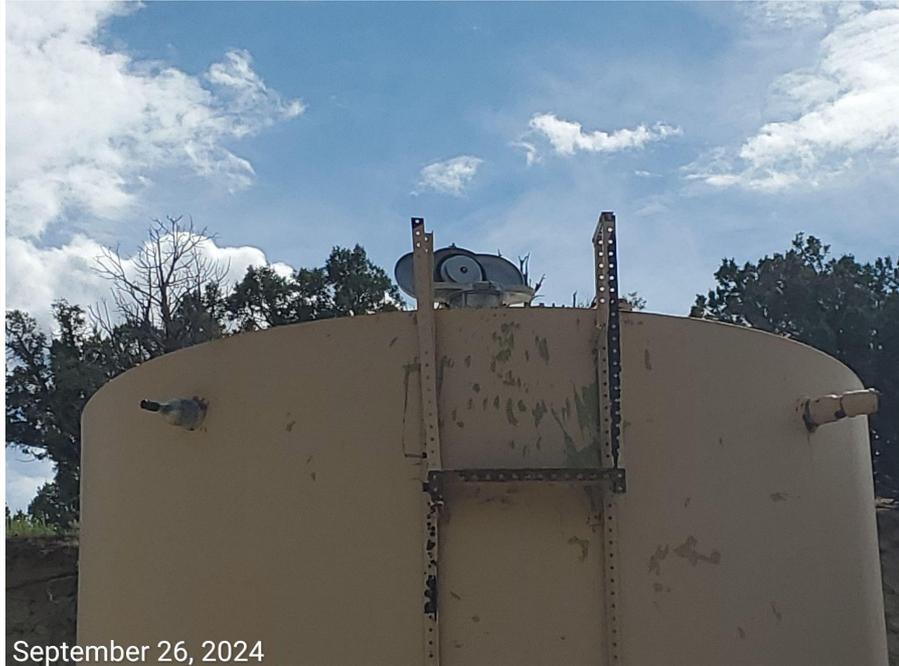
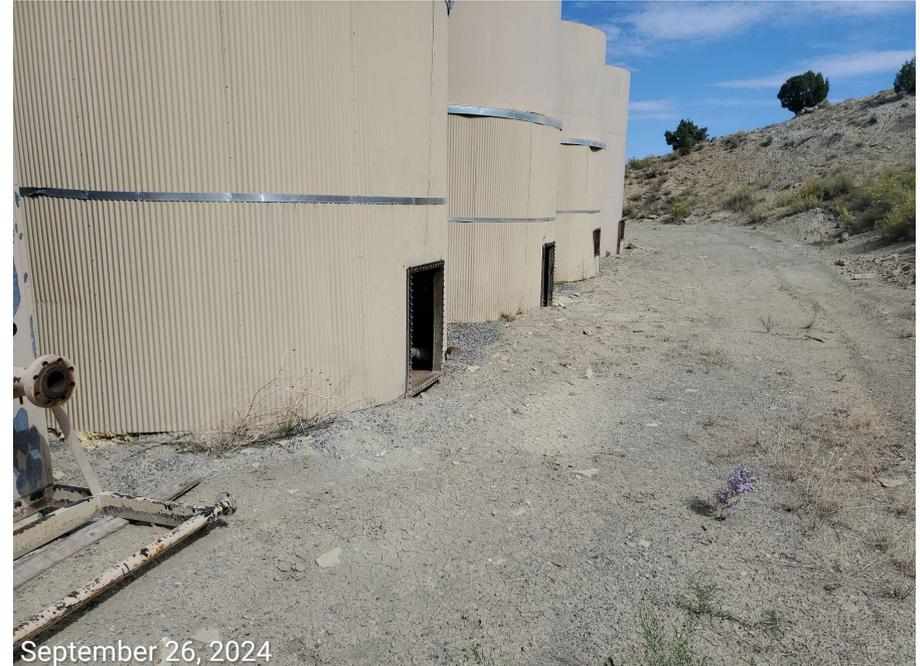
Photo 3: Tanks remaining on Location have not been properly closed/covered to prevent access by wildlife.

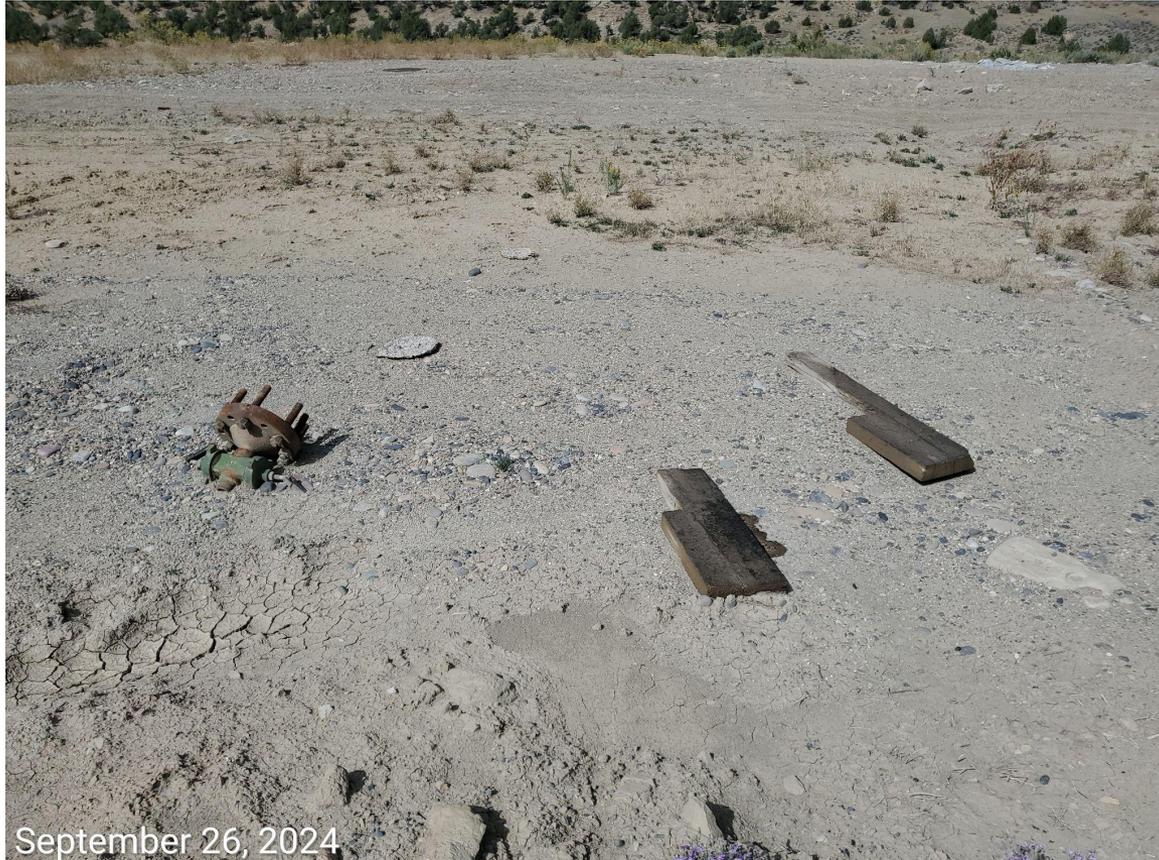
Photo 5: Photo examples showing various trash/debris/non-E&P waste improperly stored on the Location.

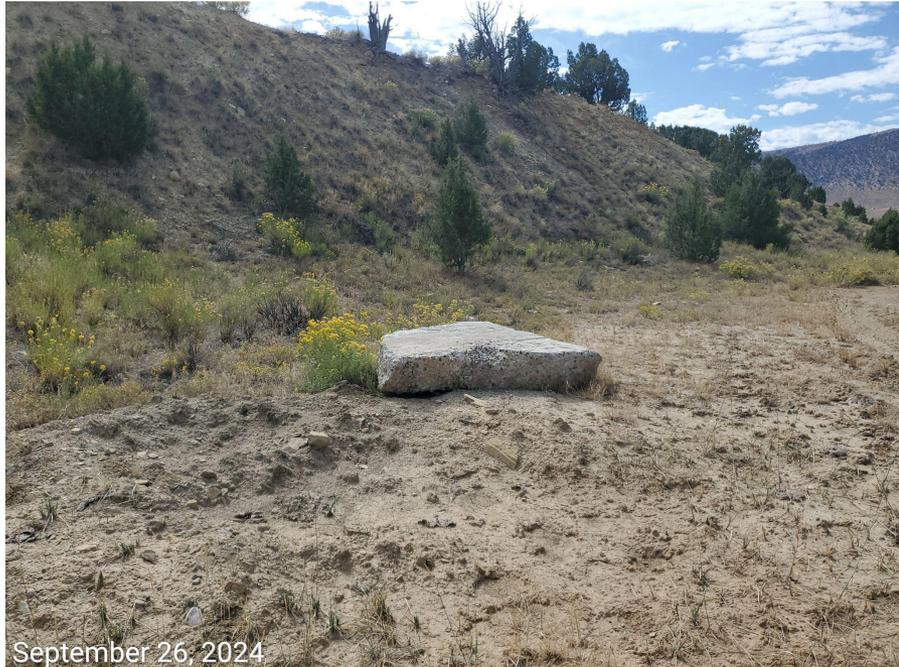
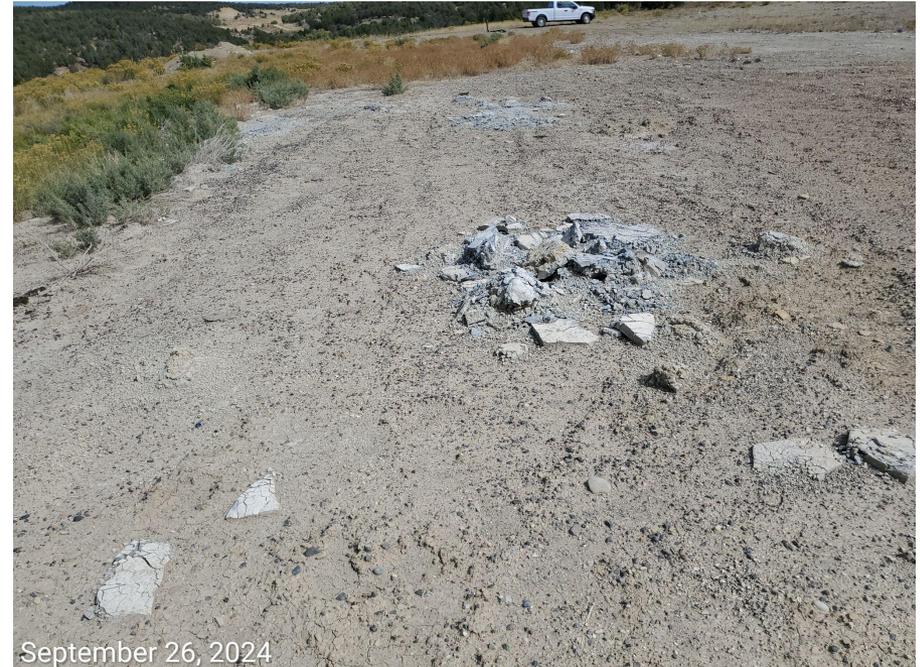
Photo 6: Photos examples showing various trash/debris/non-E&P waste improperly stored on the Location.

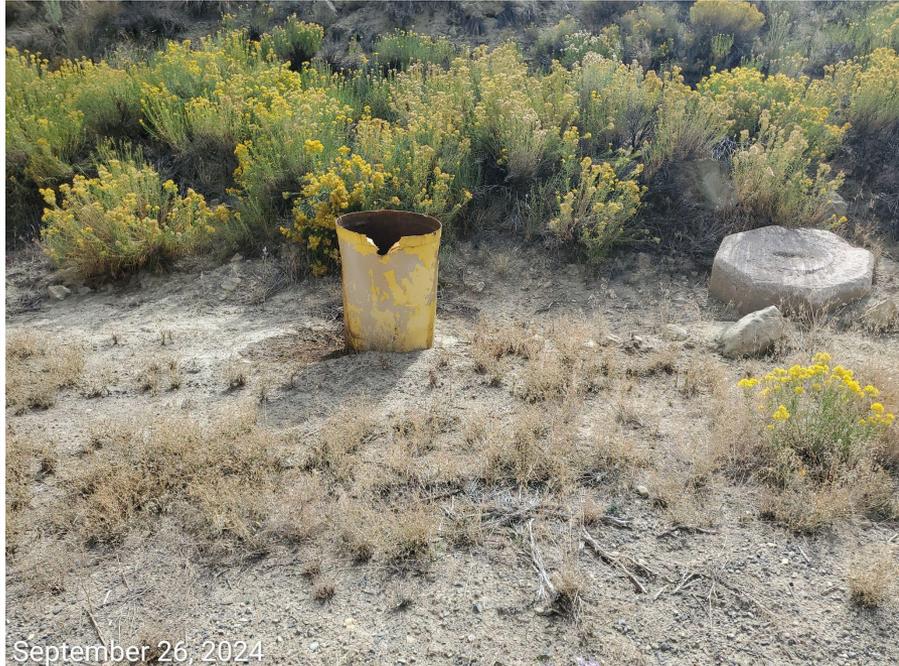
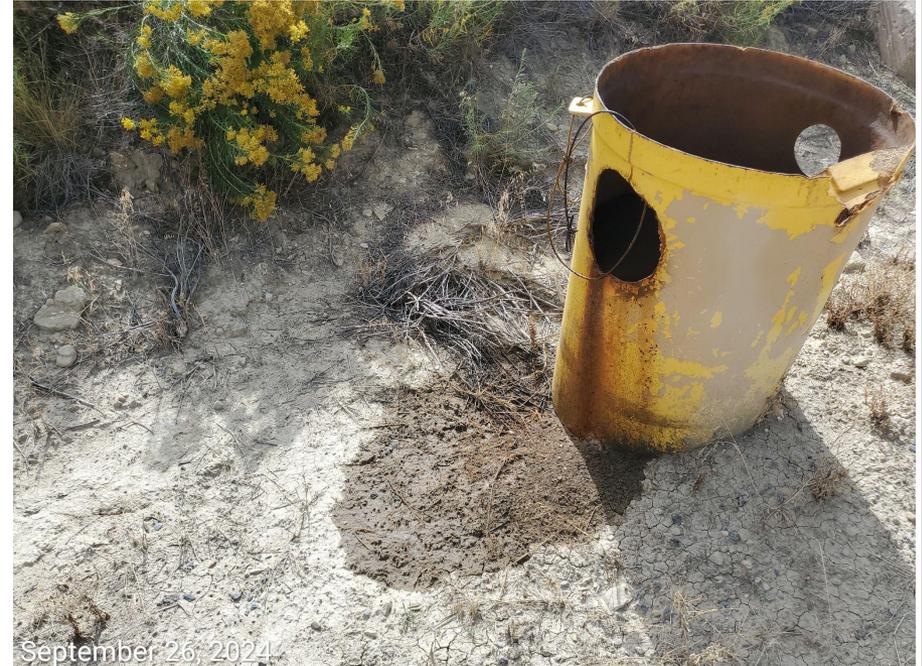
Photo 7: Photo taken from the east end of the Location. Photo shows container with unknown fluids spilled onto the pad surface. Photo also show concrete debris remaining.

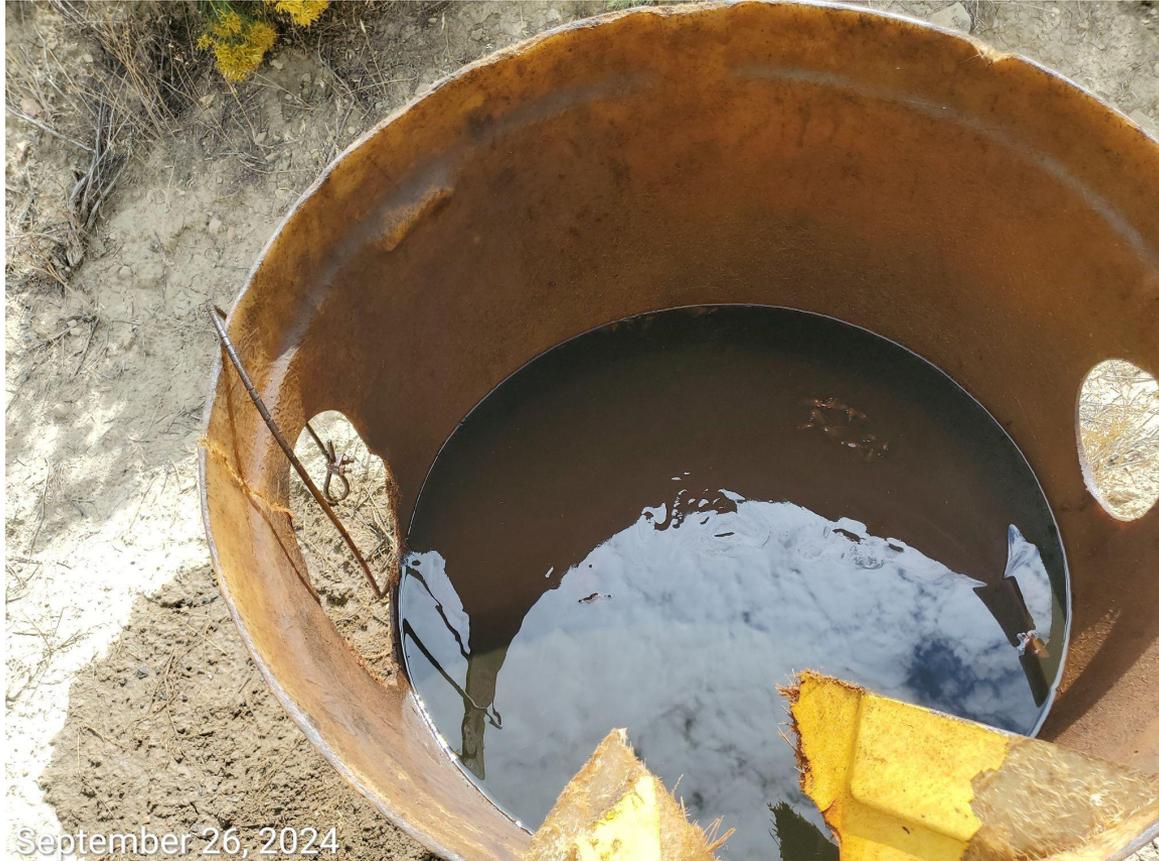
Photo 8: Continued from photo 7. Photo shows fluids within open container.

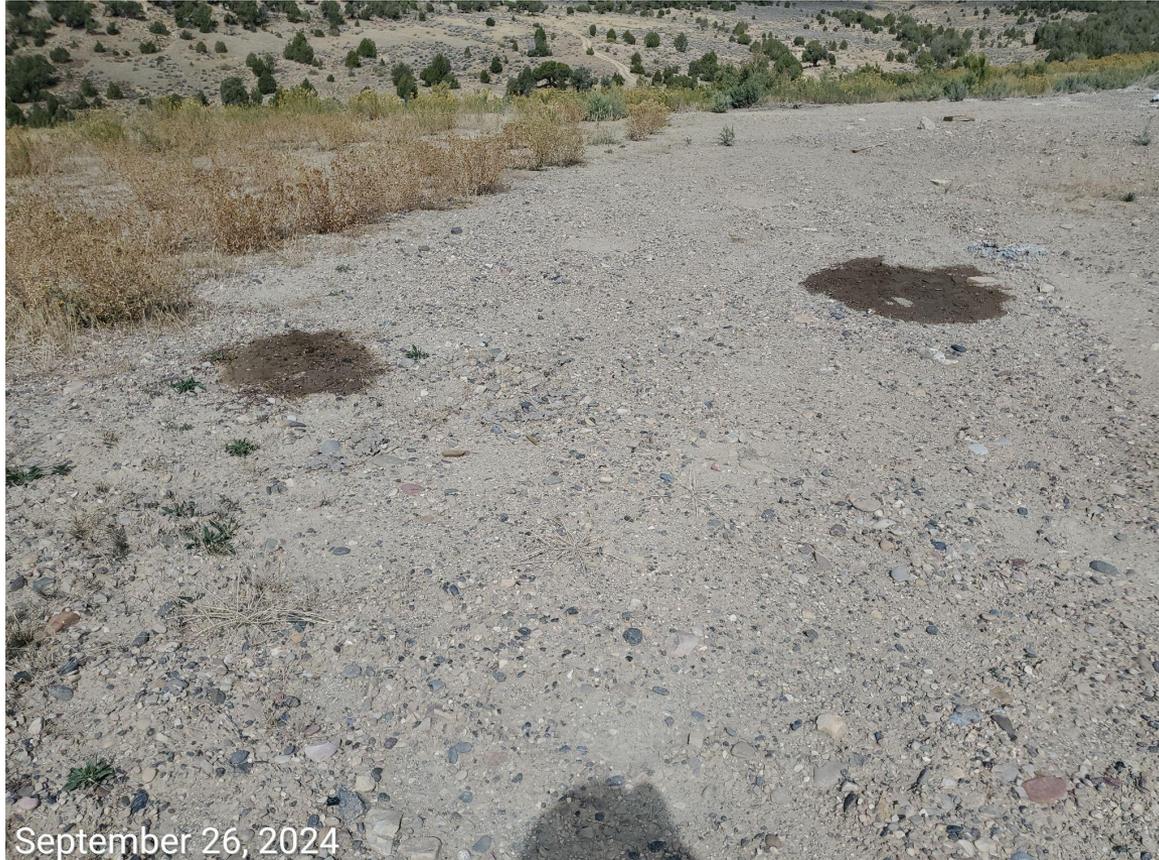
Photo 9: Photo taken from the southwest end of the Location. Photo shows additional spills/stained soils on Location.
