# Inspection Photos

**Operator:** ANSCHUTZ EXPLORATION CORP -  
3104

**Location ID:** 430927

**Inspection Doc:** 69620635

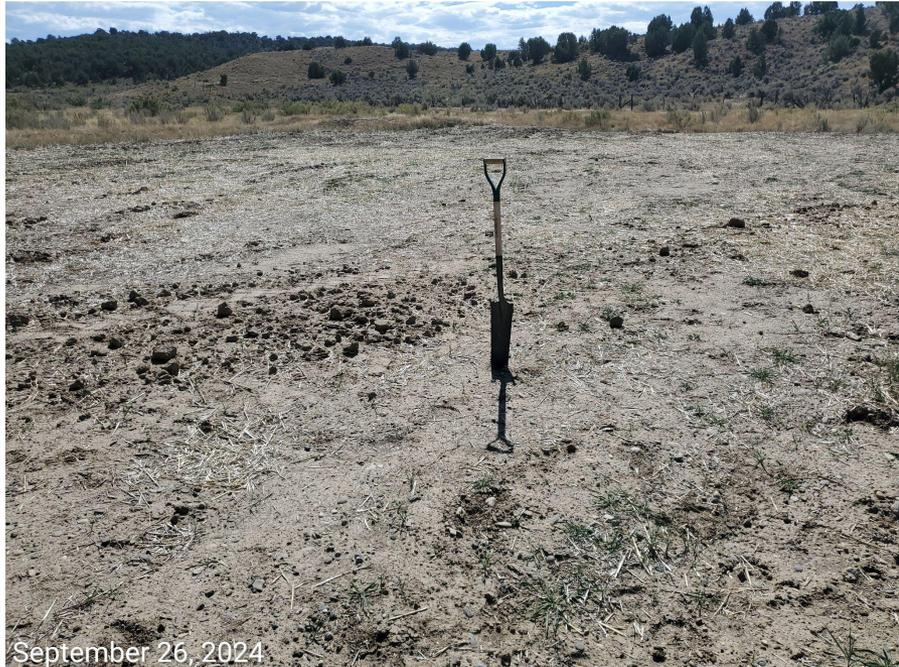
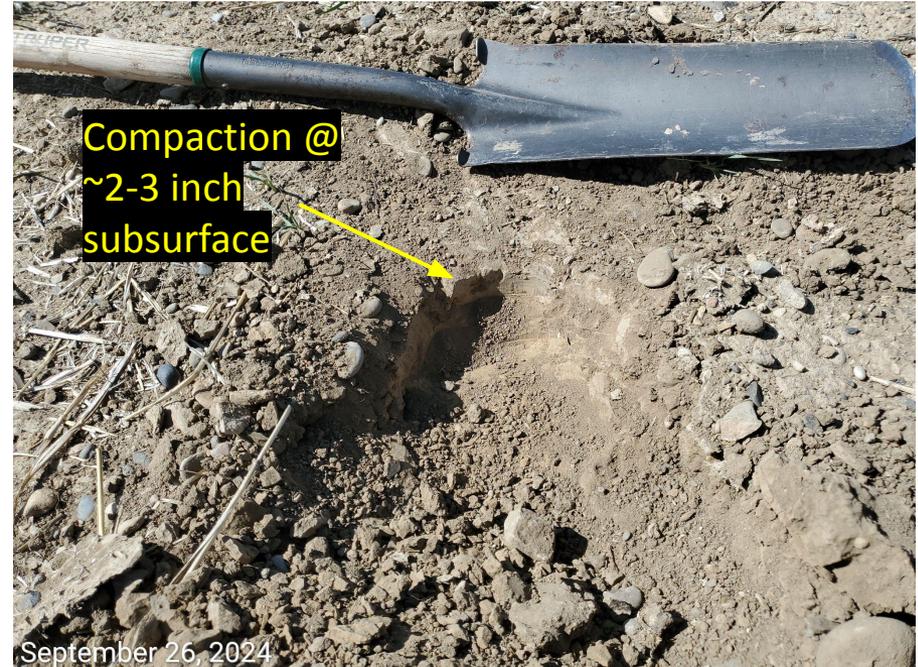
**Photo 1:** Photo taken from the interim areas on the southeast end of the Location. Photos examples showing compaction alleviation pursuant to 1003 requirements has not been performed on the southeast interim areas, and reclaimed access road on the north end of the Location.

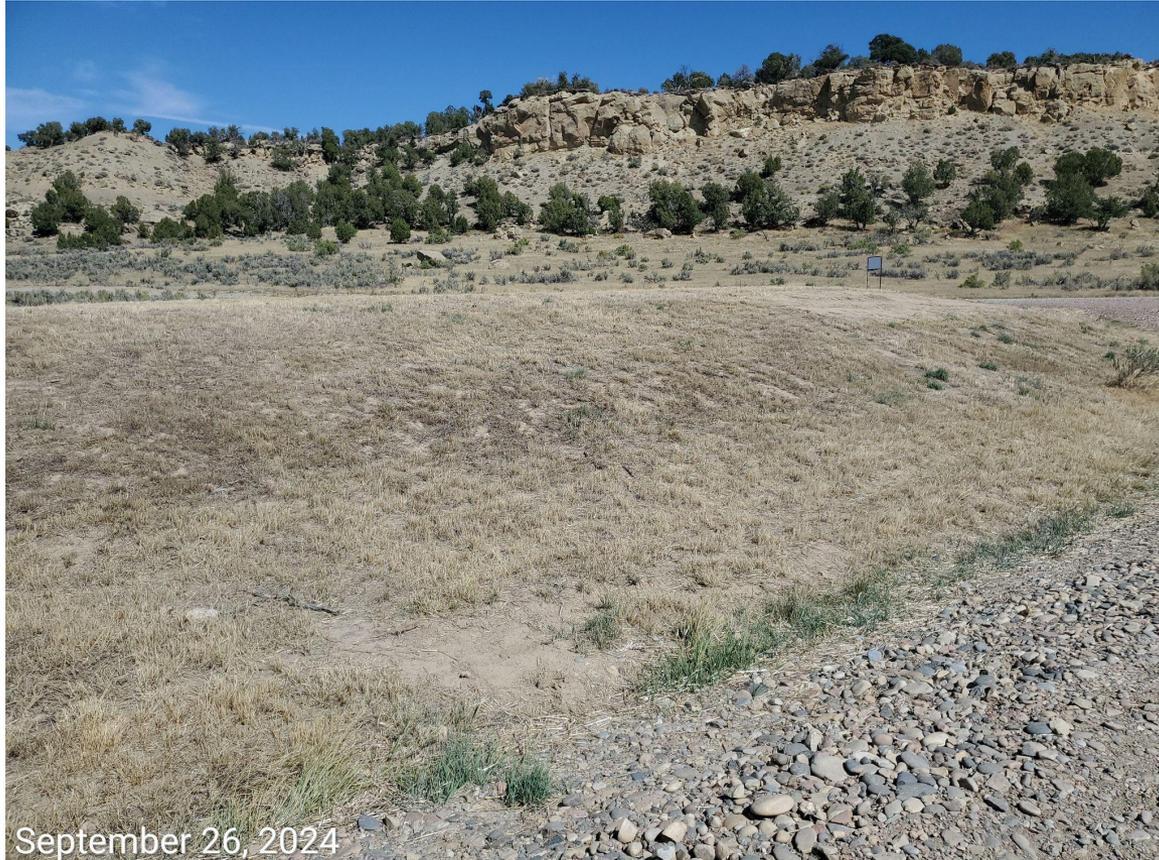
**Photo 2:** Topsoil stockpile. Operator appears to have performed mowing operations. Timing to prevent further spread of weeds is inadequate, as weeds have already seeded out for the year.

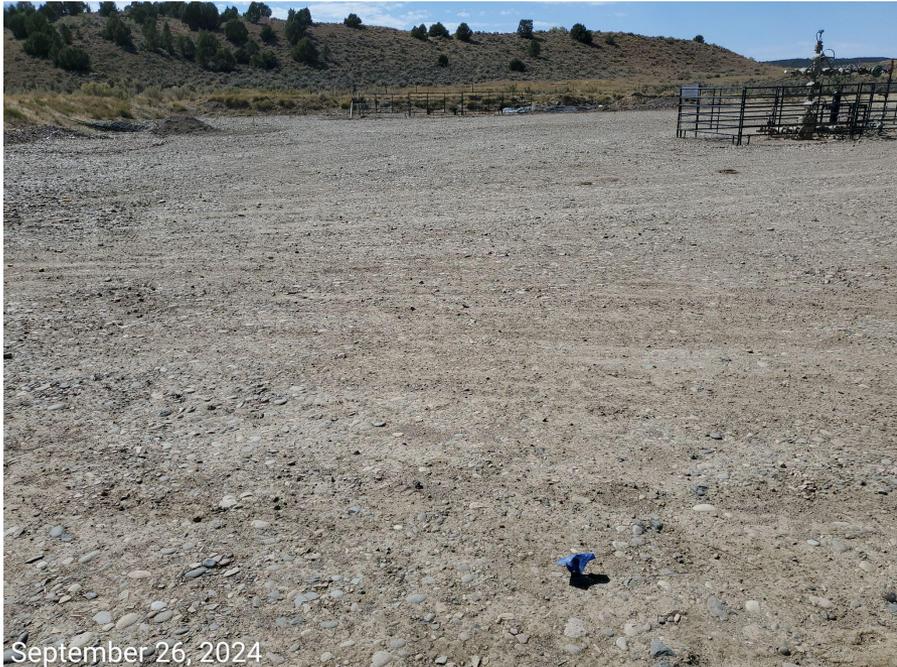
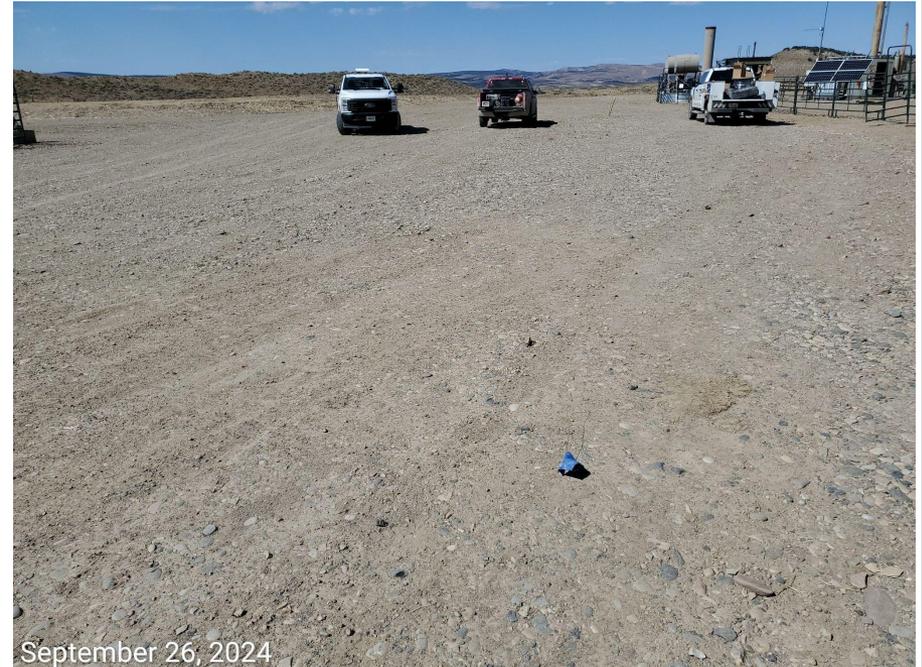
**Photo 3:** Photos examples showing anchor on the southeast end of the pad remains buried, and has not been marked pursuant to Rule 1003.a.

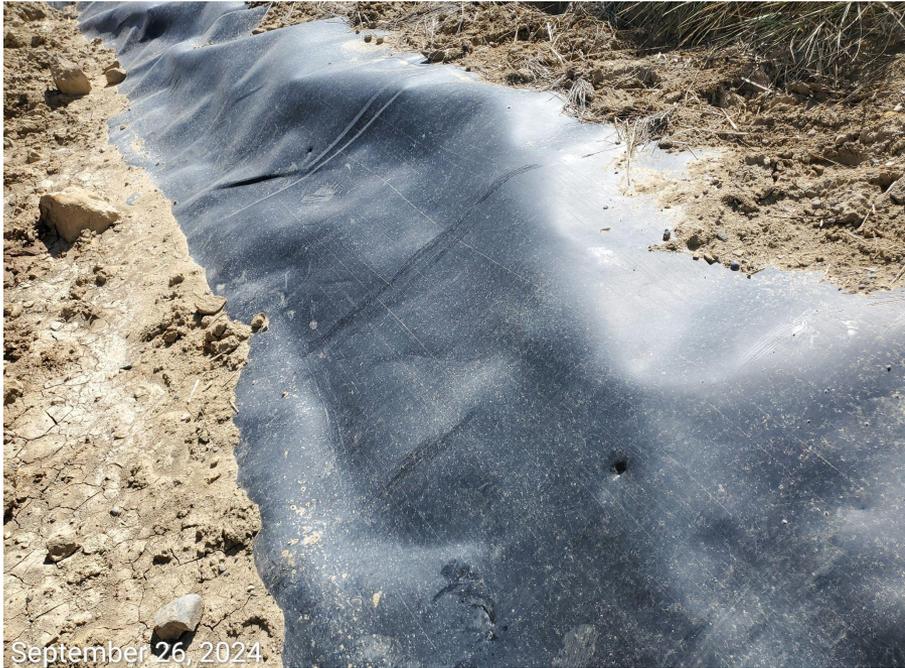
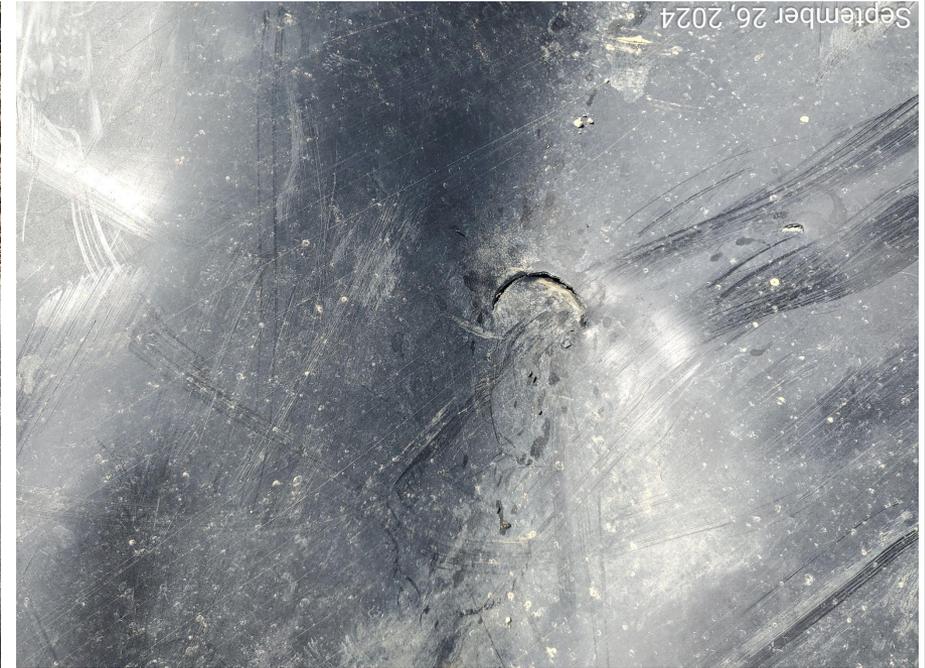
**Photo 4:** Photos show holes within containment BMP/Liner on the west end of the Location. BMP no longer impervious to contain a spill or release from the impacted materials.

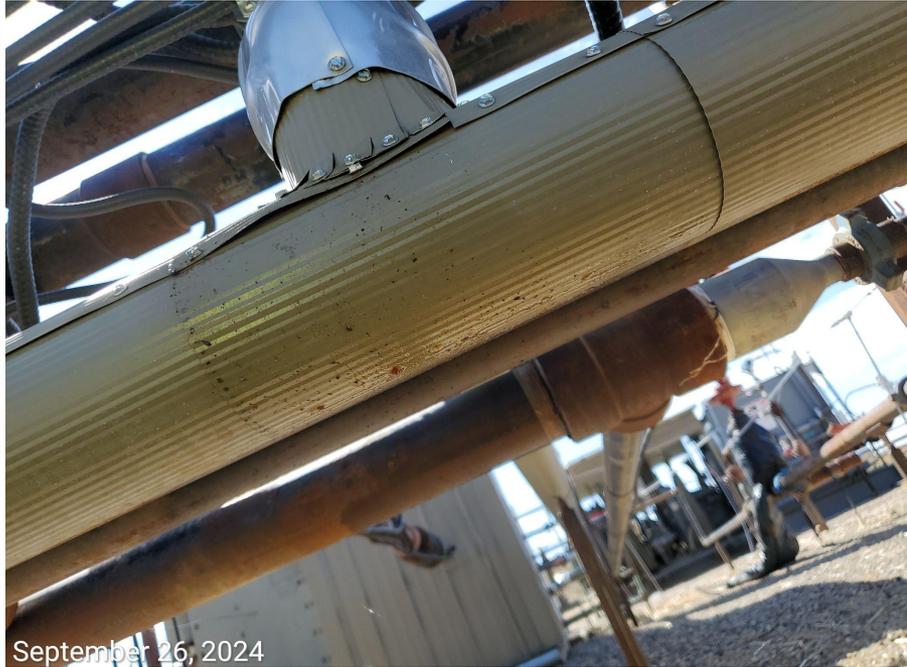
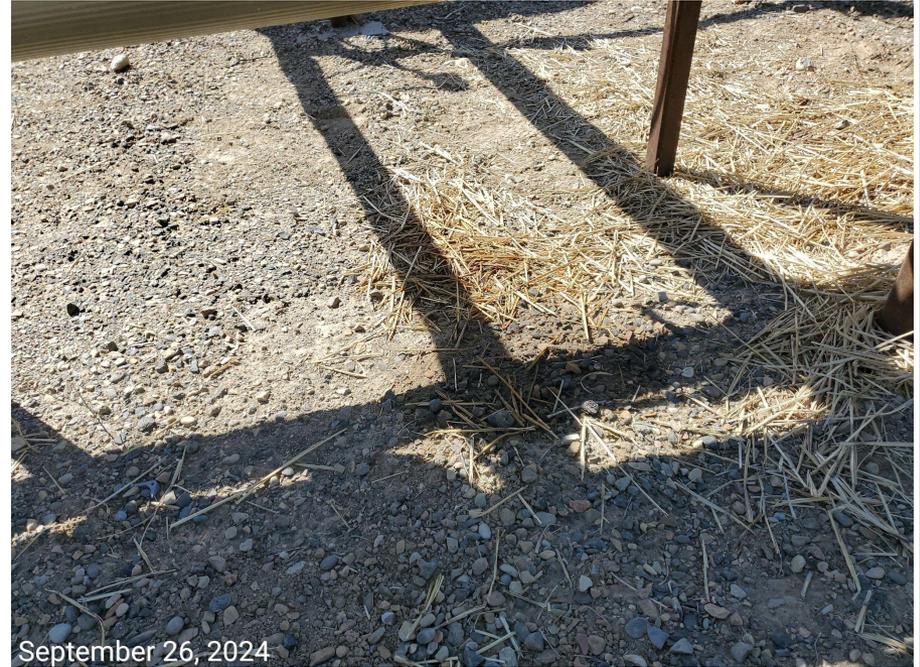
**Photo 5:** Photo shows leaks at equipment (pipe, northeast end of the Location) have persisted, and spills onto the pad surface have recurred.

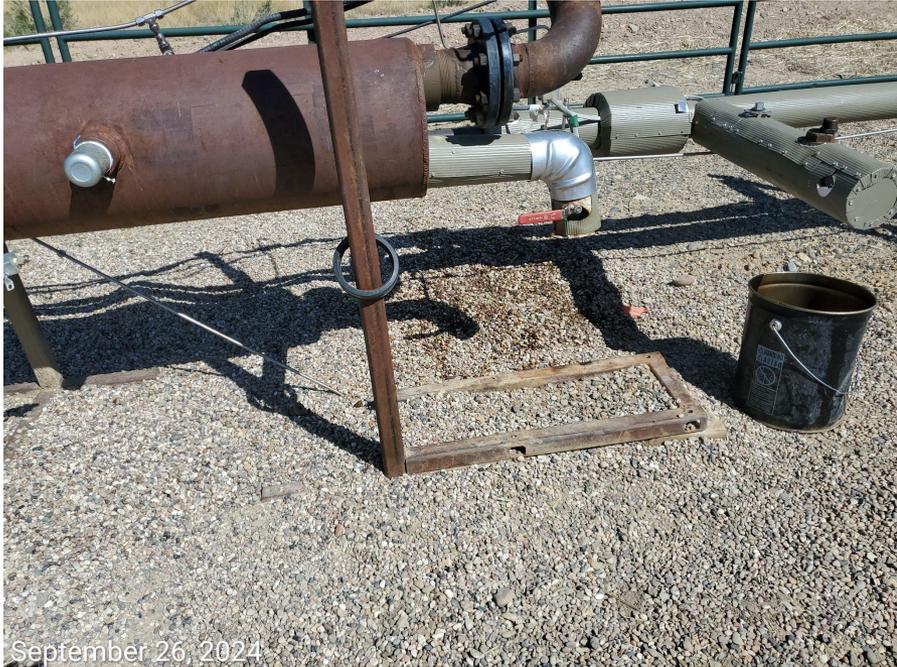
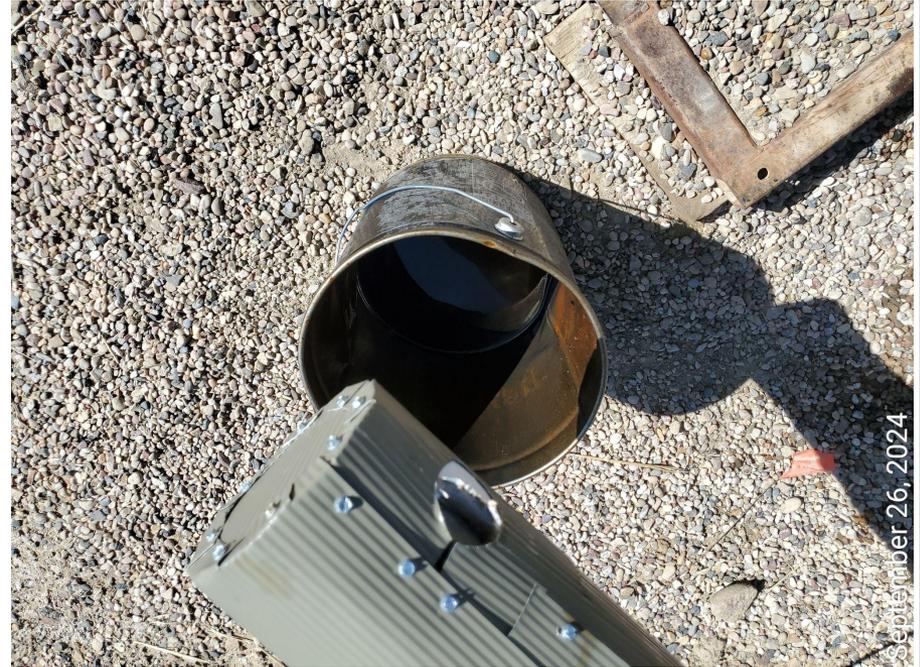
**Photo 6:** Photo shows leaks at equipment (pipe, northeast end of the Location) have persisted, and spills onto the pad surface have recurred.

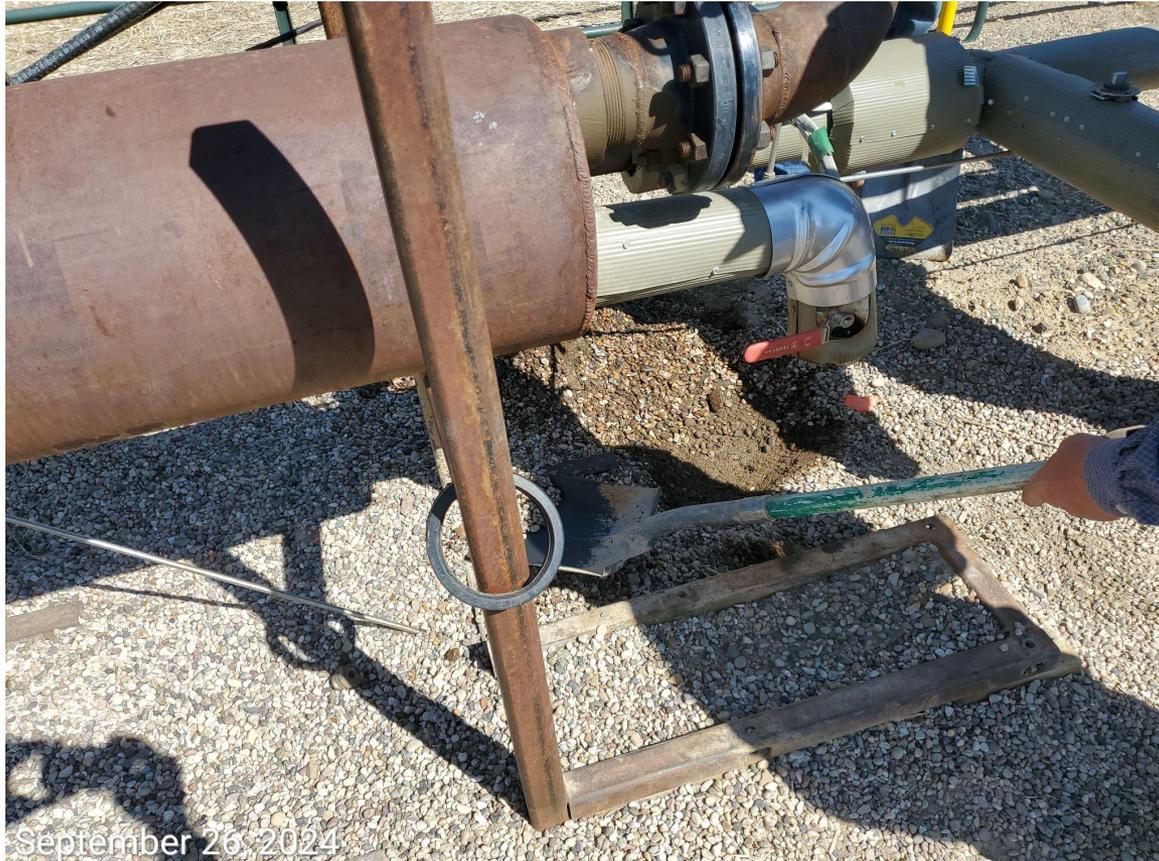
**Photo 7:** Continued from photo 6. Operator on site began work on spill at time of inspection. Impacts appear to have impacted all new clean material brought onto the Location.

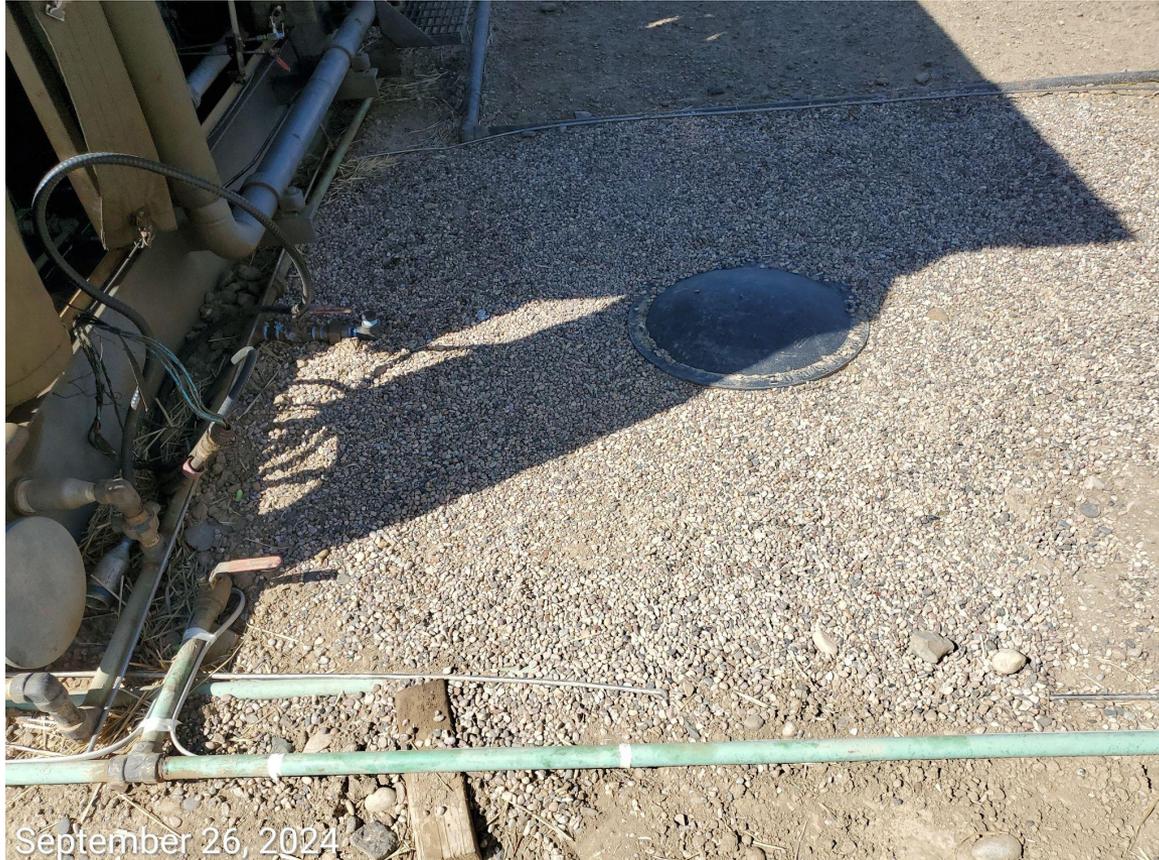
**Photo 8:** Photo taken from the behind the compressor equipment. Containment BMP has been reinstalled, and impacted soils appear to have been cleaned/removed.
