Inspection Photos
Location Name: Cleveland #2
Location ID: 332884

Energy & Carbon Management Commission
40.11106, -104.90296, 1508.7m, 41°
Sep 30, 2024 13:23:08

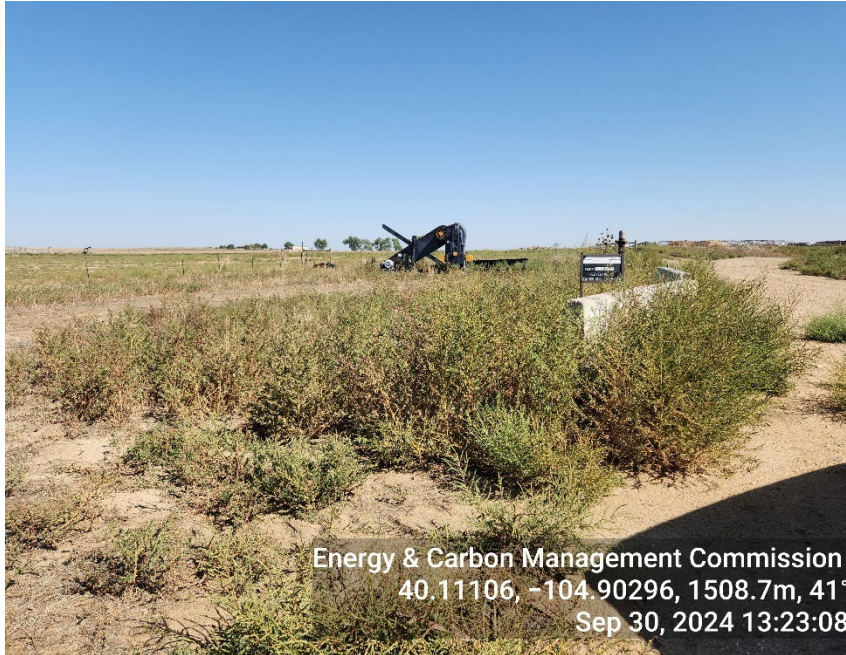
Photo 1: Location from entrance, overgrown vegetation

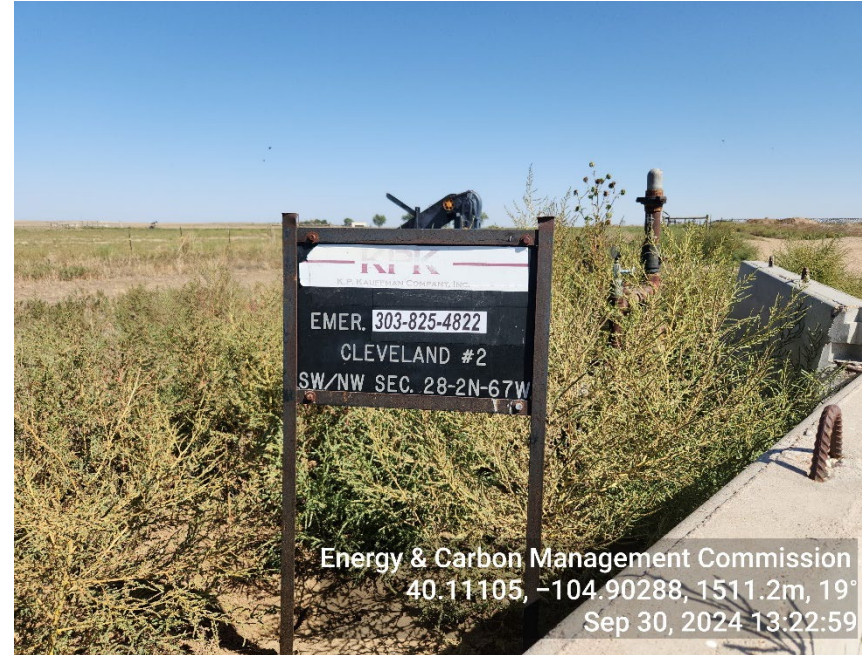
Photo 2: Wellhead Sign

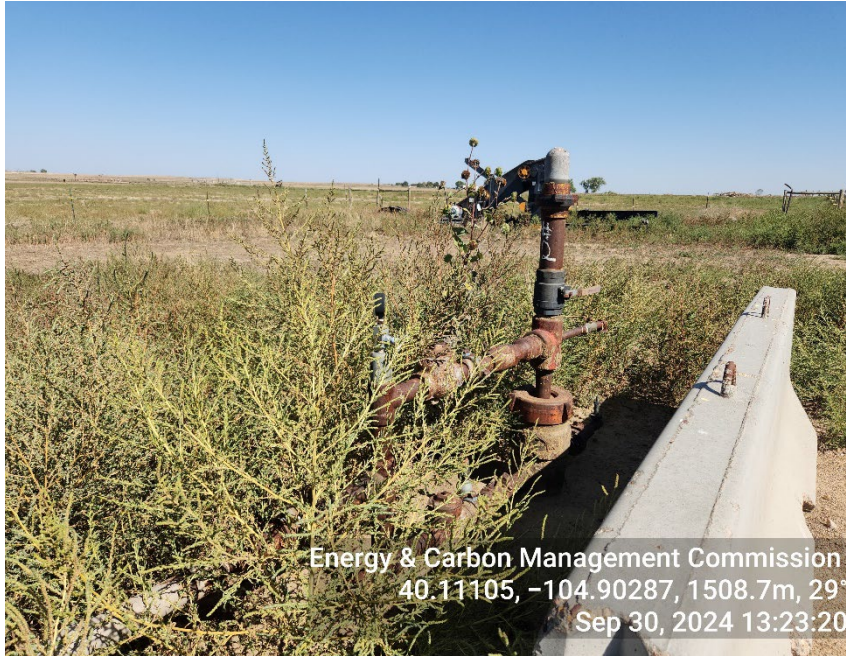
Photo 3: Wellhead, overgrown vegetation

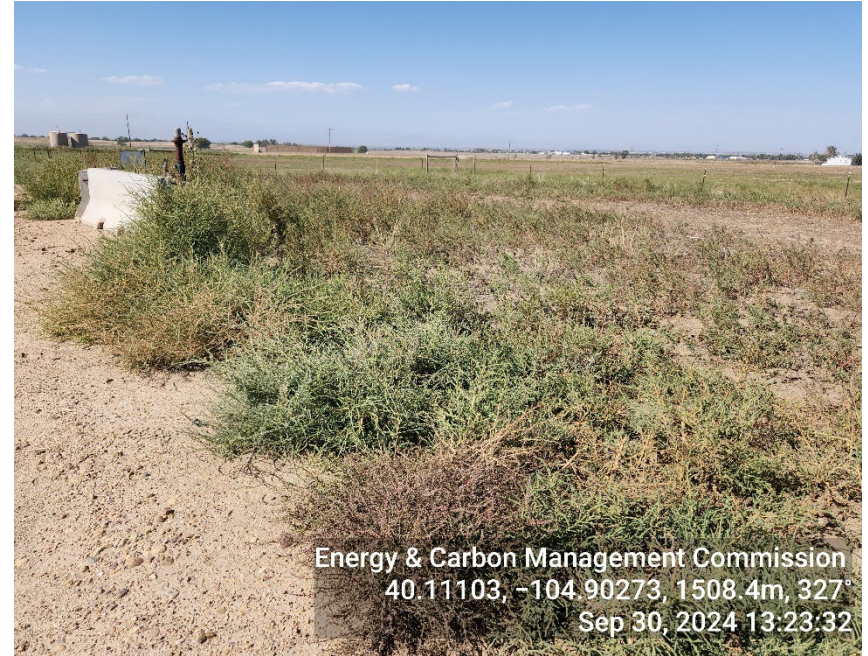
Photo 4: Overgrown vegetation

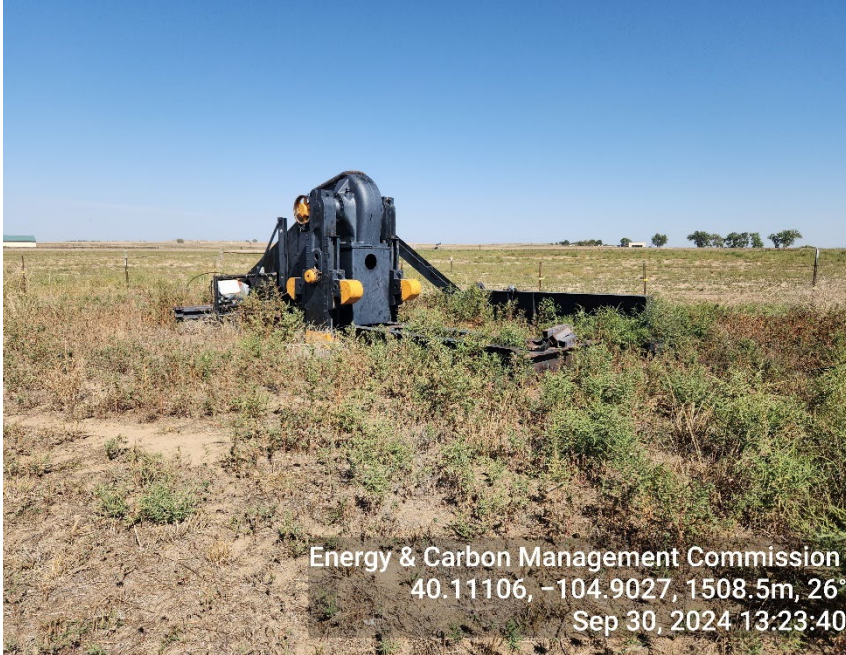
Photo 5: Unused/disconnected equipment, overgrown vegetation
