## Inspection Photos

Location Name: MUSTANG RESOURCES LLC MOORE 27-42-6S-94W Pad

Location ID: 323788

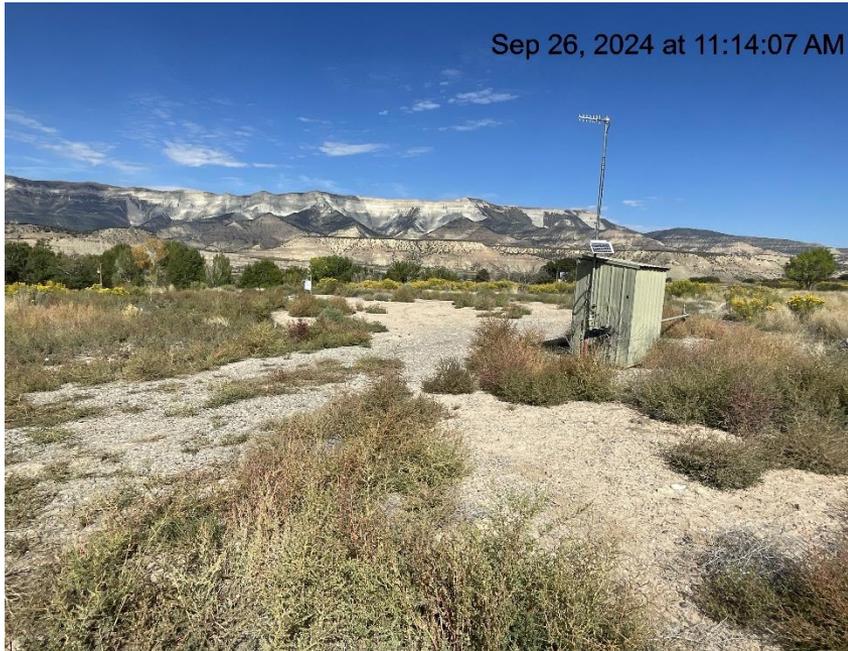
Photo # 2084 From entrance to location

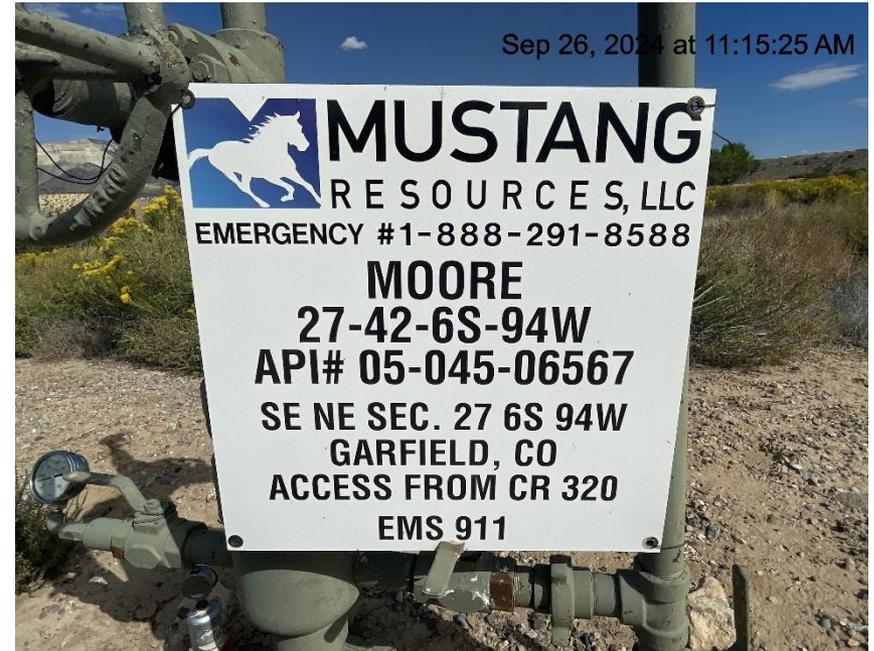
Photo # 2085 Location

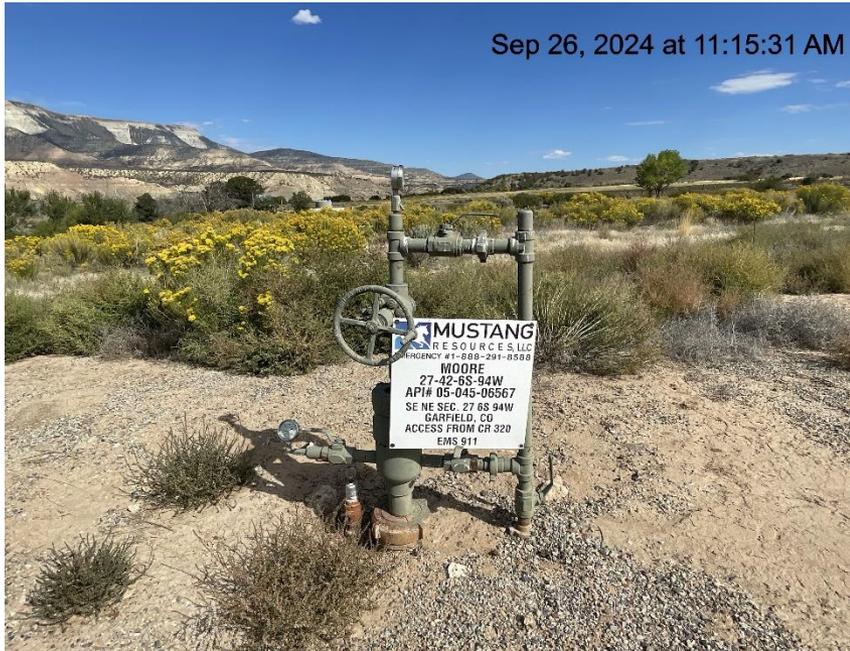
Photo # 2086 Location

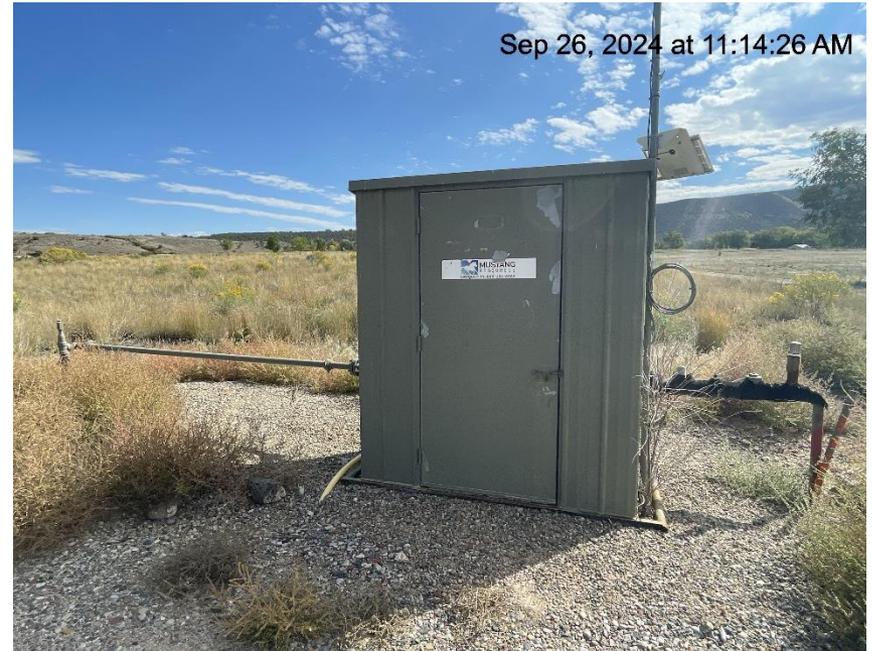
Photo # 2087 Location

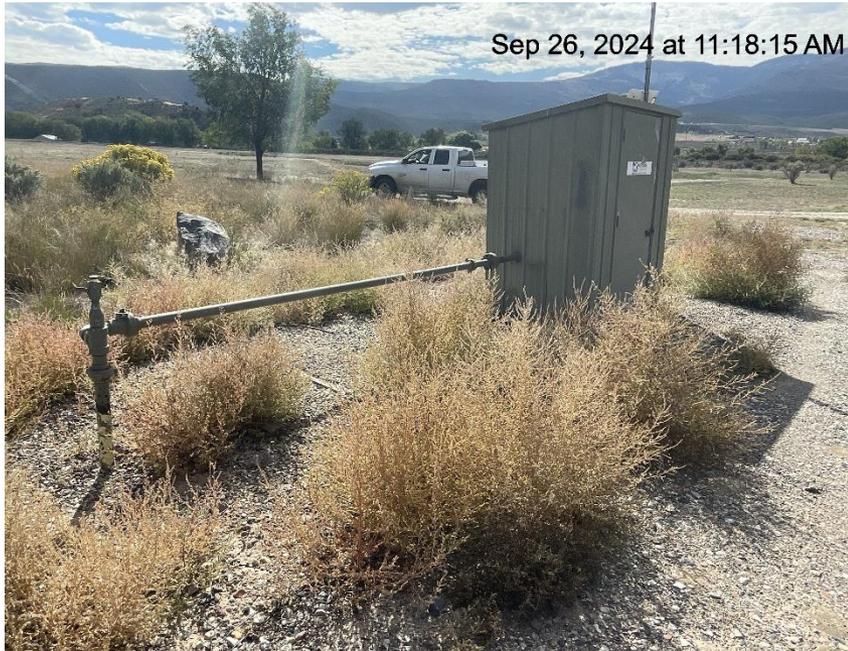
**Photo # 2088 Weeds near meter house that are causing a fire hazard**

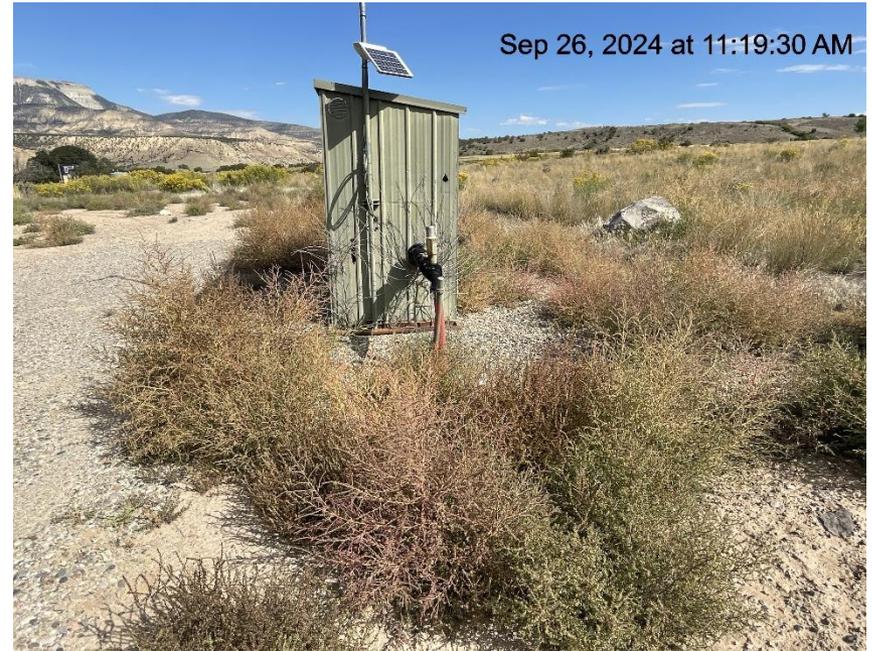
**Photo # 2089 Weeds near meter house that are causing a fire hazard**

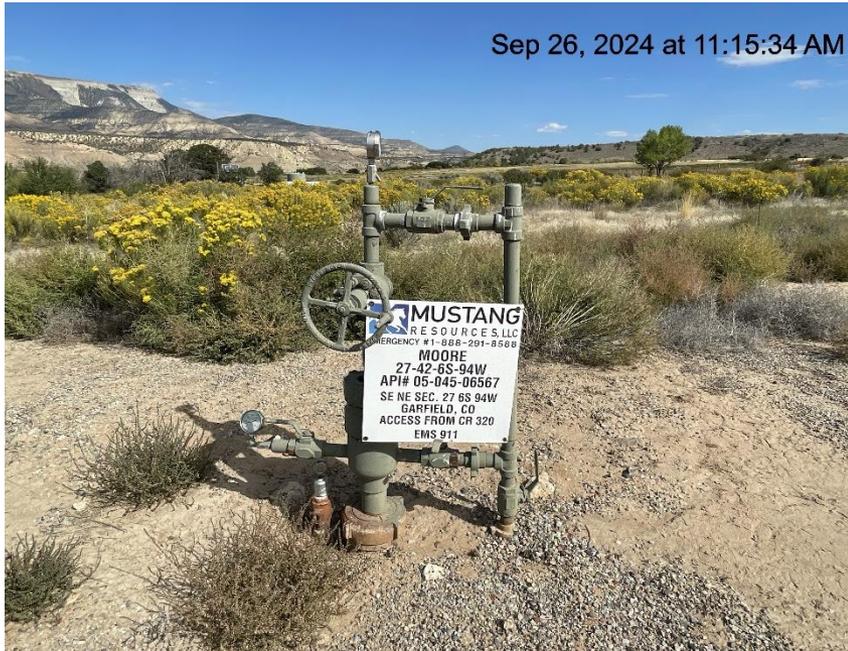
**Photo # 2090 Weeds within close proximity to wellhead that also constitute a fire hazard**
