Inspection Photos

API: 099-06285

Operator: LAMAR OIL & GAS EXPLORATION

Inspection Date: 9/24/2024

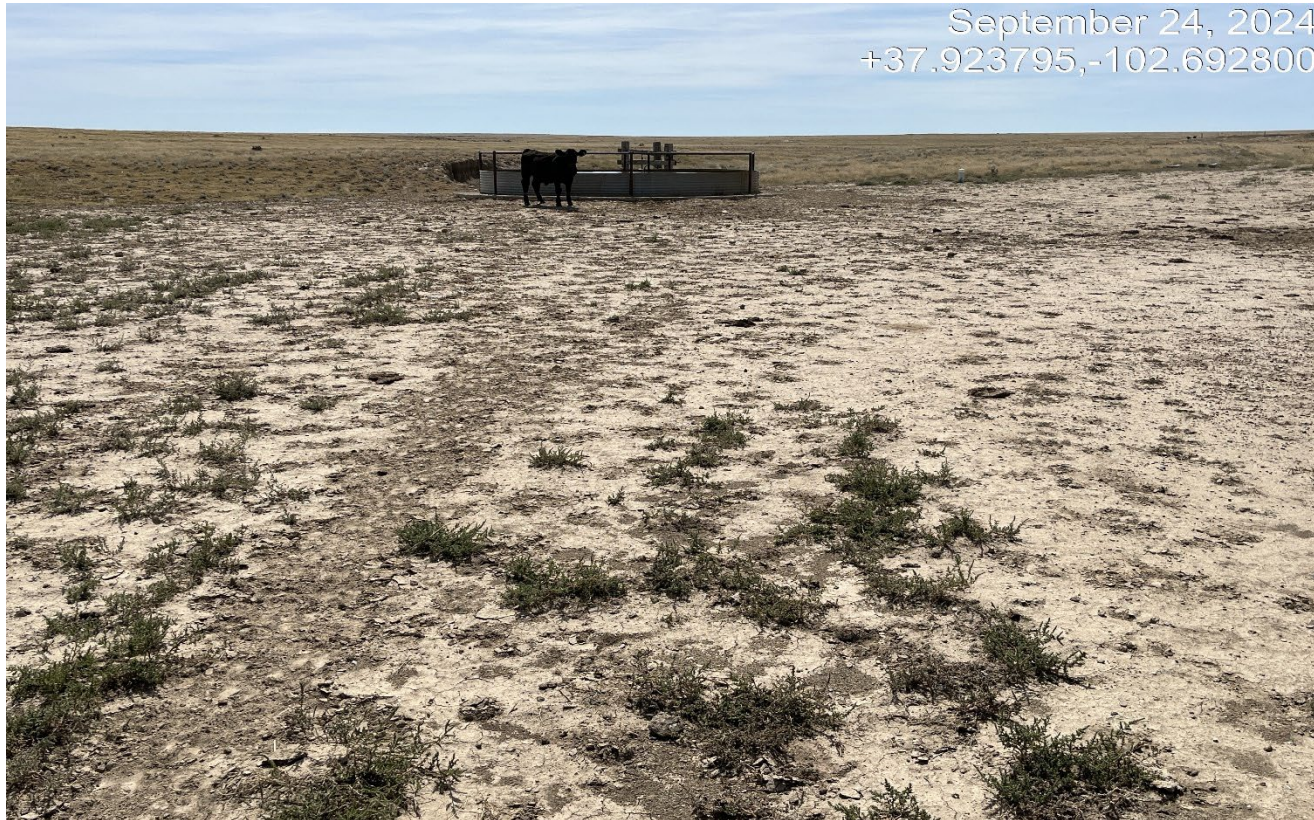
Photo 1. Facing south toward the wellsite location. There is a cattle water tank on the south side of the location.

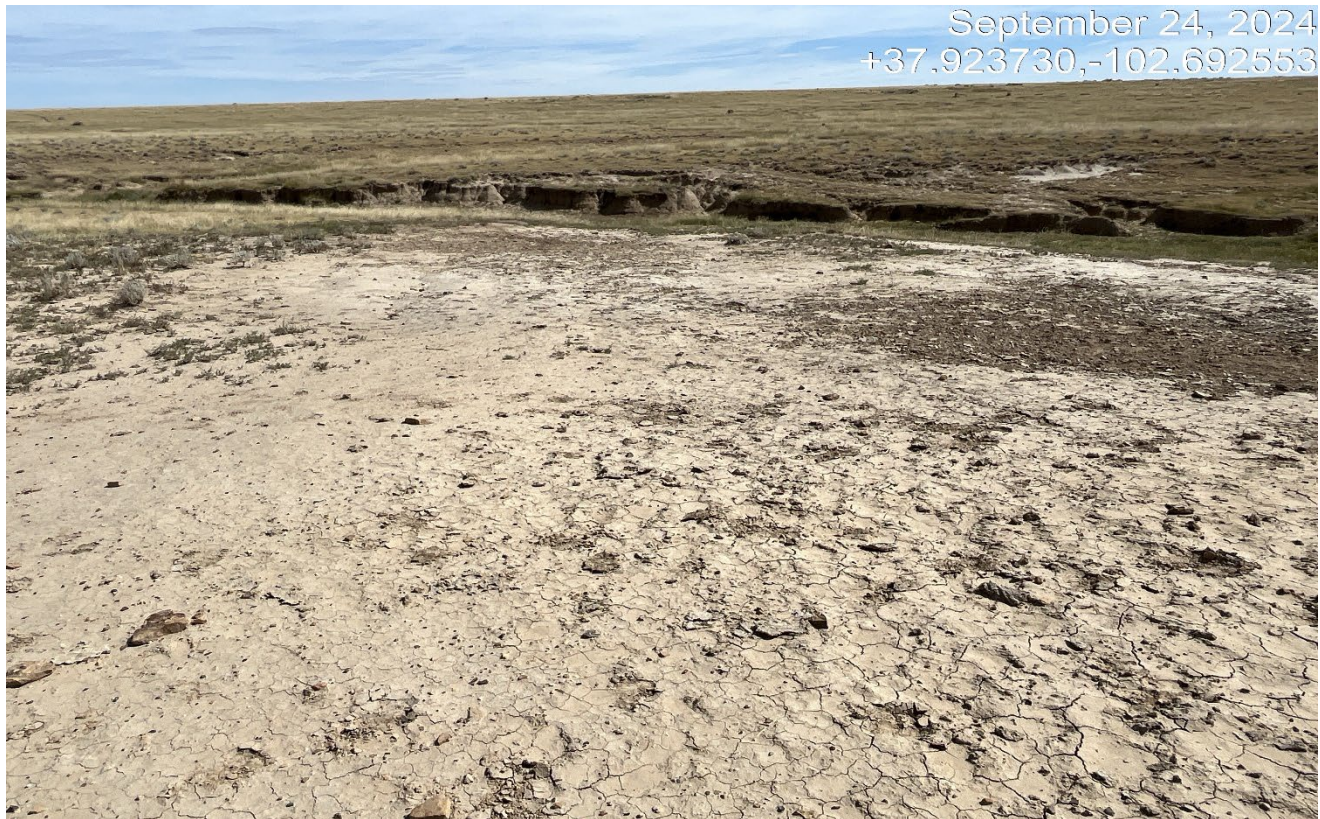
Photo 2. Center of the location facing east. This area is where the tank battery existed. It appears there is historic impacts from the tank battery that is impacting vegetation growth.

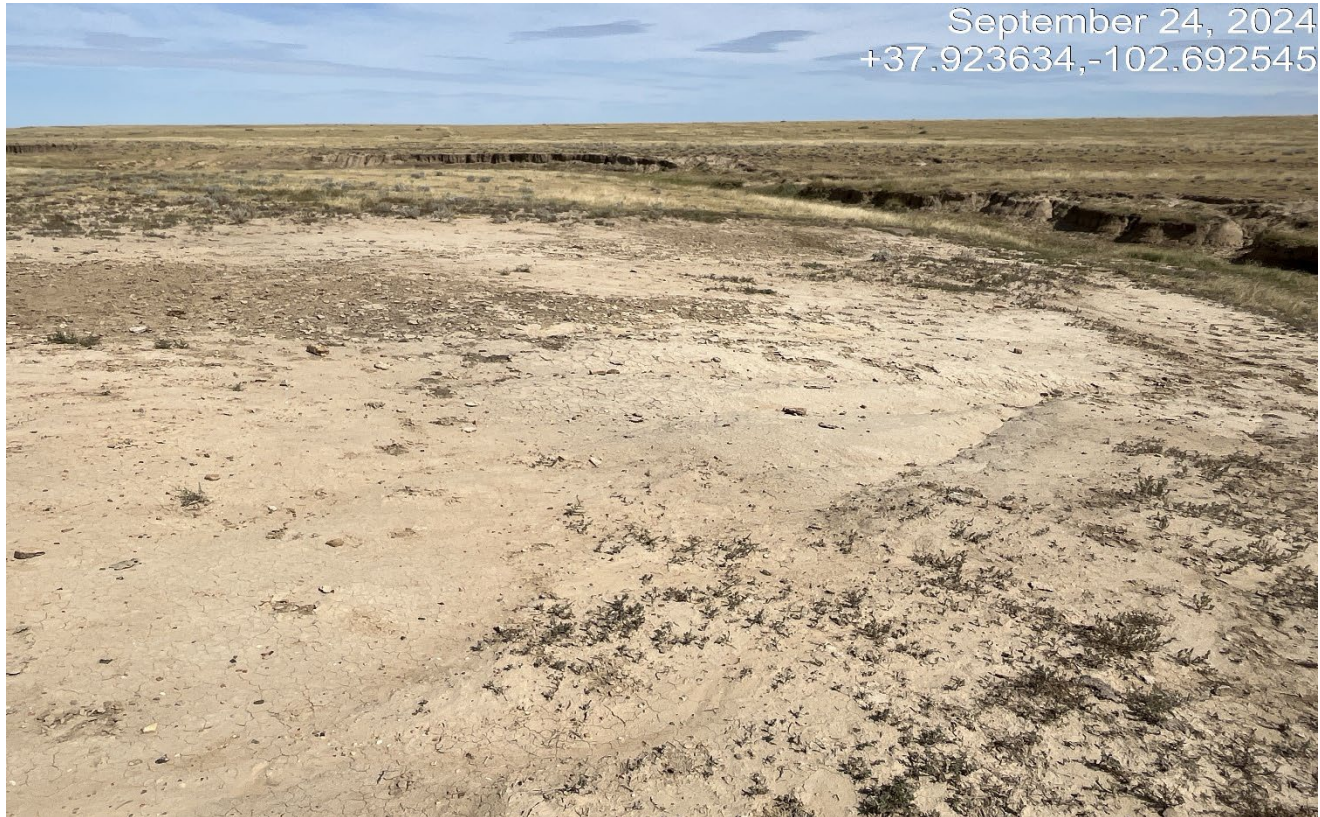
Photo 3. Facing northeast toward the impacted area which is close to the drainage in the upper right..

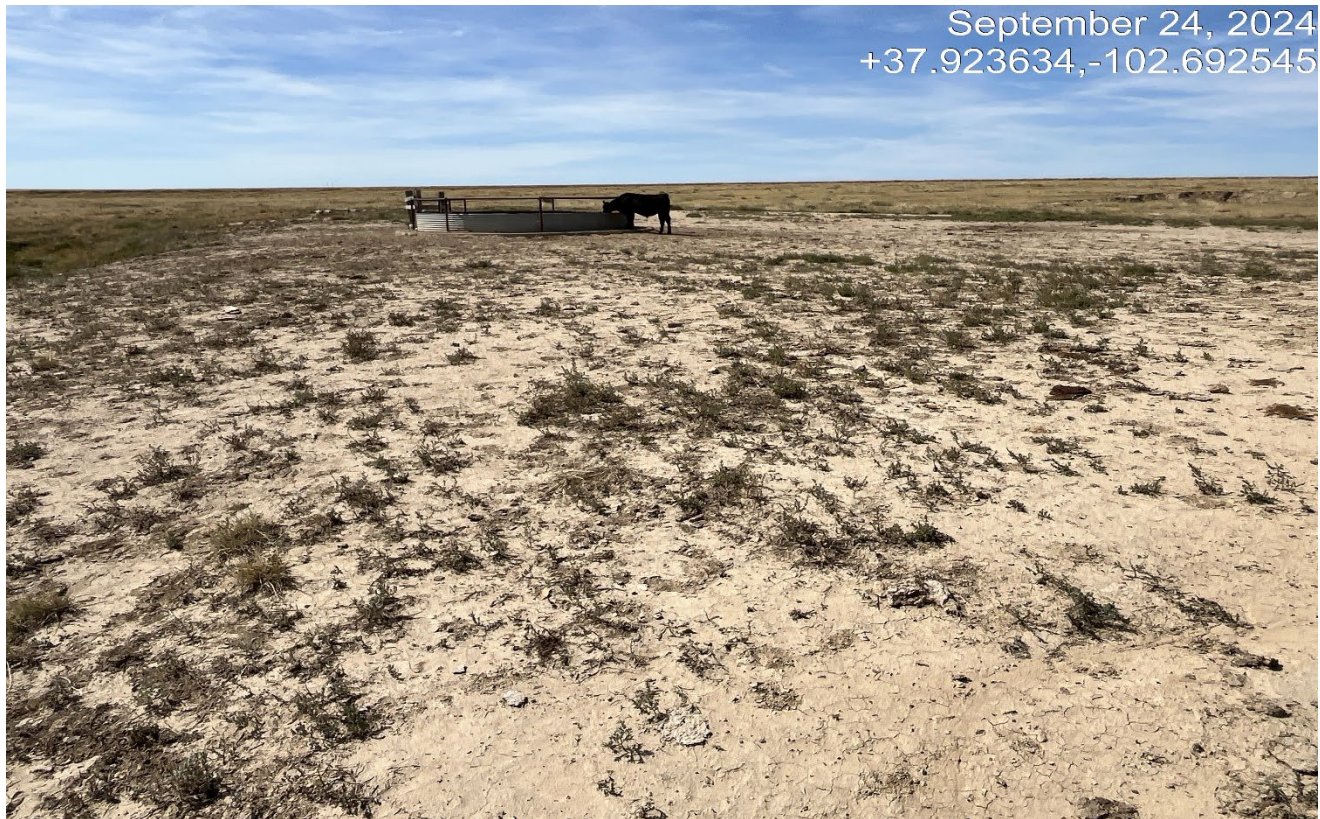
Photo 4. Facing southwest. The location excluding the area around the water tank has not been reclaimed and has mostly bare soils.

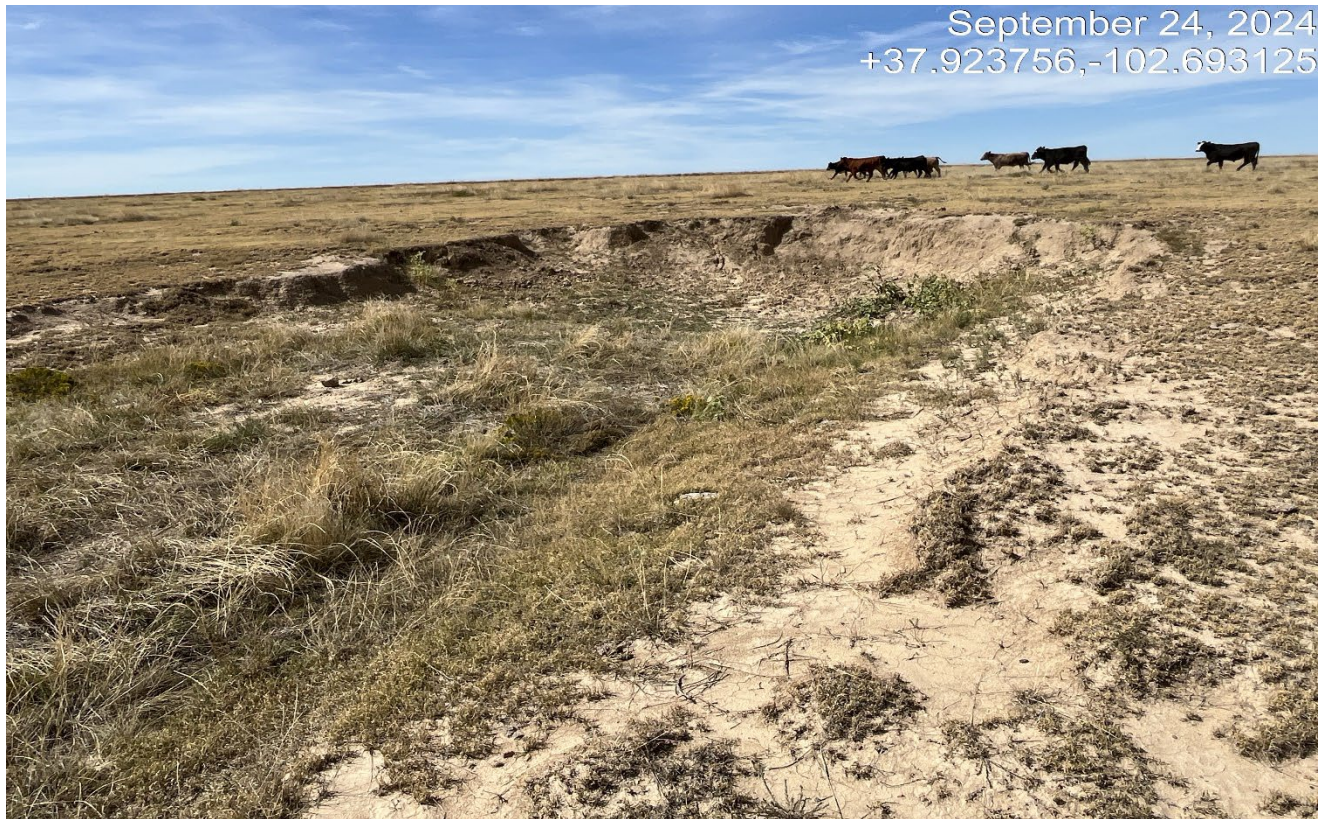
Photo 5. Facing toward the west side of the location. This area was excavated for the wellsite and was never reclaimed.
