# Interim Reclamation and Stormwater Inspection

Operator: Highpoint Operating Corporation - 10071

Location ID: 436165

Location Name: RSU Anschutz Fed 4-62-2\_1

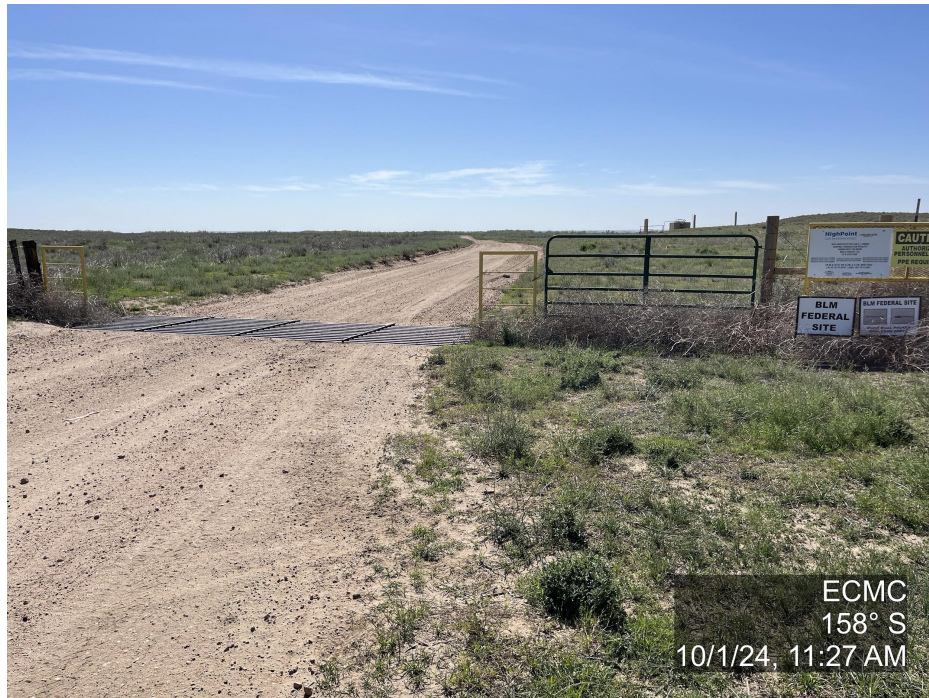
**Photo 1.** The photo was taken at the well location entrance facing South. The photo illustrates the Operator location sign and access road.

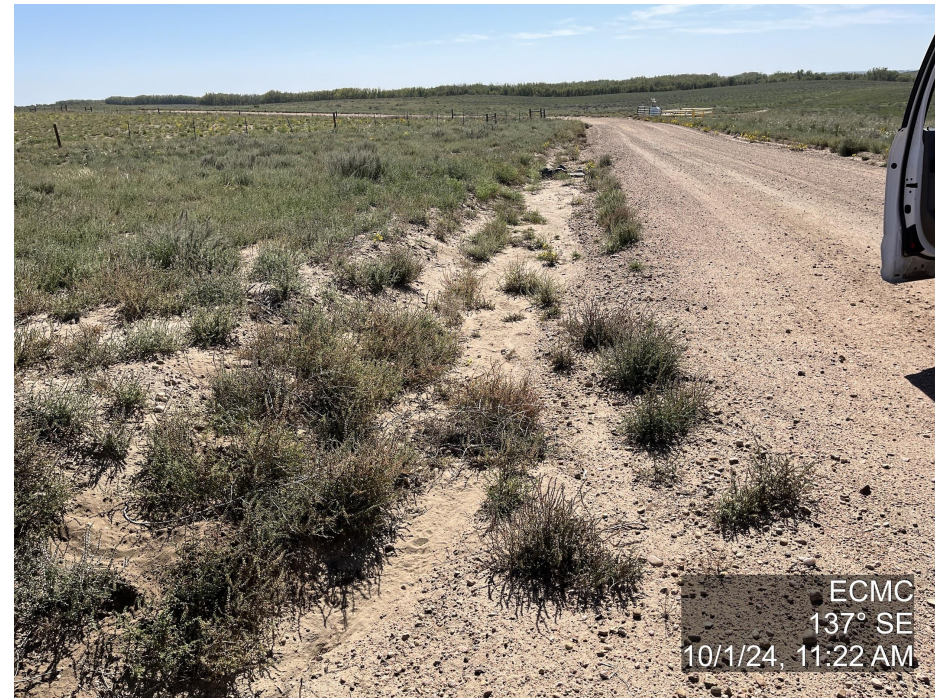
**Photo 2.** The photo was taken along the access road to the well location facing Southeast. The photo illustrates sediment has filled the ditch behind the riprap check dam and should be cleaned out.

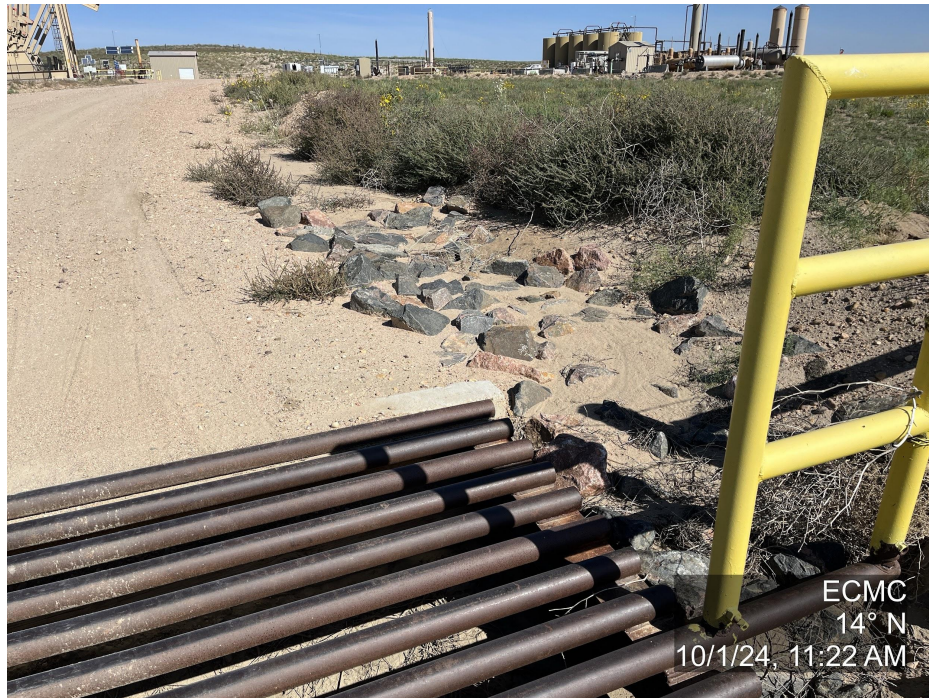
**Photo 3.** The photo was taken at the well location facing North. The photo illustrates the riprap check dam at the cattle guard has been sedimented in.

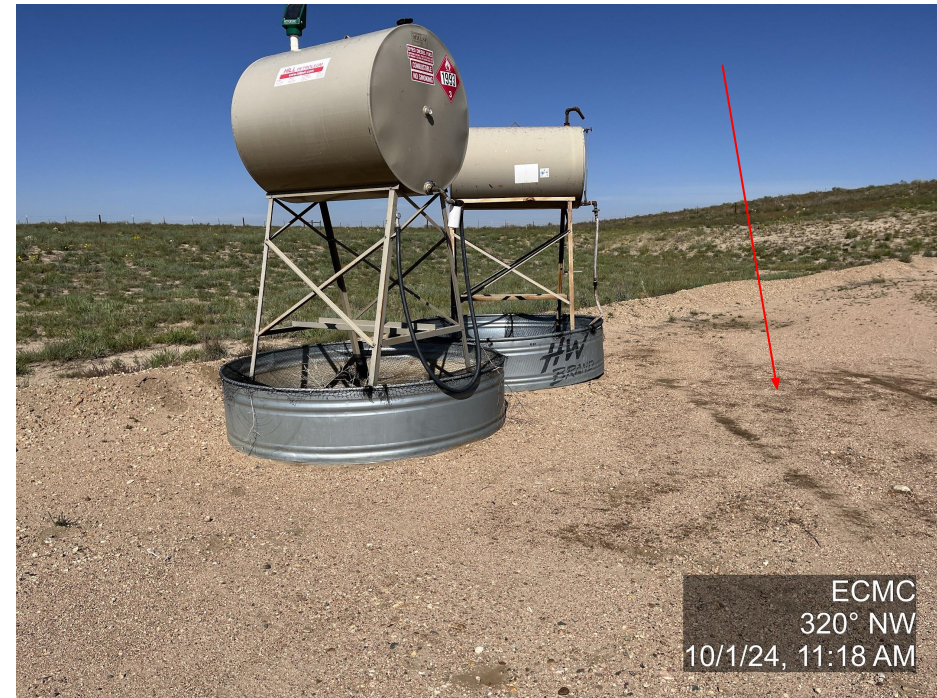
**Photo 4.** The photo was taken at the well location facing Northwest. The photo illustrates stained soil near diesel tanks.

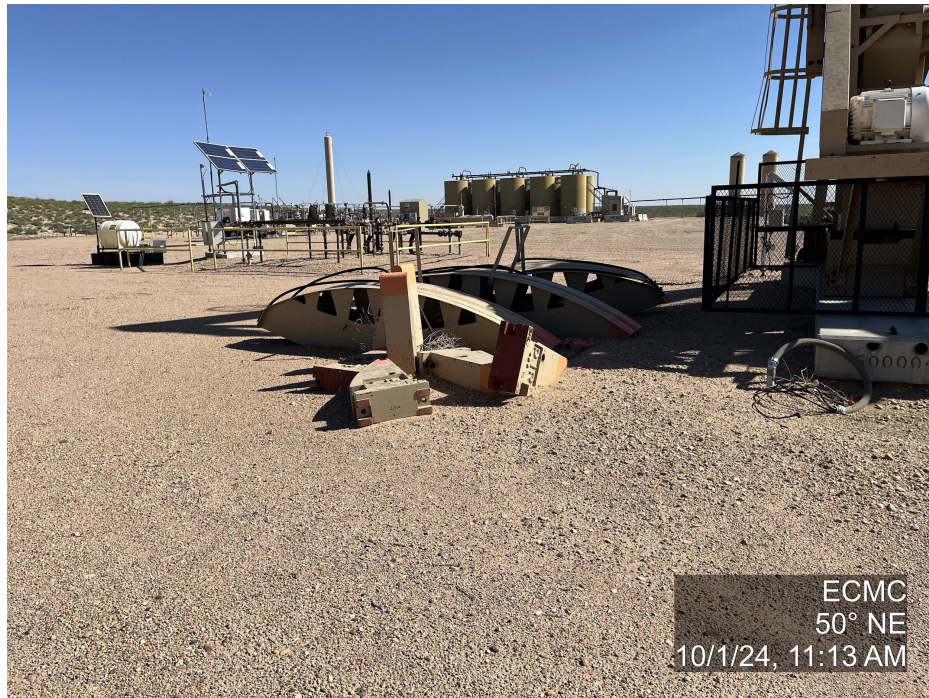
**Photo 5.** The photo was taken at the well location facing Northeast. The photo illustrates unused equipment being stored on the production pad.

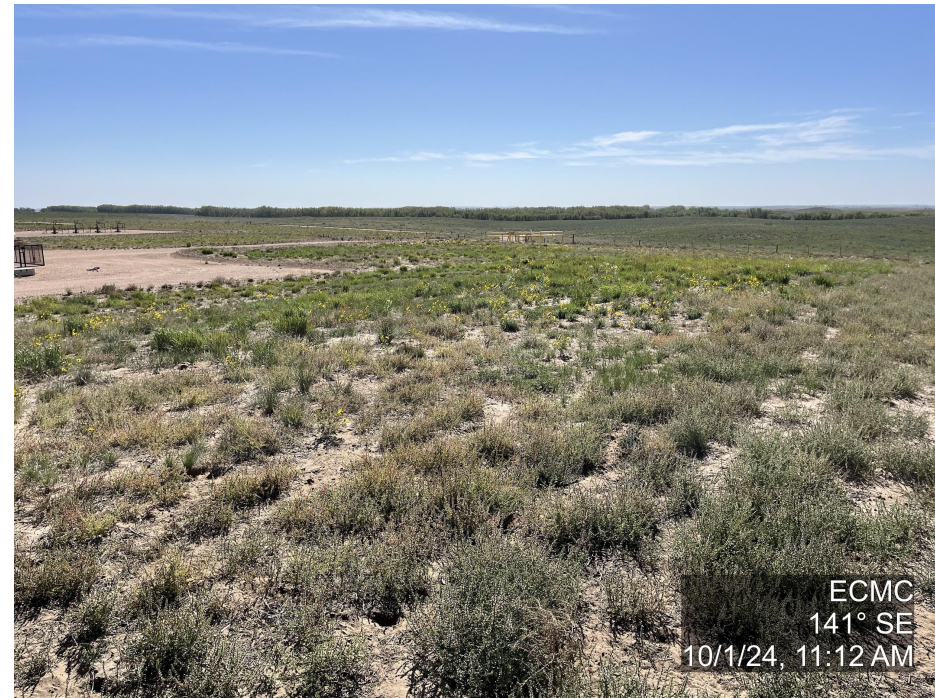
**Photo 6.** The photo was taken at the well location facing Southeast. The photo illustrates some russian thistle encroachment into the interim area that is dominated in most places by mostly perennial grasses.

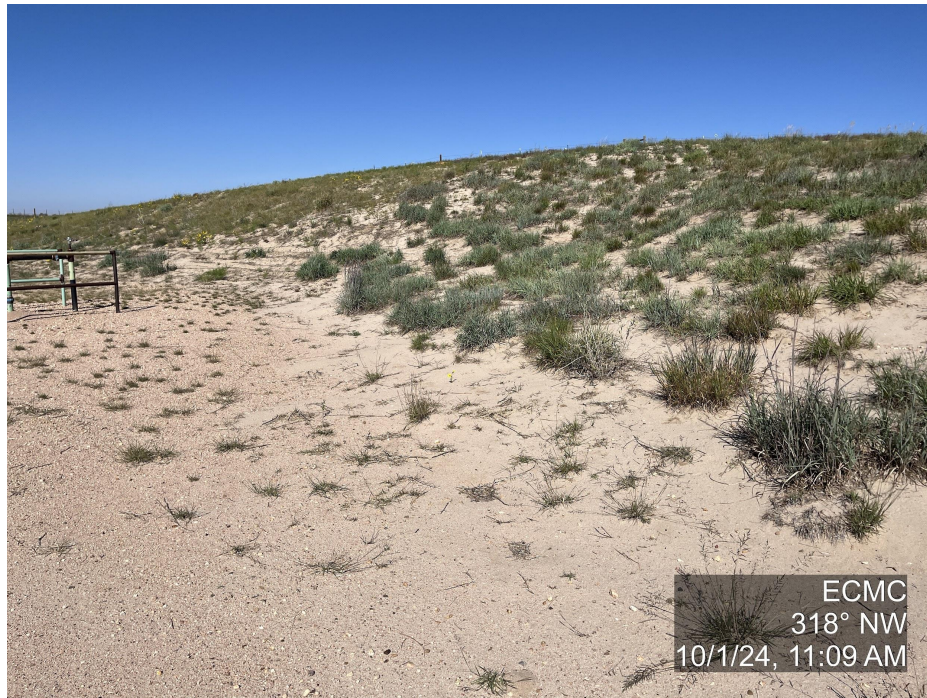
**Photo 5.** The photo was taken at the well location facing Northwest. The photo illustrates the slope has been stabilized with a combination of terracing and perennial grass vegetation.

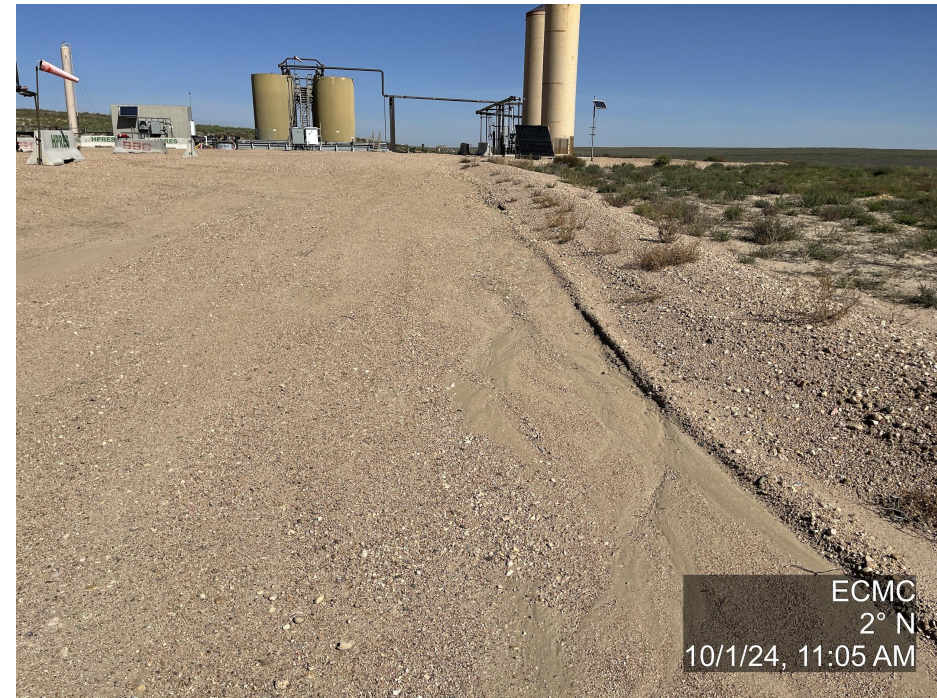
**Photo 6.** The photo was taken at the well location facing North. The photo illustrates some apparent runoff along the access road between the production facility and the wells to the South.

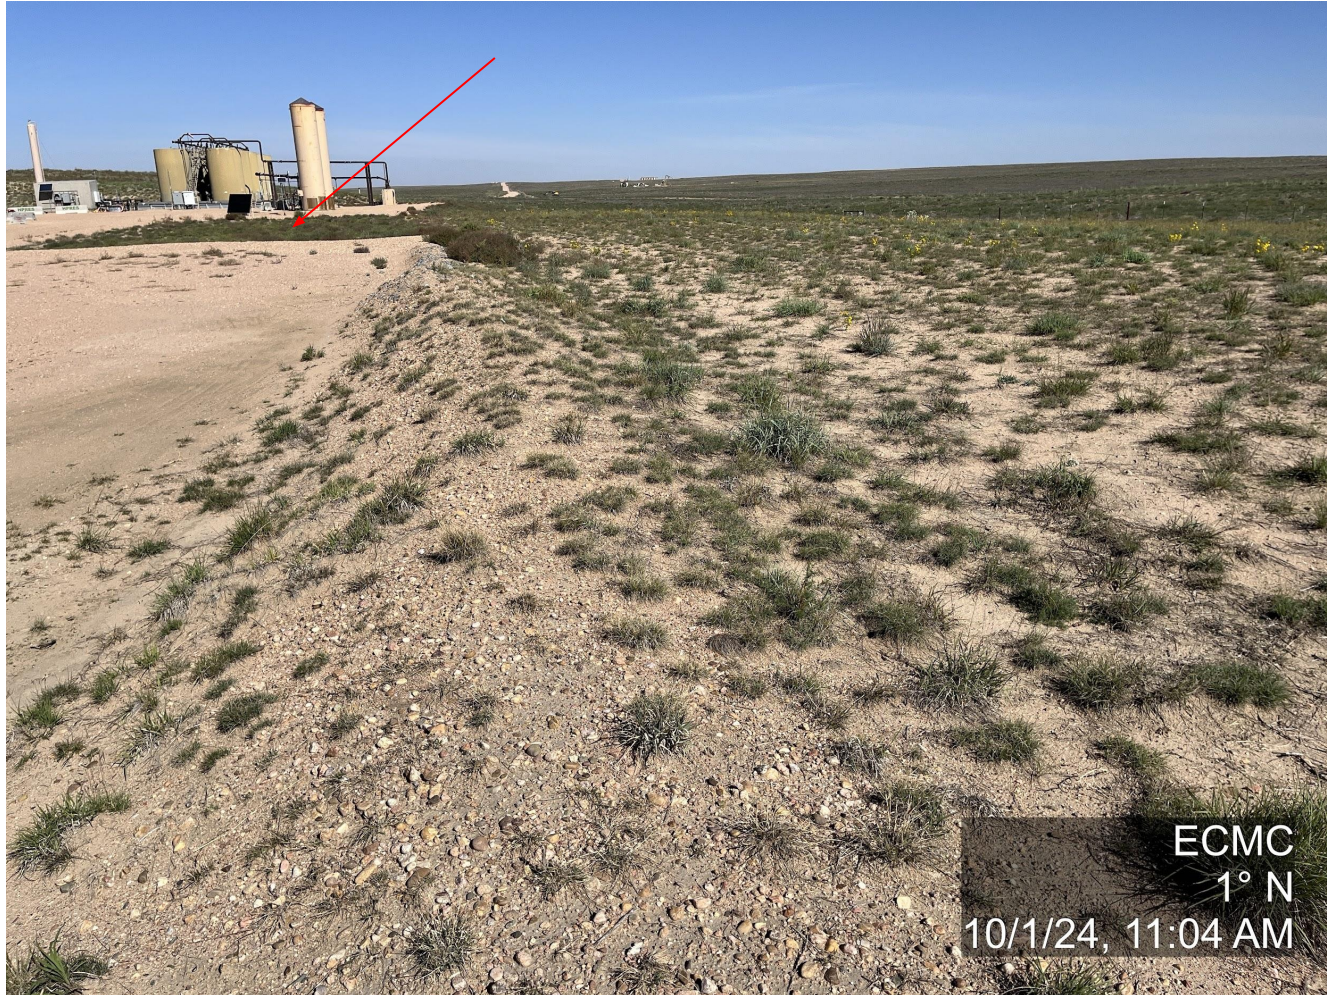
**Photo 7.** The photo was taken at the well location facing North. The photo illustrates good establishment of perennial grasses in the interim areas with some areas of russian thistle encroachment (one area noted by red arrow).
