Inspection Photos

Location Name: TEP ROCKY MOUNTAIN LLC, Federal/MV 8-4

Location ID: 334718

Date: 10/3/2024

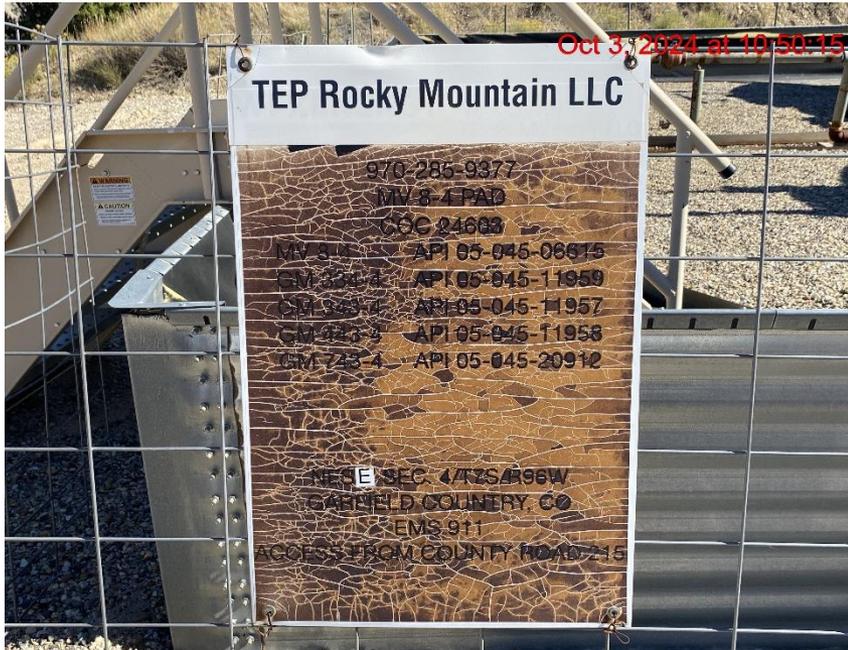
Weathered and Illegible Battery Sign – Photo #03888

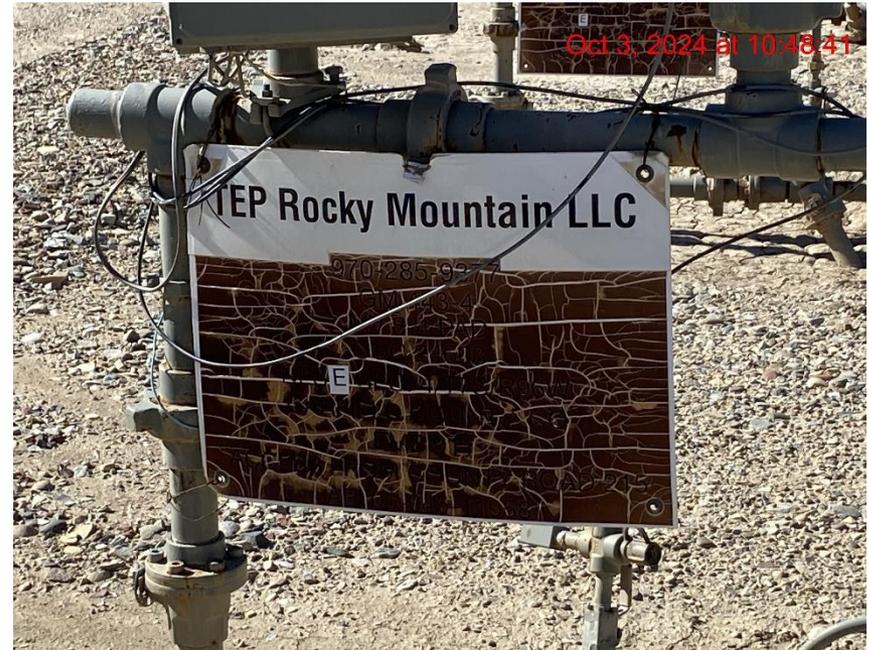
Weathered and Illegible Wellhead Sign – Photo #03885

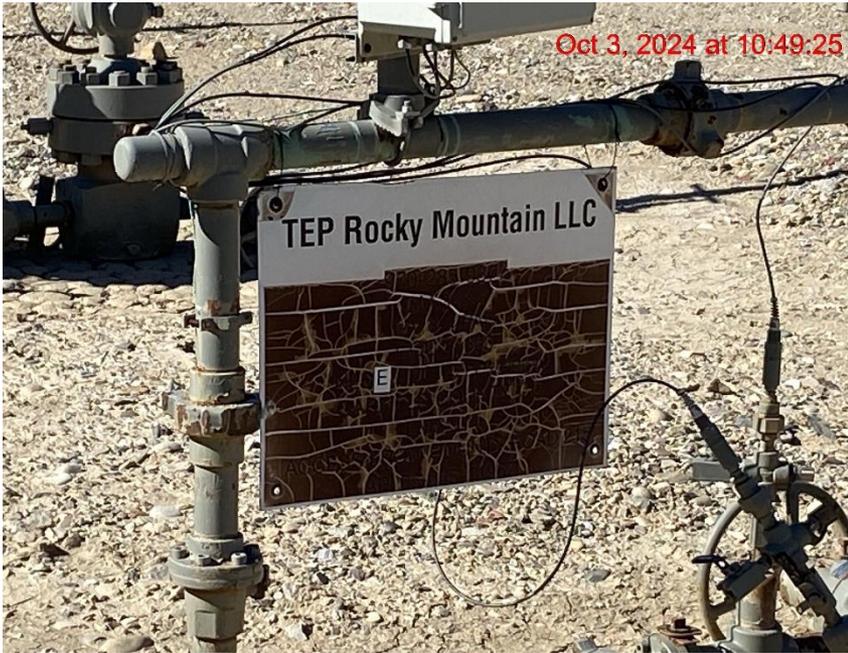
Weathered and Illegible Wellhead Sign – Photo #03886

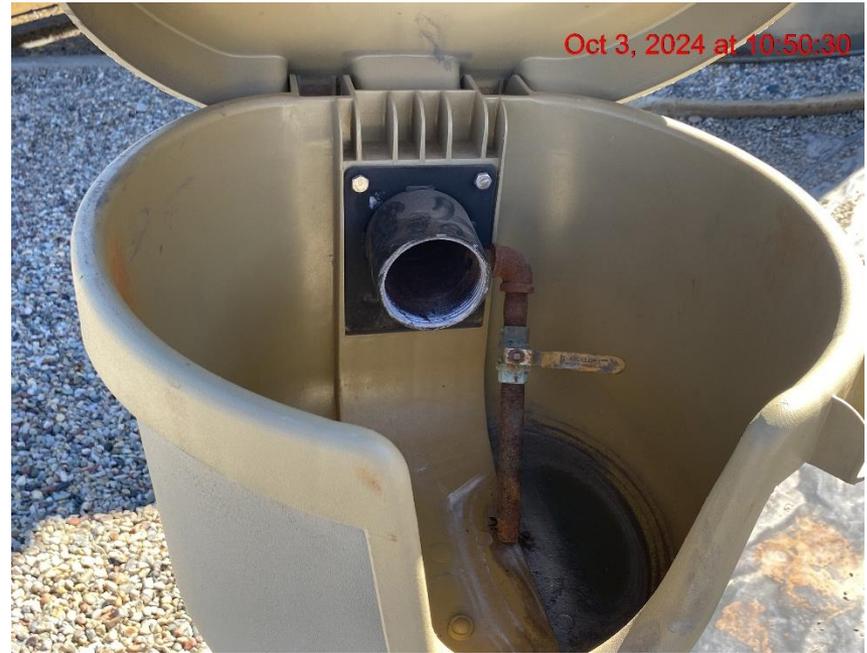
Open-Ended Load Line – Photo #03889

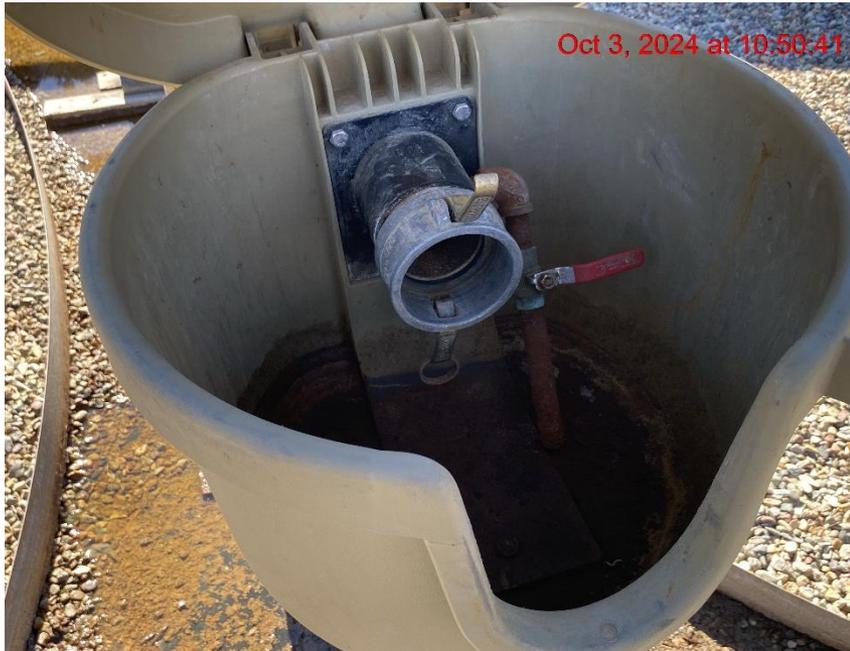
Open-Ended Load Line – Photo #03890

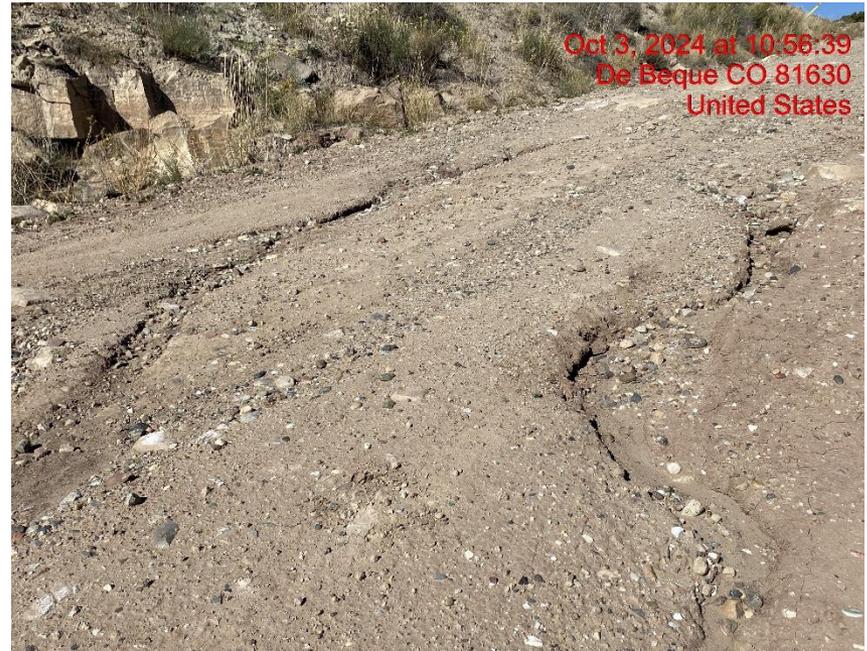
Insufficient Erosion Control; Rill Erosion on Lease Road –
Photo #03896

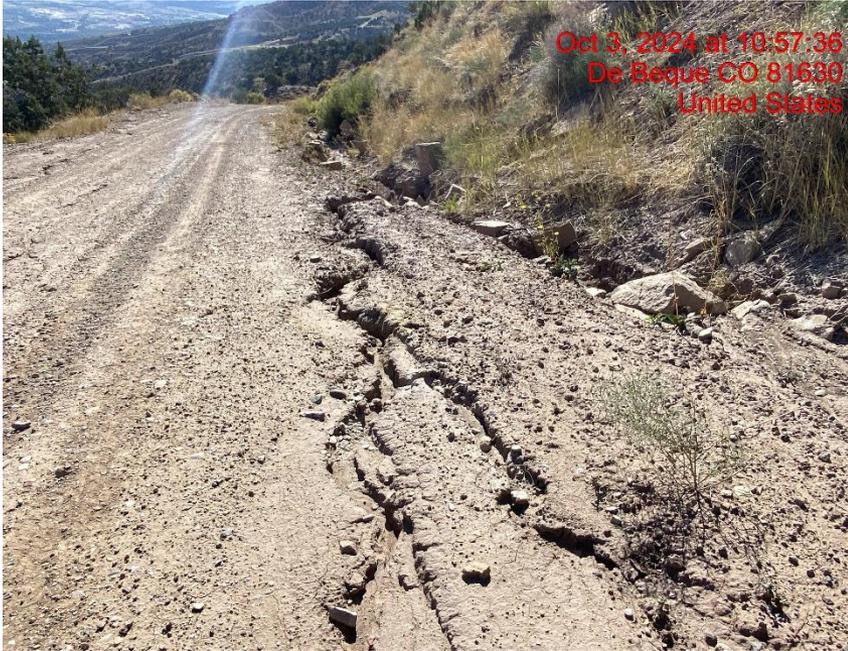
**Insufficient Erosion Control; Rill Erosion on Lease Road –
Photo #03900**

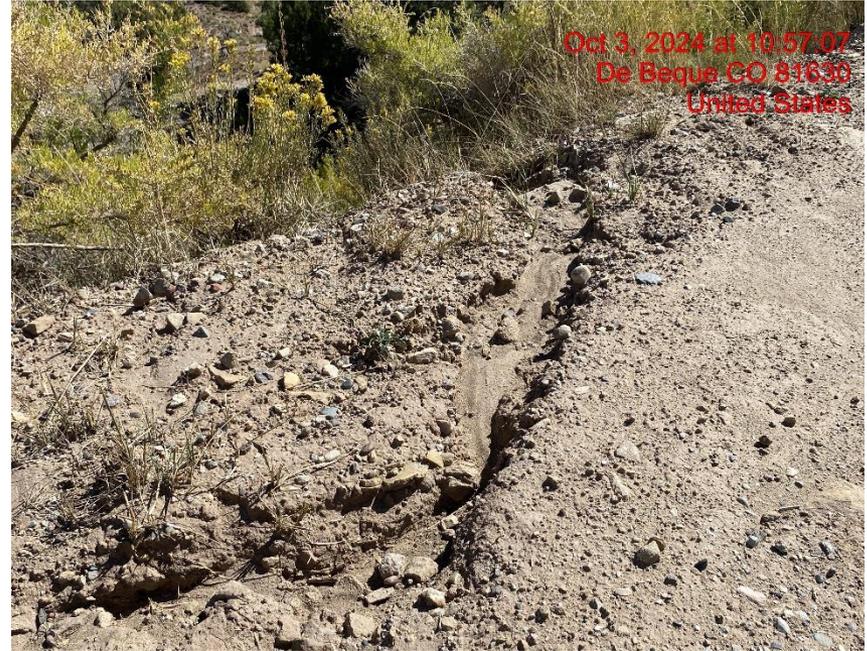
**Insufficient Erosion Control; Transport of Sediment Off of
Lease Road – Photo #03898**
