Inspection Photos

Location Name: TEP ROCKY MOUNTAIN LLC, FEDERAL-67S96W/3NESW

Location ID: 334812

Date: 10/3/2024

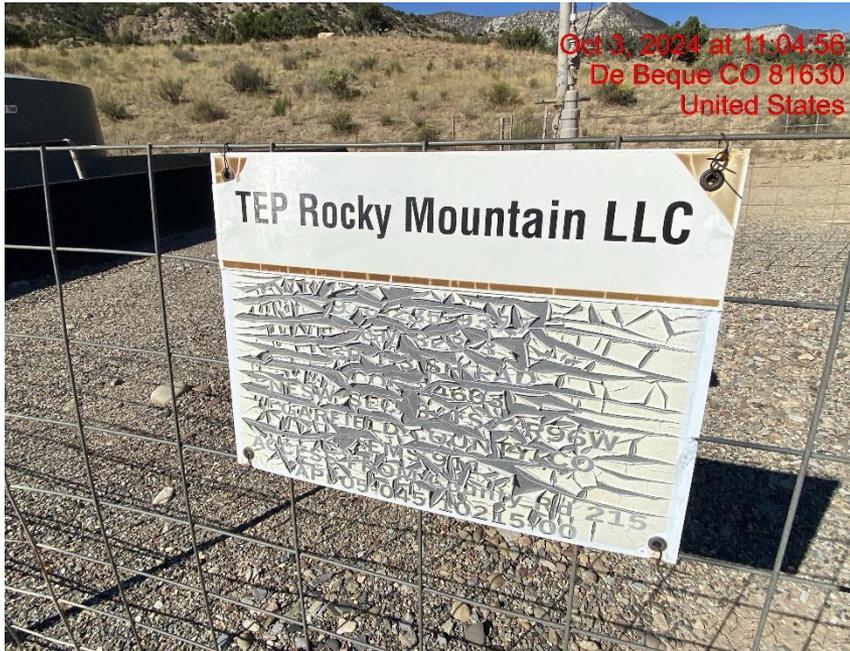
Weathered and Illegible Wellhead Sign – Photo #03911

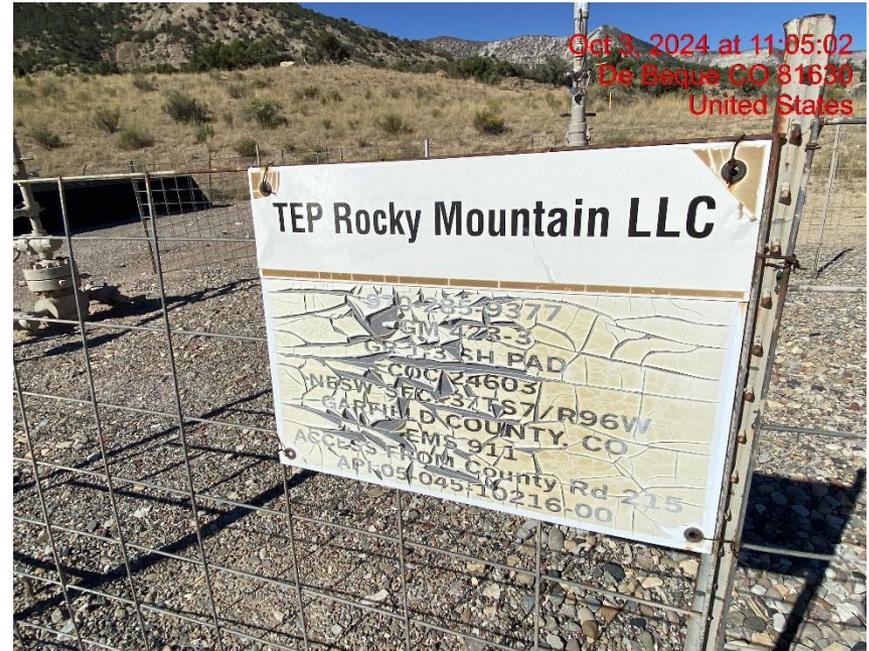
Weathered and Illegible Wellhead Sign – Photo #03912

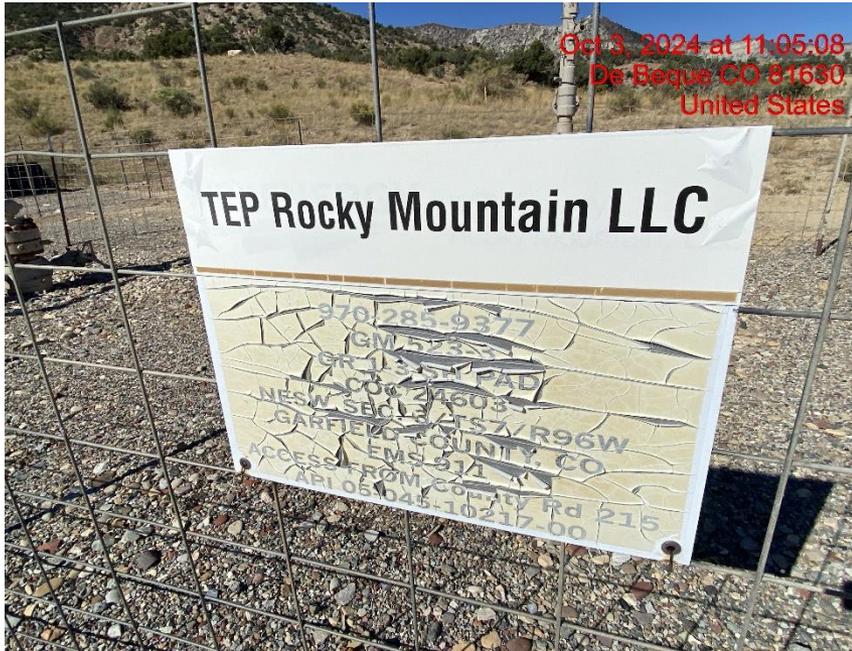
Weathered and Illegible Wellhead Sign – Photo #03913

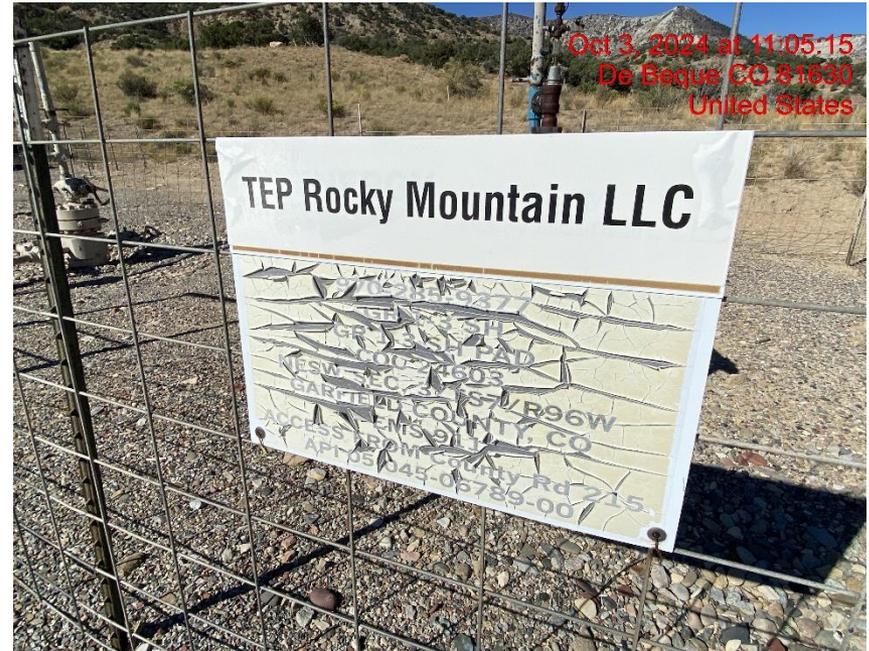
Weathered and Illegible Wellhead Sign – Photo #03914

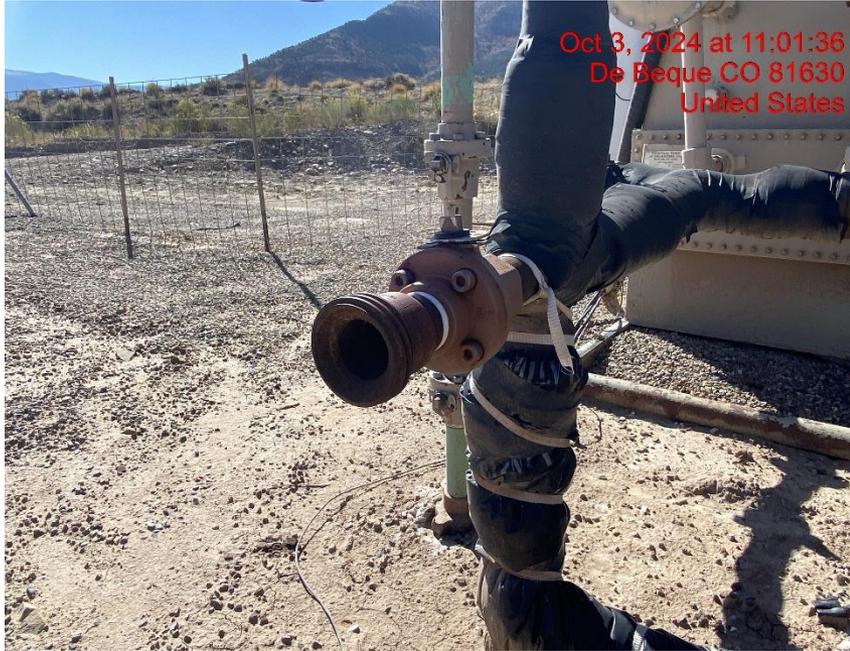
Open-Ended Line on Separator – Photo #03906

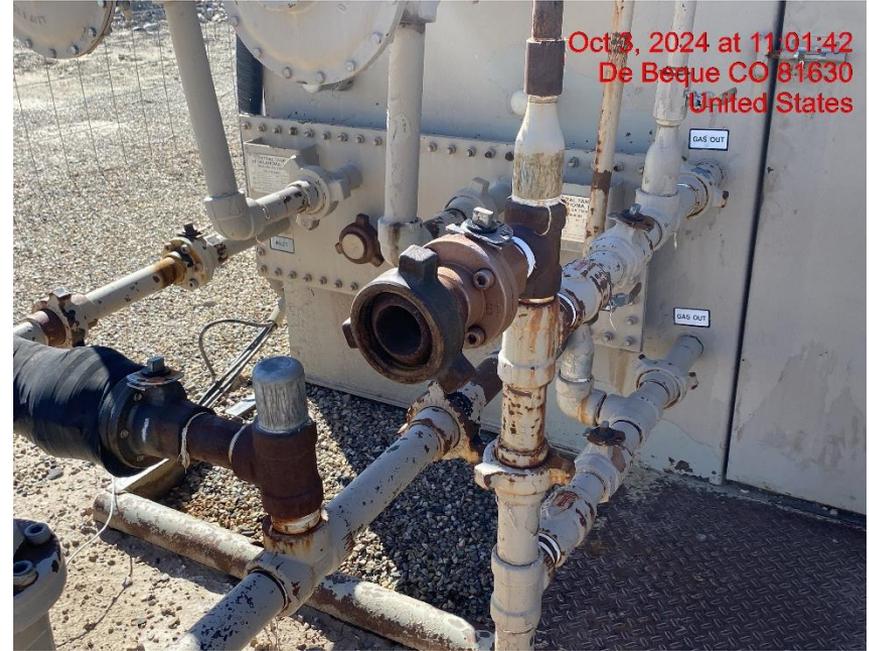
Open-Ended Line on Separator – Photo #03907

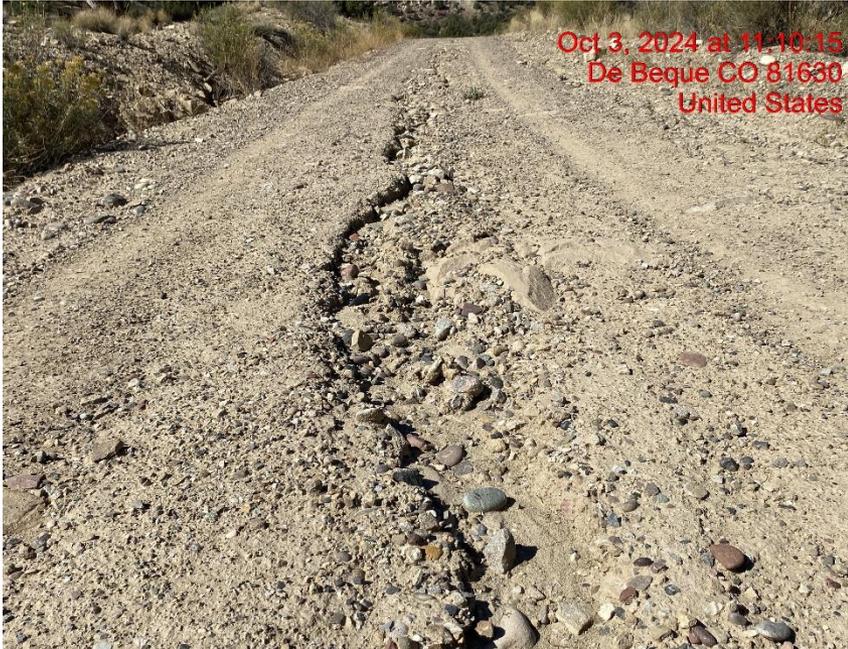
Rill Erosion on Lease Road Into Location – Photo #03918

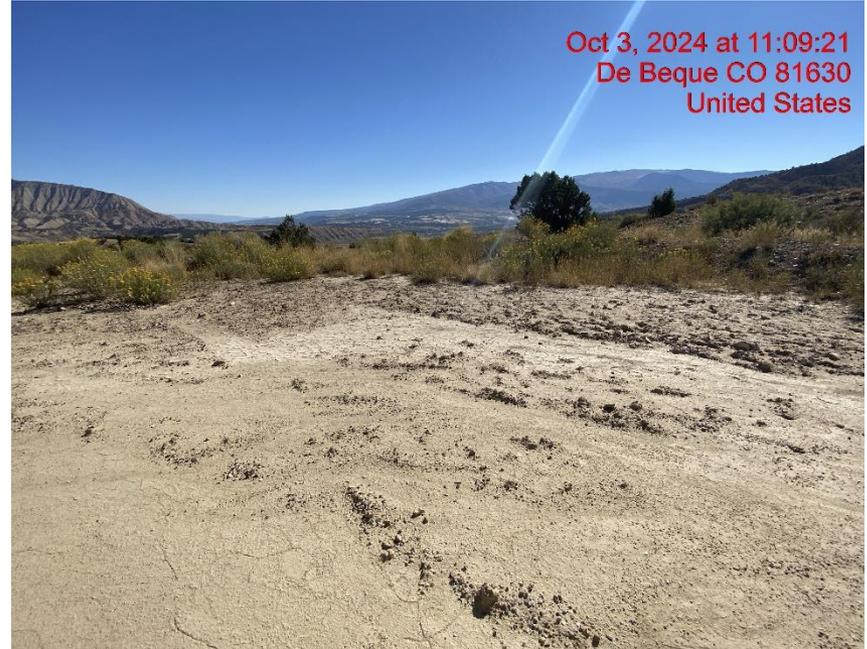
Transport of Sediment Offsite – Photo #03915

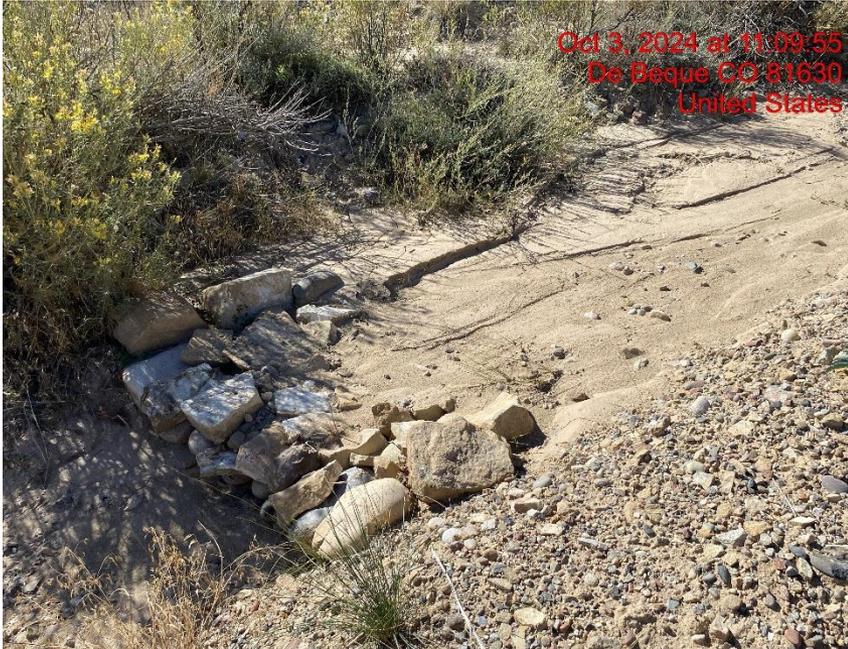
Check Dam BMP Full and Needs Maintenance – Photo #03916

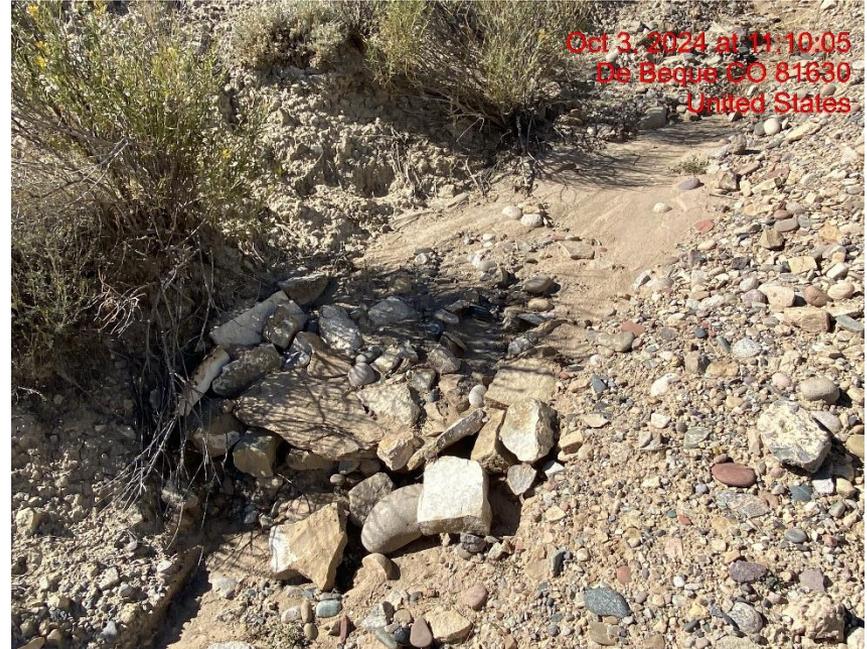
Check Dam BMP Full and Needs Maintenance – Photo #03917
