Inspection Photos

API: 061-06365

Operator: STRACHAN EXPLORATION INC

Inspection Date: 10/3/2024

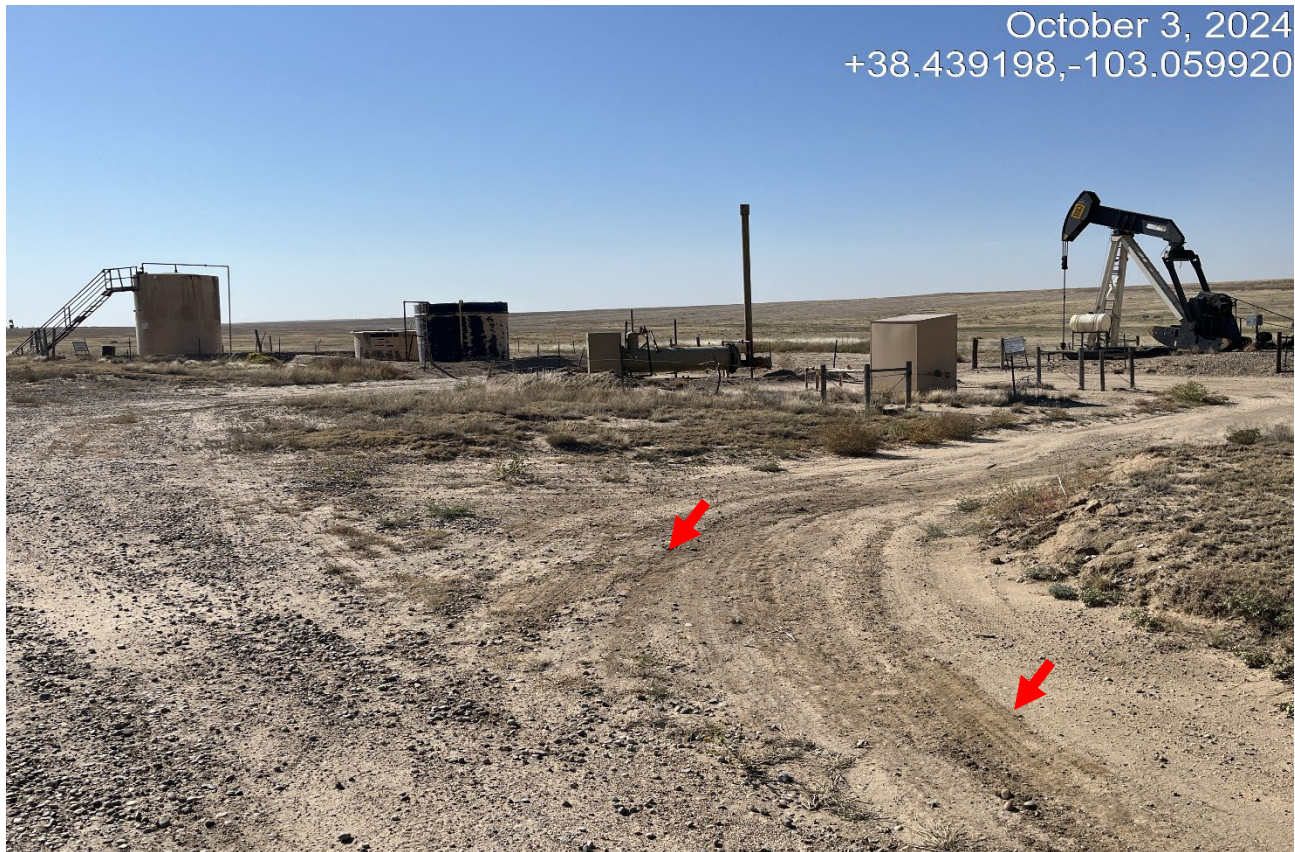
Photo 2. Facing southeast toward by the wellsite. Impacted oily soils was spread all the way from the tank battery to the roadway. Red arrows point to visible impacted stained soils that have not been cleaned up. Previous CA was not completed.

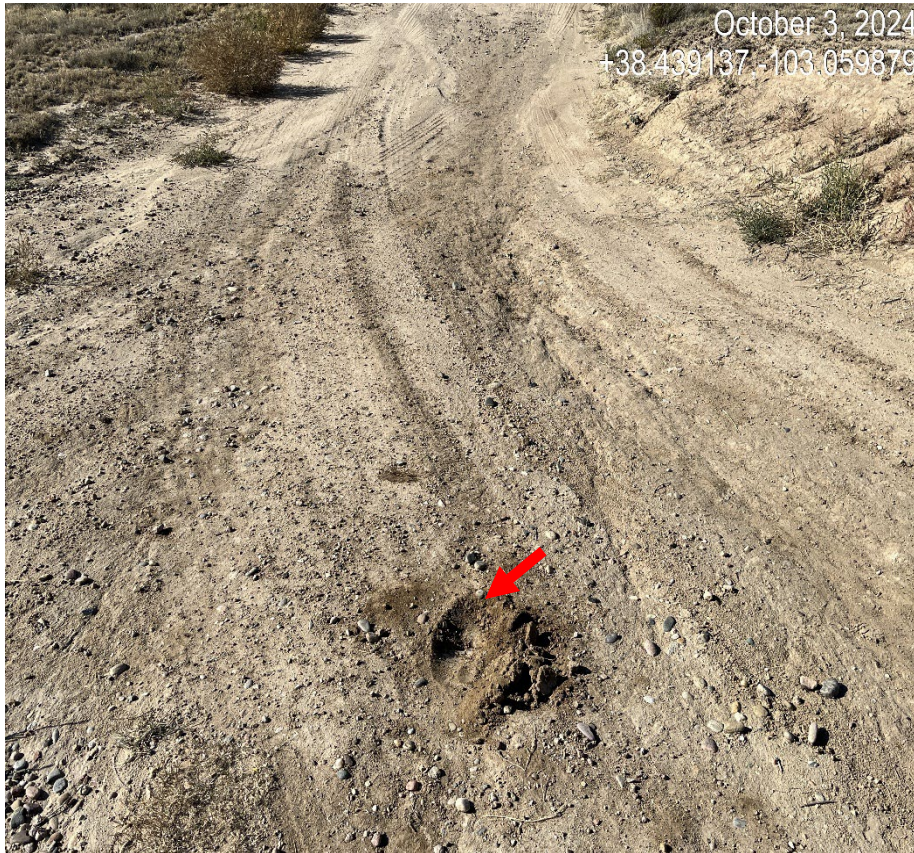
Photo 3. View of the stained soils that still remains along the road where oily material was spread along the road.

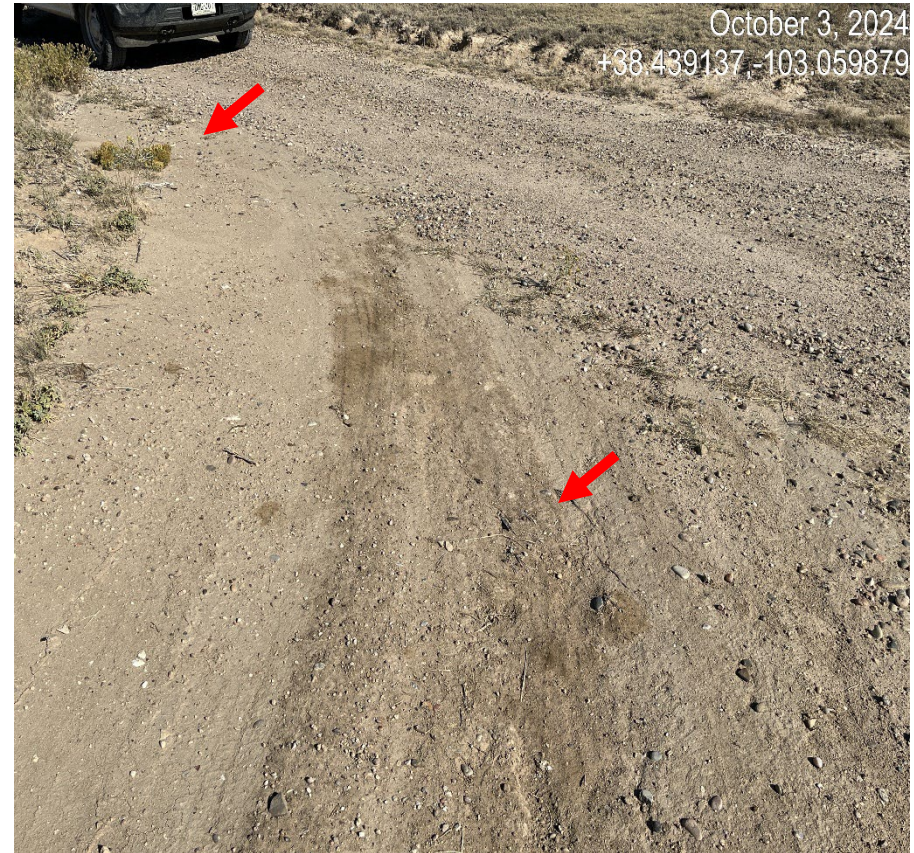
Photo 4. View of the stained soils that still remains along the road where oily material was spread along the road.

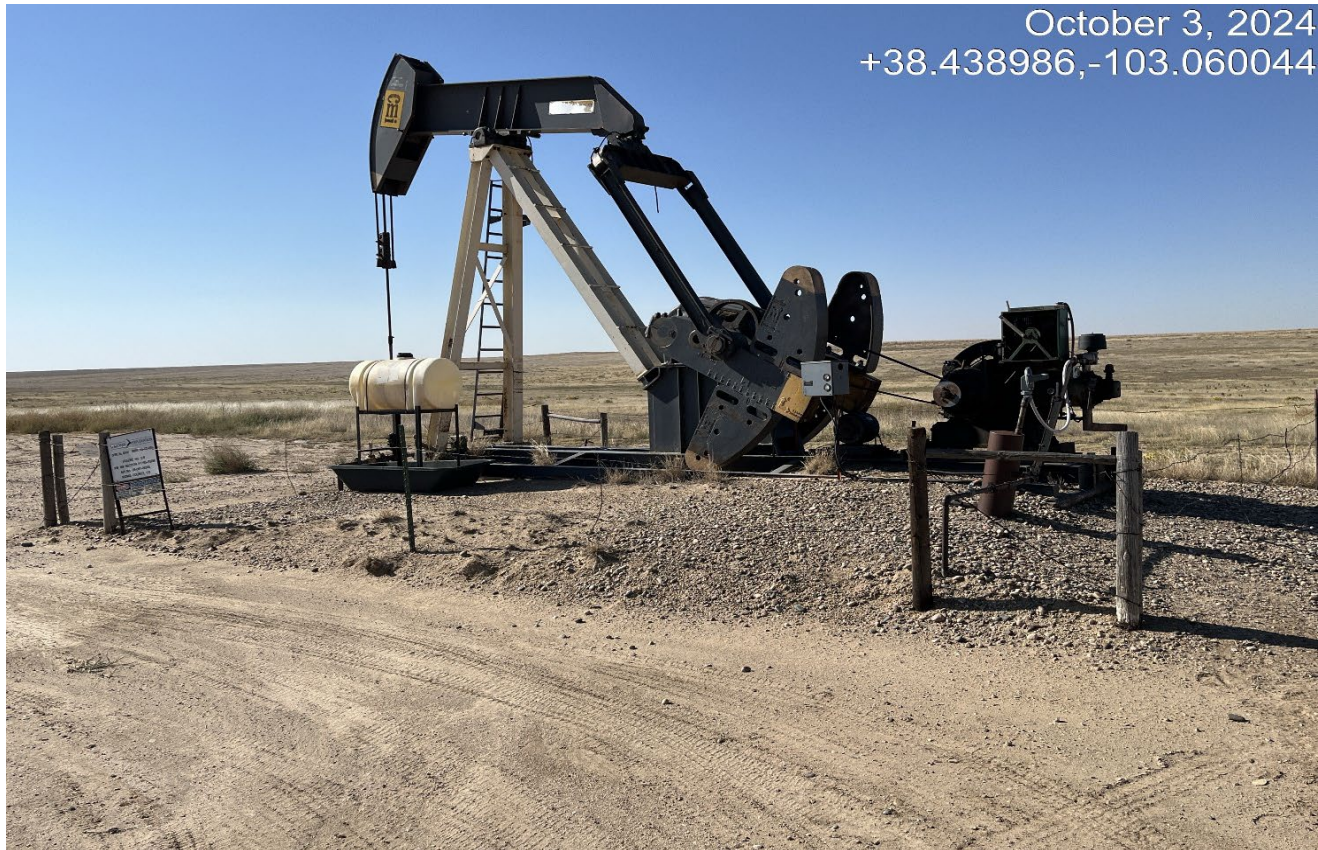
Photo 5. Facing toward the pump jack. A new well sign has been installed. The 2 wire fence around the equipment is not sufficient to prevent livestock entry.

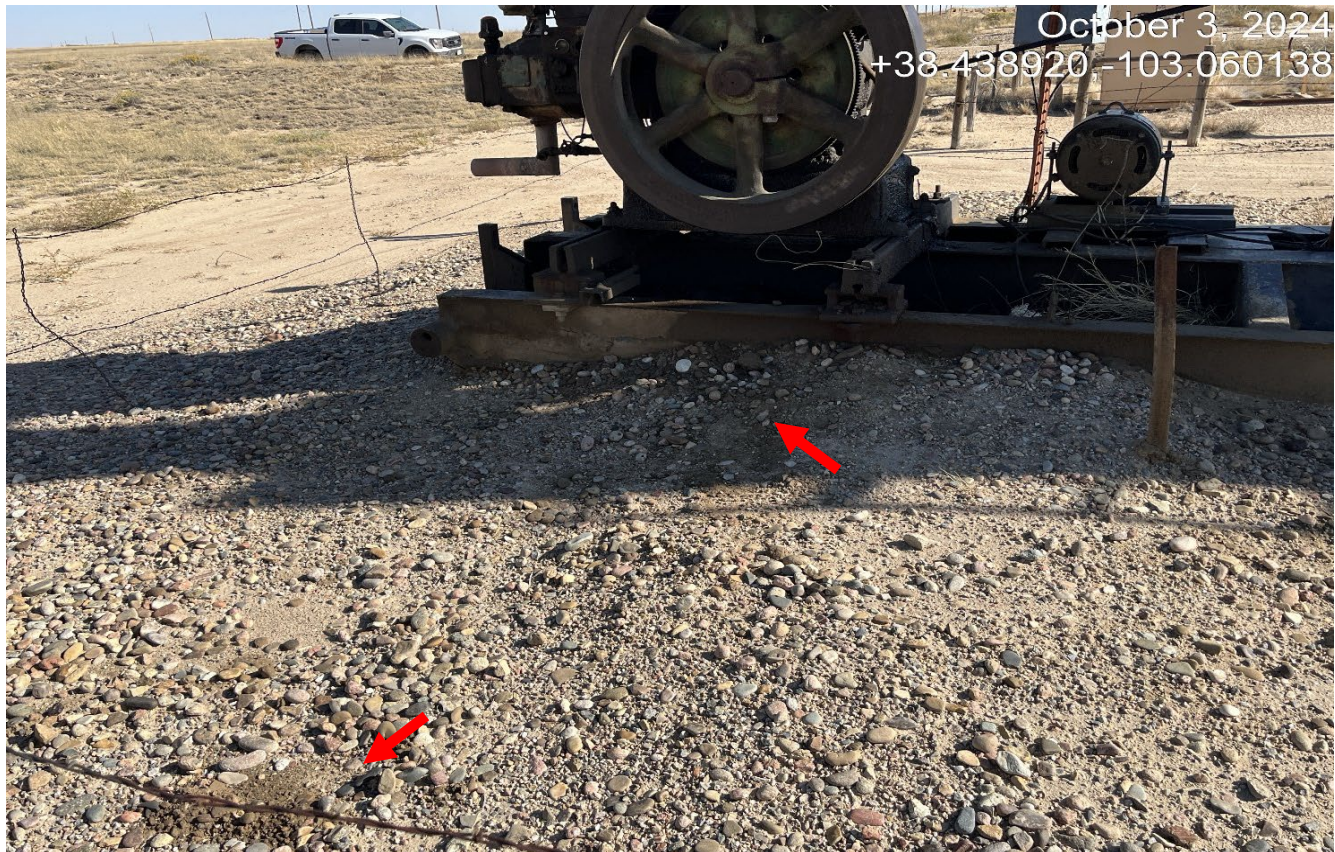
Photo 6. There is still oil stained soils at the back side of the pumpjack that must be cleaned up. Previous CA was not completed.

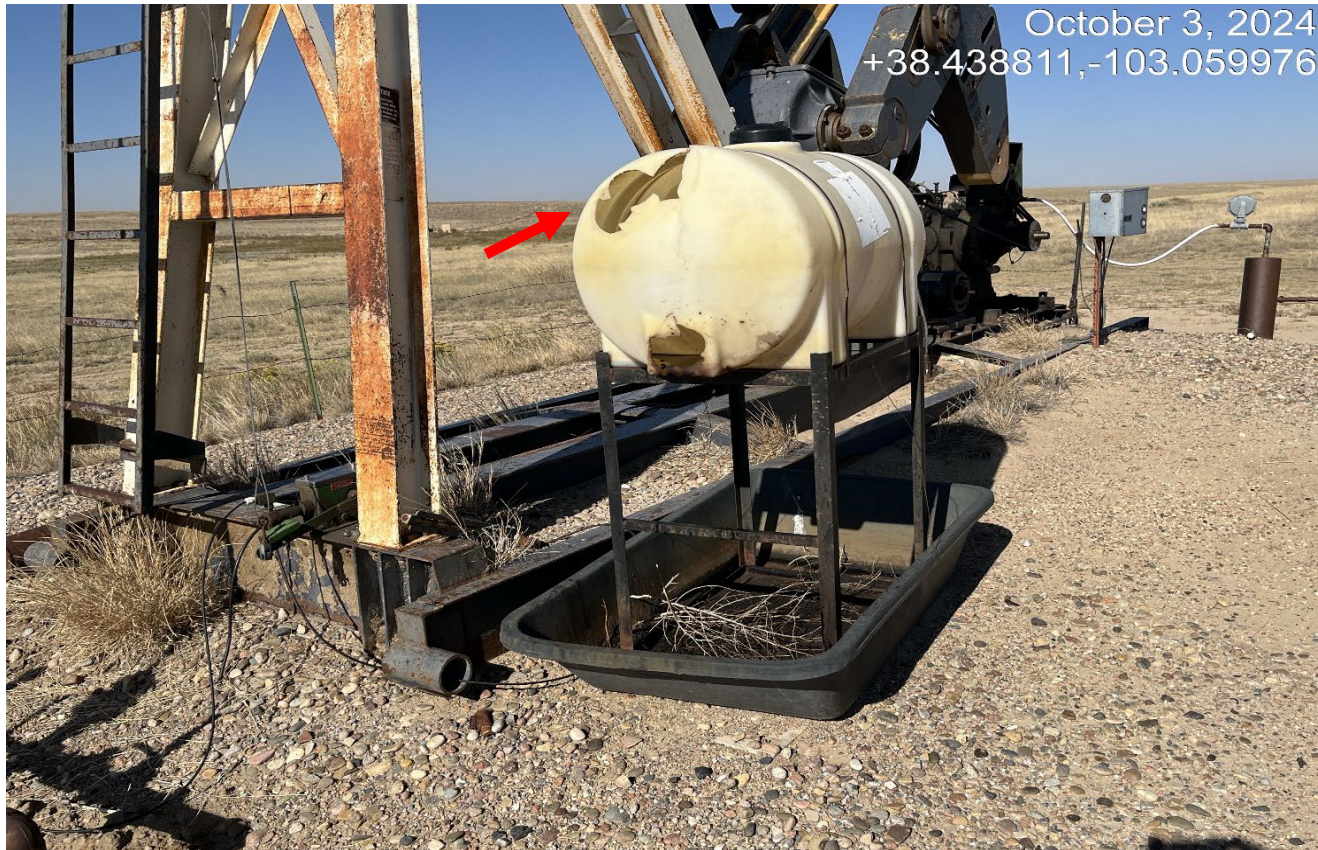
Photo 7. The plastic container at the pumpjack is broke and needs to be removed and disposed.

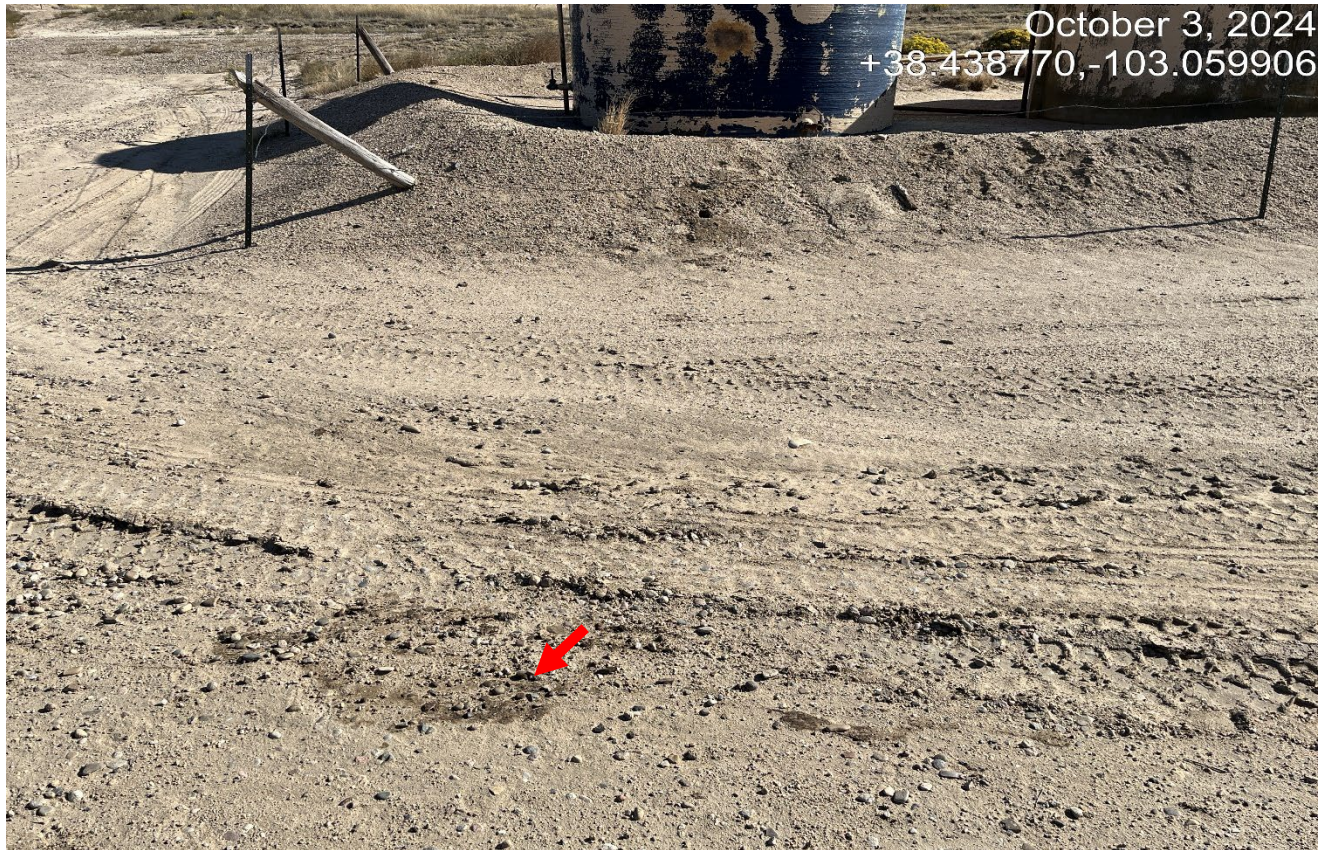
Photo 8. Facing northeast by the tank battery. There is still oil stained soils where spill crude oil was spread along the road. Red arrows point to visible oil impacted soils.

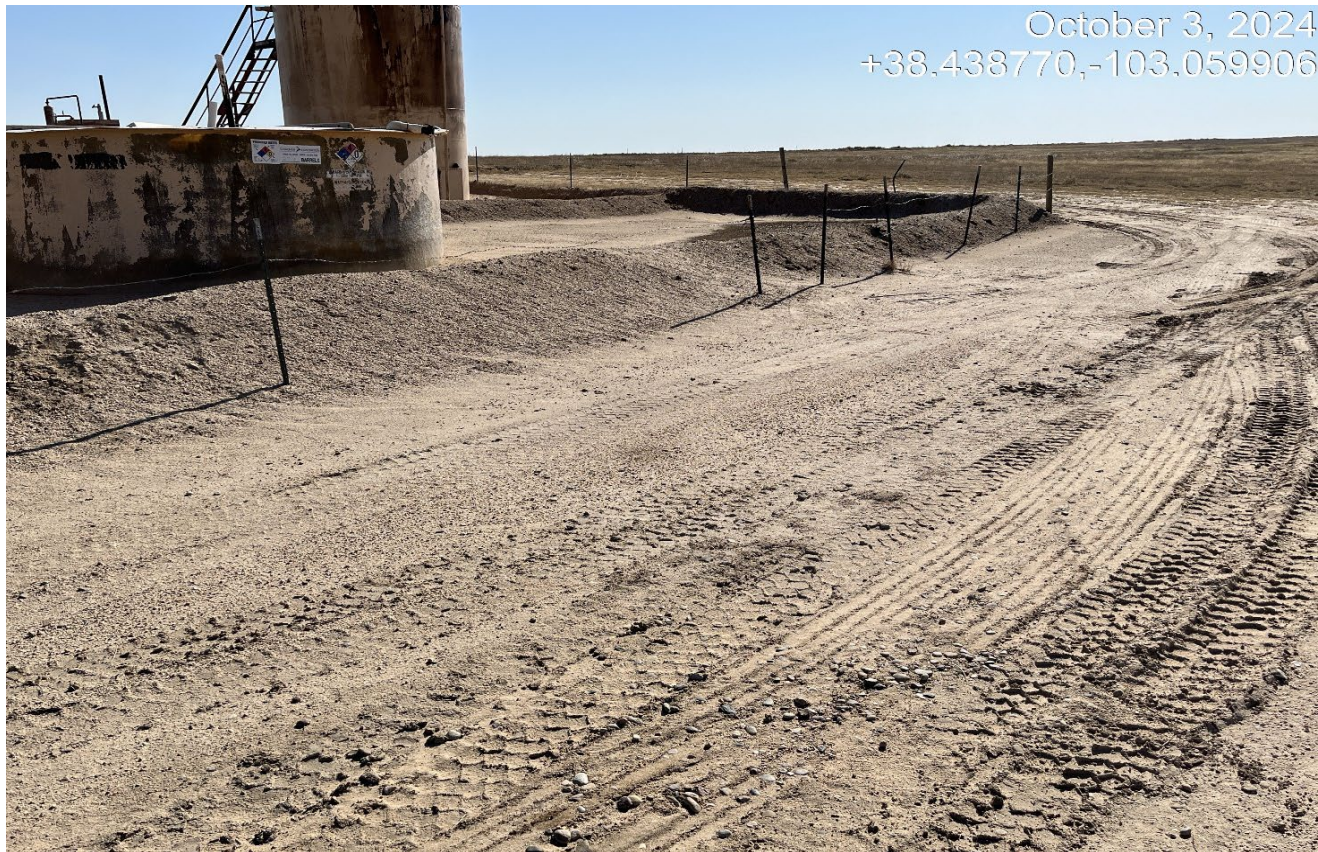
Photo 9. Facing northeast toward the tank battery where previous spill had occurred. The berm around the tanks has been rebuilt but contains oily impacted material with hydrocarbon odor.

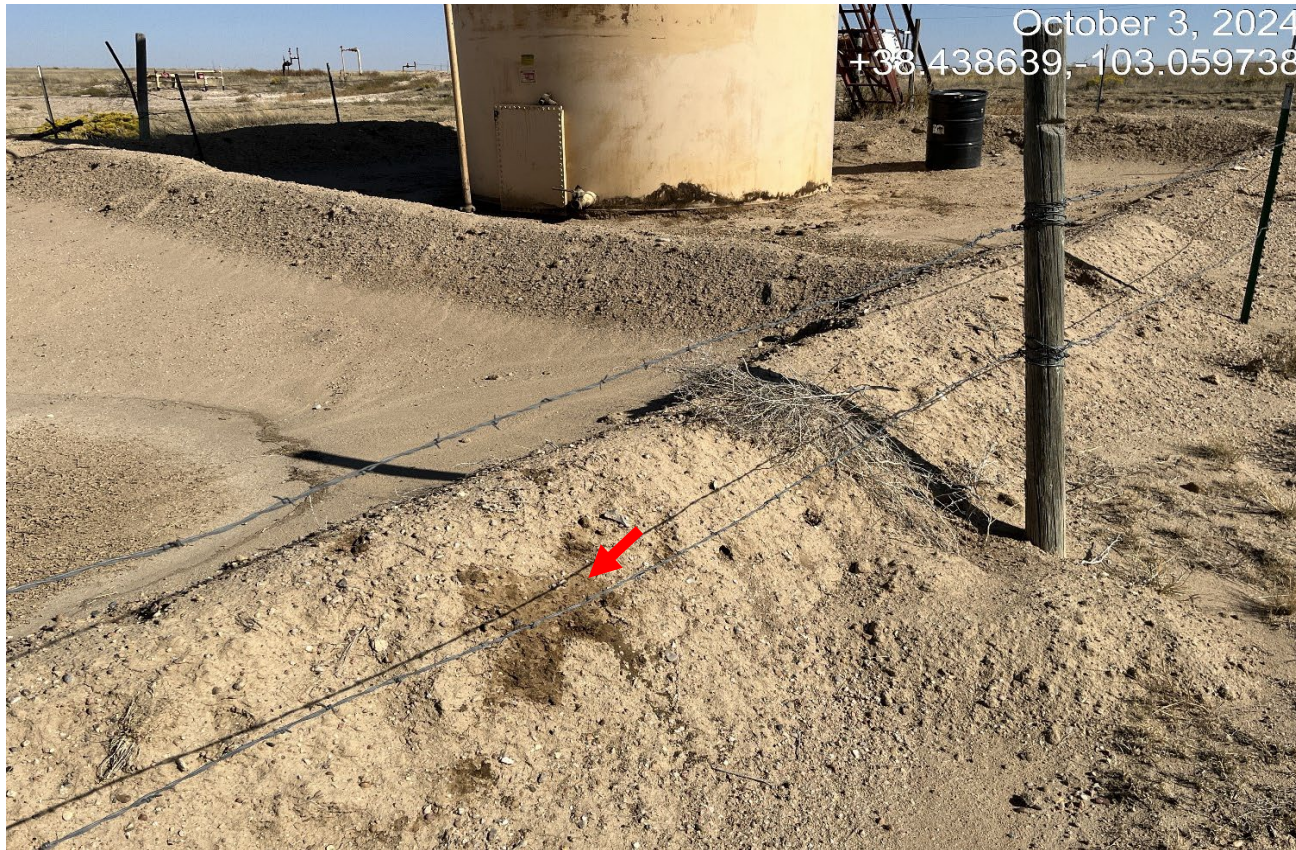
Photo 10. The berm around the tanks has been rebuilt but contains oily impacted material with hydrocarbon odor. The contaminated berm material must be removed and properly disposed. Previous CA was not completed.

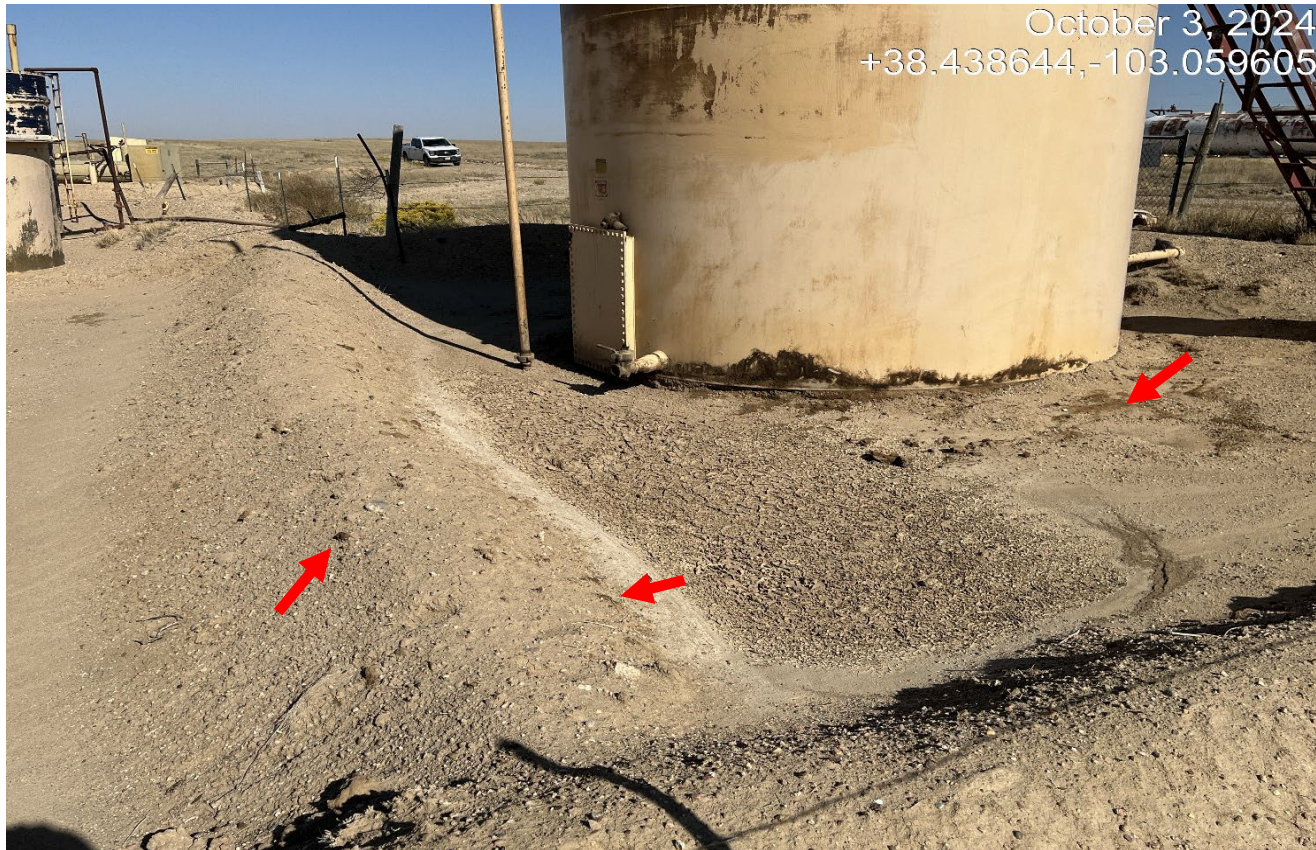
Photo 11. The berms around the tanks contains oily impacted material with hydrocarbon odor. The spill at the tank has not been cleaned up. Previous CA was not completed.

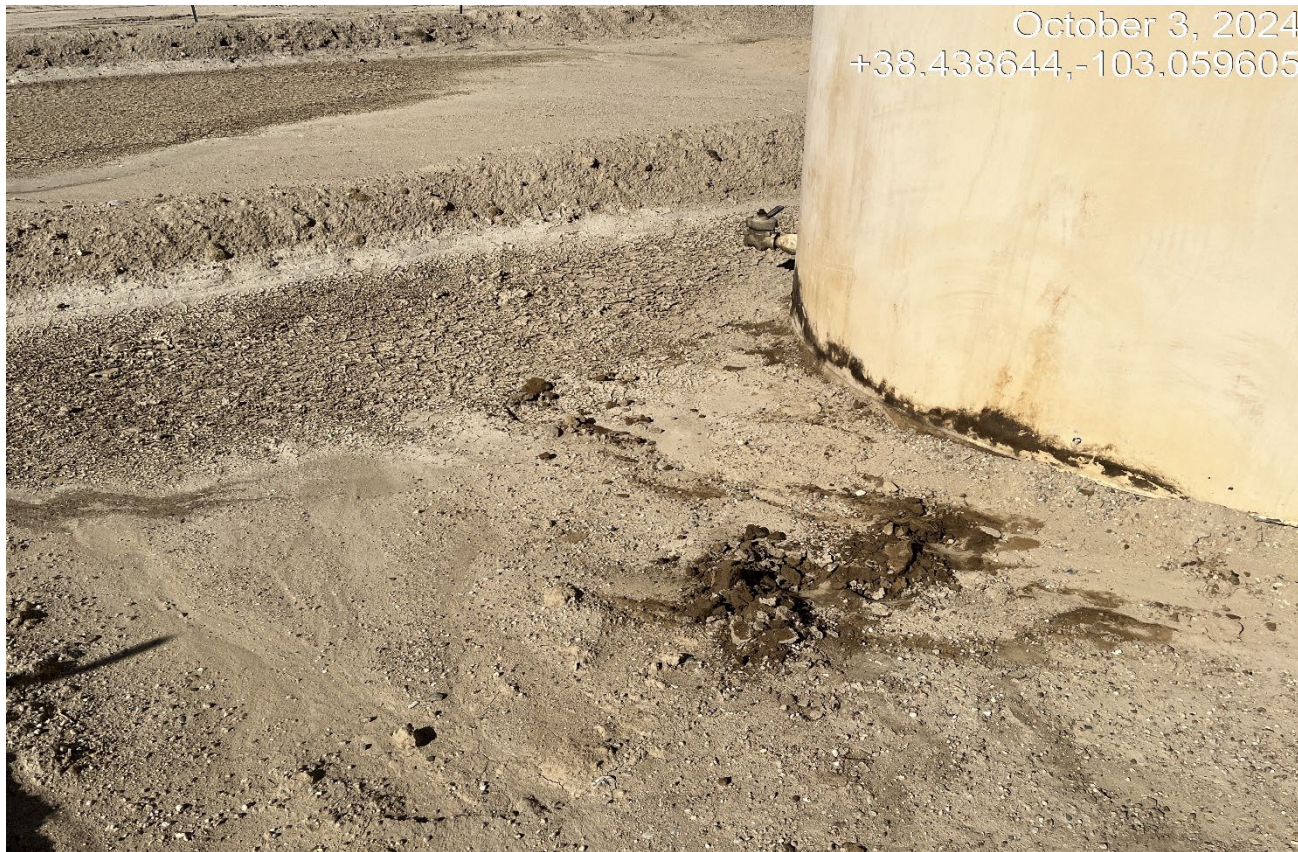
Photo 12. There are still impacted soils around the tank where spill had occurred. It is unknown the amount that was spilled and impacts still remain. Previous CA was not completed. The tank will likely need to be removed to excavate and remove all of the impacted soils.

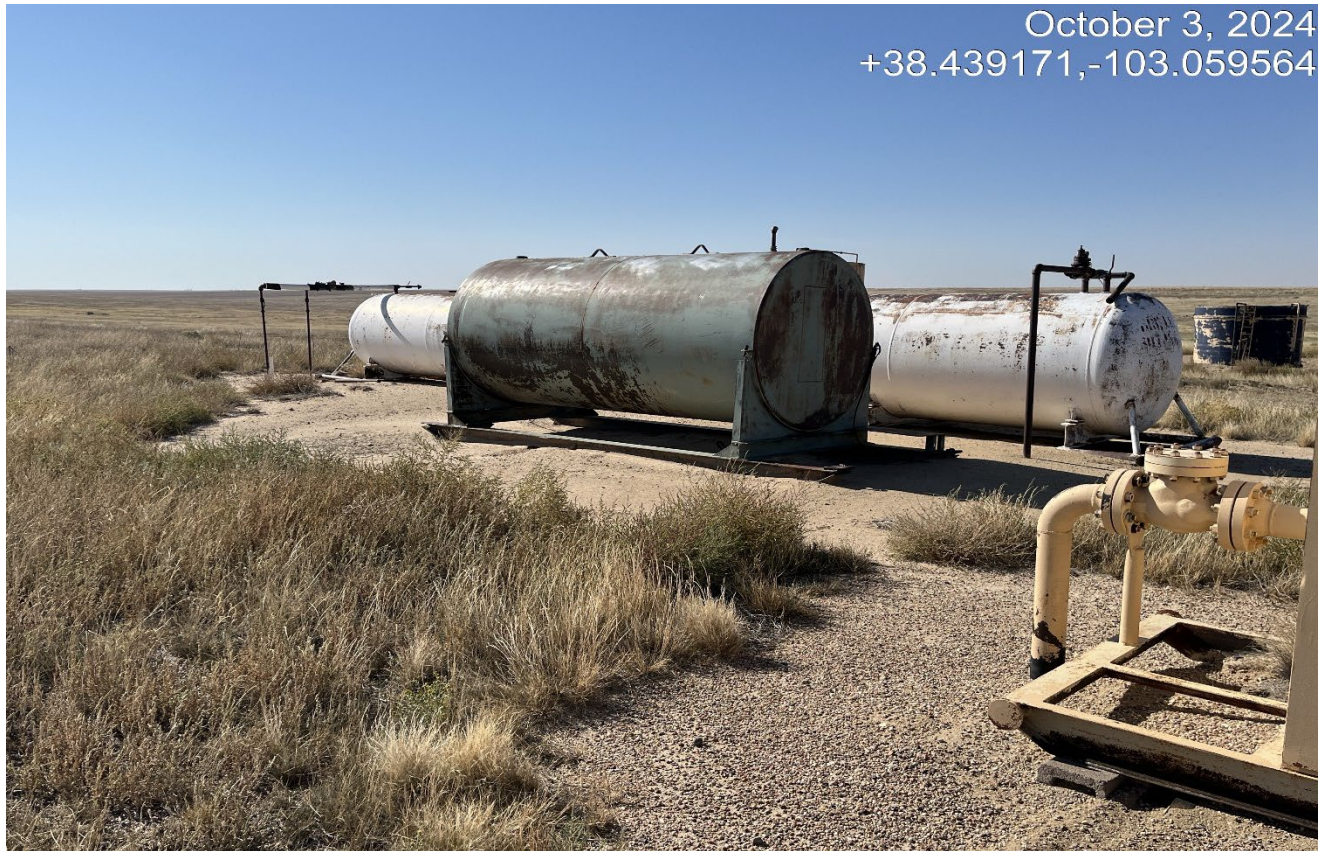
Photo 13. Facing southeast at the location. The two large volume tanks do not have proper labeling or secondary containment. If the tanks are unused then they need to be removed. Previous corrective action was not completed.

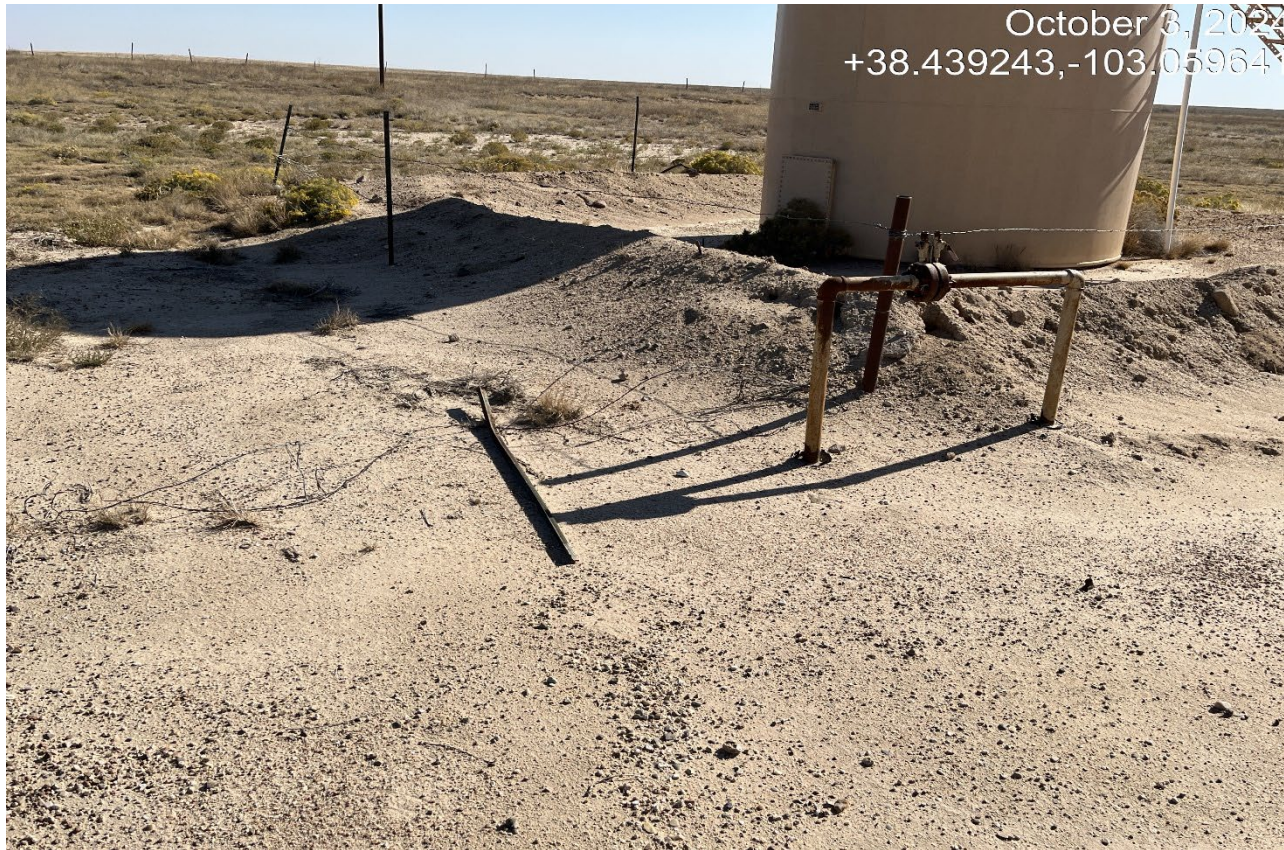
Photo 14. Facing at the north side of the location. The fence around the tank battery is inadequate to prevent livestock entry and is not maintained. The berm around the tank has been rebuilt.

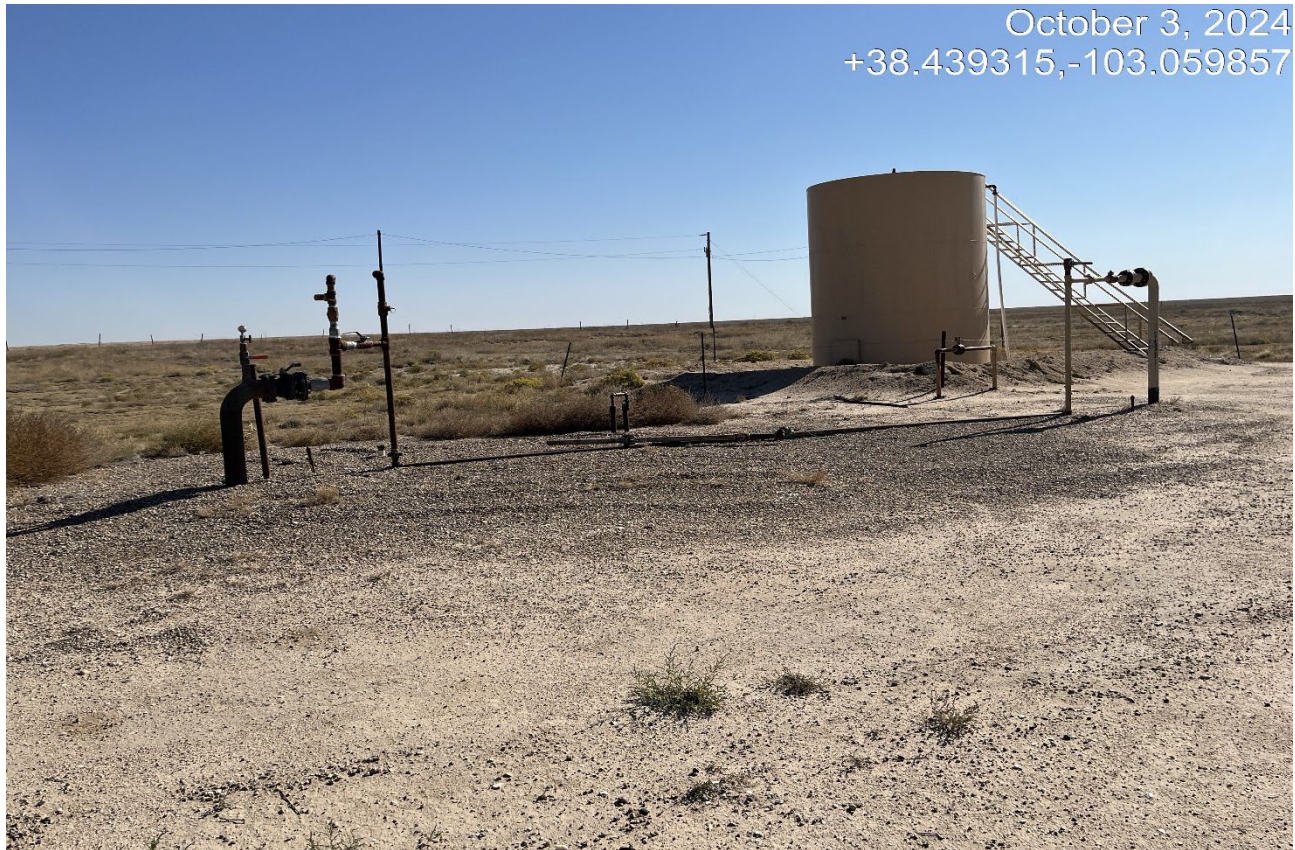
Photo 15. Facing northeast at the north side of the location. The dilapidated shed has been removed from this area.
