Inspection Photos

Location Name: TEP ROCKY MOUNTAIN LLC, FEDERAL-67S96W/4SENE

Location ID: 334884

Date: 10/3/2024

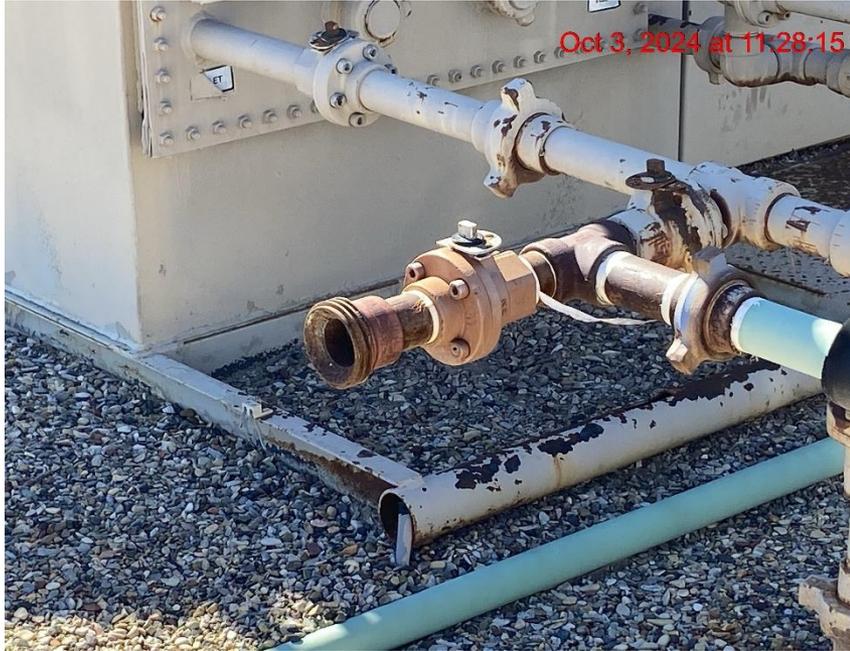
Open-Ended Line – Photo #03943

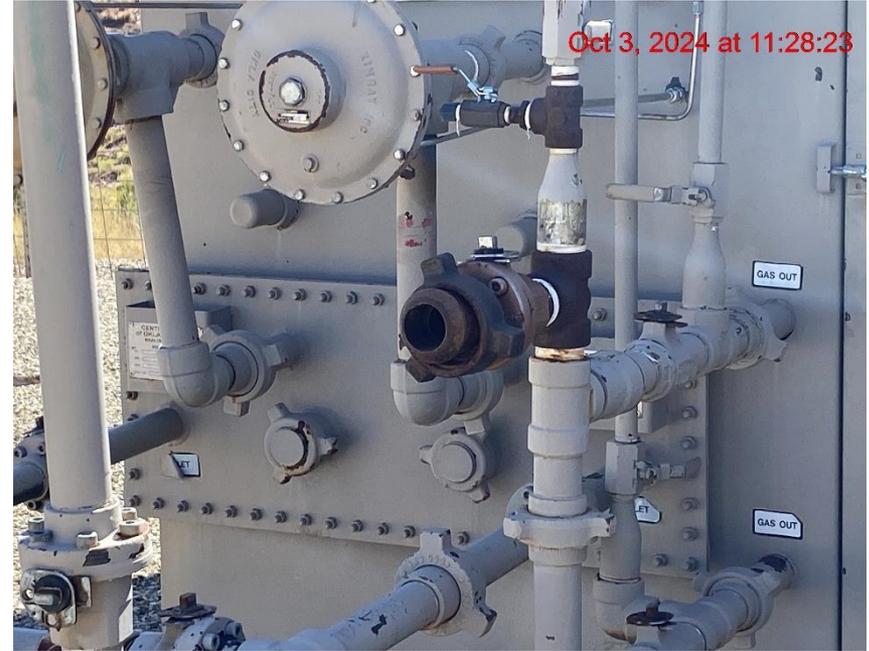
Open-Ended Line – Photo #03944

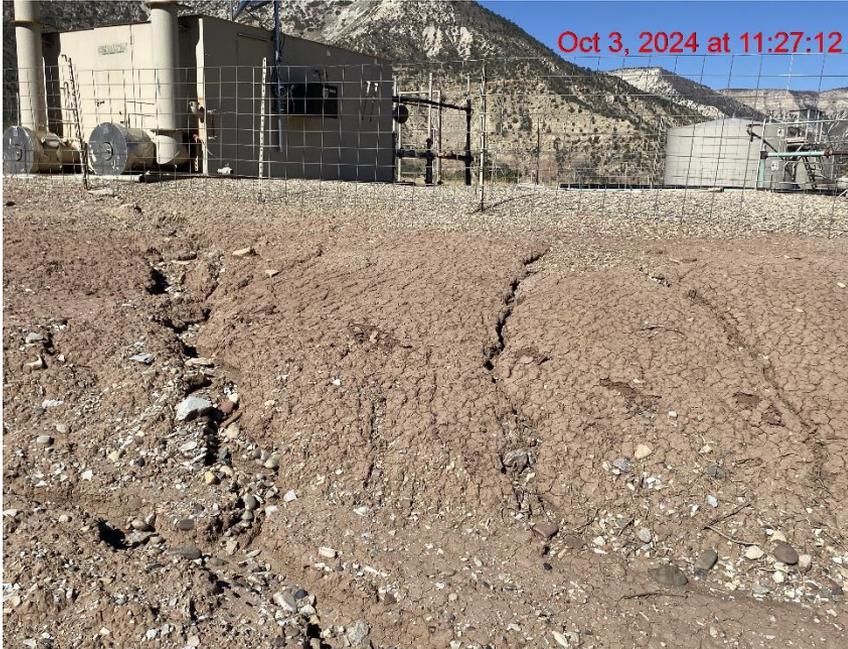
Rill Erosion Transporting Sediment from Location – Photo #03939

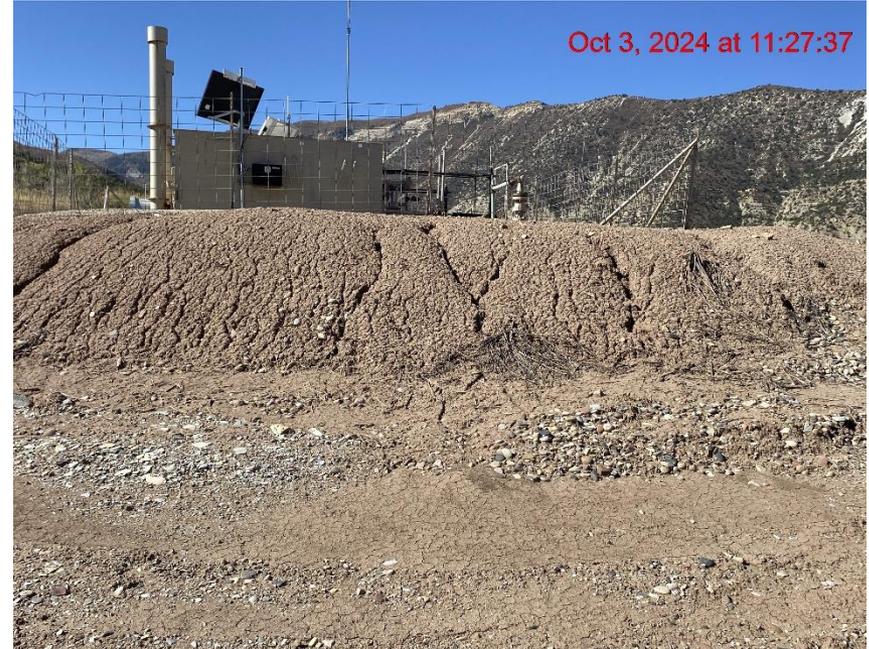
Rill Erosion Transporting Sediment from Location – Photo #03941

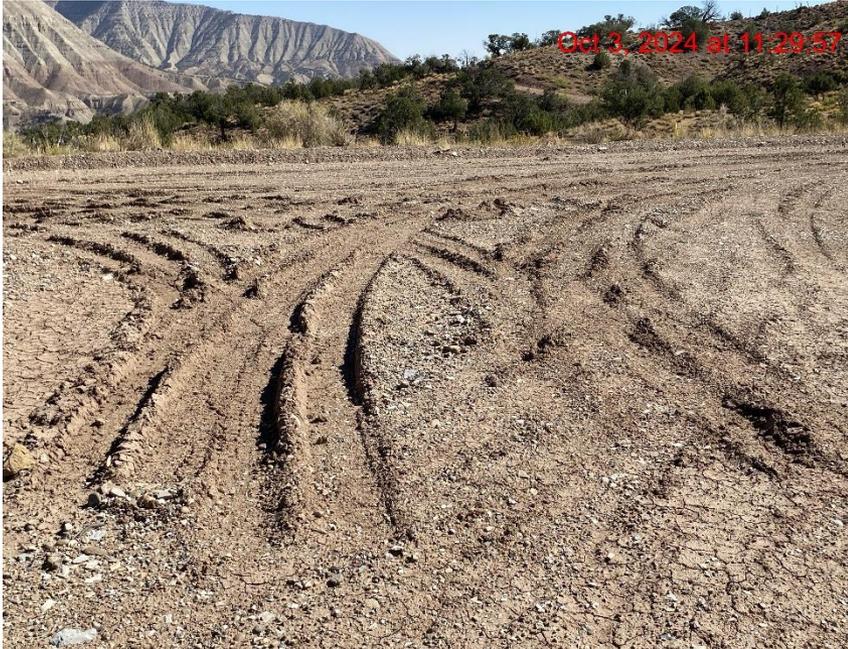
Lack of Stabilization – Photo #03947
