Inspection Photos

API: 061-06296

Operator: STRACHAN EXPLORATION INC

Inspection Date: 10/3/2024

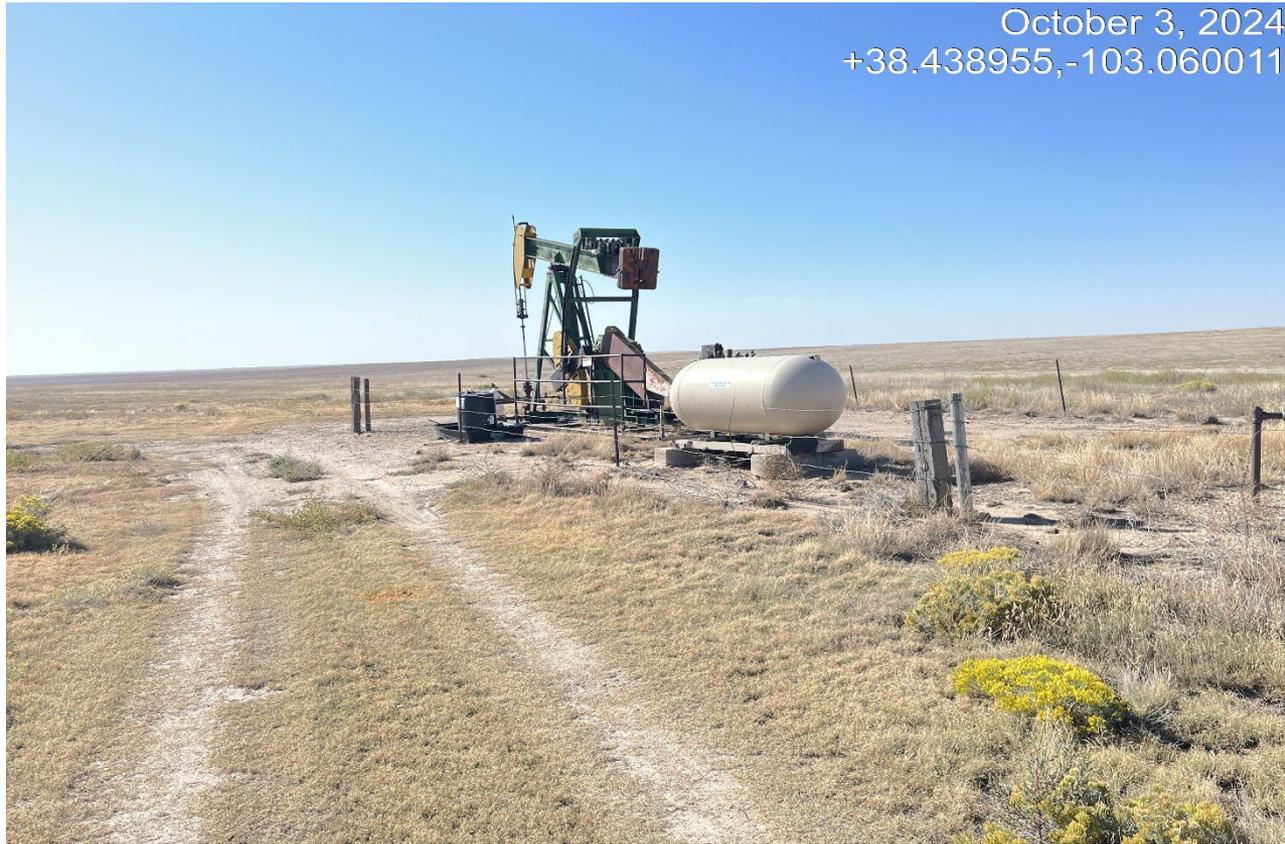
Photo 1. Facing toward the wellsite.

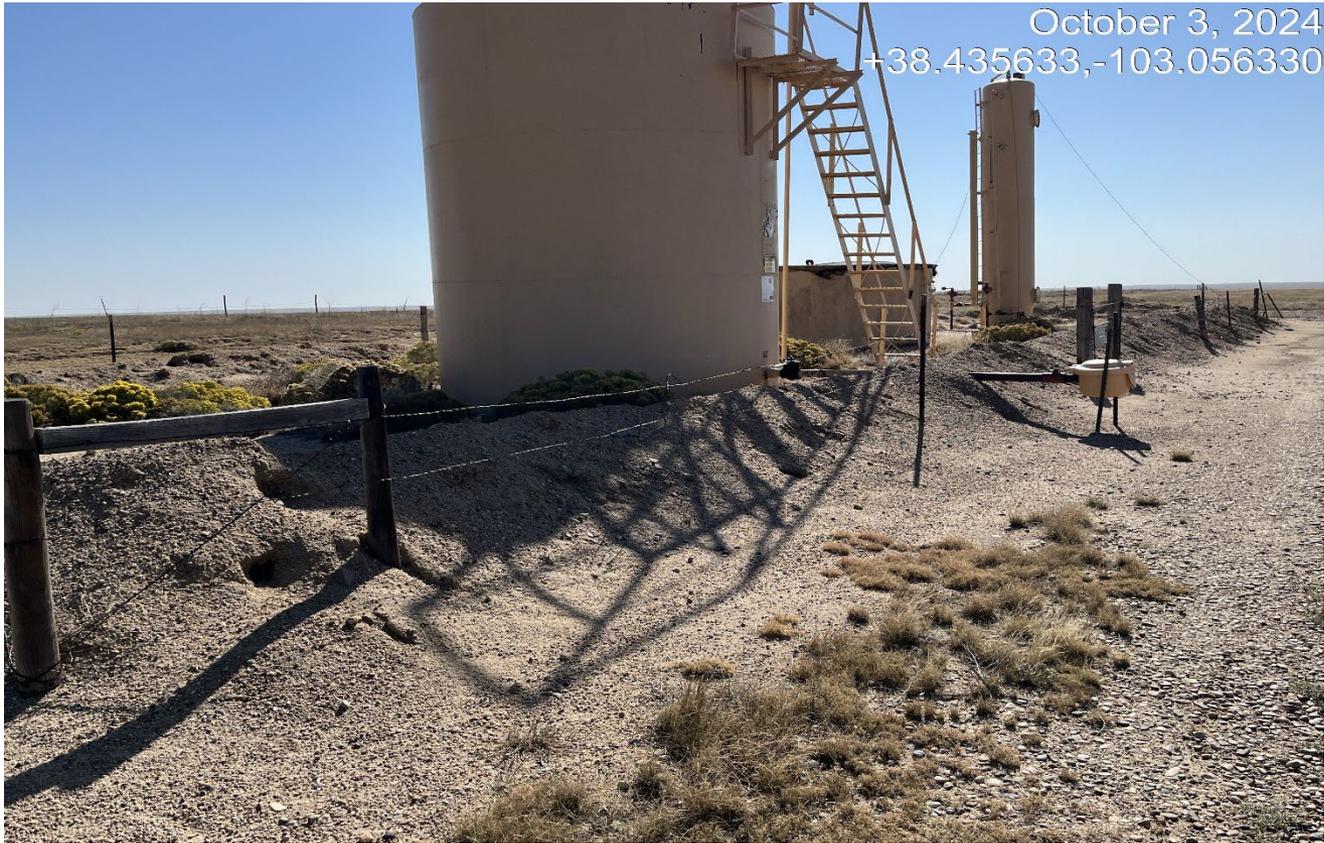
Photo 2. Facing east toward the tank battery.

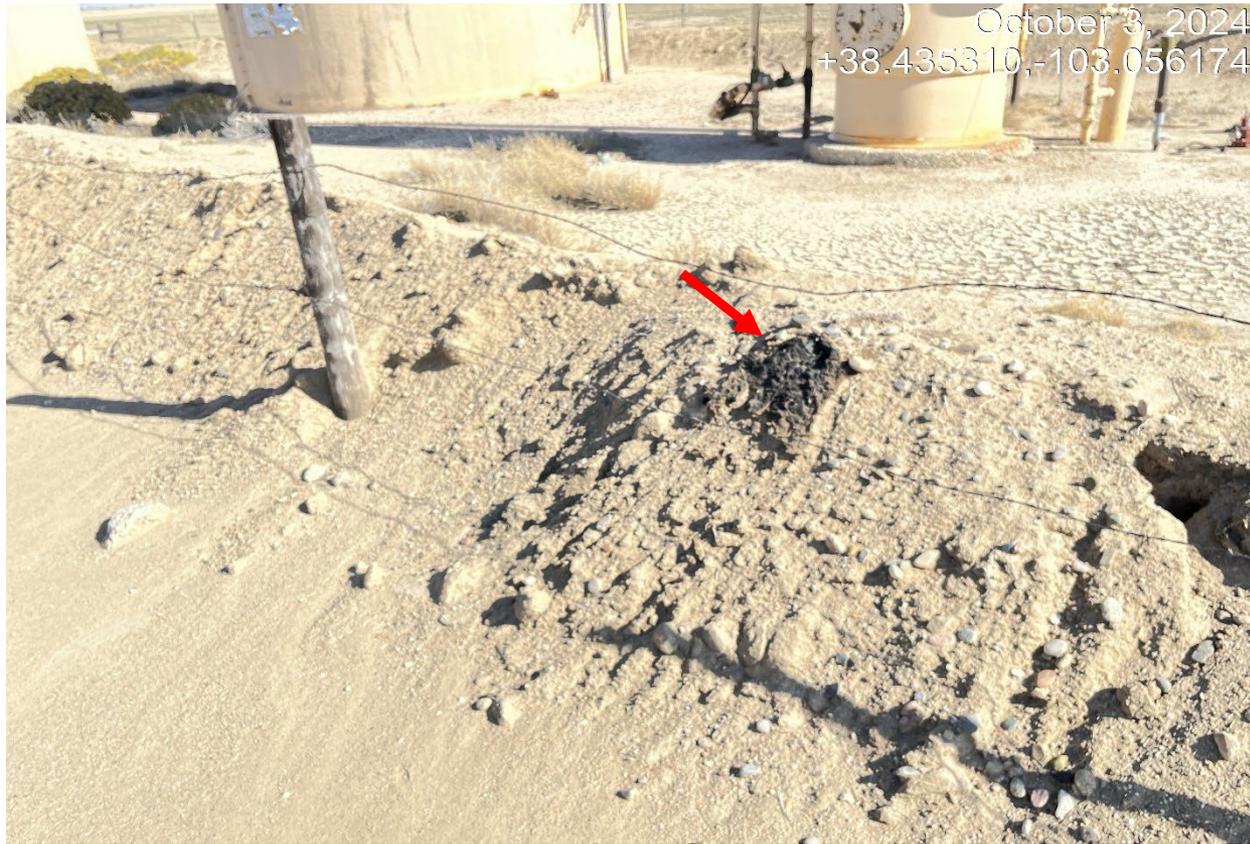
Photo 3. There is oily sludge on the berm that needs to be cleaned up.

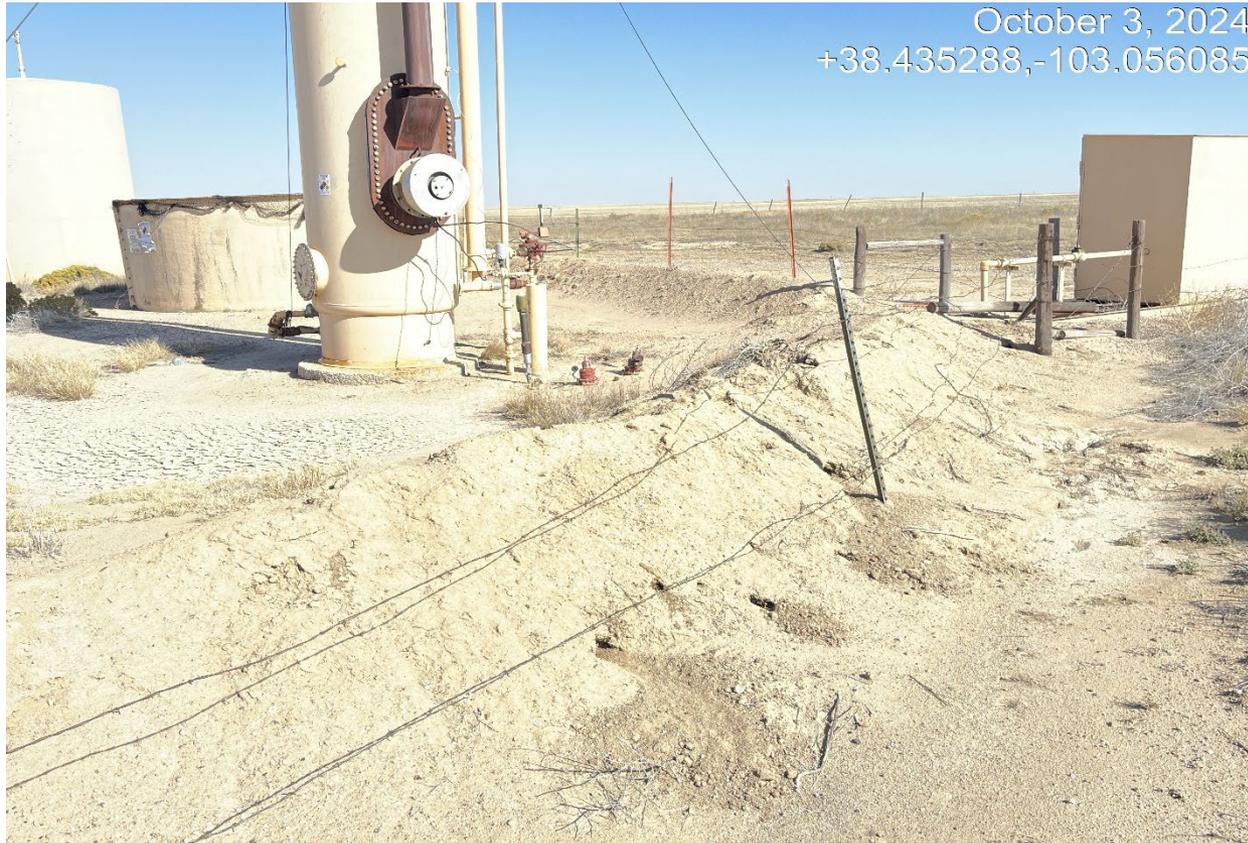
Photo 4. The 2 strand fence is inadequate to prevent livestock entry. Previous CA was not completed.
