Inspection Photos

API: 061-06353

Operator: STRACHAN EXPLORATION INC

Inspection Date: 10/3/2024

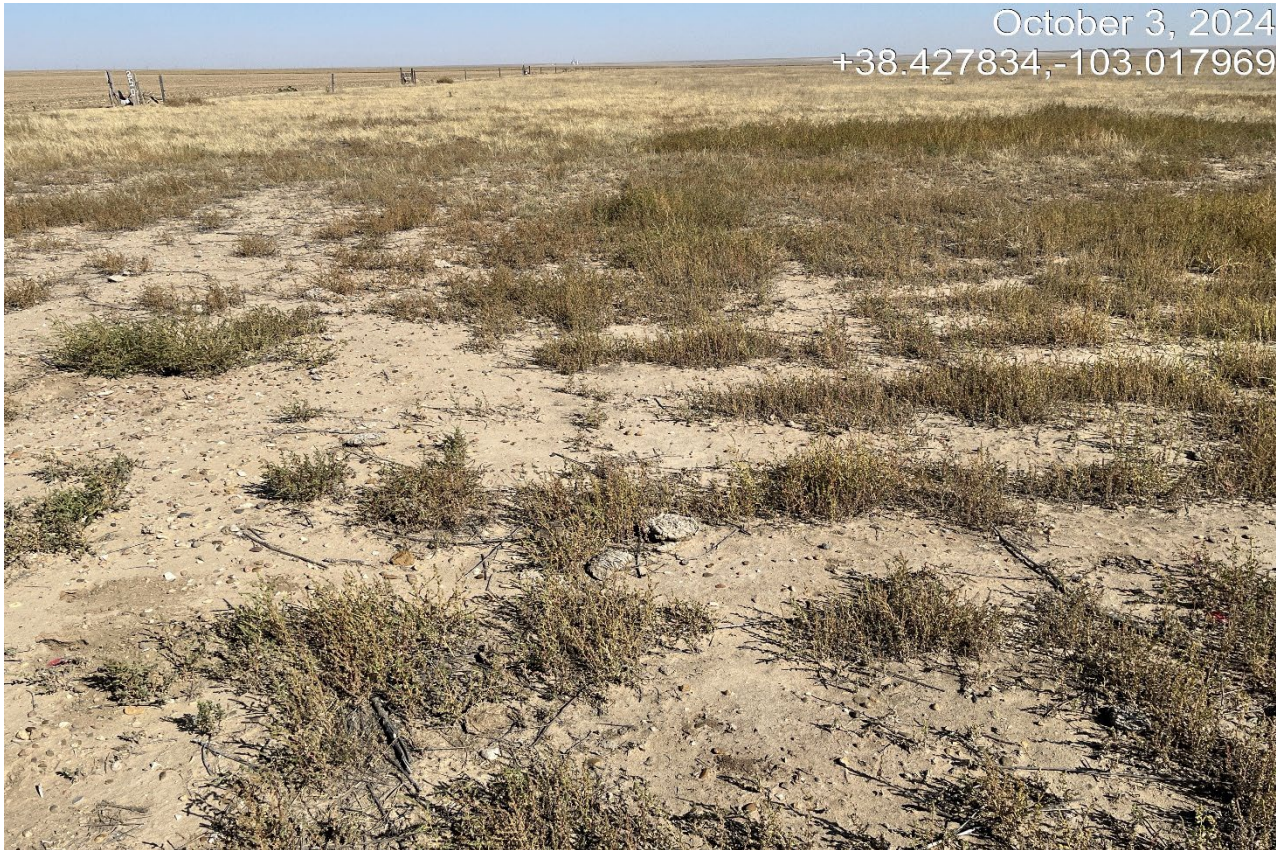
Photo 1. Center of the location facing north. Perennial vegetation has not established and there are undesirable weeds throughout the location.

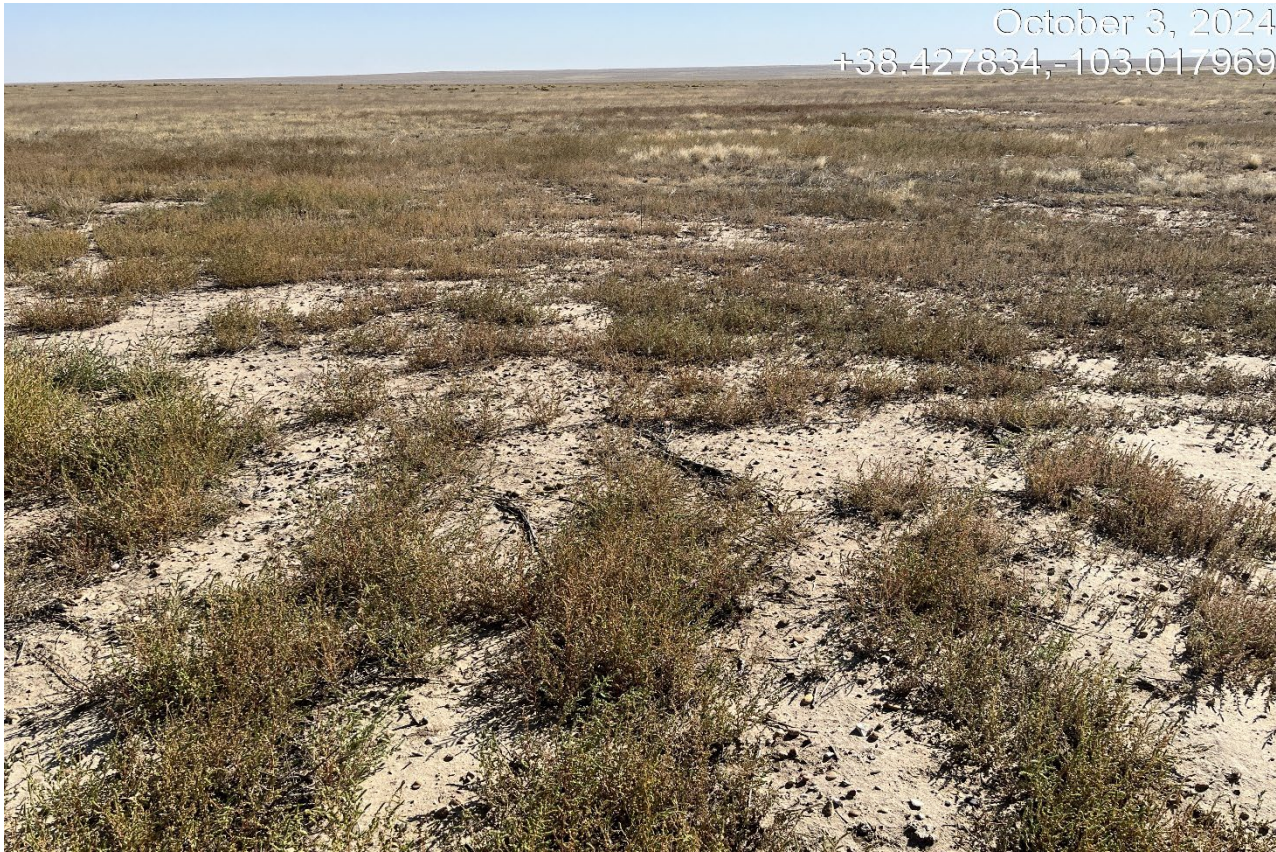
Photo 2. Center of the location facing east. Perennial vegetation has not established and there are undesirable weeds throughout the location.

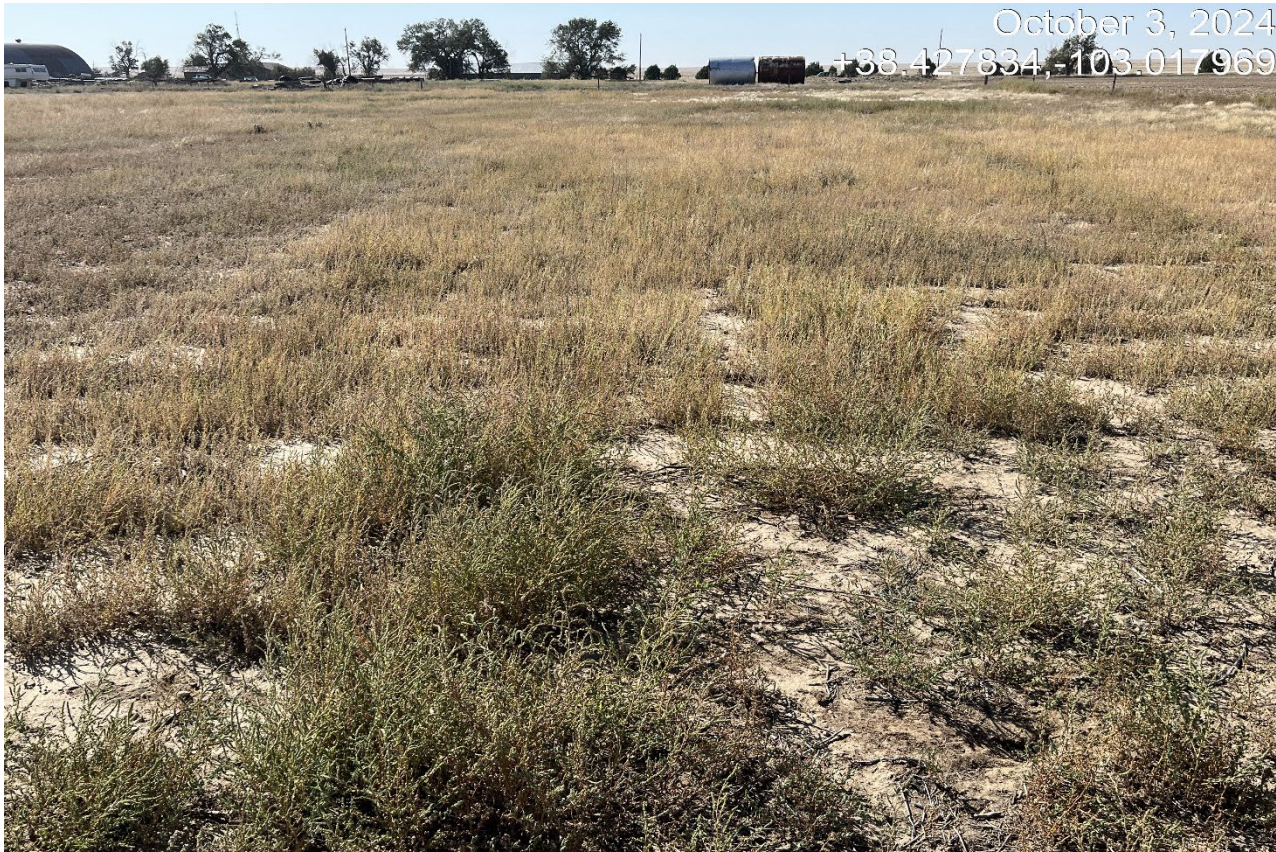
Photo 3. Center of the location facing south. Perennial vegetation has not established and there are undesirable weeds throughout the location.

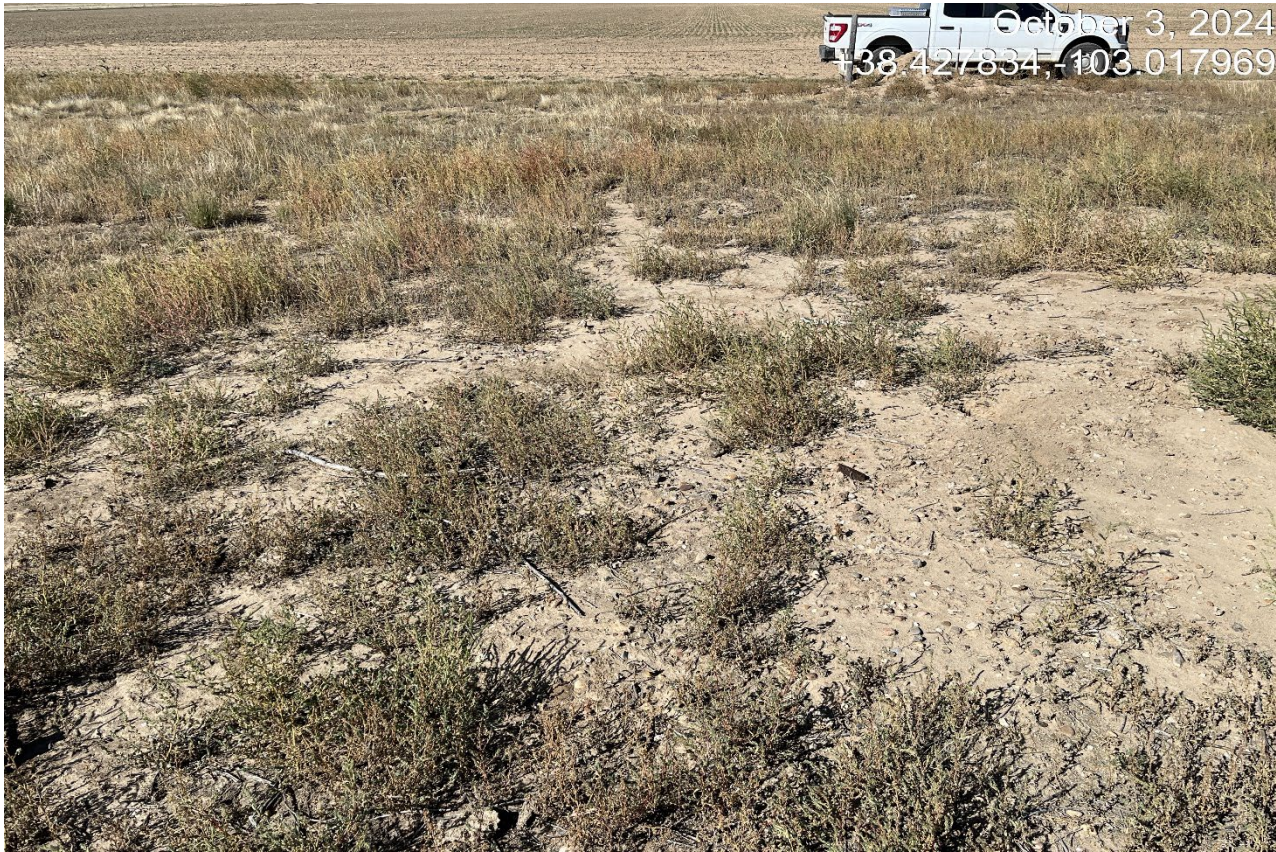
Photo 4. Center of the location facing west. Perennial vegetation has not established and there are undesirable weeds throughout the location.

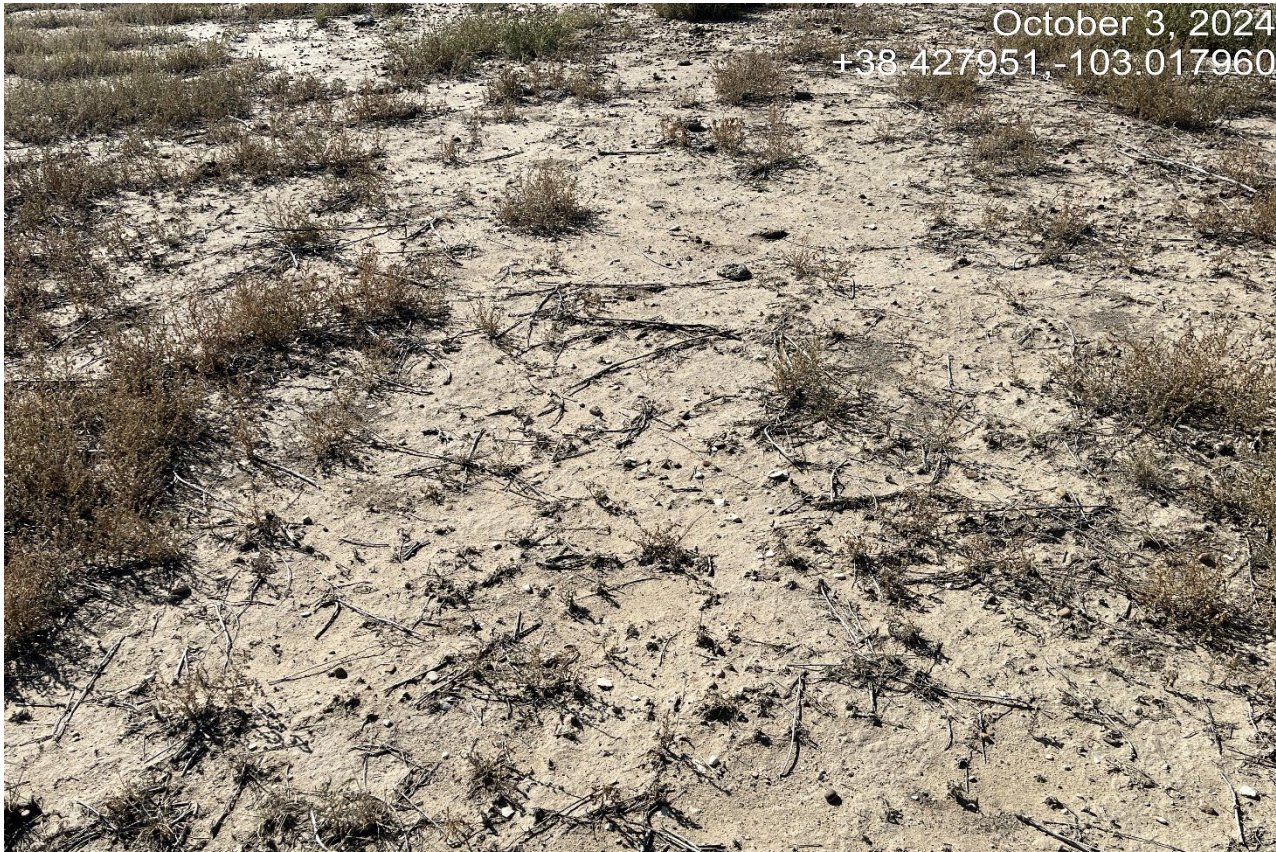
Photo 5. View of groundcover shows bare soils and undesirable weeds (Russian thistle).

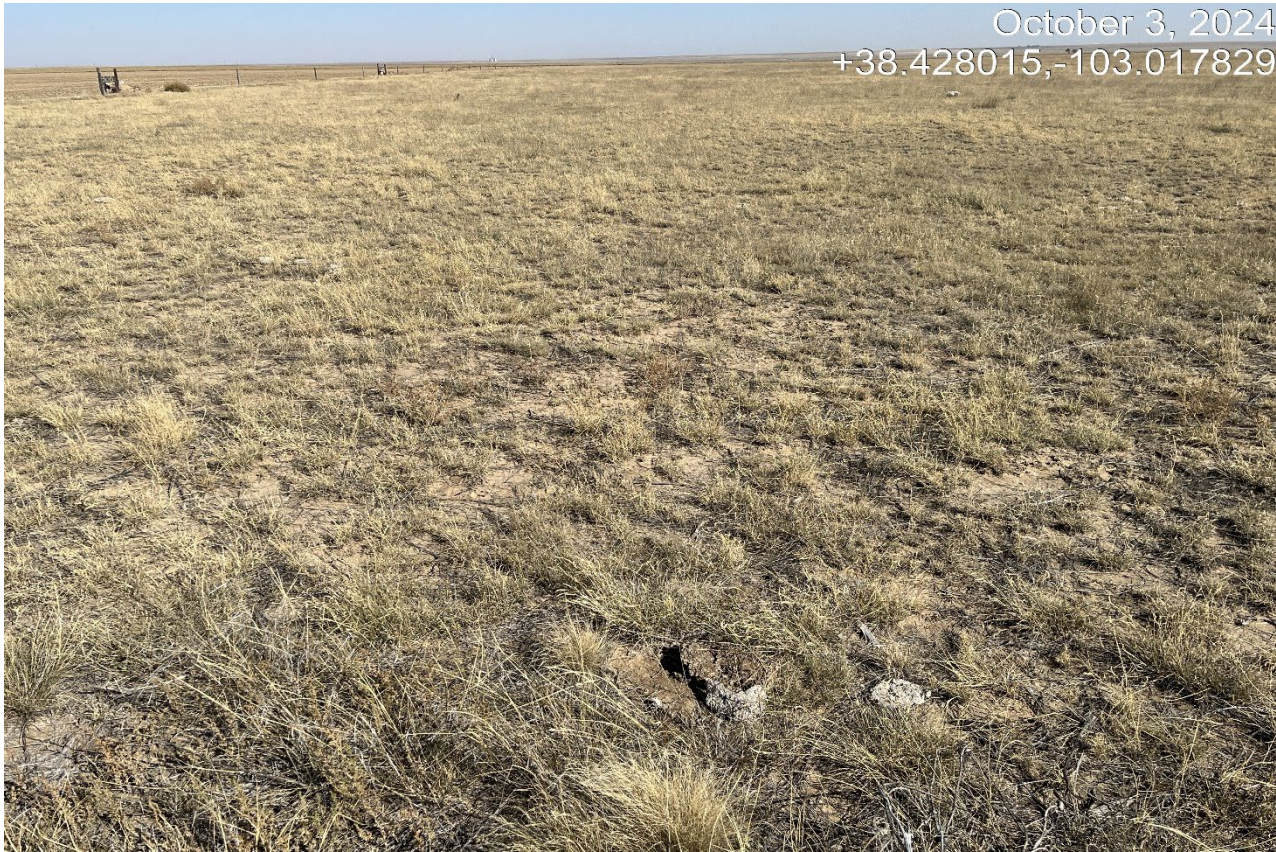
Photo 6. Facing north toward the surrounding undisturbed pasture which consists of Native Bluer grama grassland.
