Inspection Photos

API: 061-06394

Operator: STRACHAN EXPLORATION INC

Inspection Date: 10/3/2024

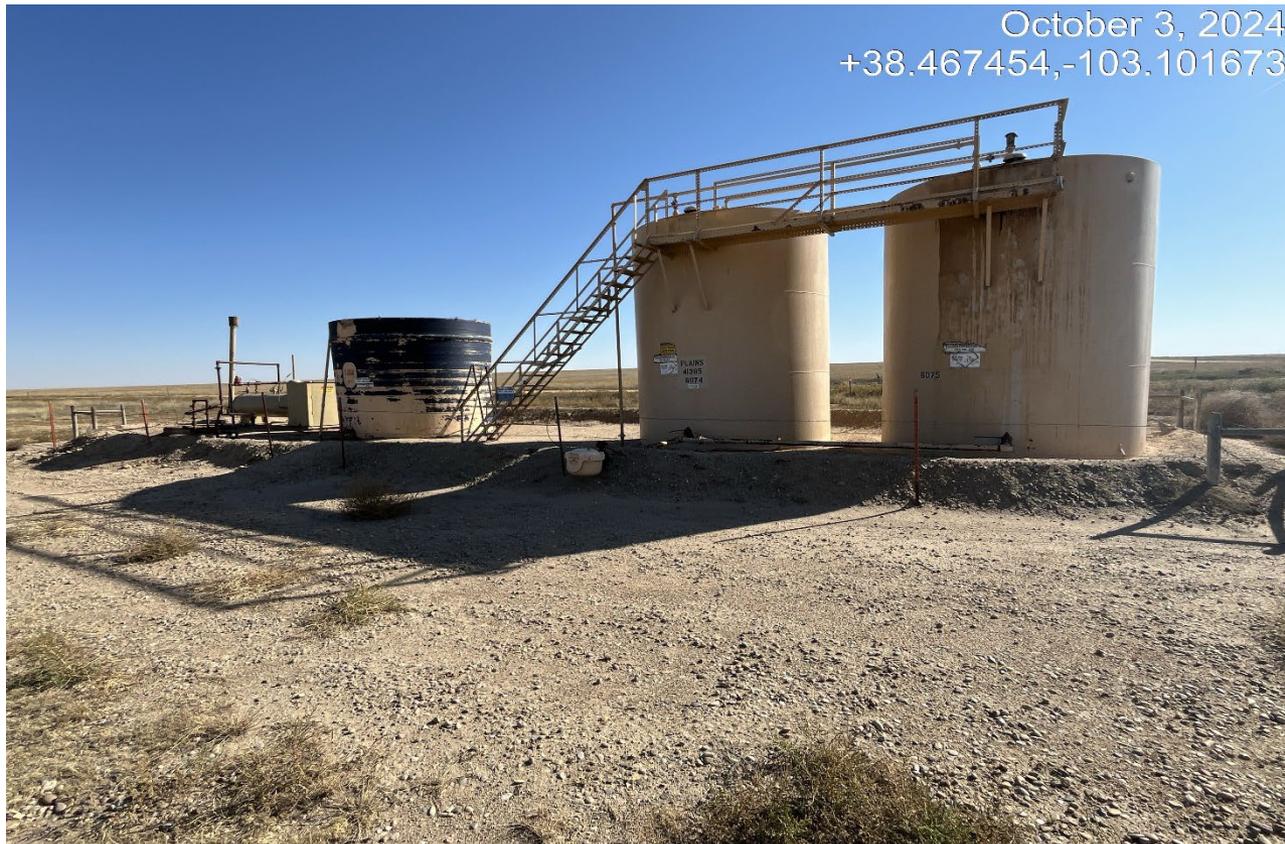
Photo 1. Facing northeast toward the offsite tank battery location.

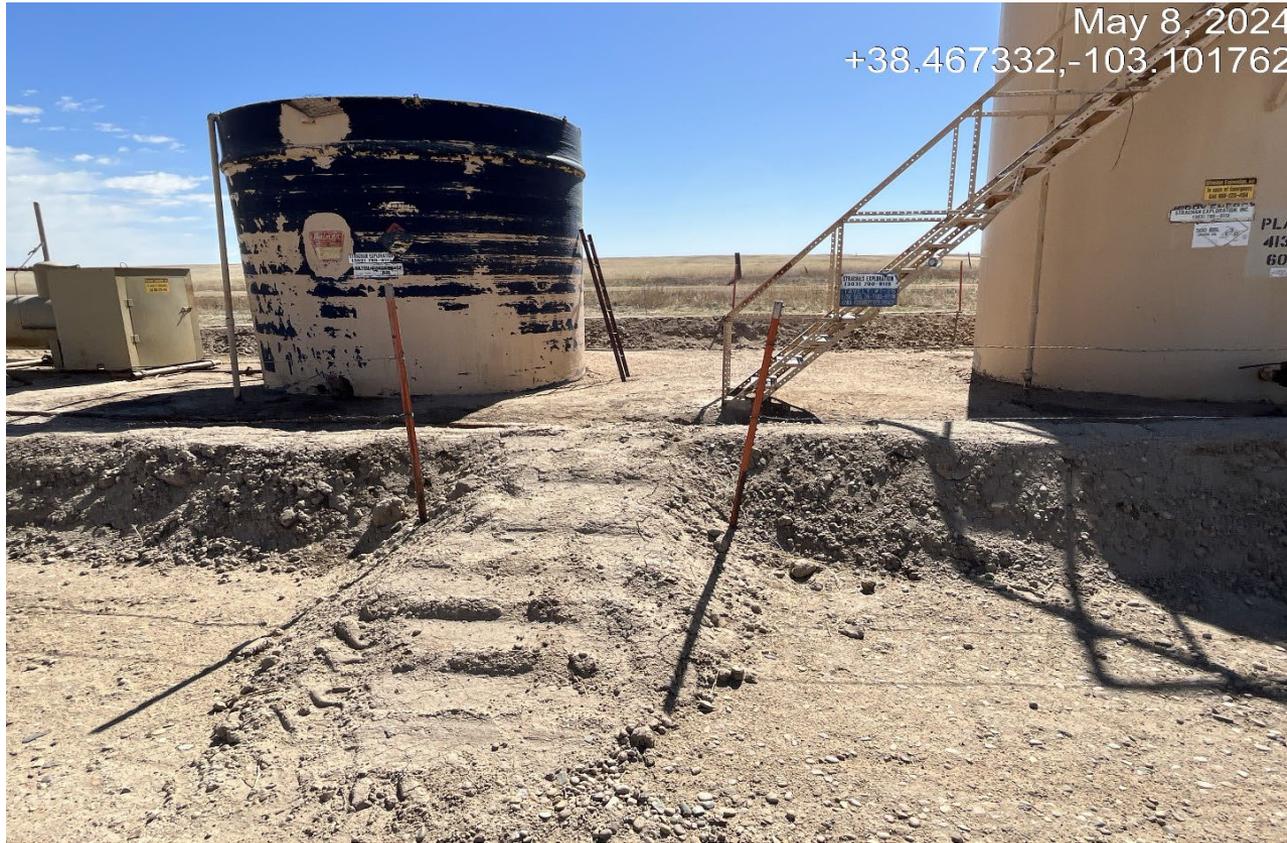
Photo 2. The fence around the tank has been repaired but there is an opening at this area and there are only 2 wires which will not keep livestock out.

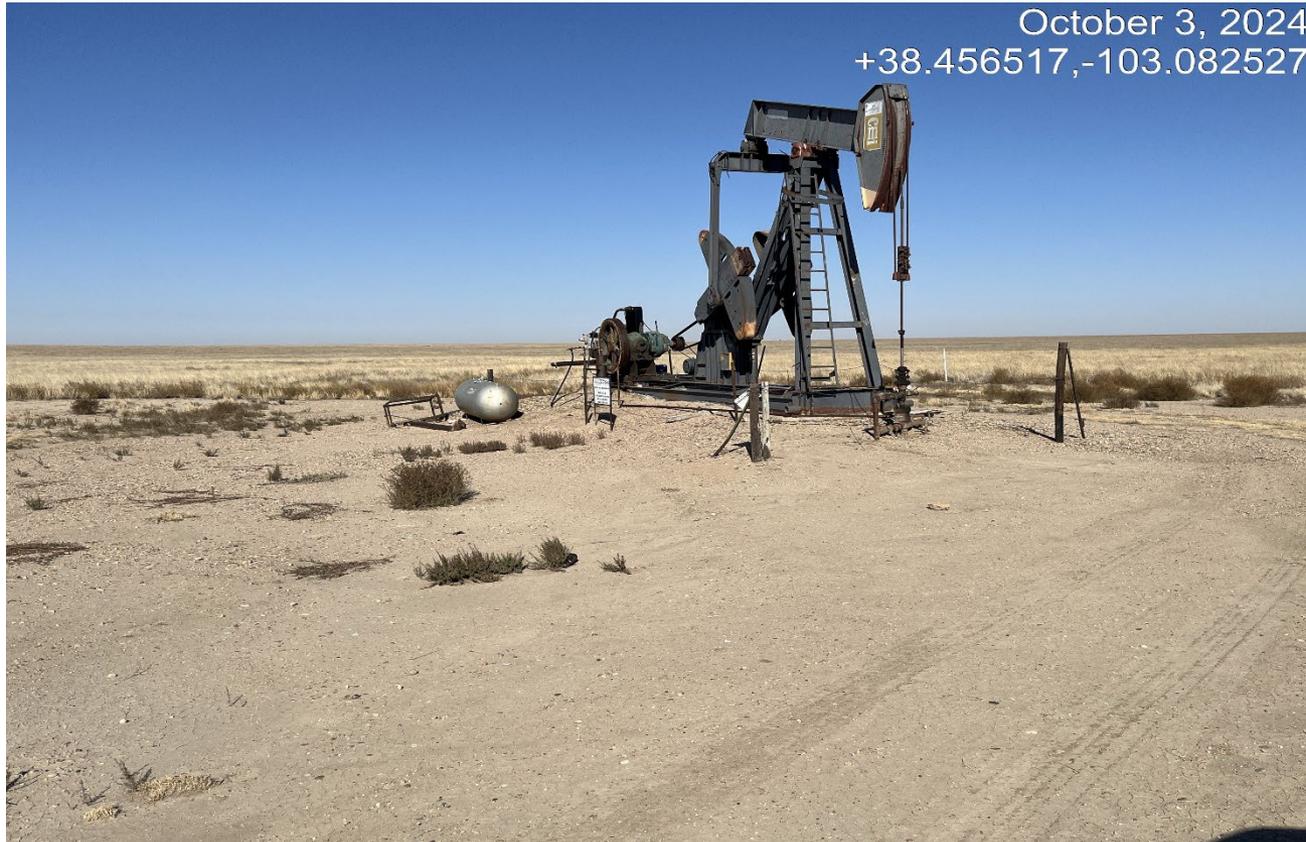
Photo 3. Facing northwest toward the wellsite. The fence around the pumpjack is in disrepair and wont prevent livestock entry. A new well sign has been installed.

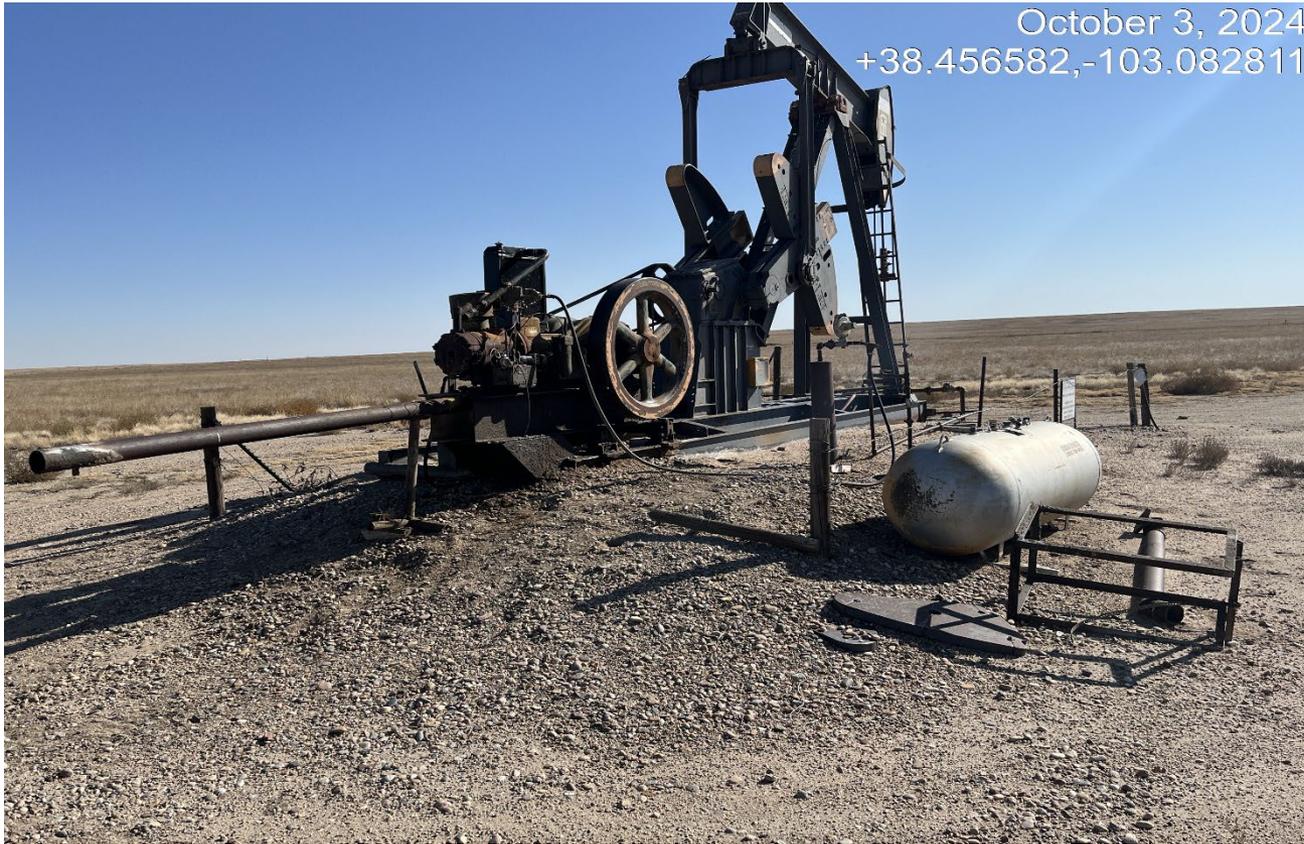
Photo 4. Facing east toward the wellsite. The are parts laying on the ground that should be removed.
