Inspection Photos

Location Name: TEP ROCKY MOUNTAIN LLC BEAVER CREEK 11-7-793

Location ID: 432702

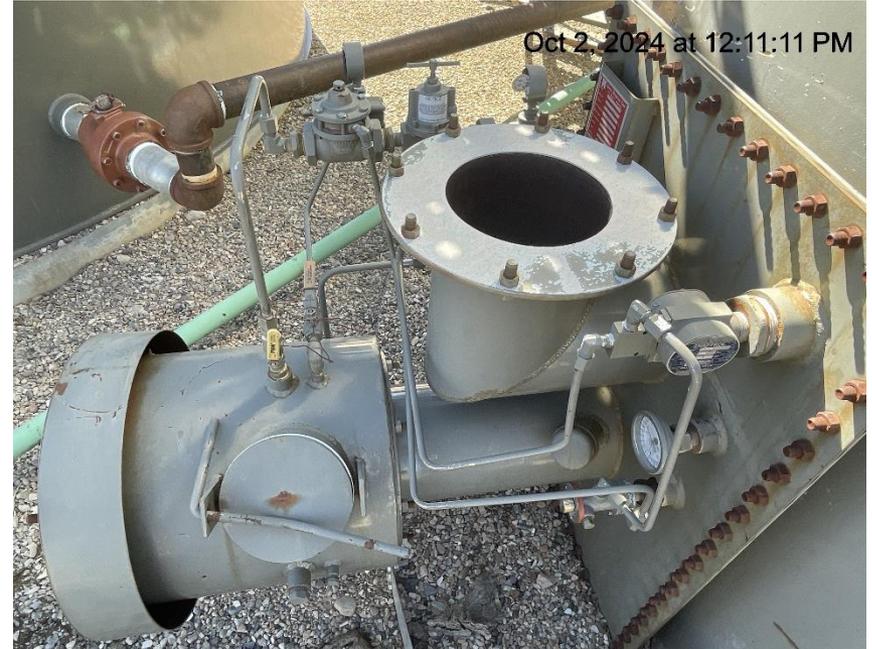
Photo # 3206 Burner exhaust open ended/available for entry by wildlife/wildlife hazard

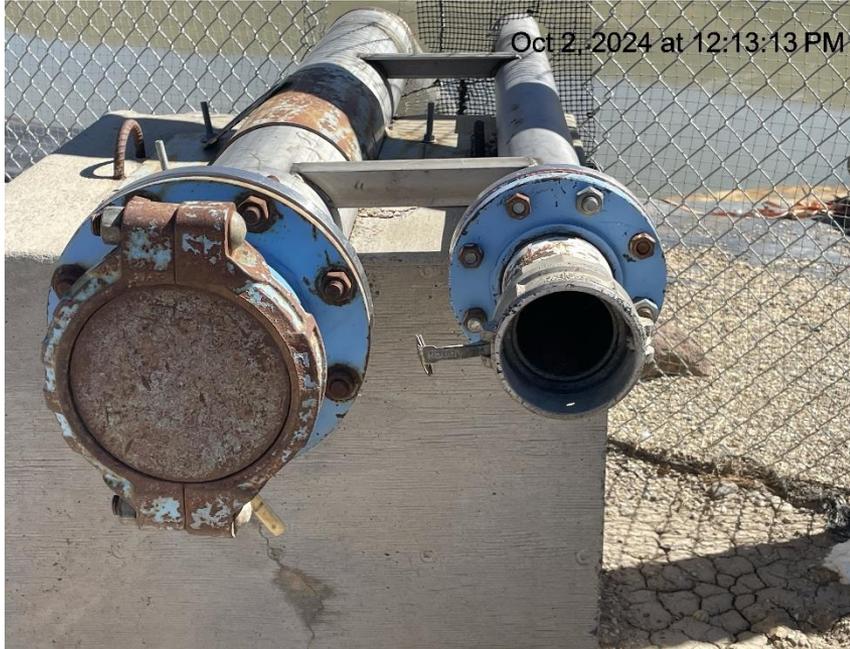
Photo # 3207 Open ended load line

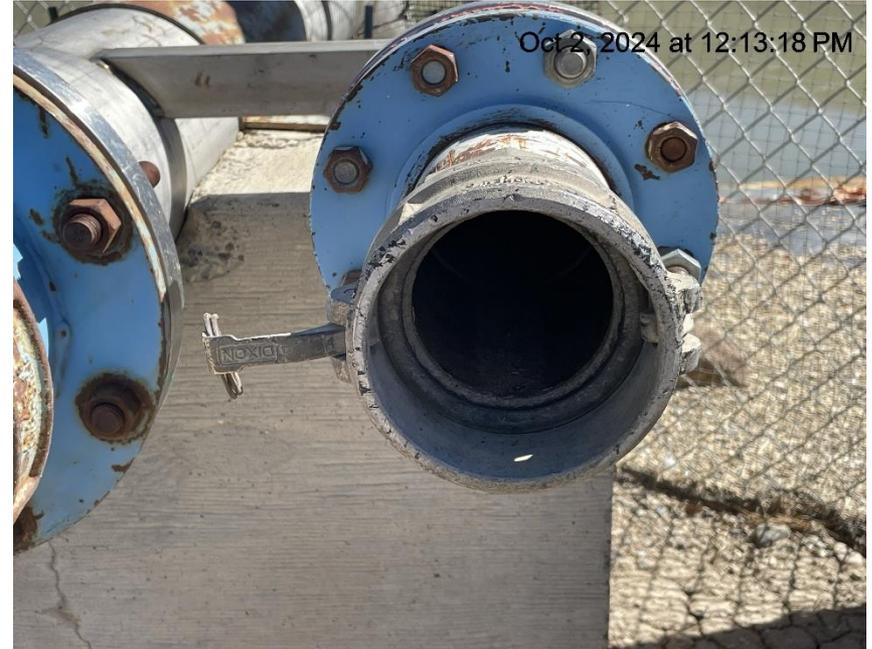
Photo # 3208 Same open ended load line

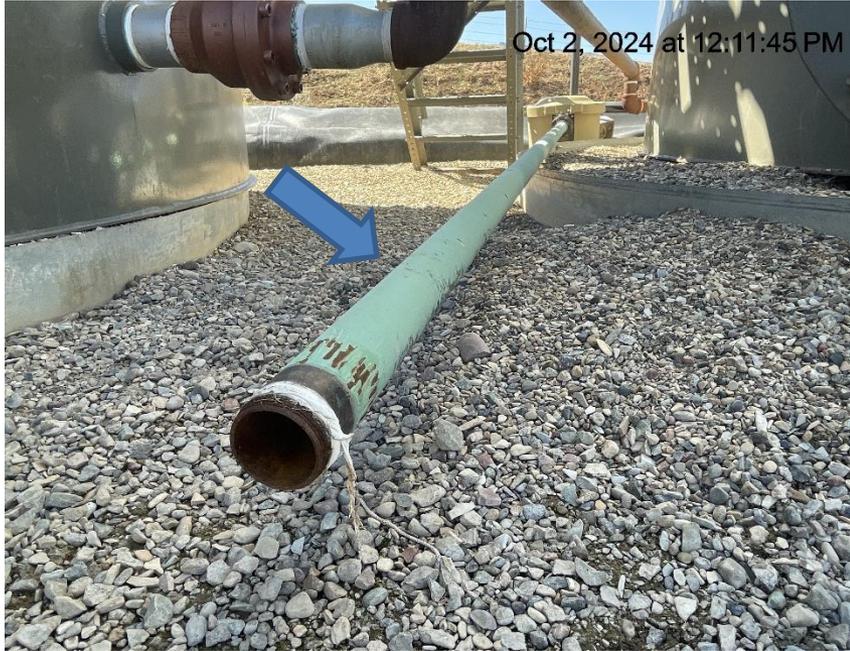
Photo # 3209 Debris

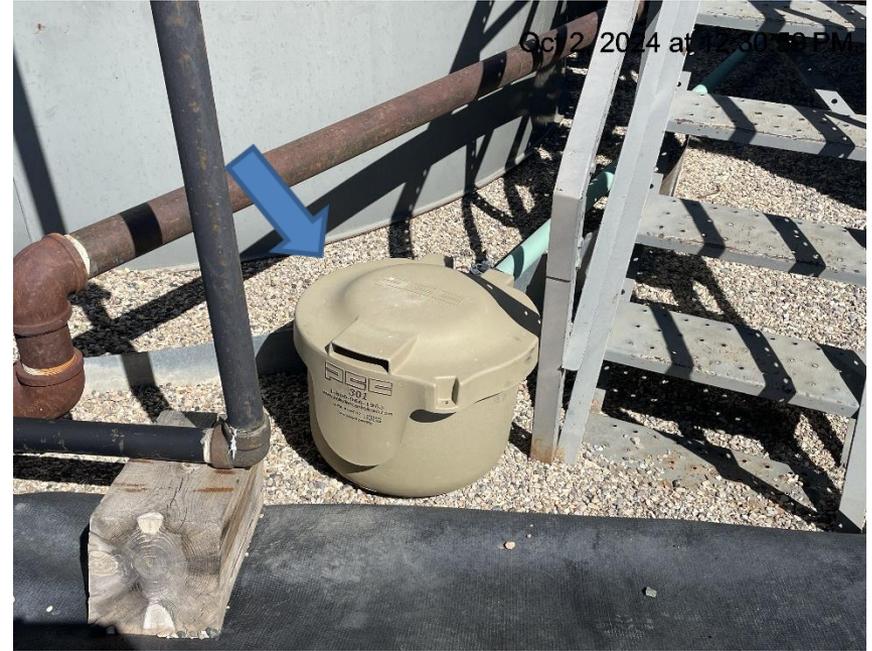
Photo # 3210 Debris

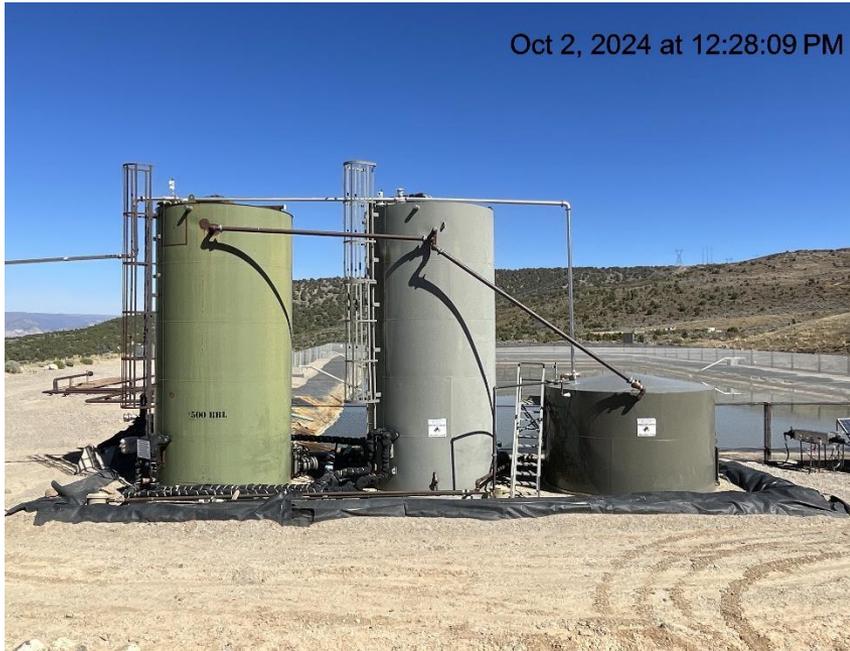
Photo # 3211 Tank battery lacks signage/does not comply with CECMC rules

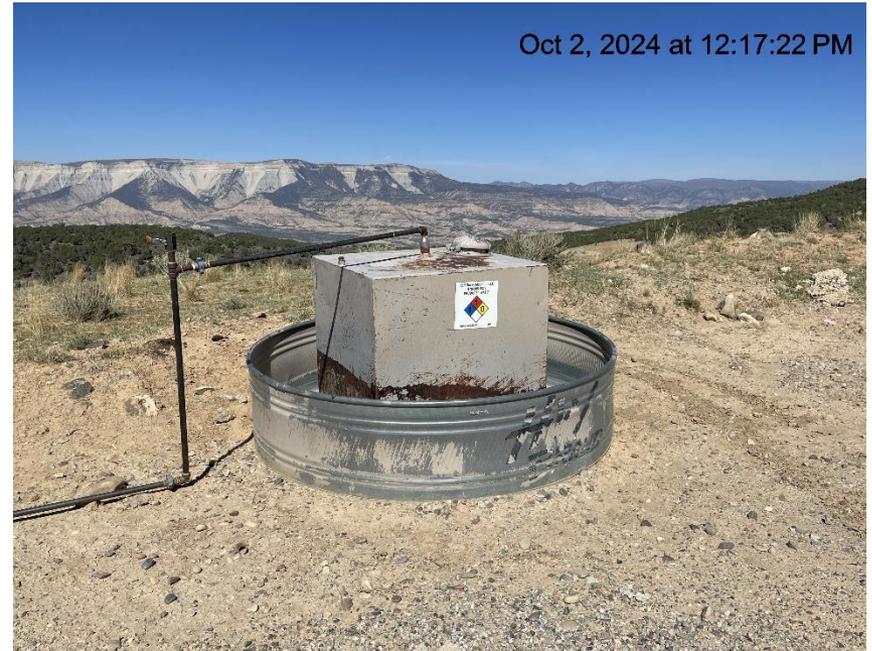
Photo # 3212 Tank label lacks capacity
