Inspection Photos

Location Name: TEP ROCKY MOUNTAIN LLC FEDERAL RU 31-17 Pad

Location ID: 452011

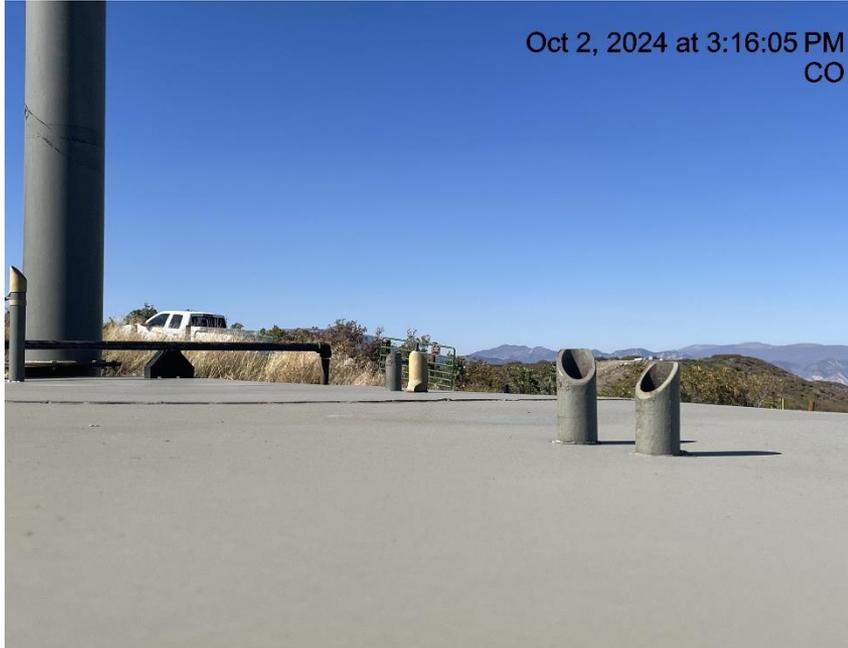
Photo # 3597 PRV & rupture disc vent lines do not comply with CECMC pressure safety device rules

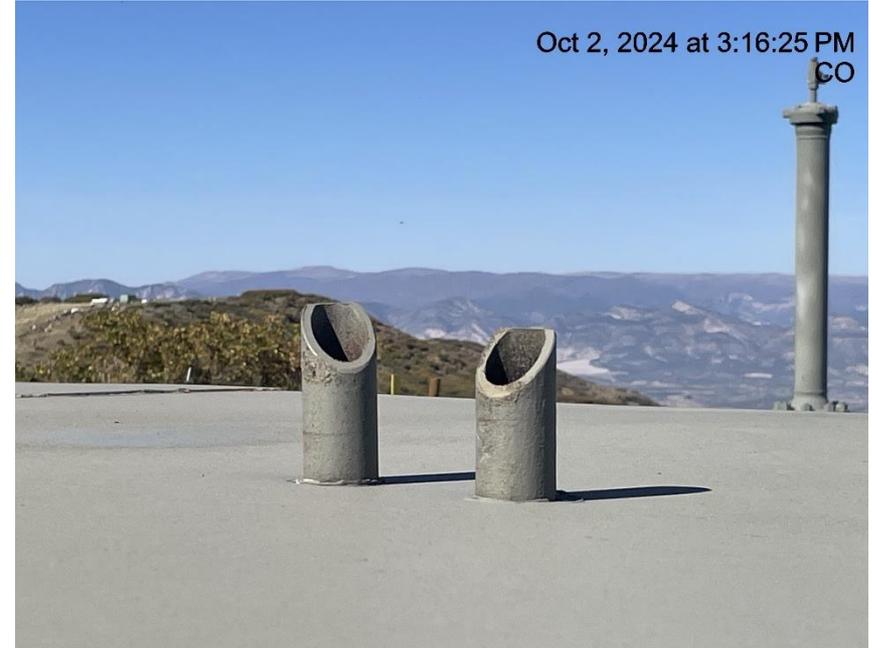
Photo # 3598 PRV & rupture disc vent lines do not comply with CECMC pressure safety device rules

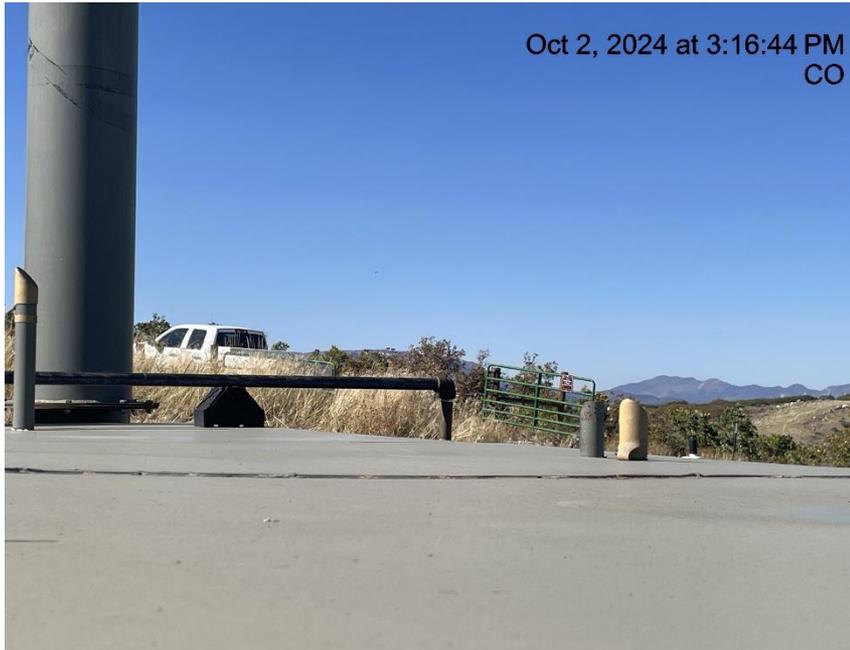
Photo # 3599 PRV vent line does not comply with CECMC pressure safety device rules

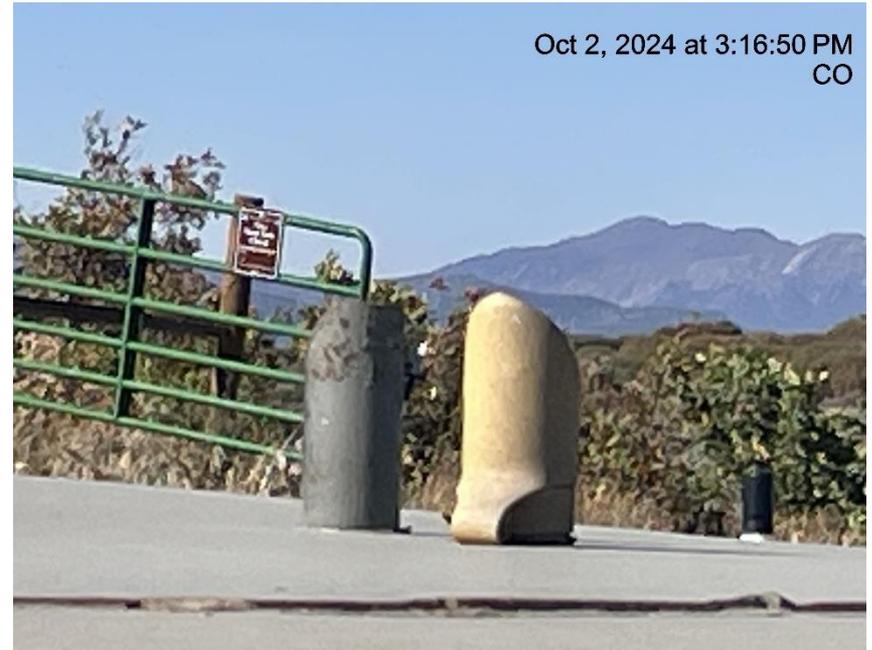
Photo # 3600 PRV vent line does not comply with CECMC pressure safety device rules

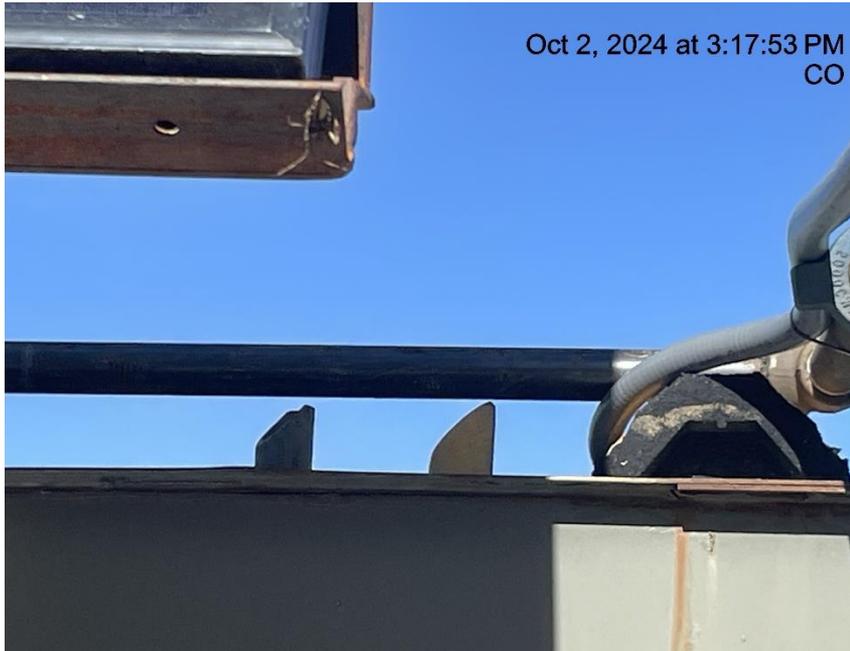
Photo # 3601 PRV vent line does not comply with CECMC pressure safety device rules

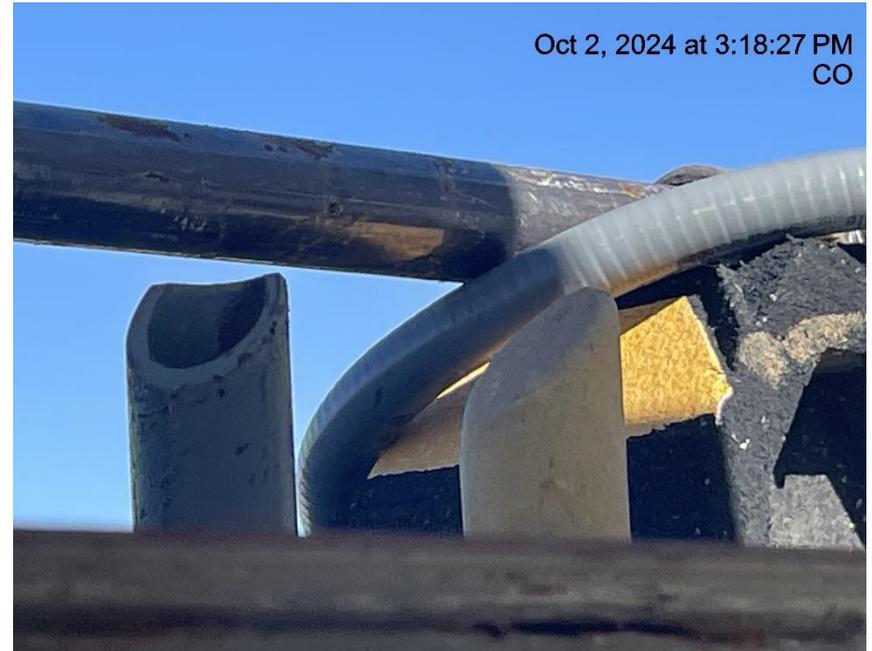
Photo # 3602 PRV vent line does not comply with CECMC pressure safety device rules

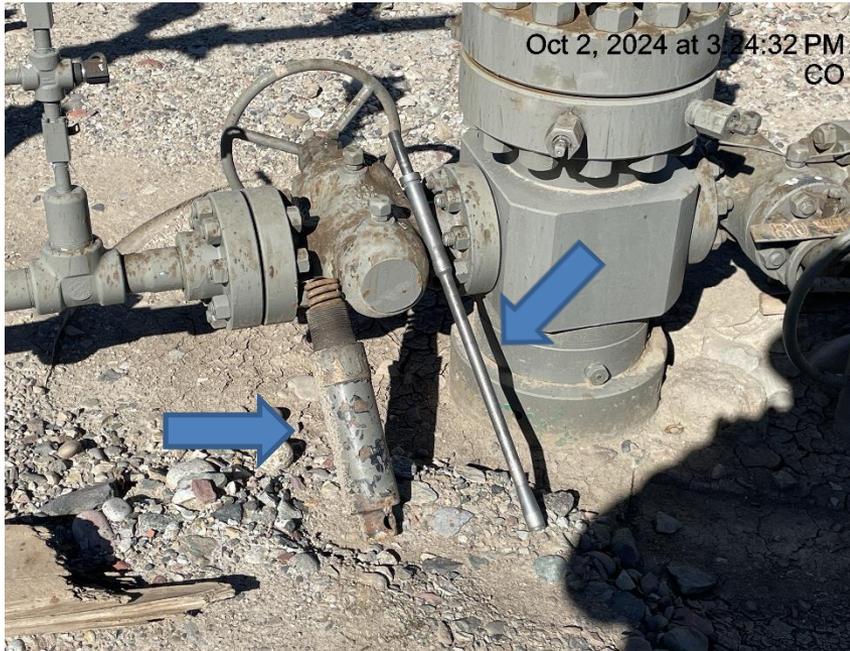
Photo # 3603 Debris
