Inspection Photos

API: 061-06838

Operator: INVESTMENT EQUIPMENT LLC

Inspection Date: 10/3/2024

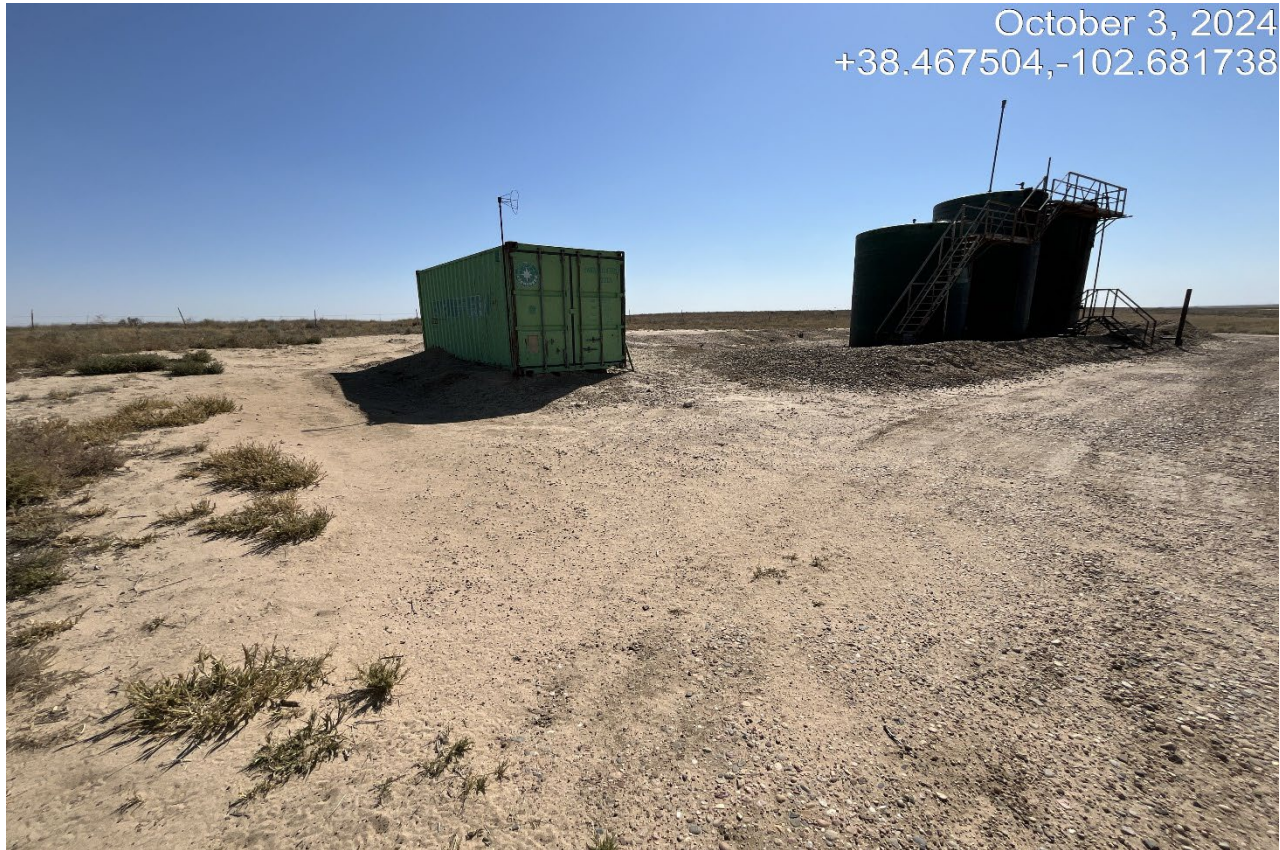
Photo 1. Facing southeast toward the location. The soils around the conex have eroded and no BMP's have been installed. The H2S wind sock is missing. Previous CA's were not completed.

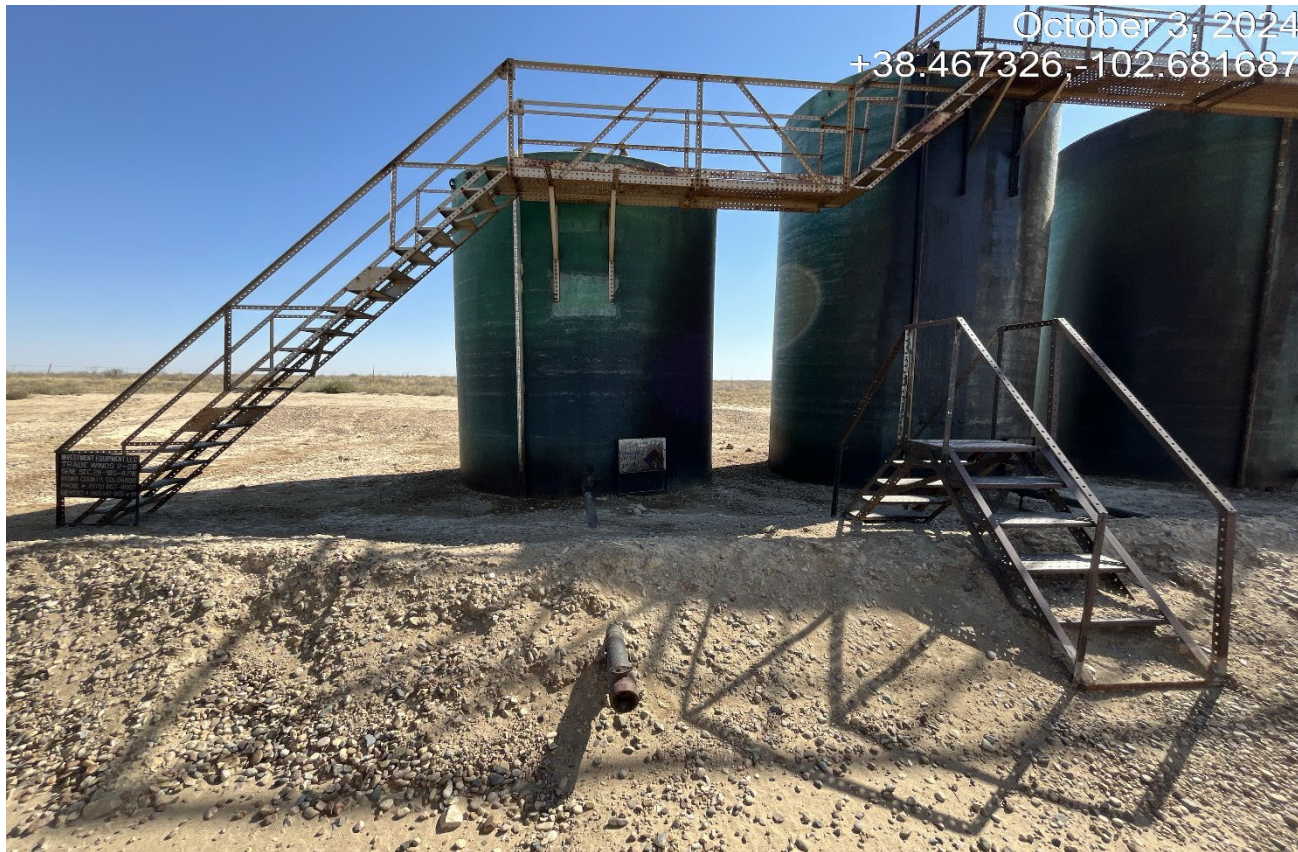
Photo 2. Facing toward the tank battery. The H₂S wind sock is missing. There is oily stained soils that extend the entire area of the containment from a previous spill that was never cleaned up. Previous CA's were not completed.

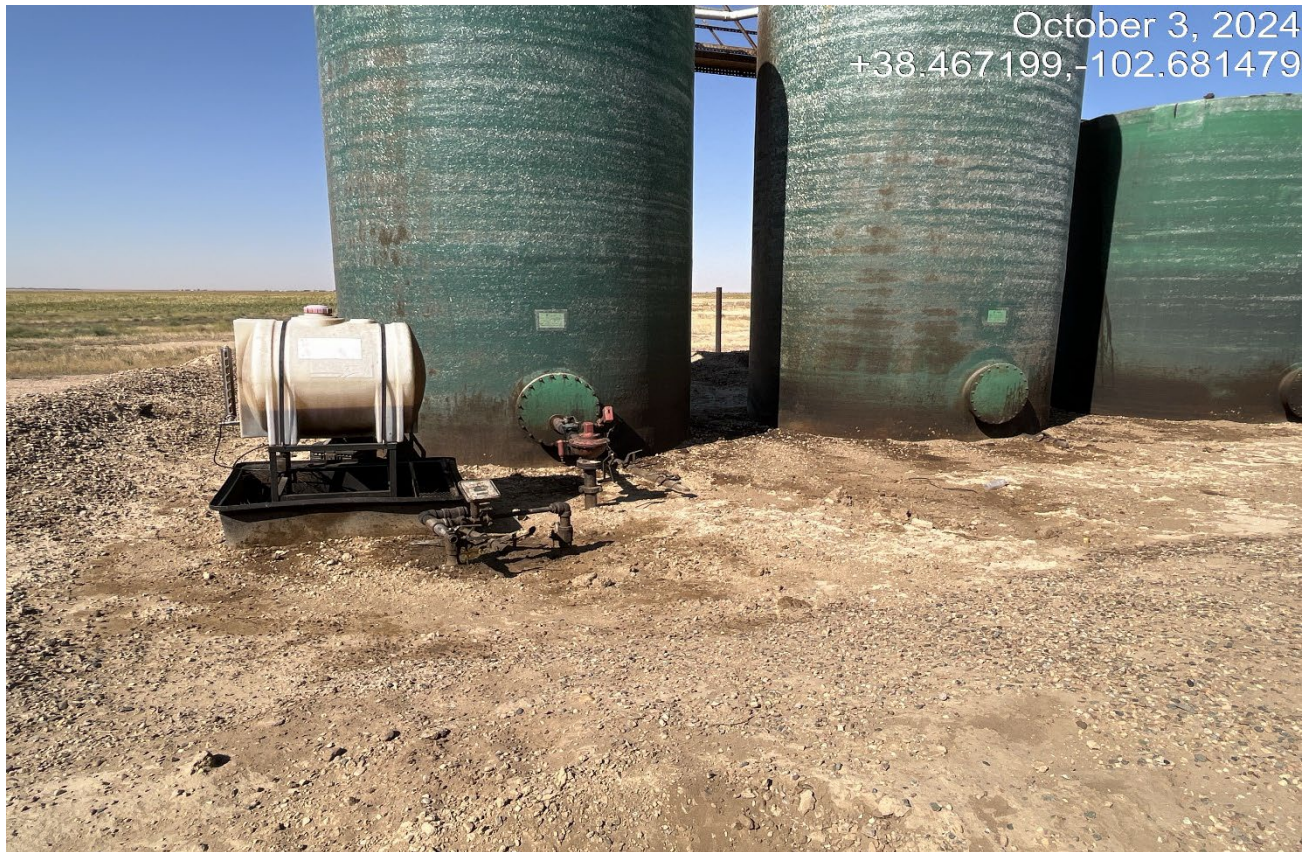
Photo 3. There are stained soils at the back side of the tank battery that must be cleaned up. Previous CA was not completed.

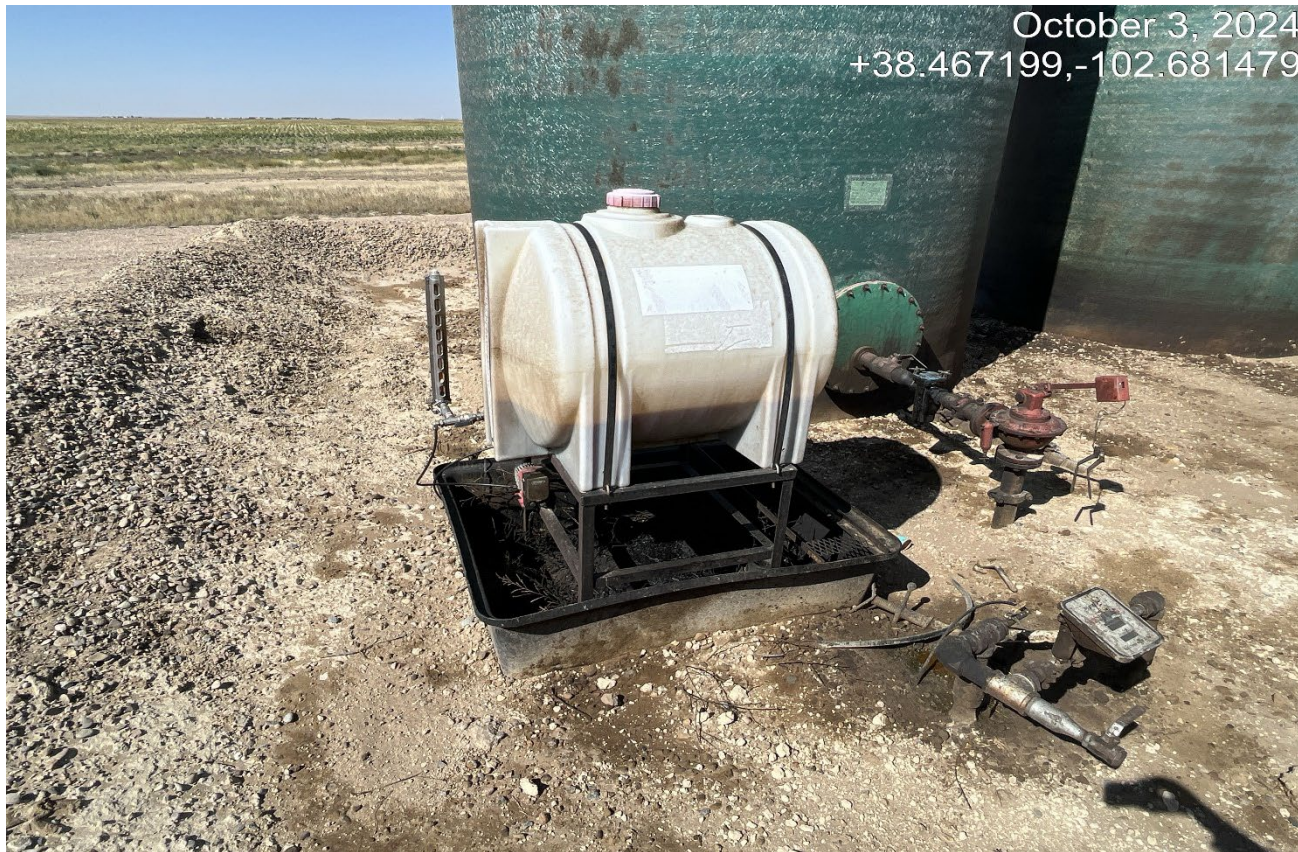
Photo 4. There is oily material inside the black containment which has no wildlife protections. There are stained soils around the tank battery that must be cleaned up. Previous CA was not completed.

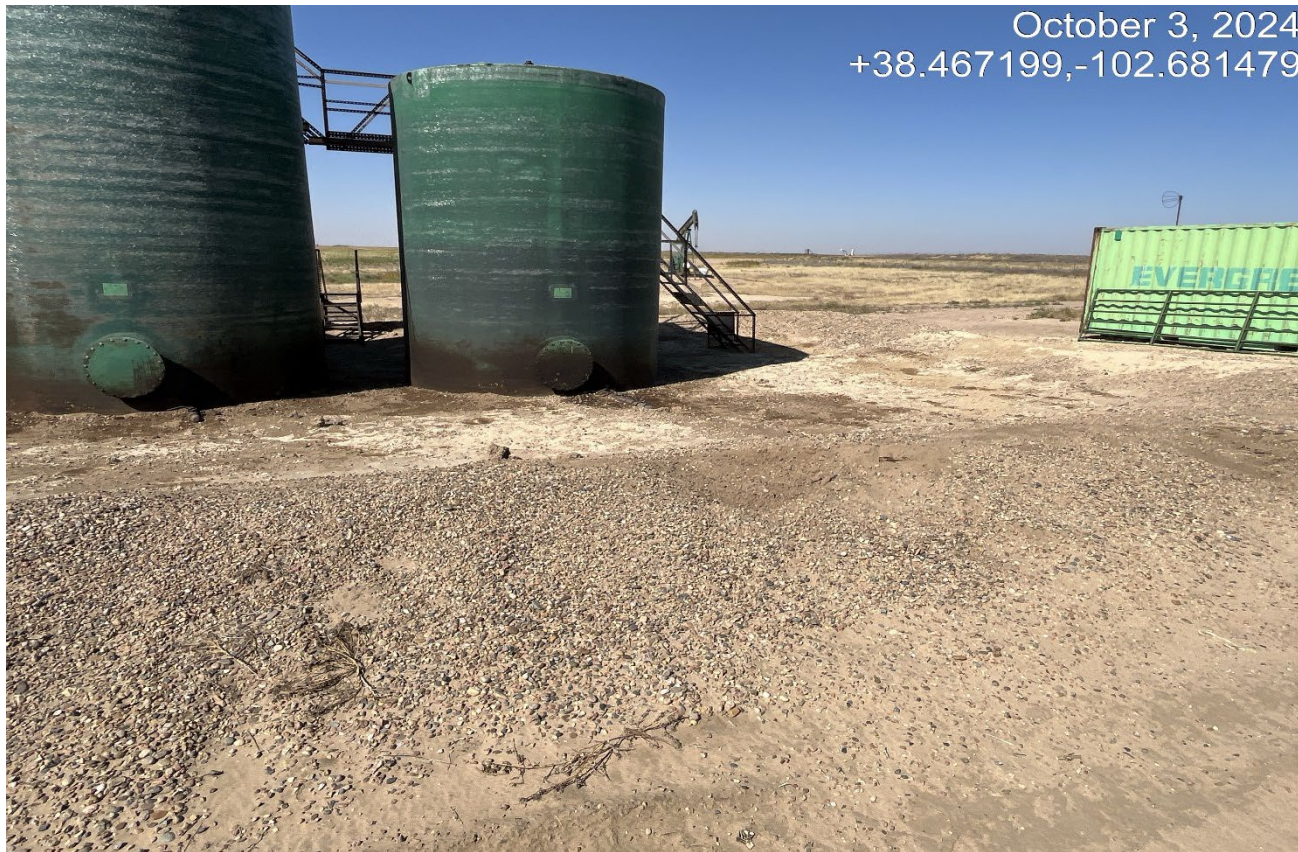
Photo 5. Facing northwest at the backside of the tank battery. There is oily stained soils that extend the entire area of the containment from a previous spill that was never cleaned up. Previous CA was not completed.

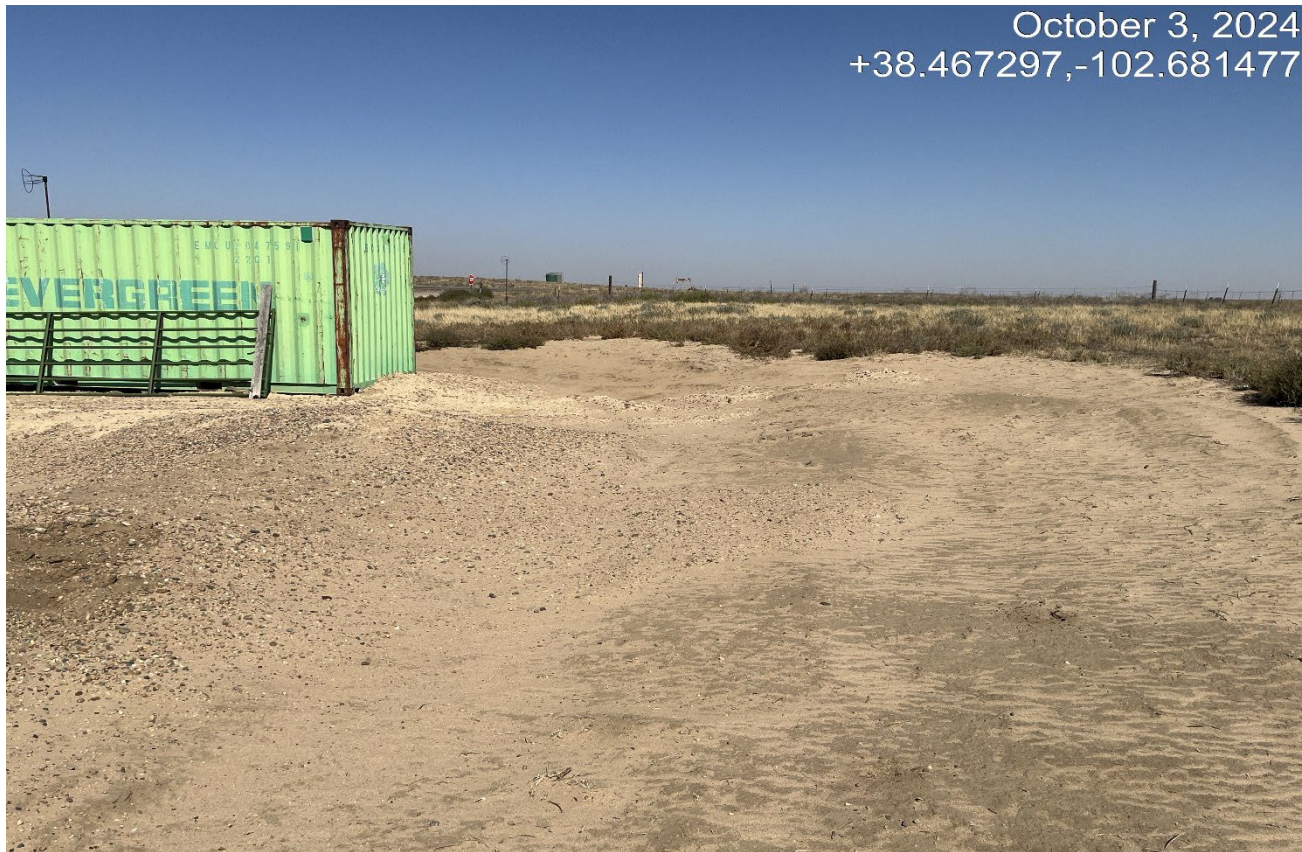
Photo 6. Facing north at the east side of the location. The soil near the conex have eroded and are bare of vegetation. This area must be stabilized to prevent further erosion.

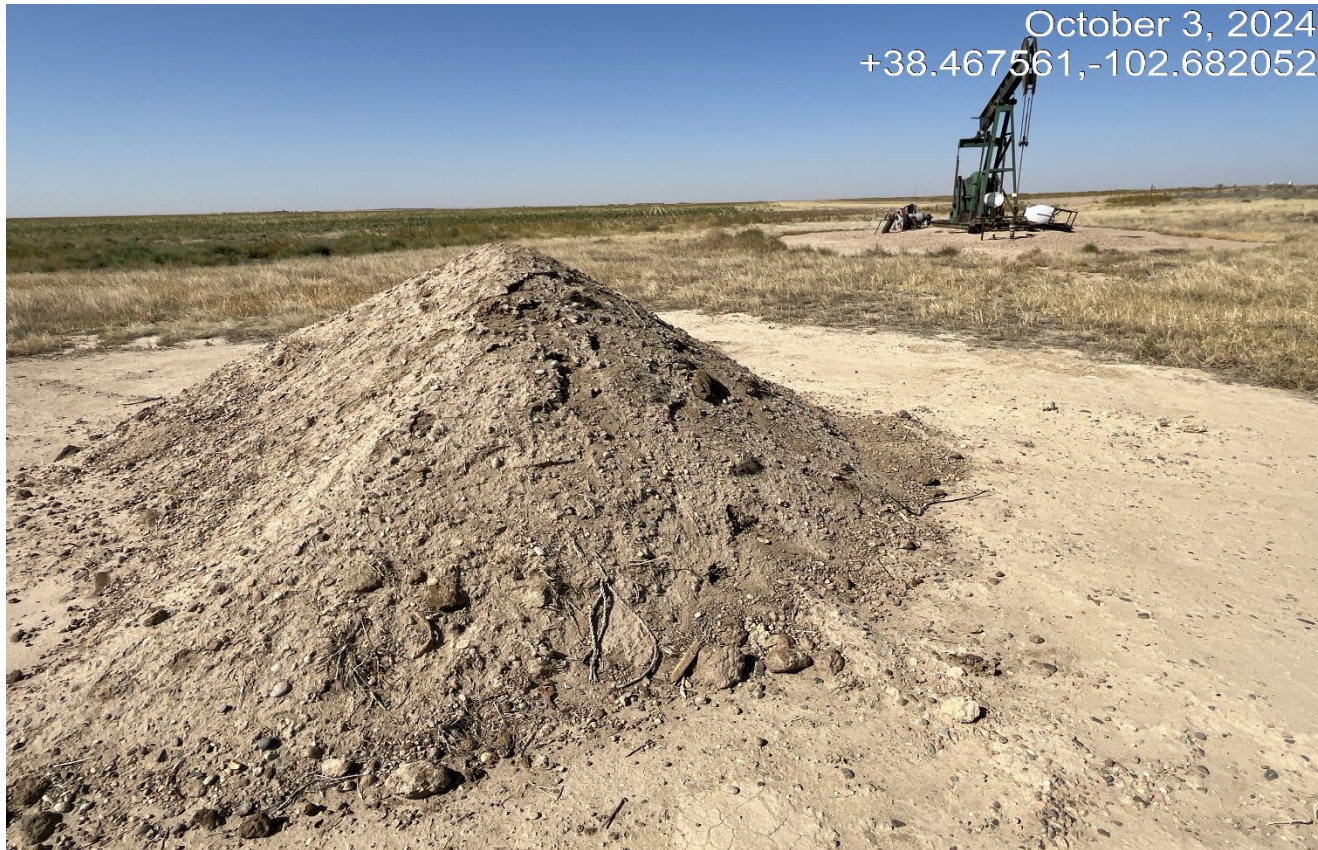
Photo 7. There is a pile of oily contaminated soil material stored on location that must be removed and properly disposed. Previous CA was not completed.

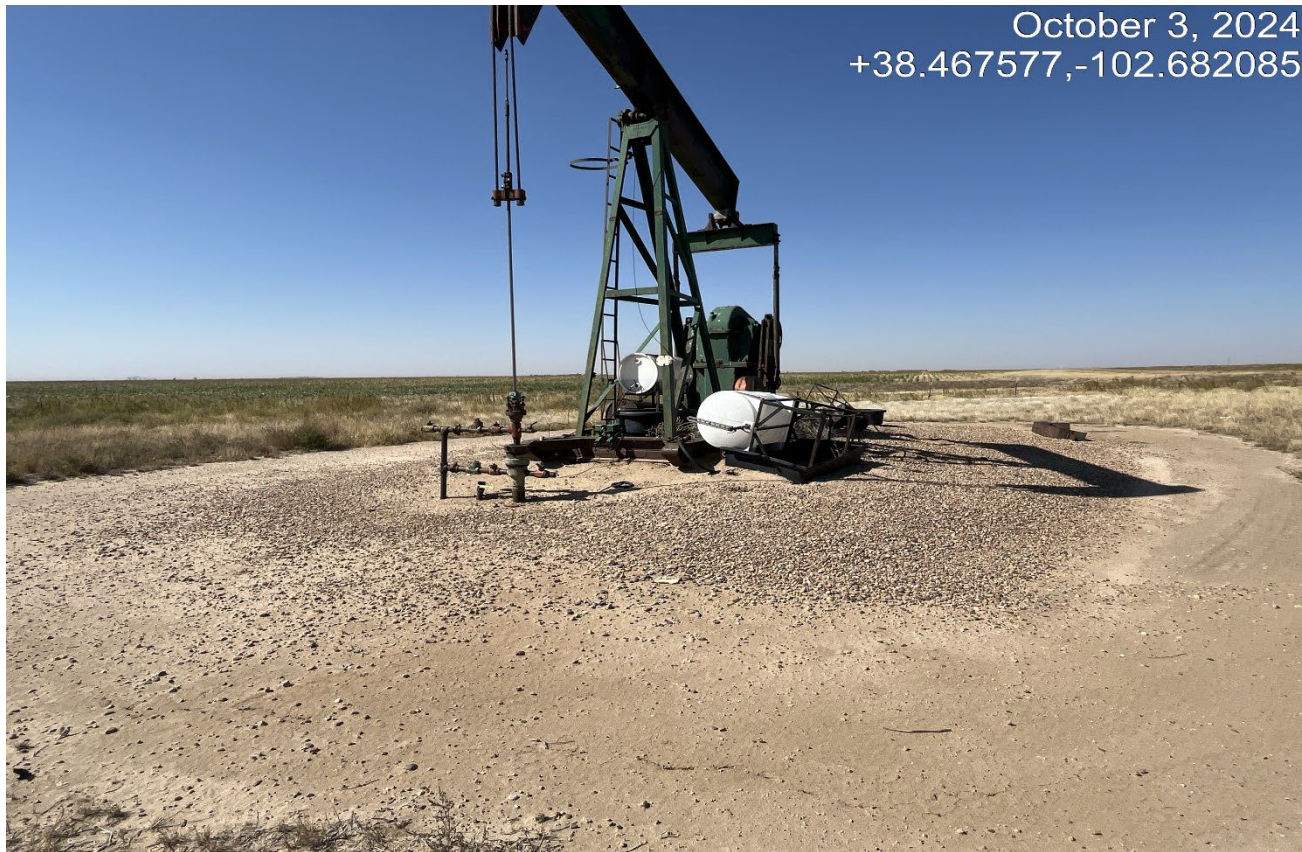
Photo 8. Facing toward the wellsite. The chemical container has tipped over. Previous CA was not completed.

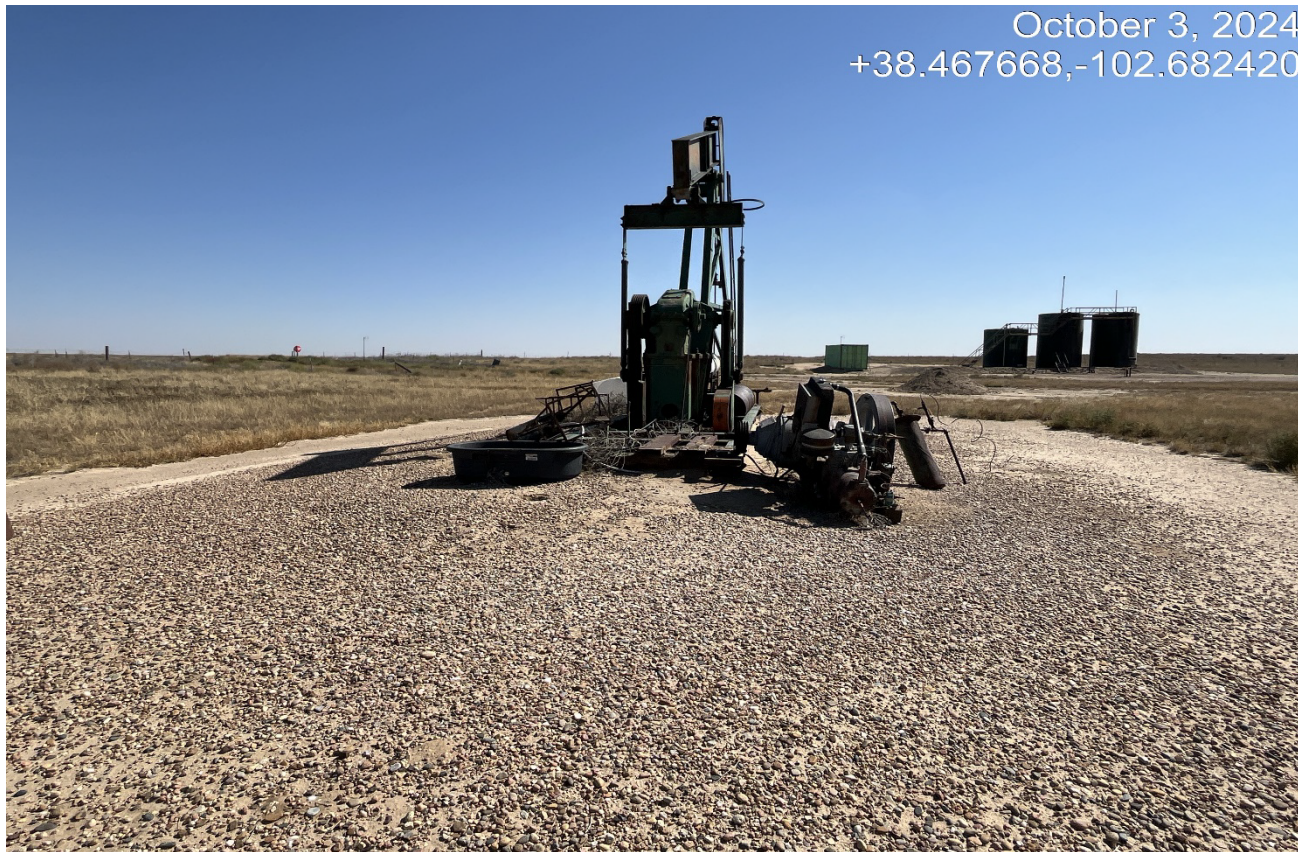
Photo 9. The chemical container at the backside has also tipped over. There are unused parts of the pumpjack laying on the ground that need to be removed.
