Inspection Photos
Location: Sheryl Lynn 22-31
Location ID: 308912
API # 05-071-08798

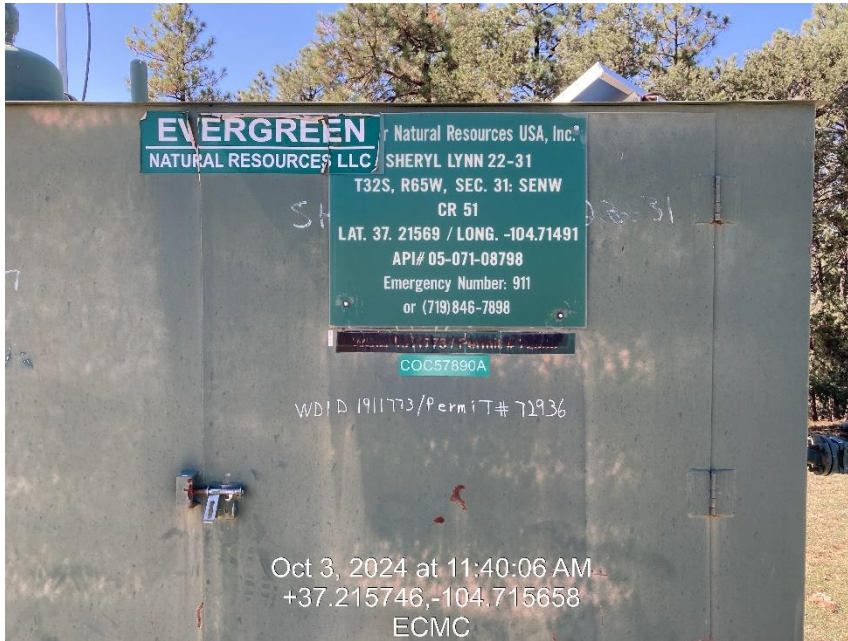
Photo 1 –Well placard on meter house

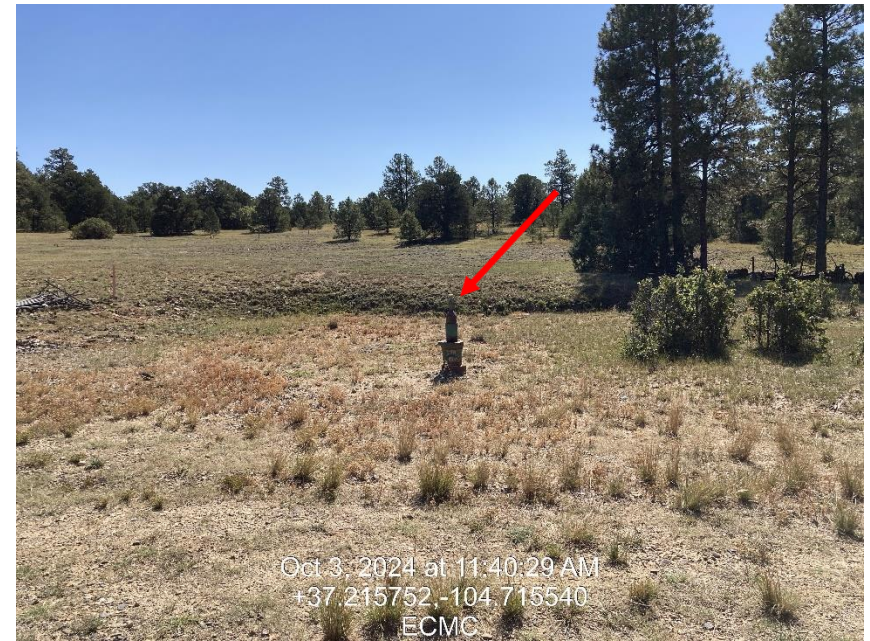
Photo 2 – KV wellhead and equipment

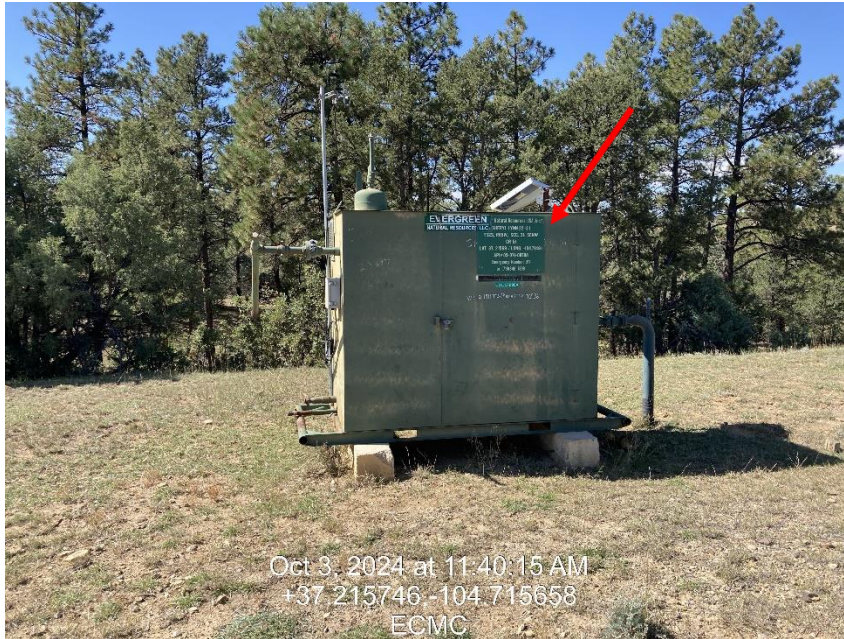
Photo 3 – Meter house

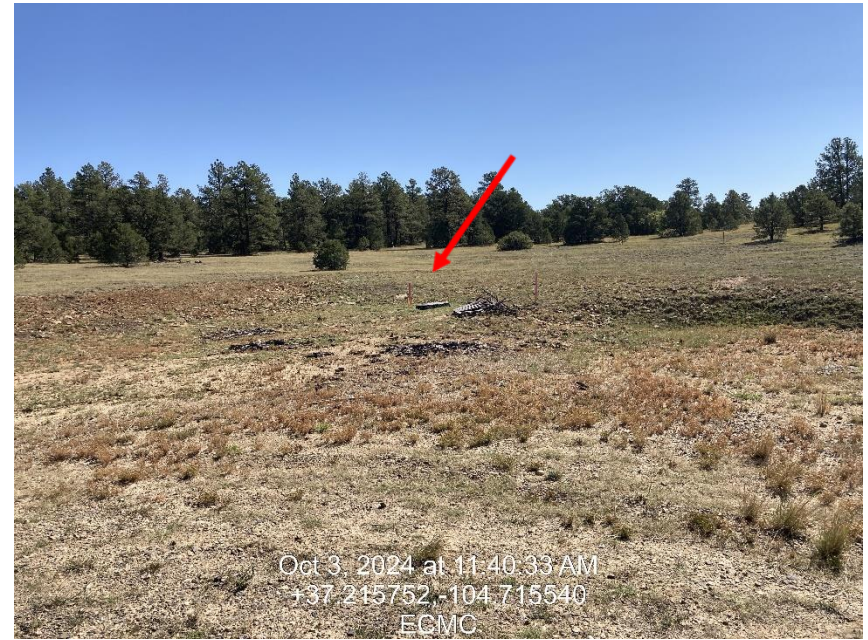
Photo 4 – Wood pallets on location

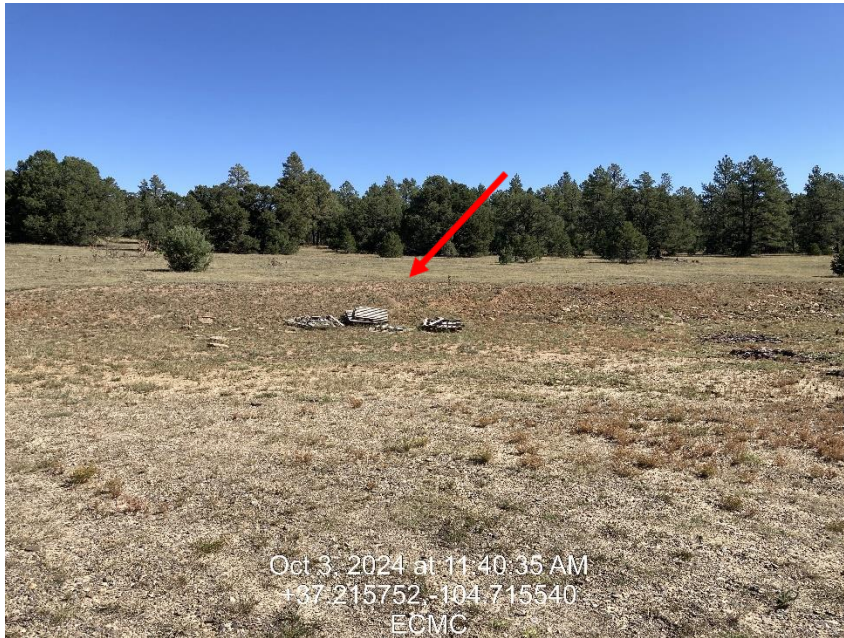
Photo 5 – Wood pallets on location

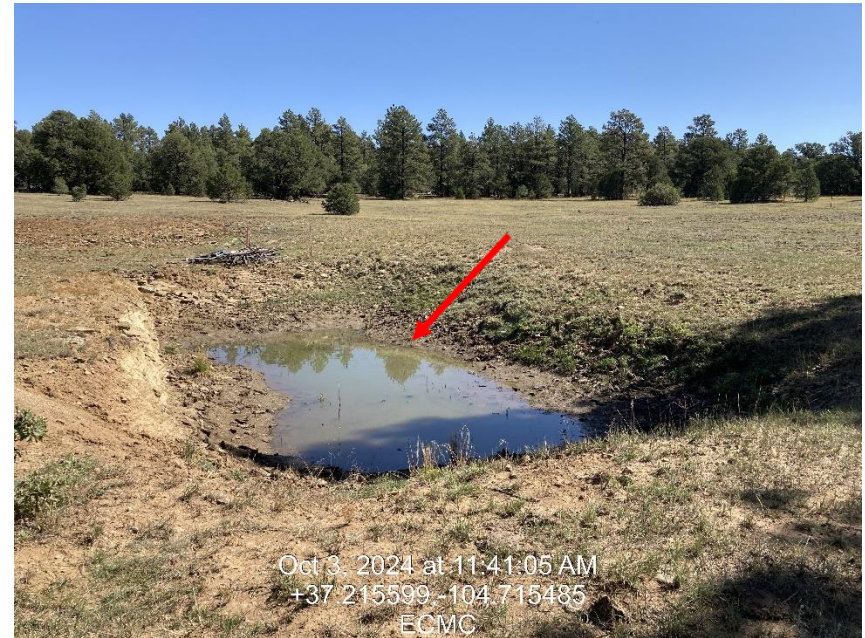
Photo 6 – Pit Facility ID 301072

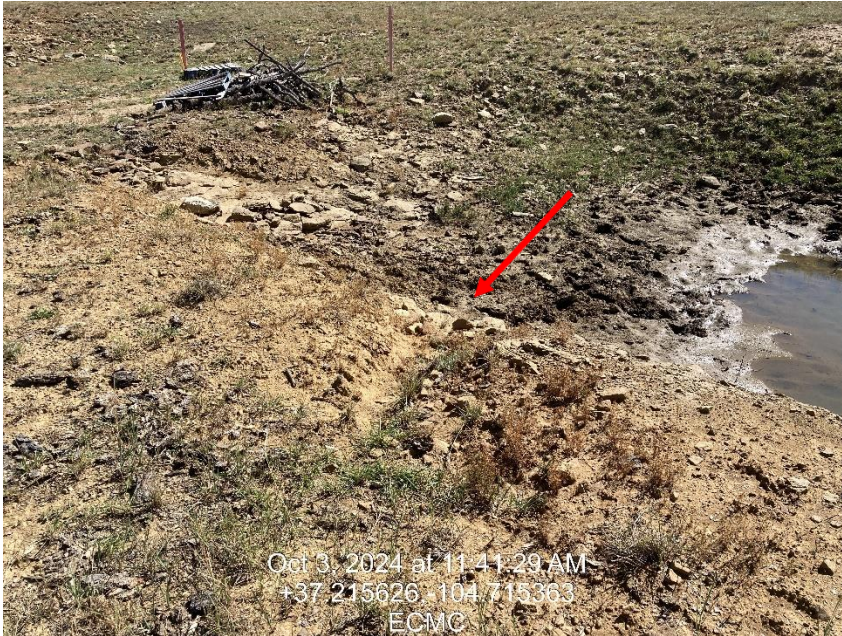
Photo 7 – Pit Facility ID 301072, Stormwater entering pit

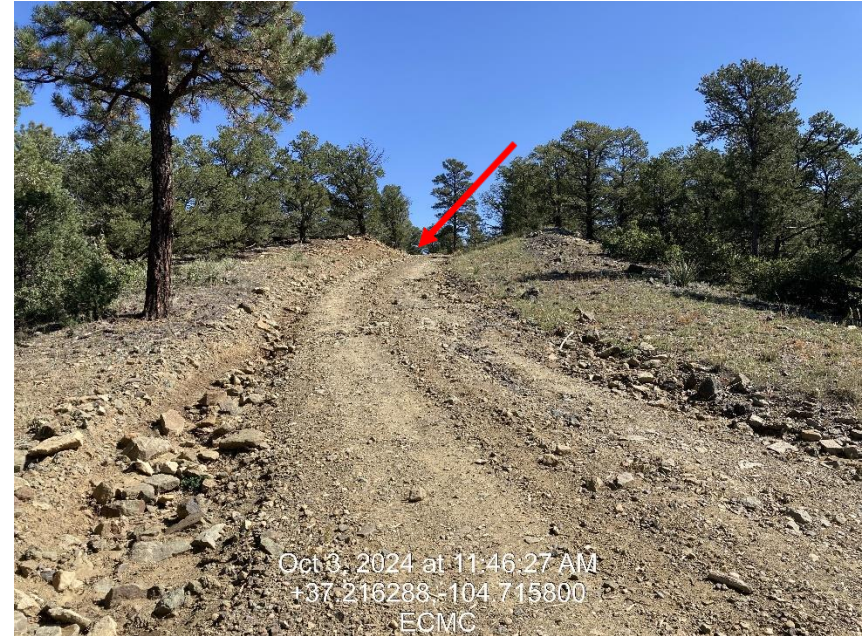
Photo 8 – Erosion along access road
