Inspection Photos
Location: Fanny 34-29
Location ID: 308866
API # 05-071-08744

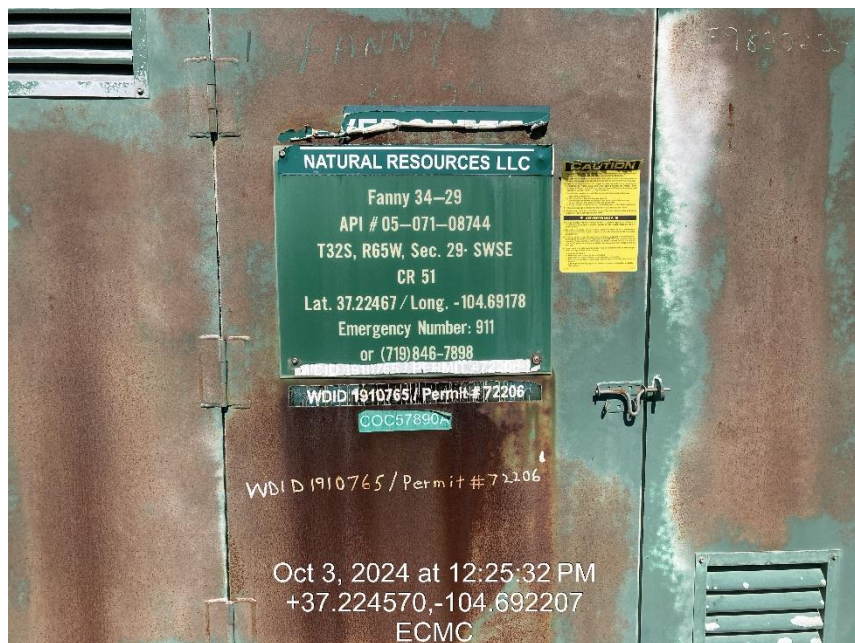
Photo 1 –Well placard on meter house

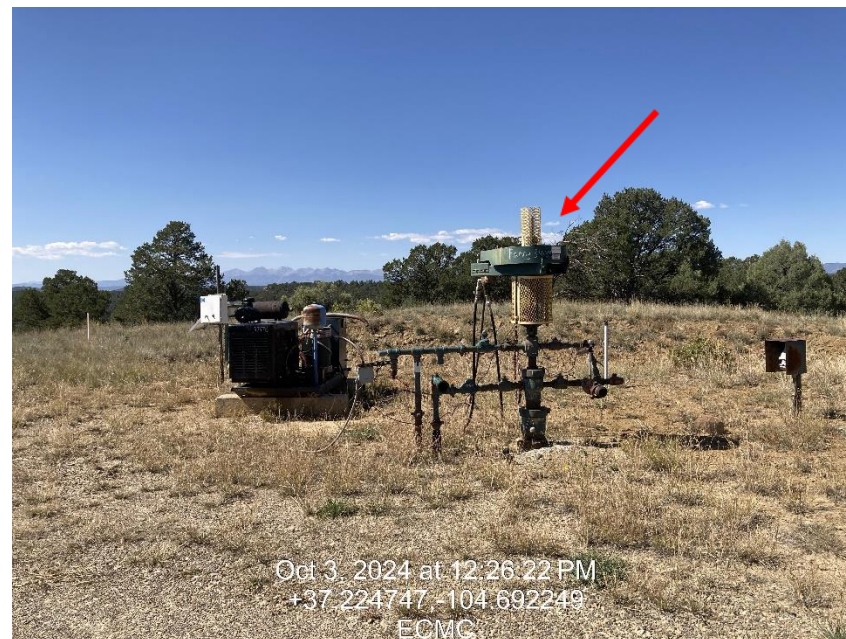
Photo 2 – KV wellhead and equipment

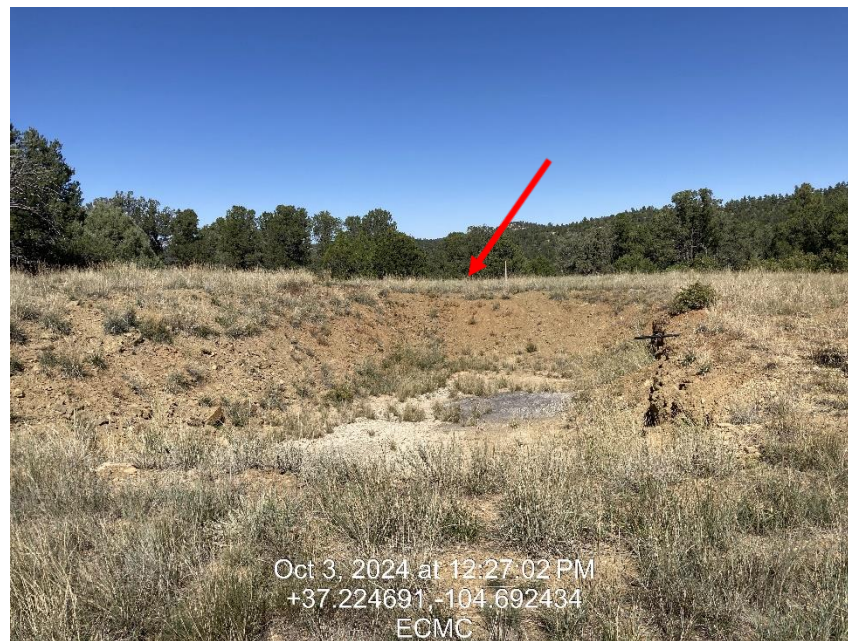
Photo 4 – Pit Facility ID 285706

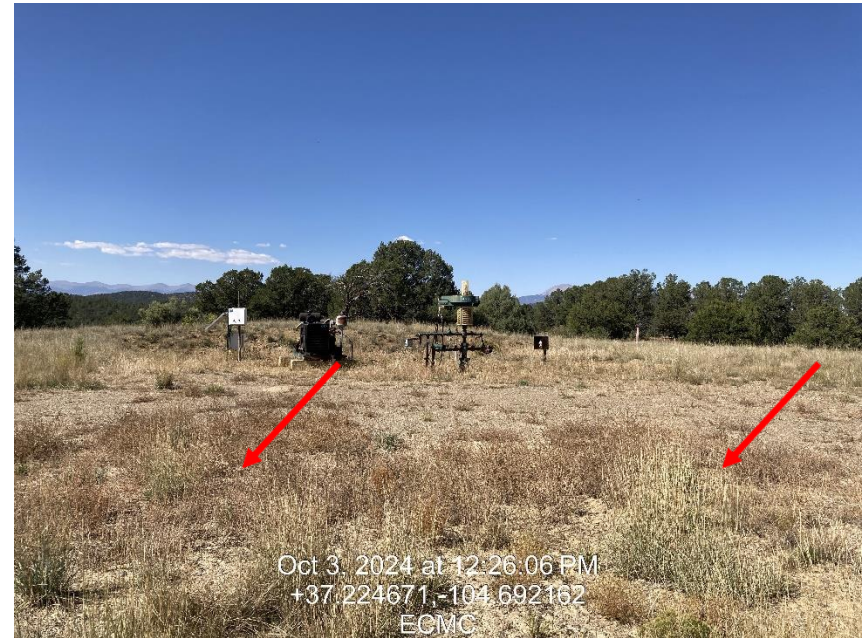
Photo 6 – Undesirable weeds

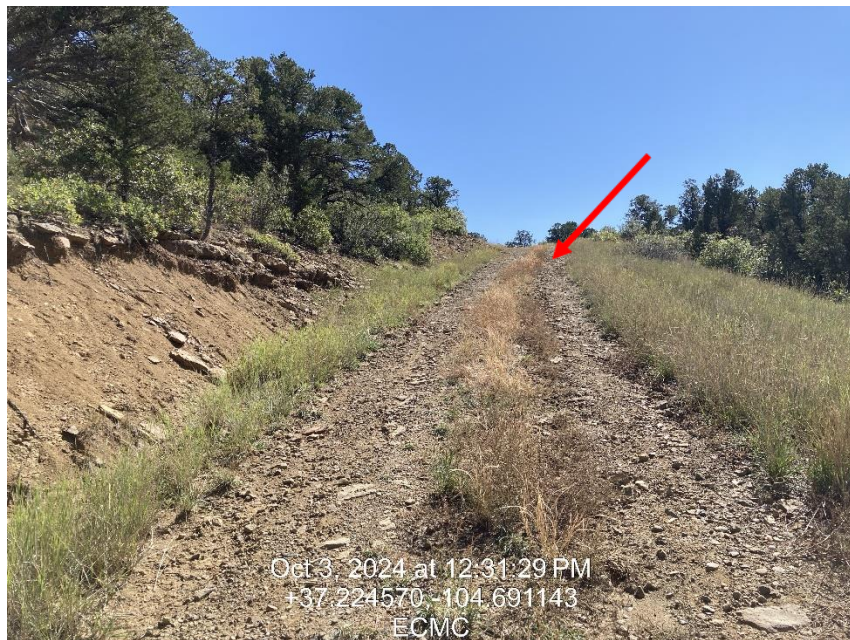
Photo 7 – Erosion along access road

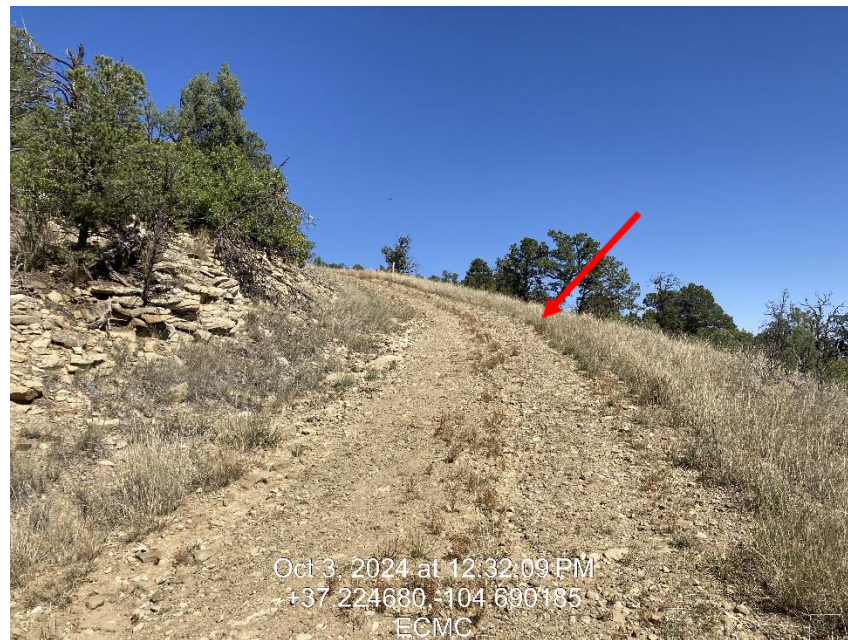
Photo 8 – Erosion along access road
