# Inspection Photos

Loc: 324797

Operator: WESTERN OPERATING COMPANY

Inspection Date: 10/3/2024

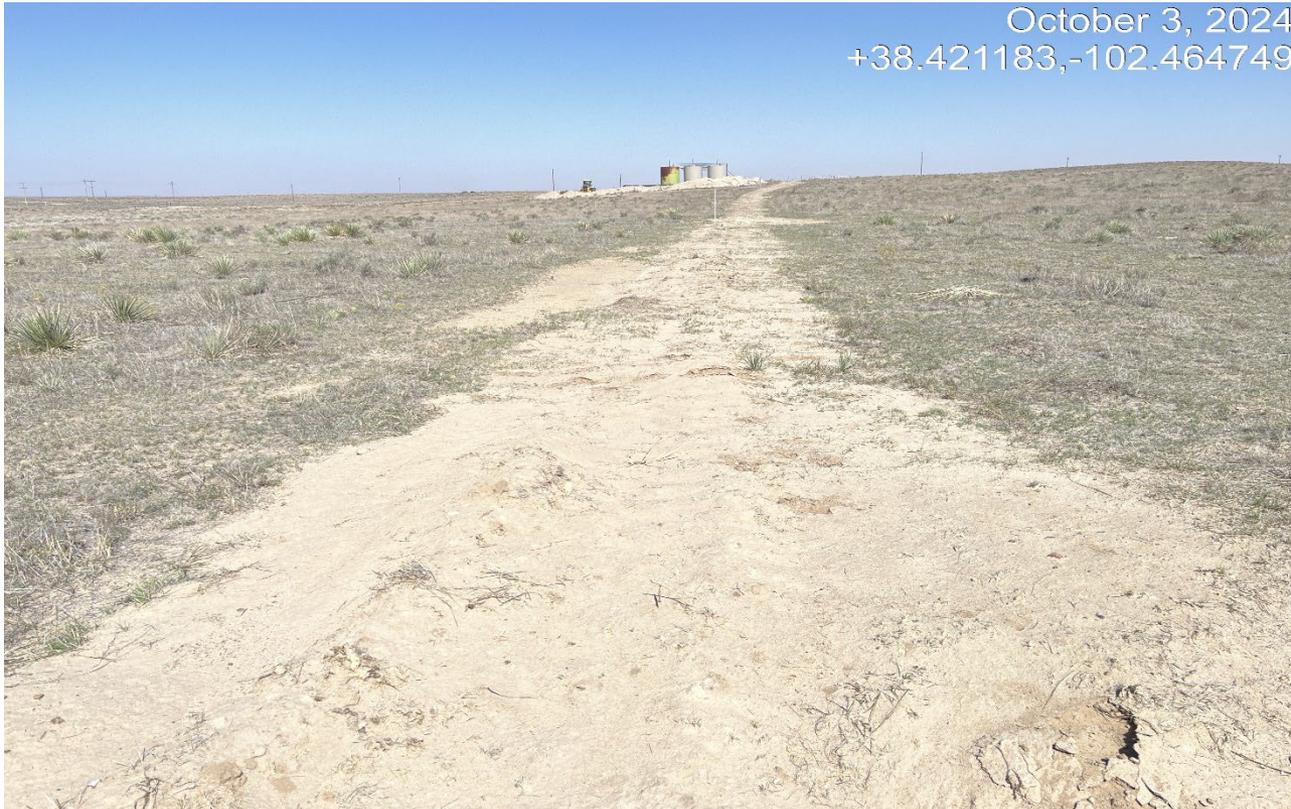
**Photo 1.** Facing north along the flowline disturbance. The soils along the flowline need to be regraded and reclaimed.

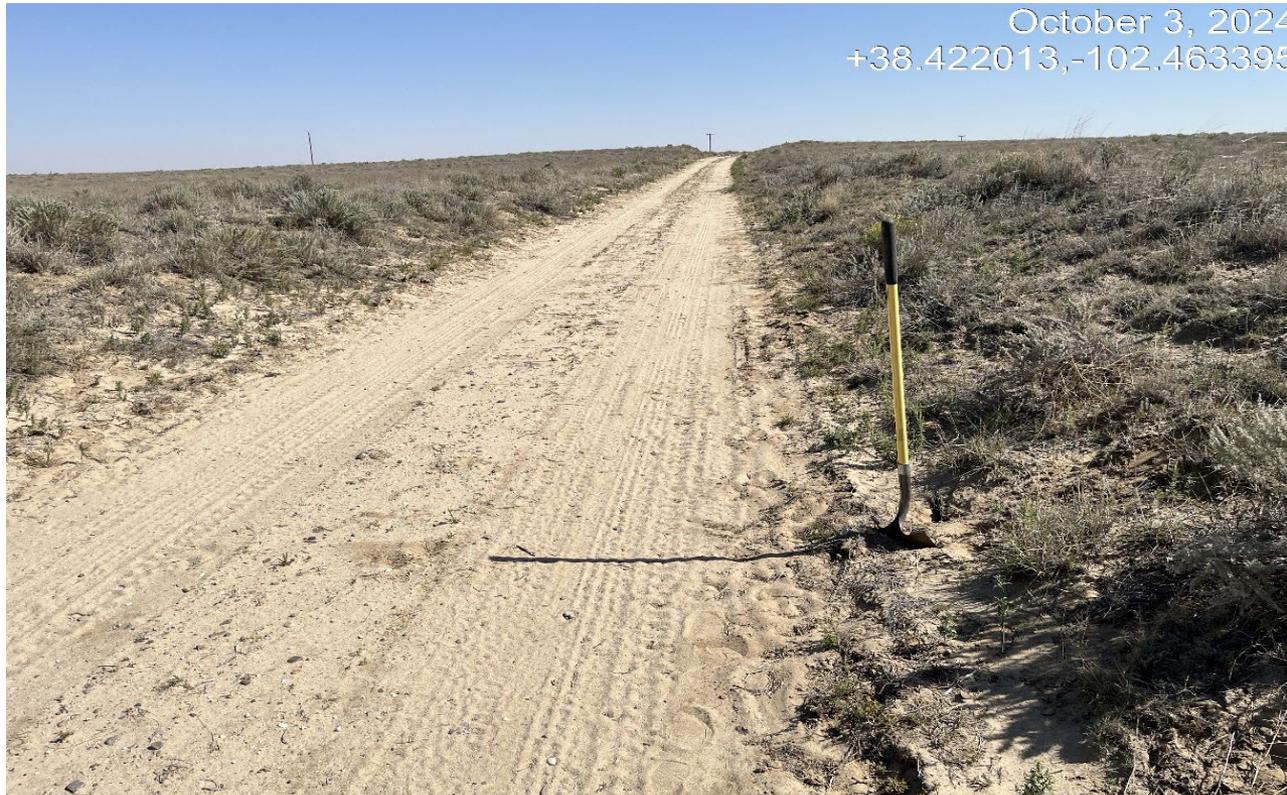
**Photo 2.** Facing east along the main access road. The road is below the grade of the land and causes issues with snow accumulation during the winter.

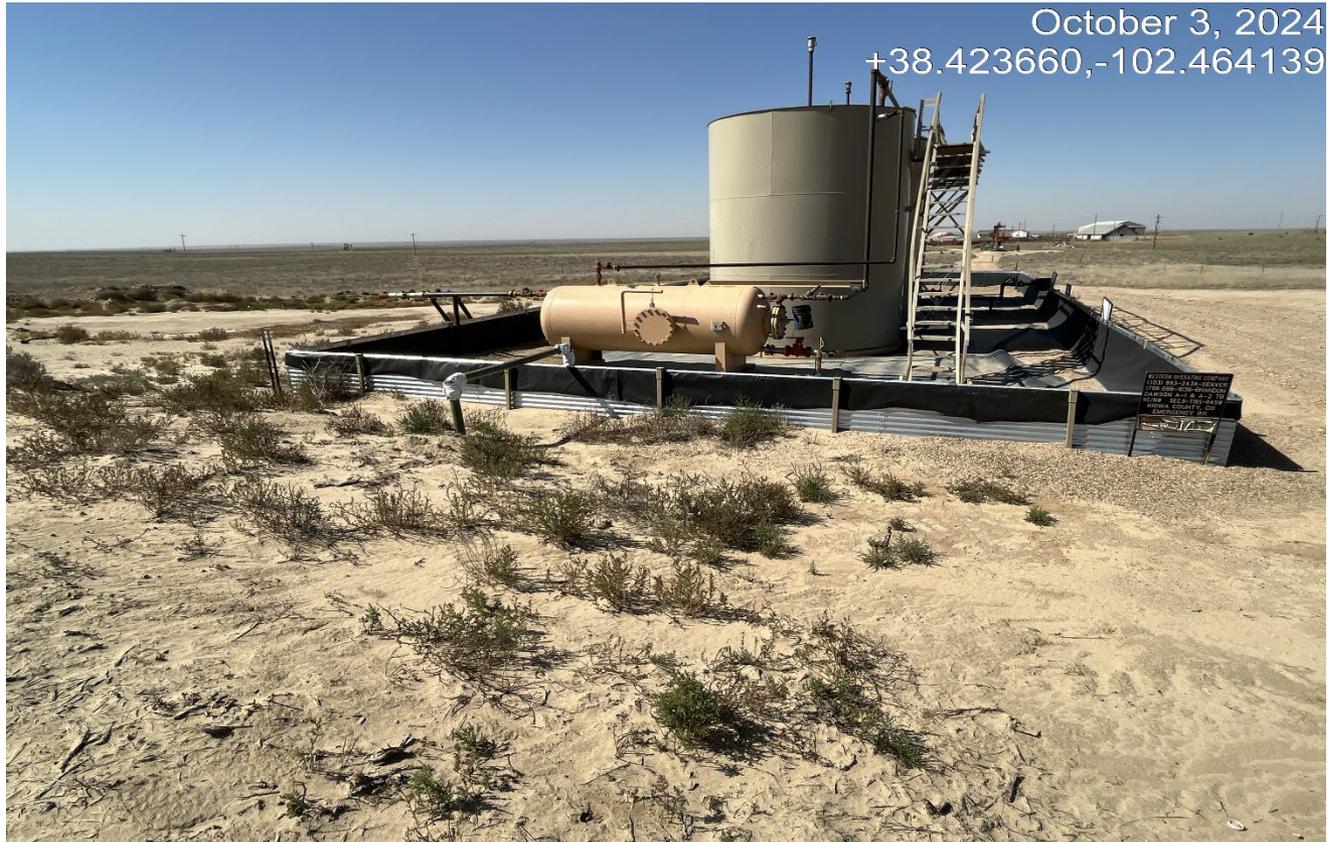
**Photo 3.** Facing east at the tank battery. Tanks have been installed with secondary containment.

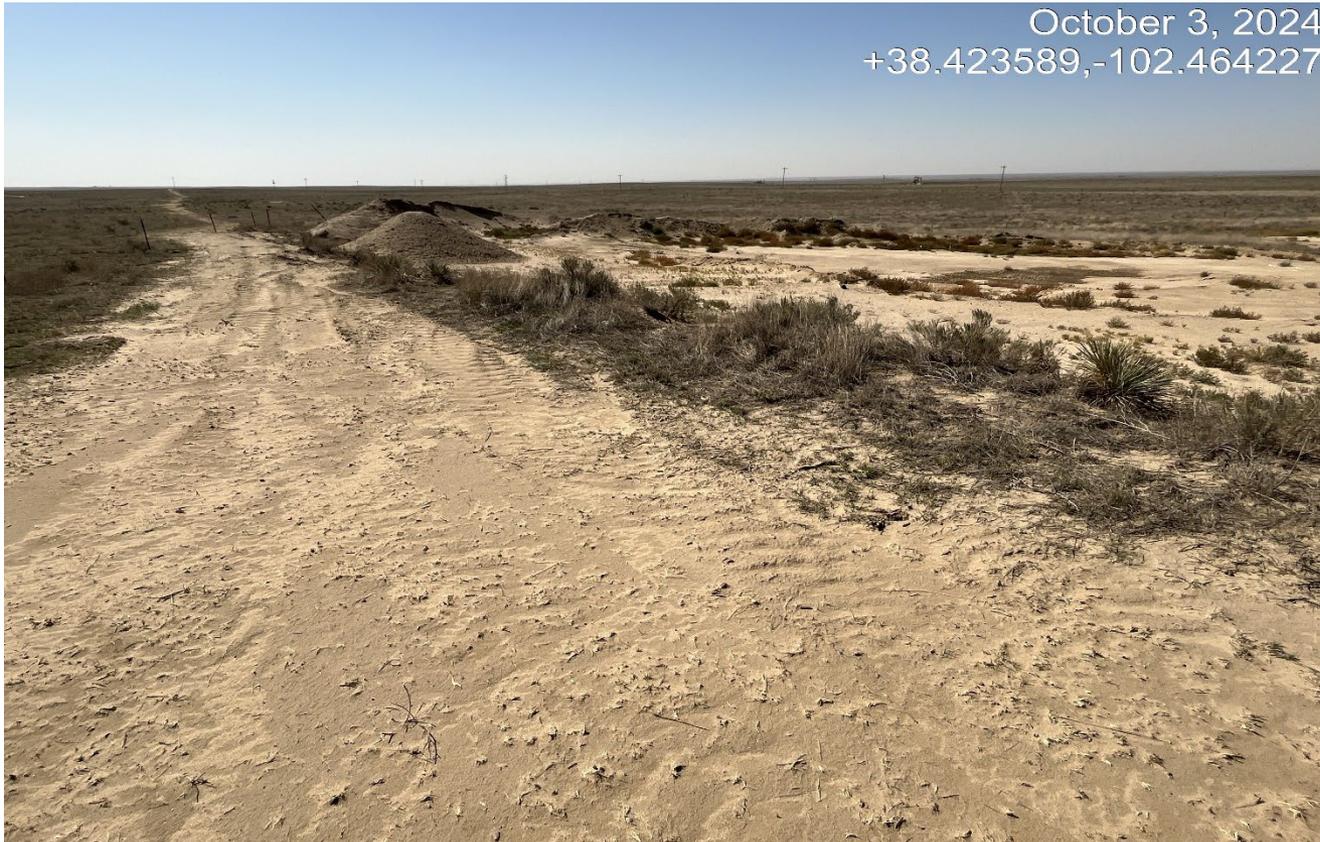
**Photo 4.** Facing southwest at the tank battery location. The flowline disturbance must be reclaimed and stabilized..

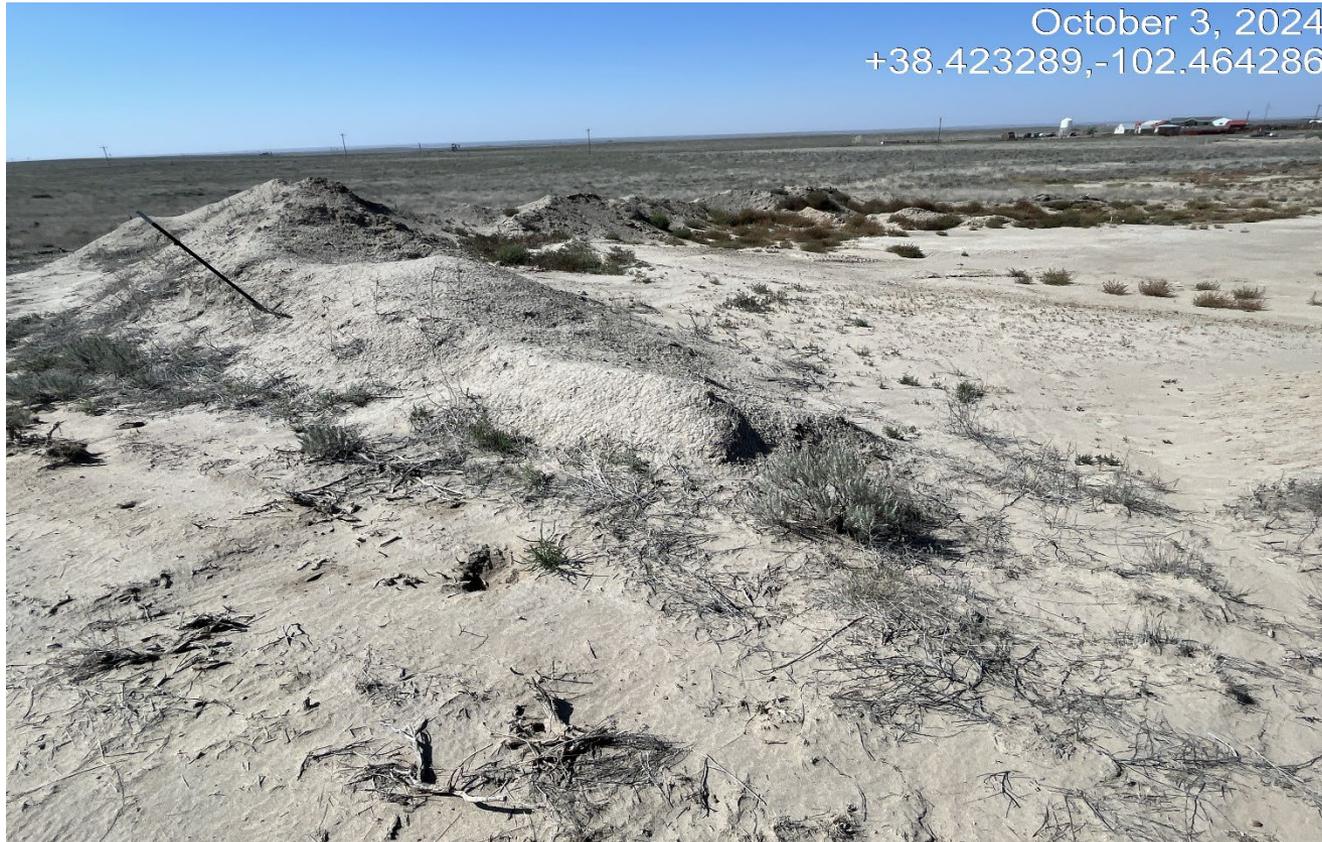
**Photo 5.** Facing toward the stockpile of soil which remains bare and susceptible to erosion.

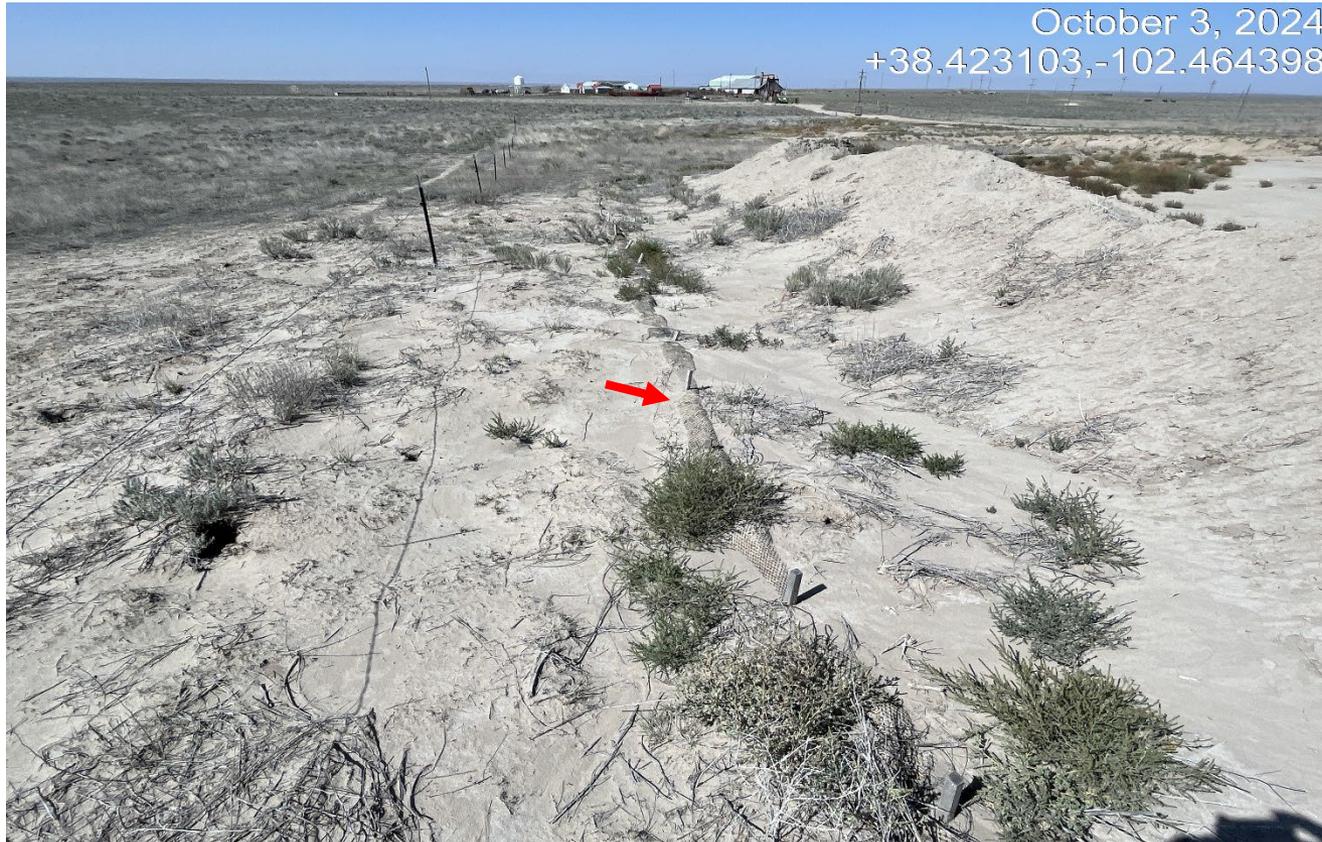
**Photo 6.** Facing east at the south side of the tank battery. It appears the stock piled soils have wind blown and almost completely covered up the perimeter wattles shown at red arrow.

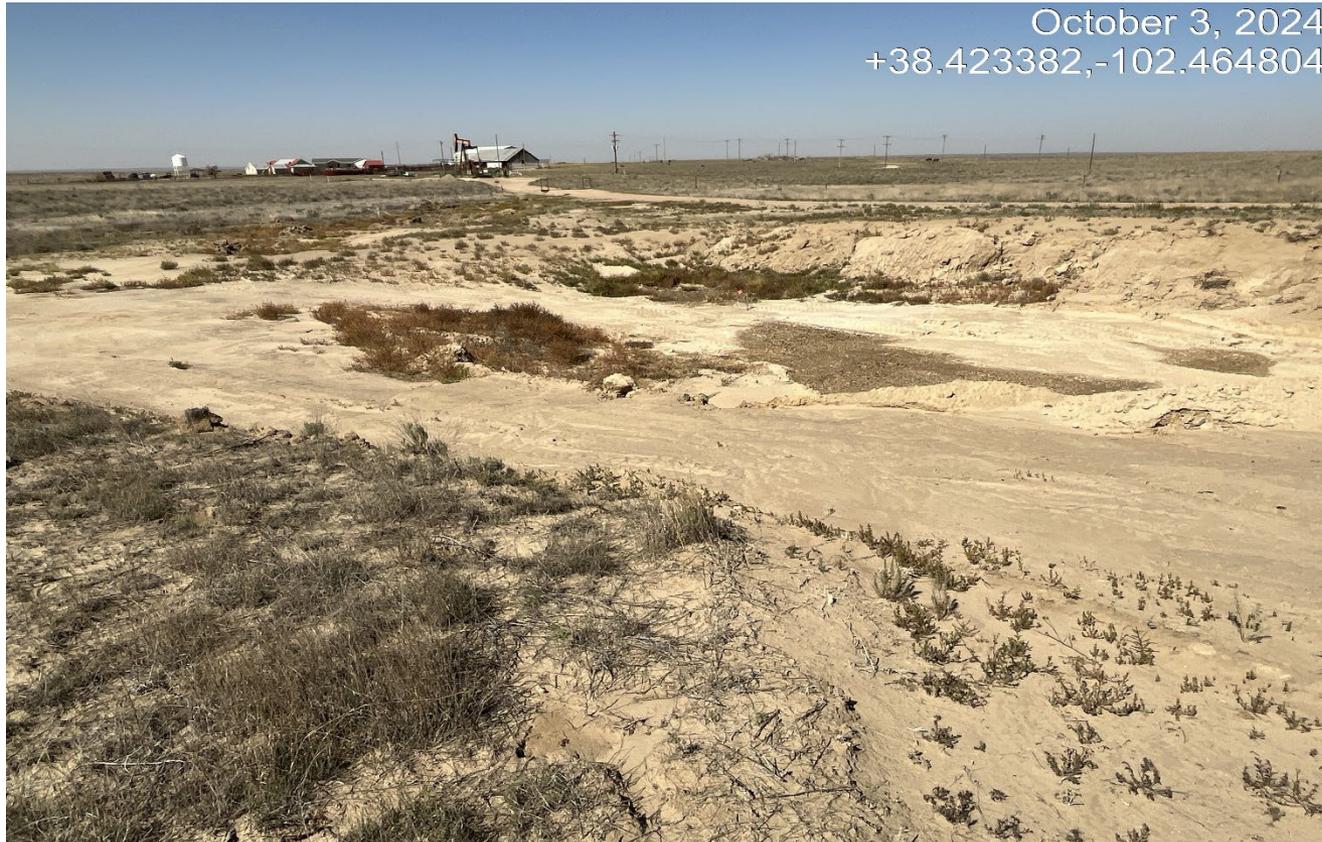
**Photo 8.** Facing northwest toward the remediation disturbance.

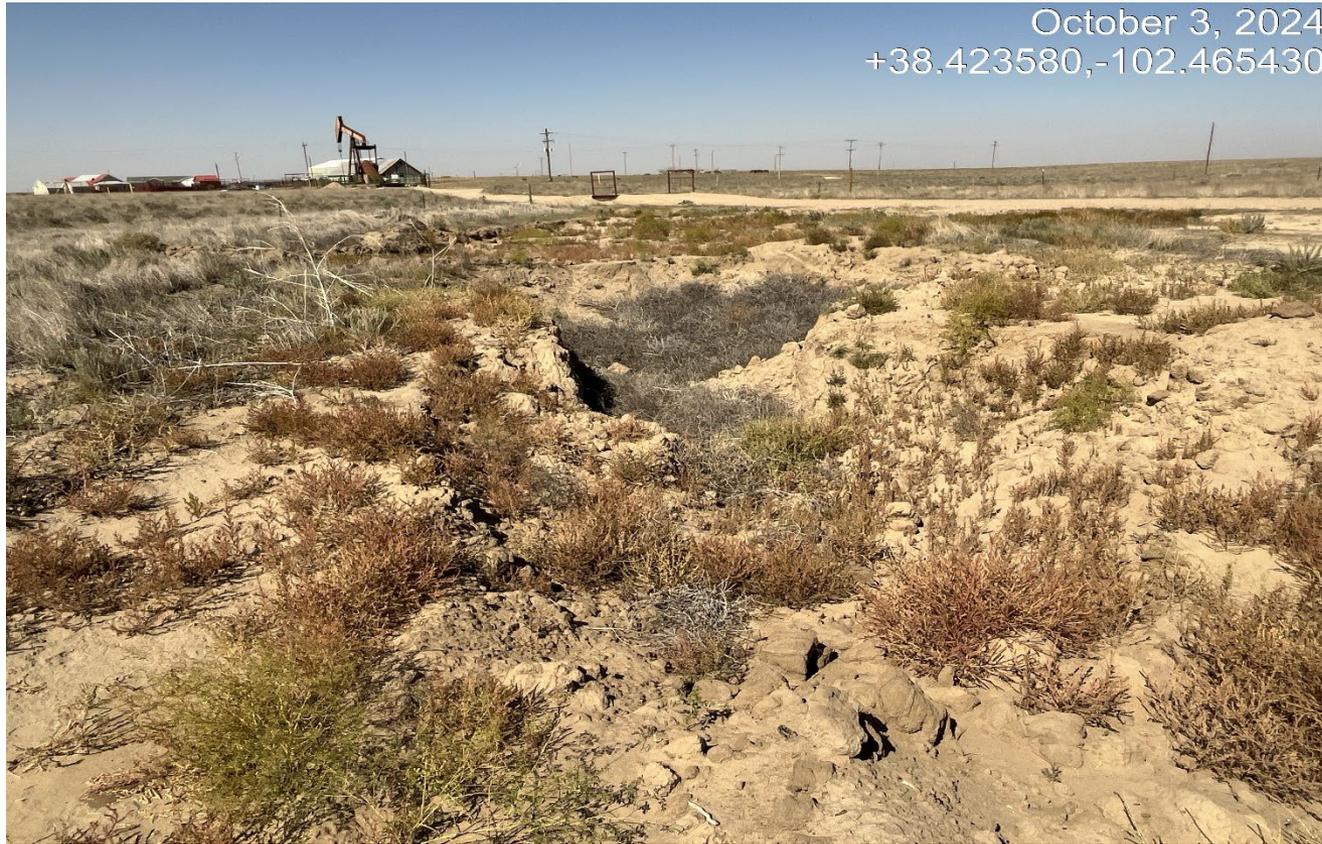
**Photo 9.** Facing northwest toward the remediation disturbance.
