Interim Reclamation and Stormwater Inspection

Date:09/30/2024

Operator: WESTERN OPERATING COMPANY - 95620

Location ID: 312292

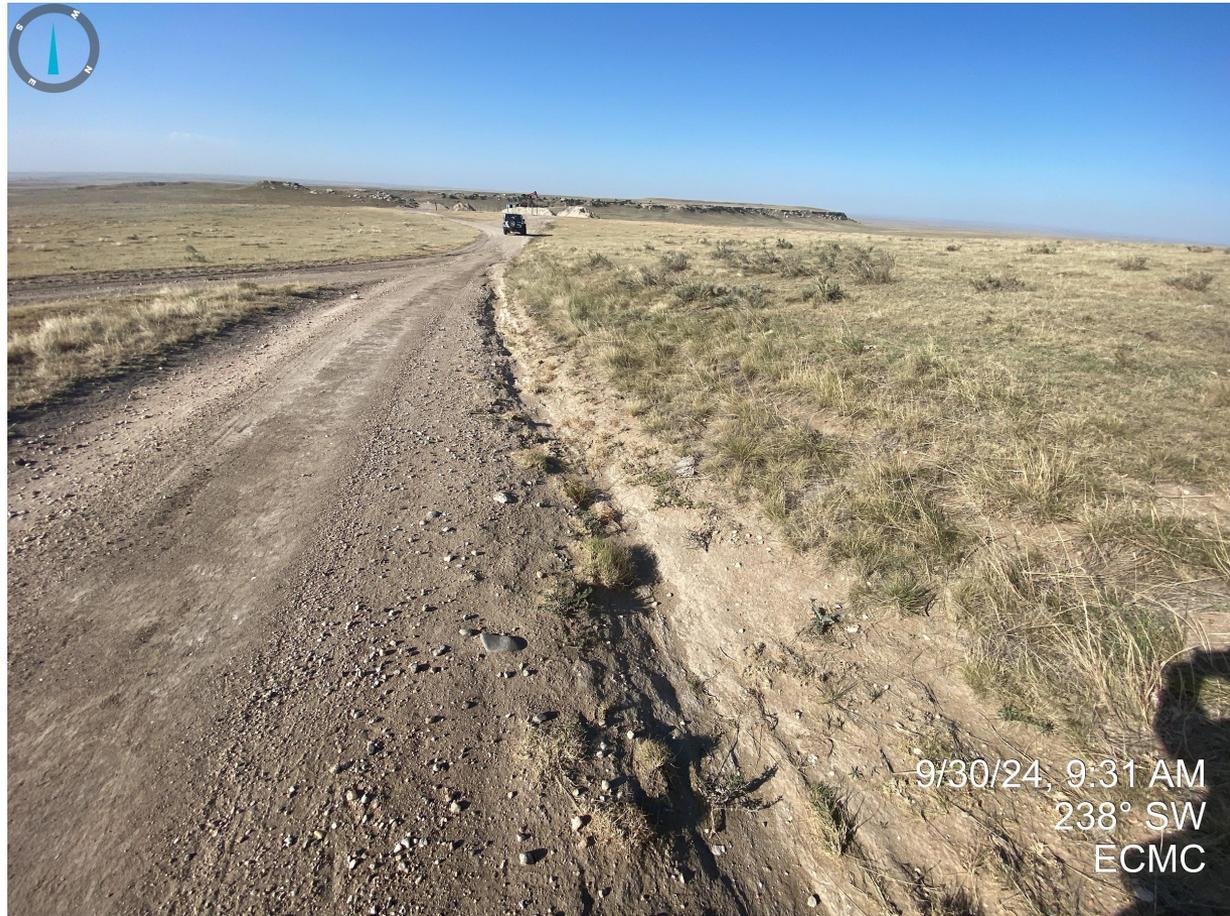
Photo 1. Erosion degradation observed along the start of the access road.

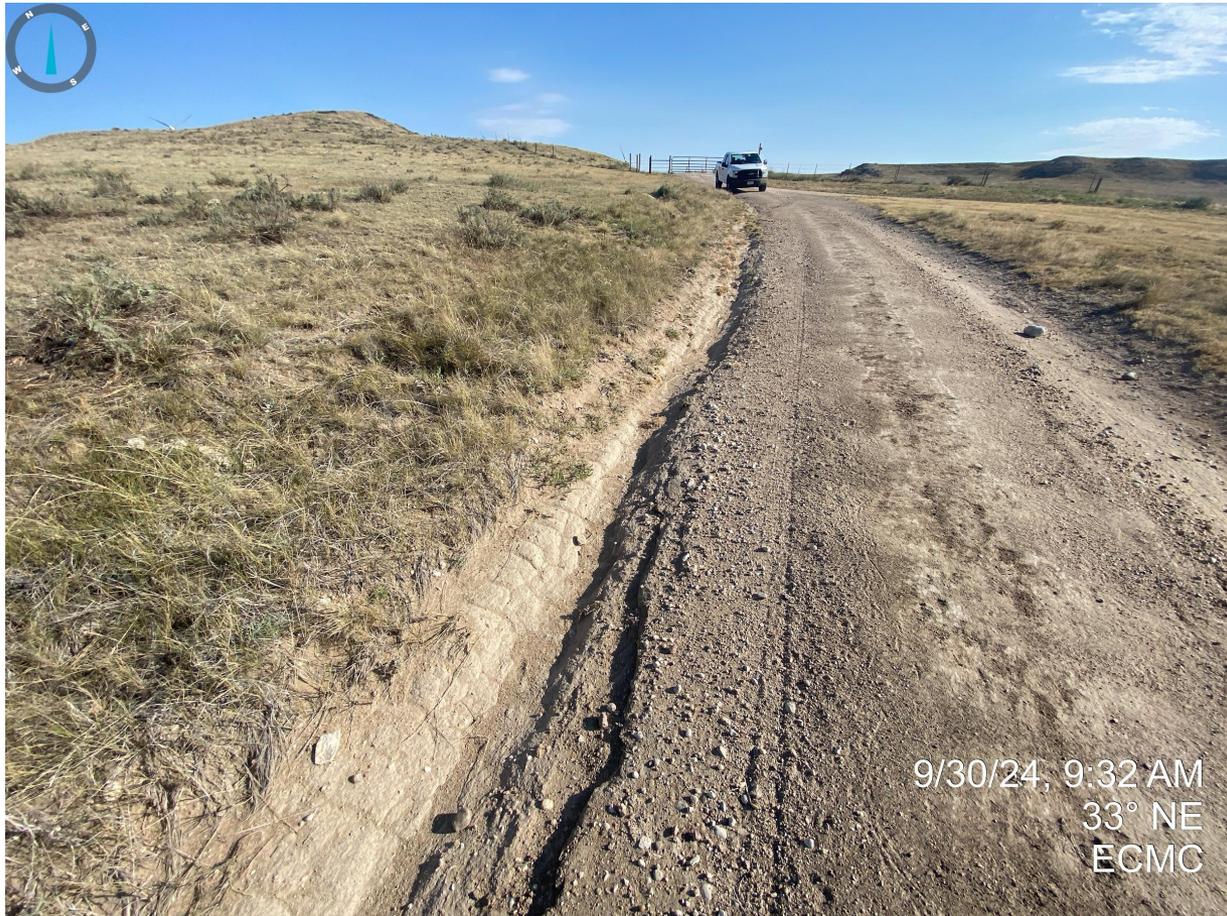
Photo 2. Erosion degradation observed along the start of the access road.

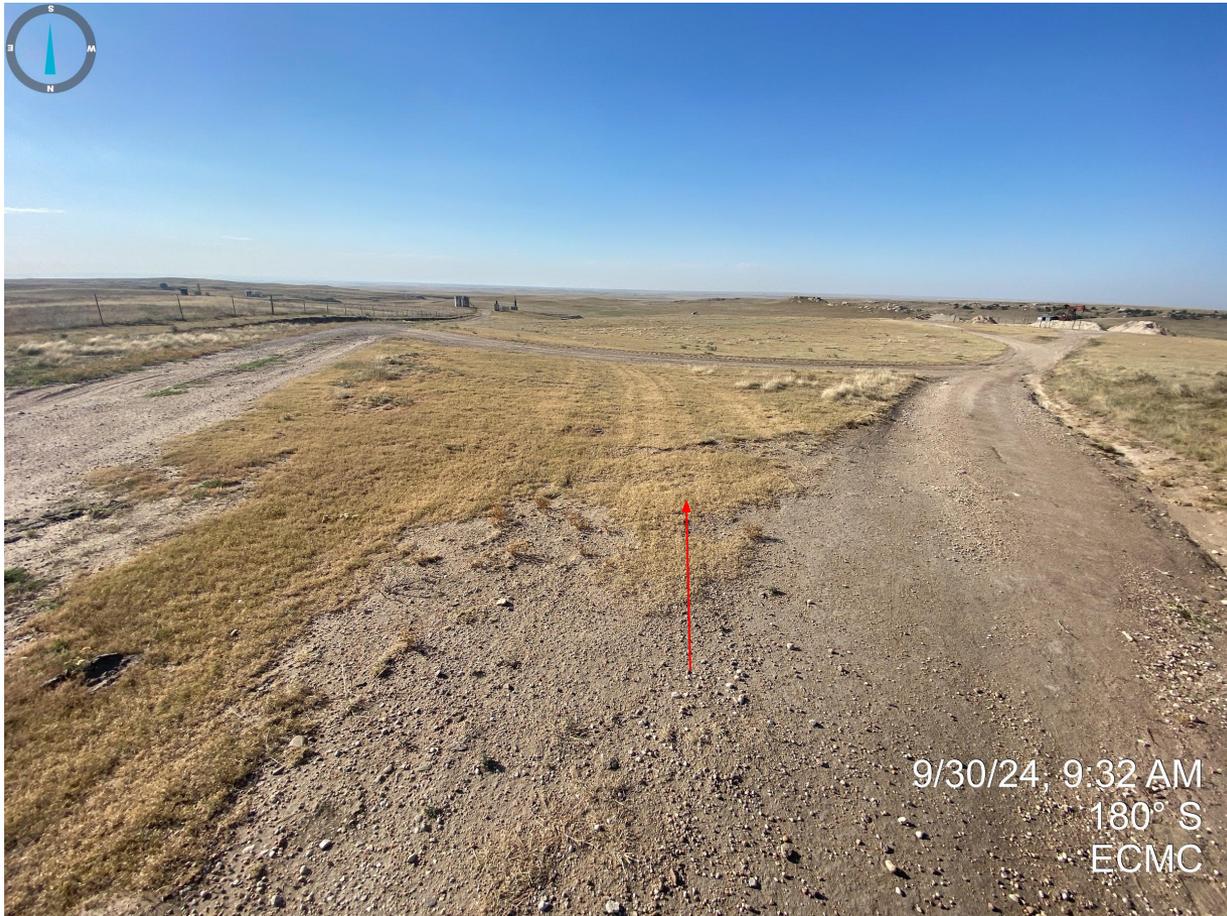
Photo 3. Taken near the Y intersection of the access road. Vehicle traffic observed outside of the established access roads. Additional reclamation activities may be required if the disturbed area fails to meet Rule 1003 standards.

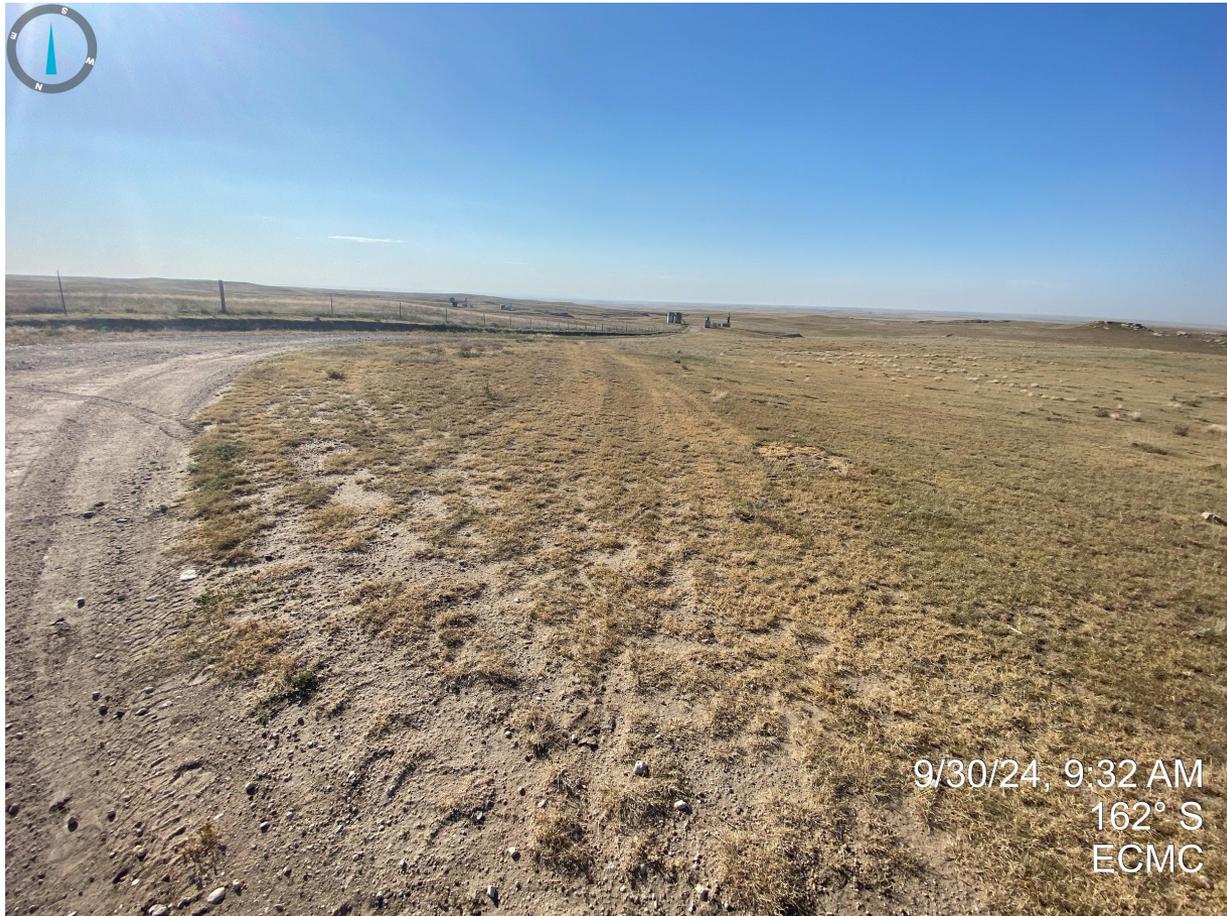
Photo 4. Continued from Photo 3; see comments in previous photo.

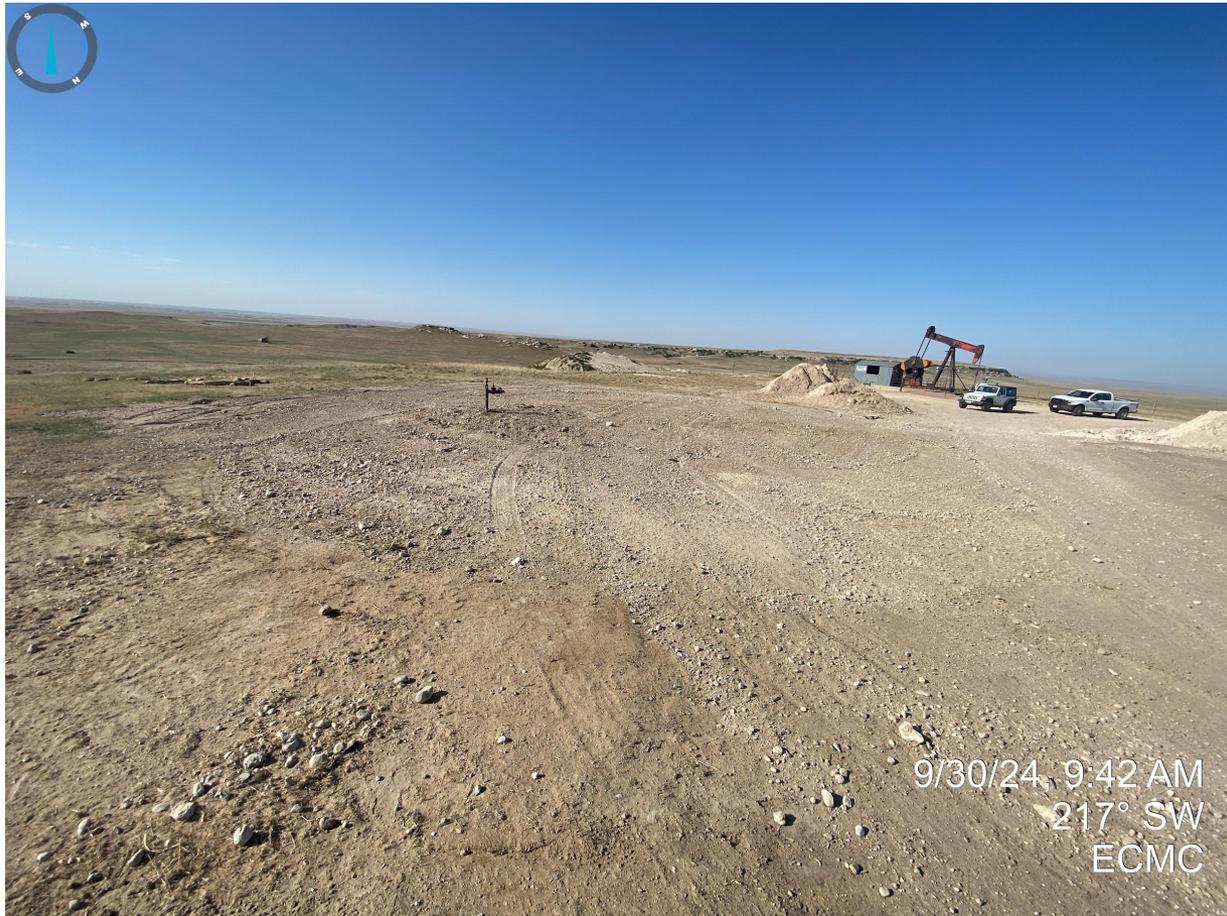
Photo 5. Vertical heater treater appears to have been removed.

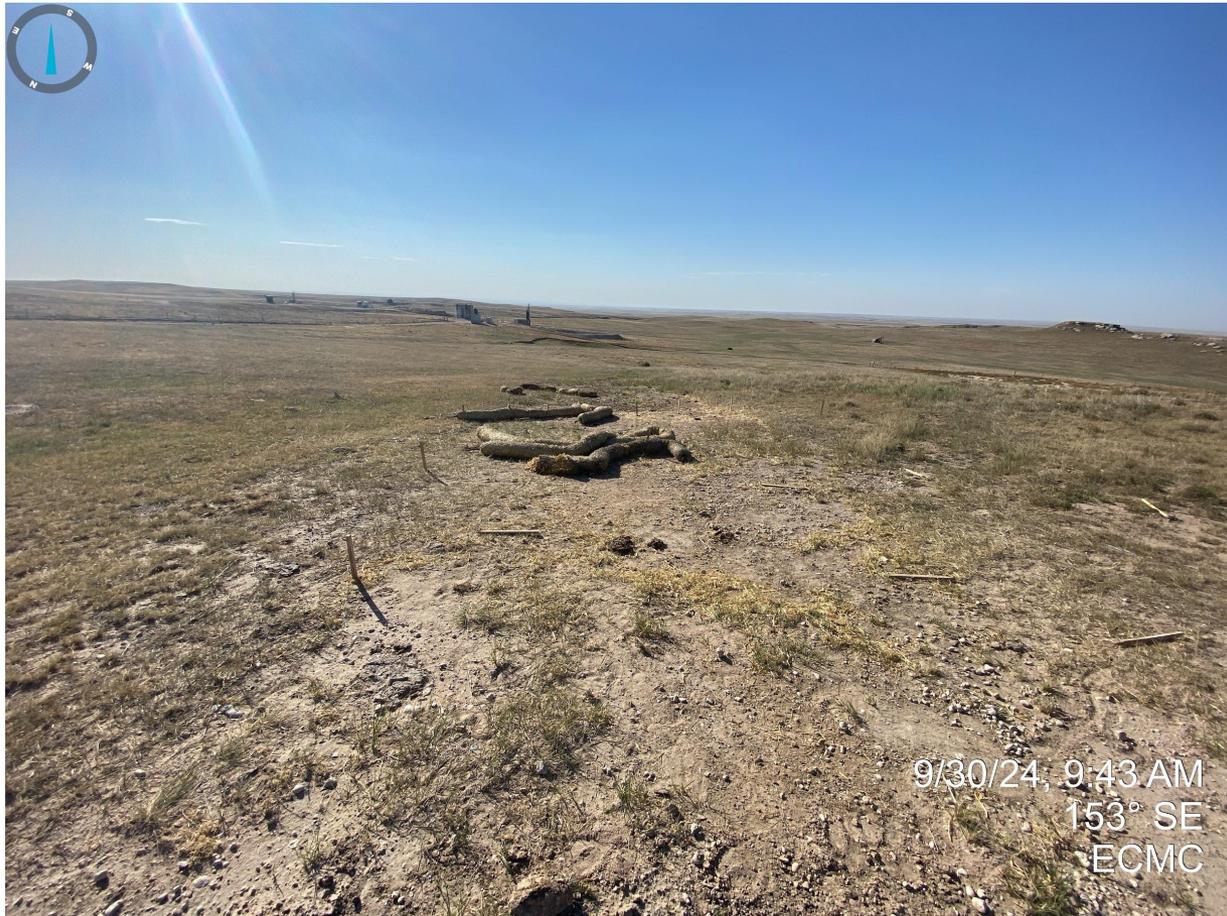
Photo 6. Stormwater control measures south of the former heater treater remain inadequate; additional maintenance and/or implementation of more robust stormwater control measures/BMPs required.

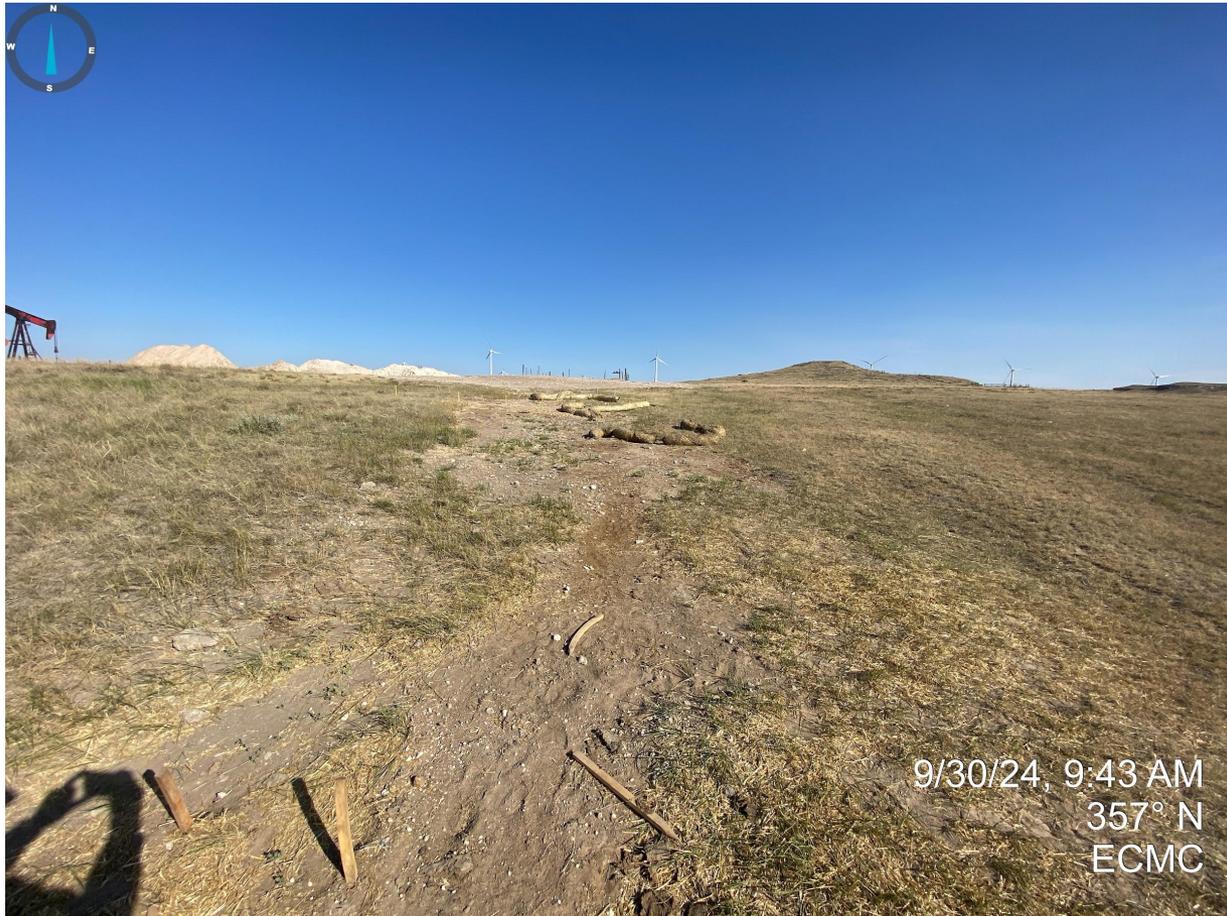
Photo 7. Continued from Photo 6. Erosion degradation evident from lack of proper stormwater control measures.

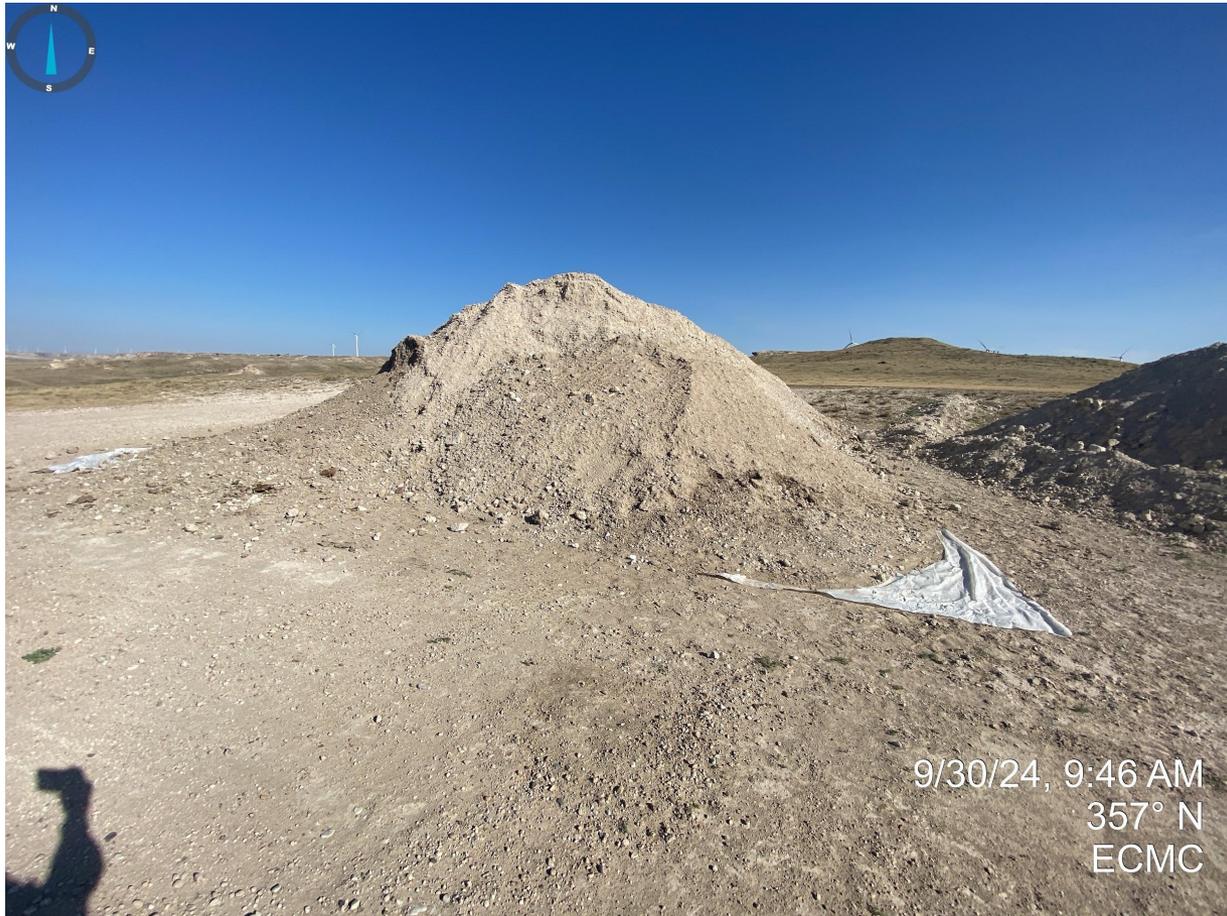
Photo 8. Stockpile immediately adjacent to the wellhead (northeast) without proper stormwater control measures/berms to contain the soil; no signage observed.

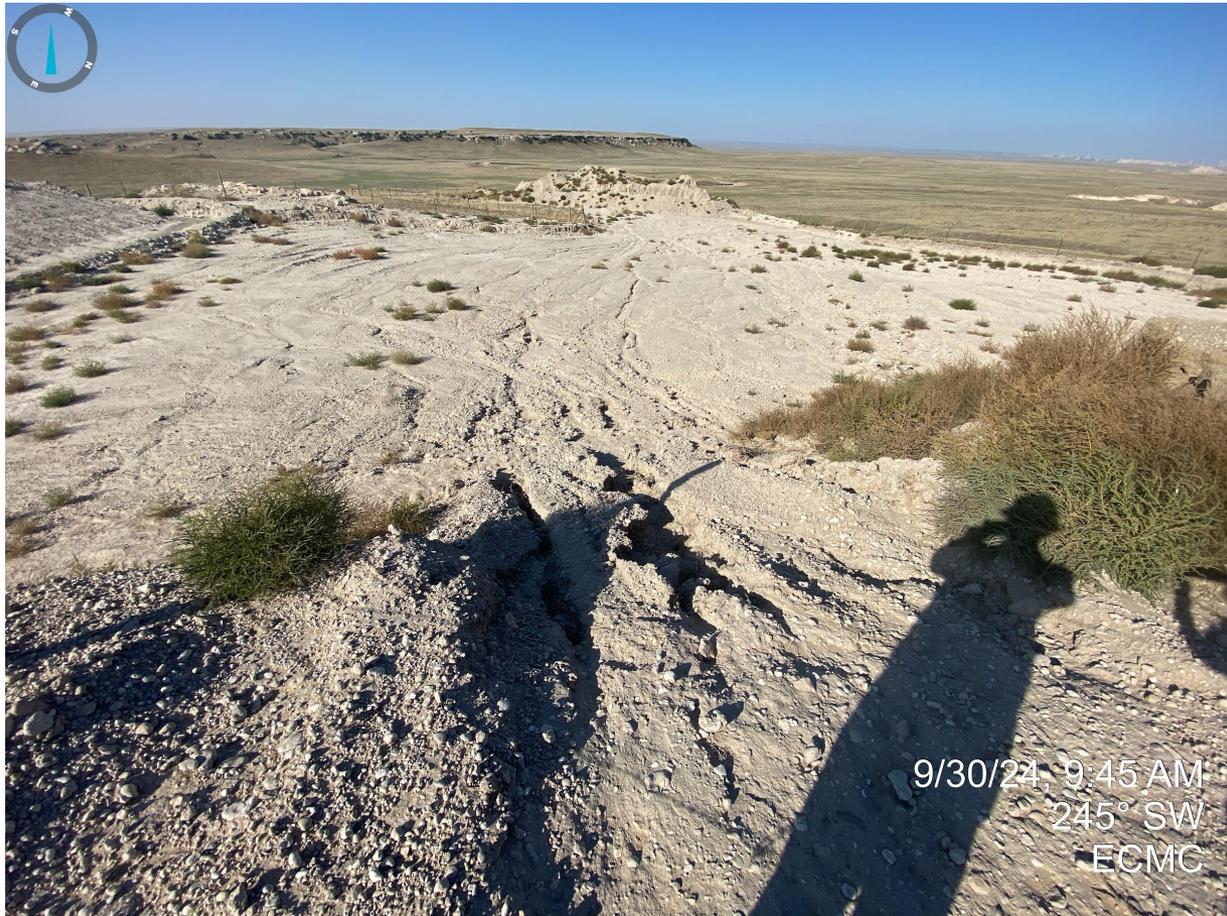
Photo 9. Erosion degradation and undesirable vegetation observed within the excavated pit.

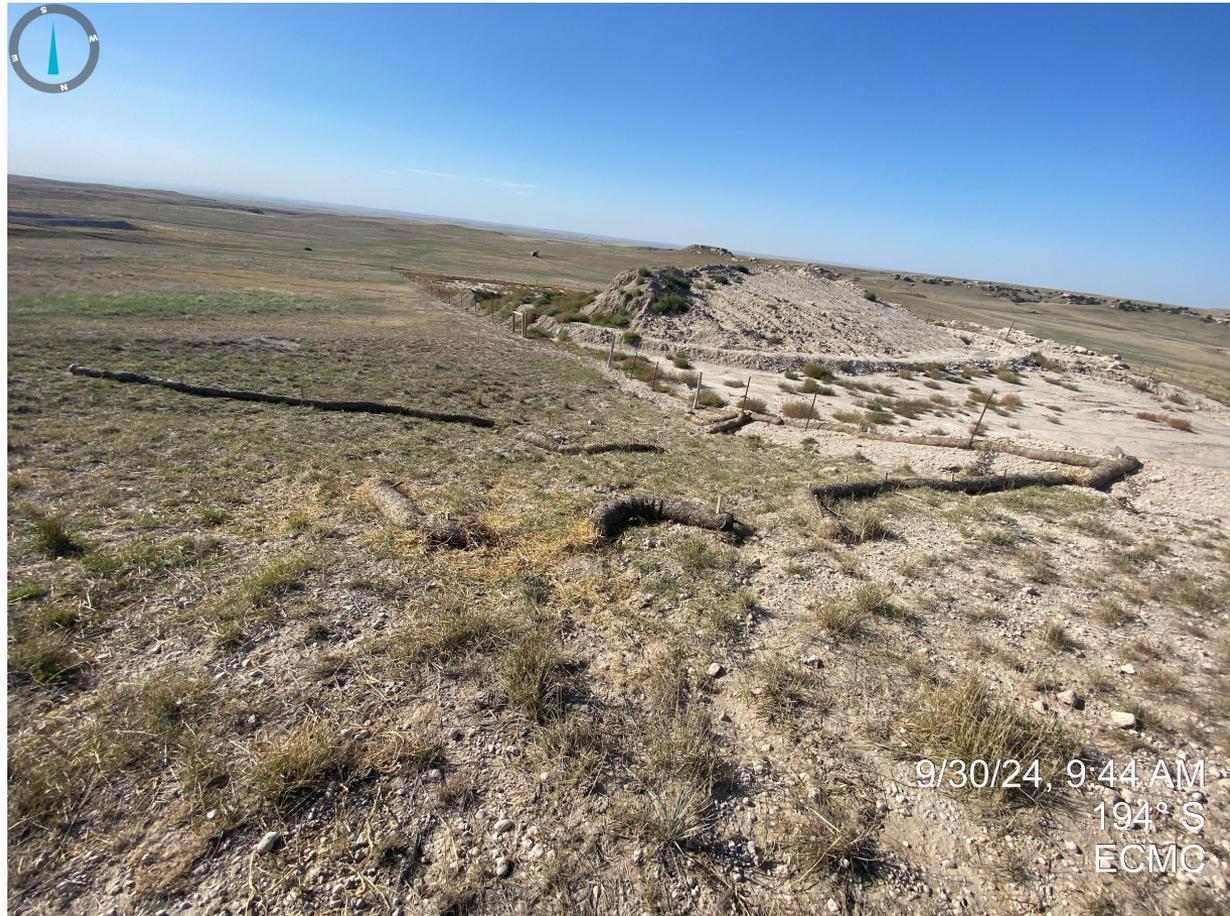
Photo 10. Stormwater control measures east of pit remain inadequate; additional maintenance and/or implementation of more robust stormwater control measures/BMPs required.

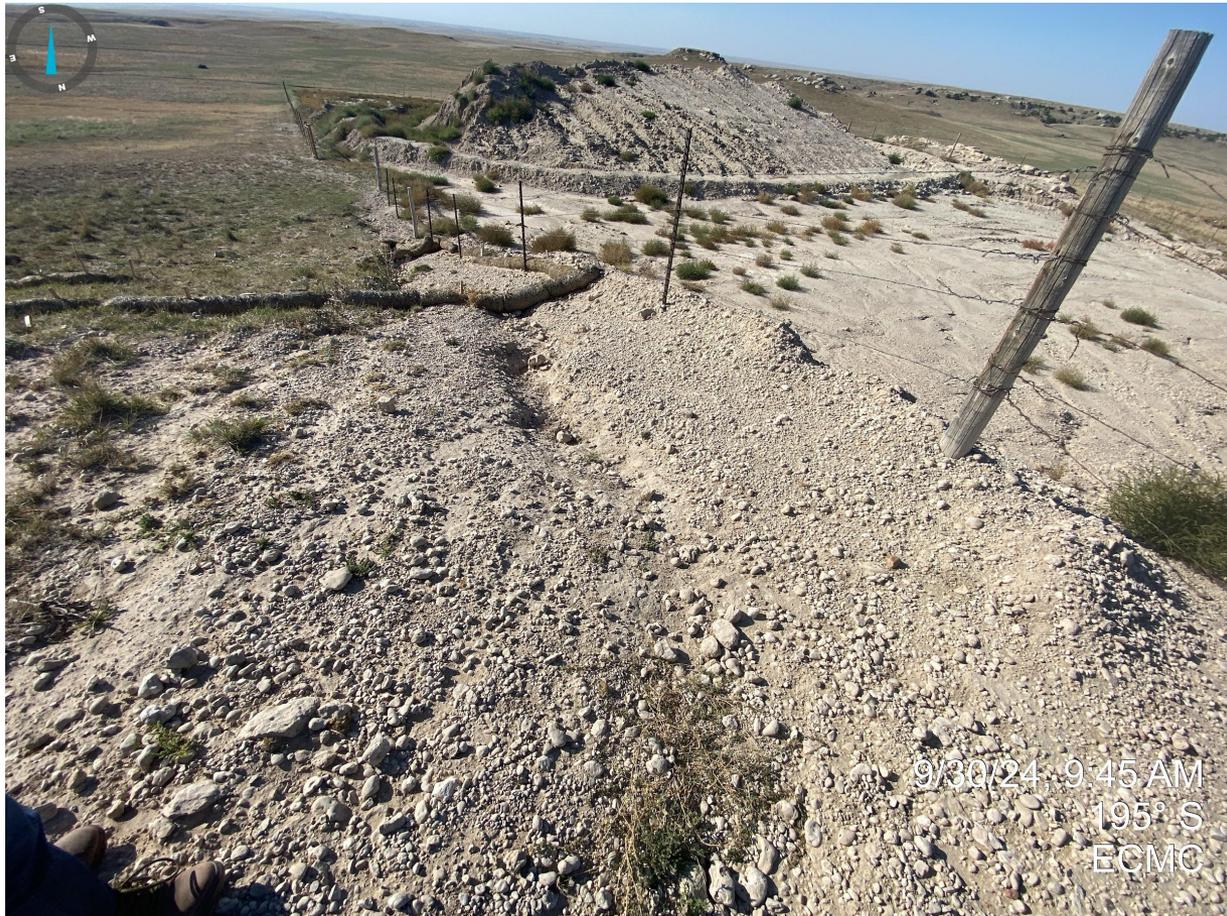
Photo 11. Erosion degradation east of pit remain evident; additional maintenance and/or implementation of more robust stormwater control measures/BMPs required.

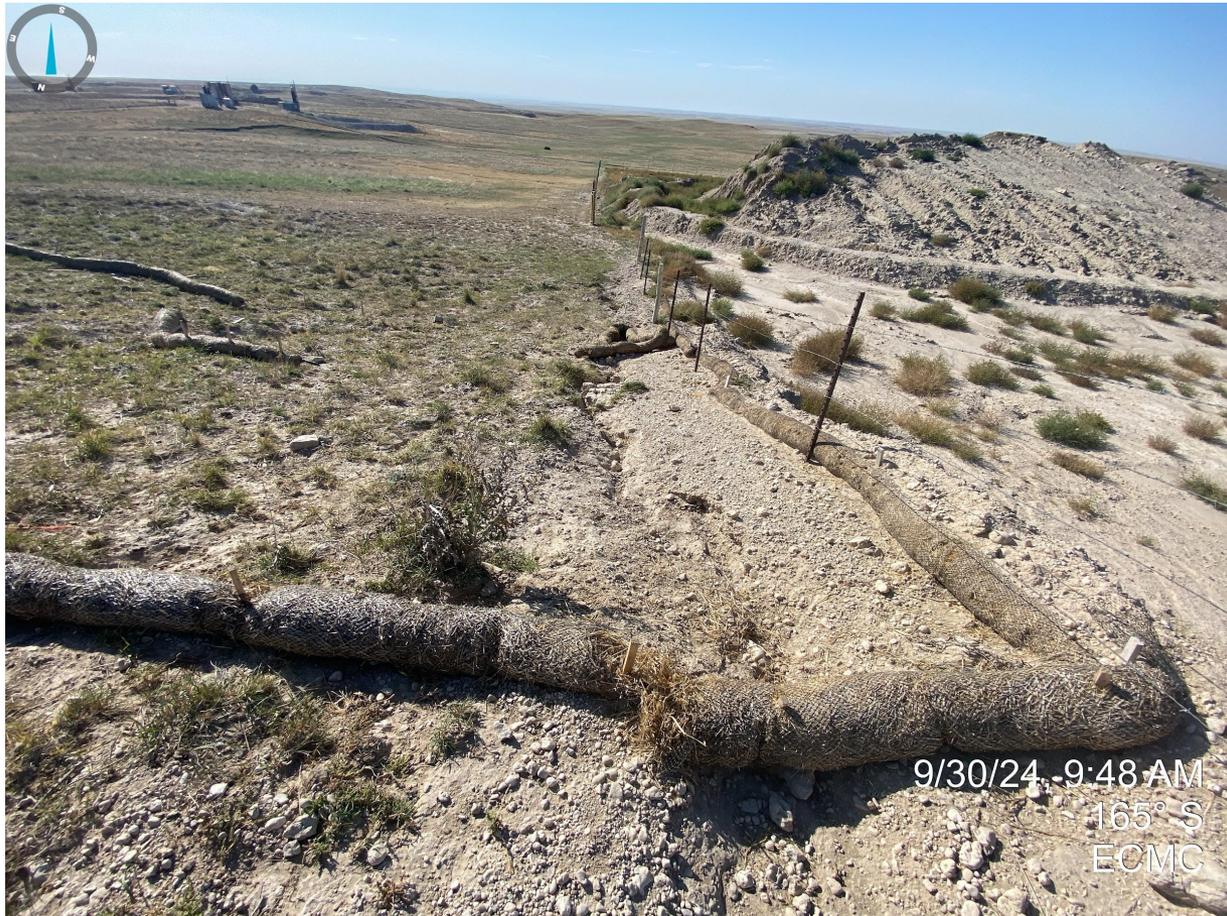
Photo 12. Erosion degradation and improper control measures/BMPs east of pit remain evident; additional maintenance and/or implementation of more robust stormwater control measures/BMPs required.

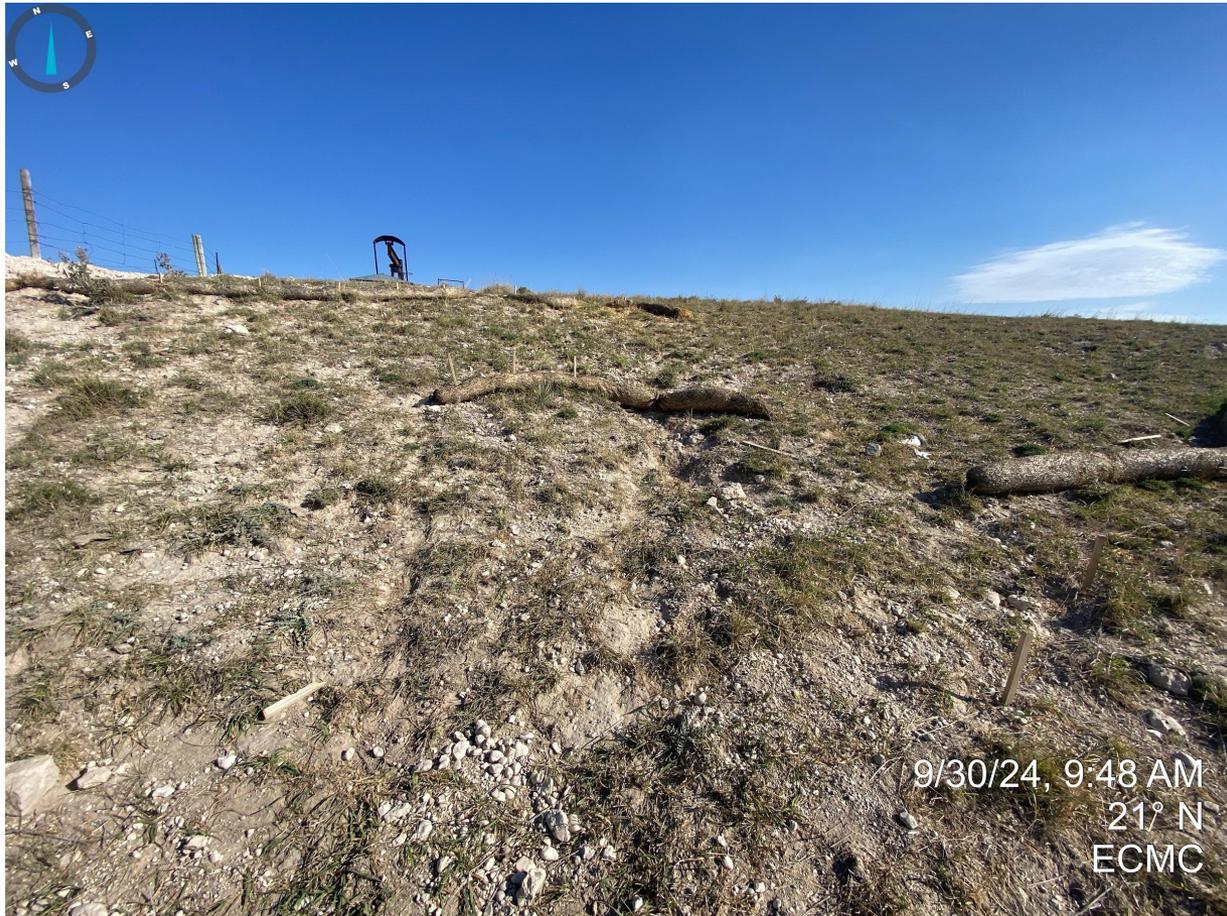
Photo 13. Erosion degradation and improper control measures/BMPs east of pit remain evident; additional maintenance and/or implementation of more robust stormwater control measures/BMPs required.

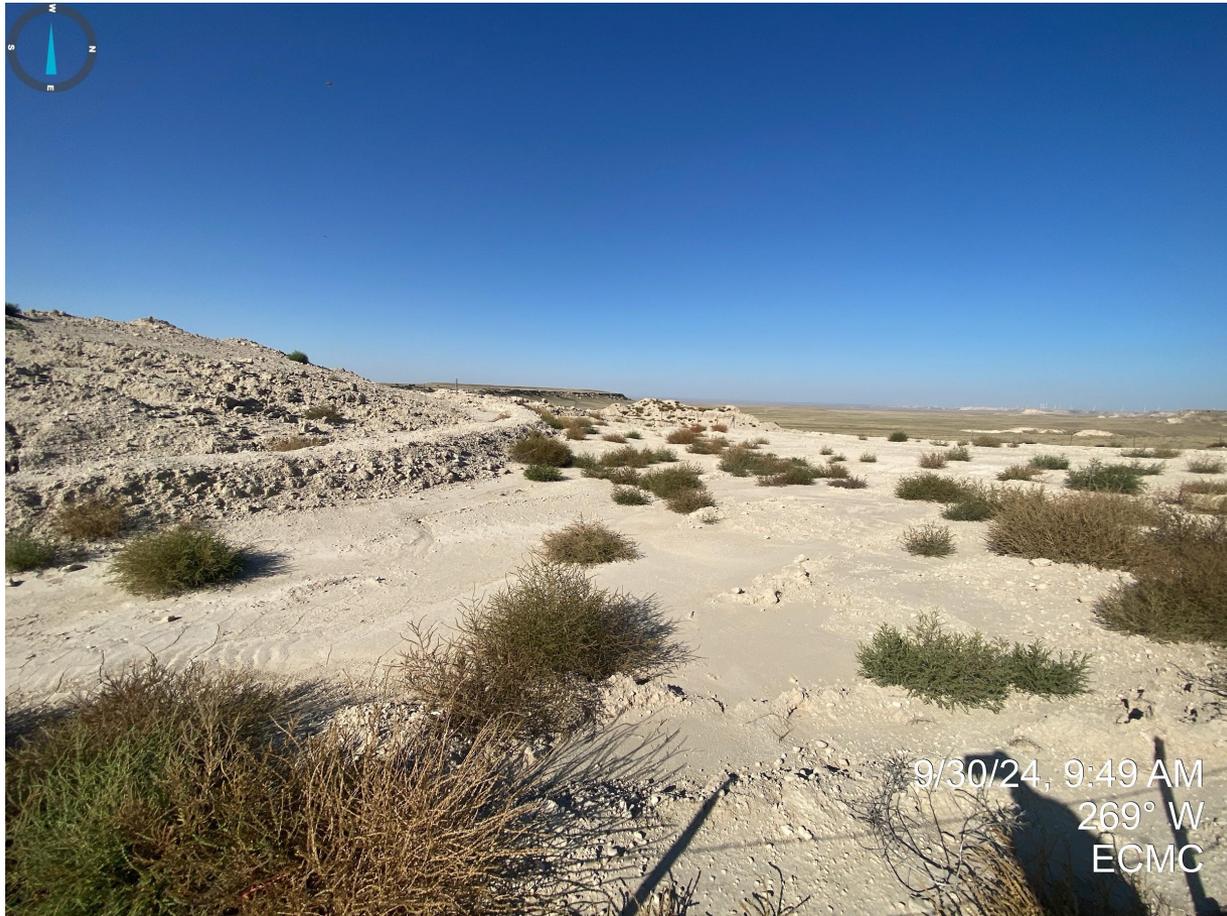
Photo 14. Undesirable vegetation within pit excavation.

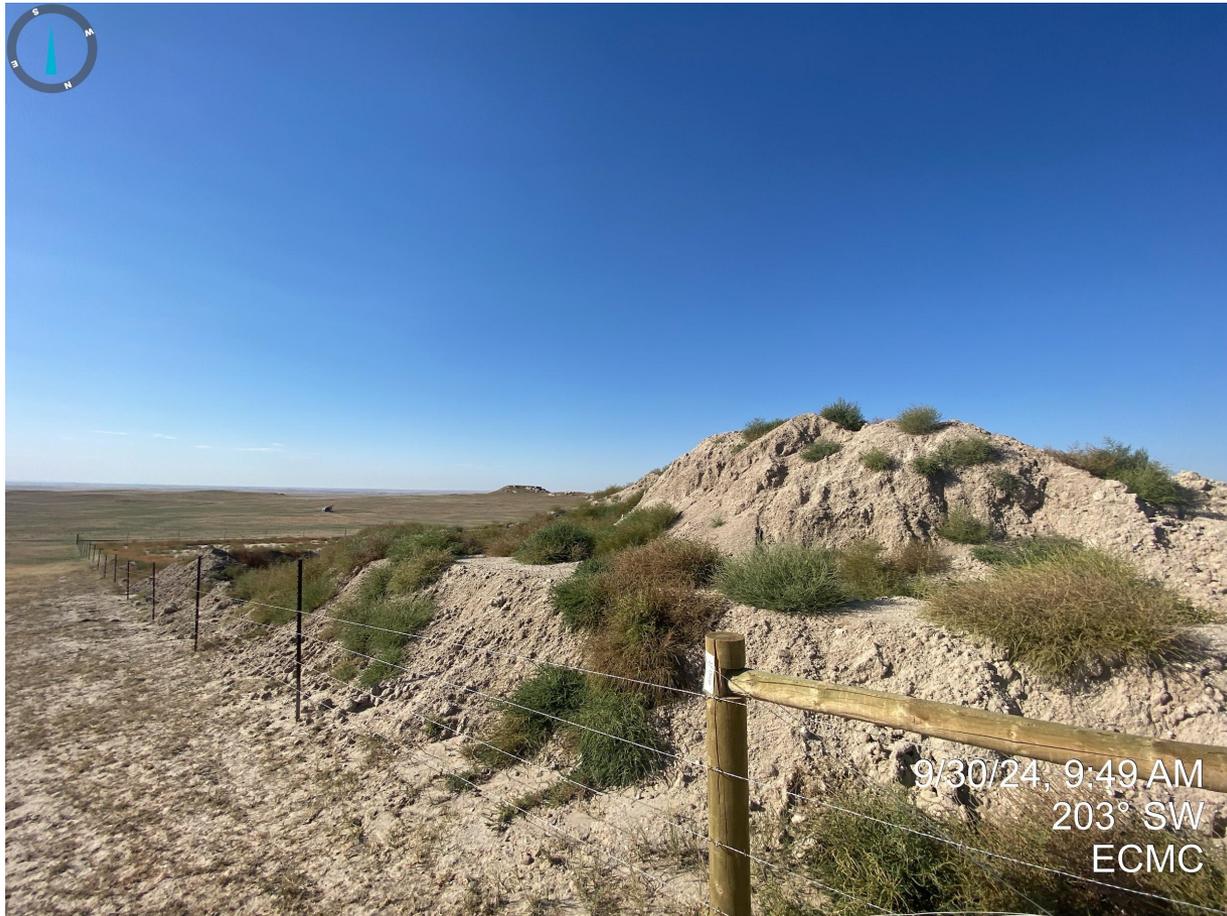
Photo 15. Stockpiled materials remain unstabilized with evidence of unconsolidated material; undesirable vegetation observed throughout stockpile and excavation.

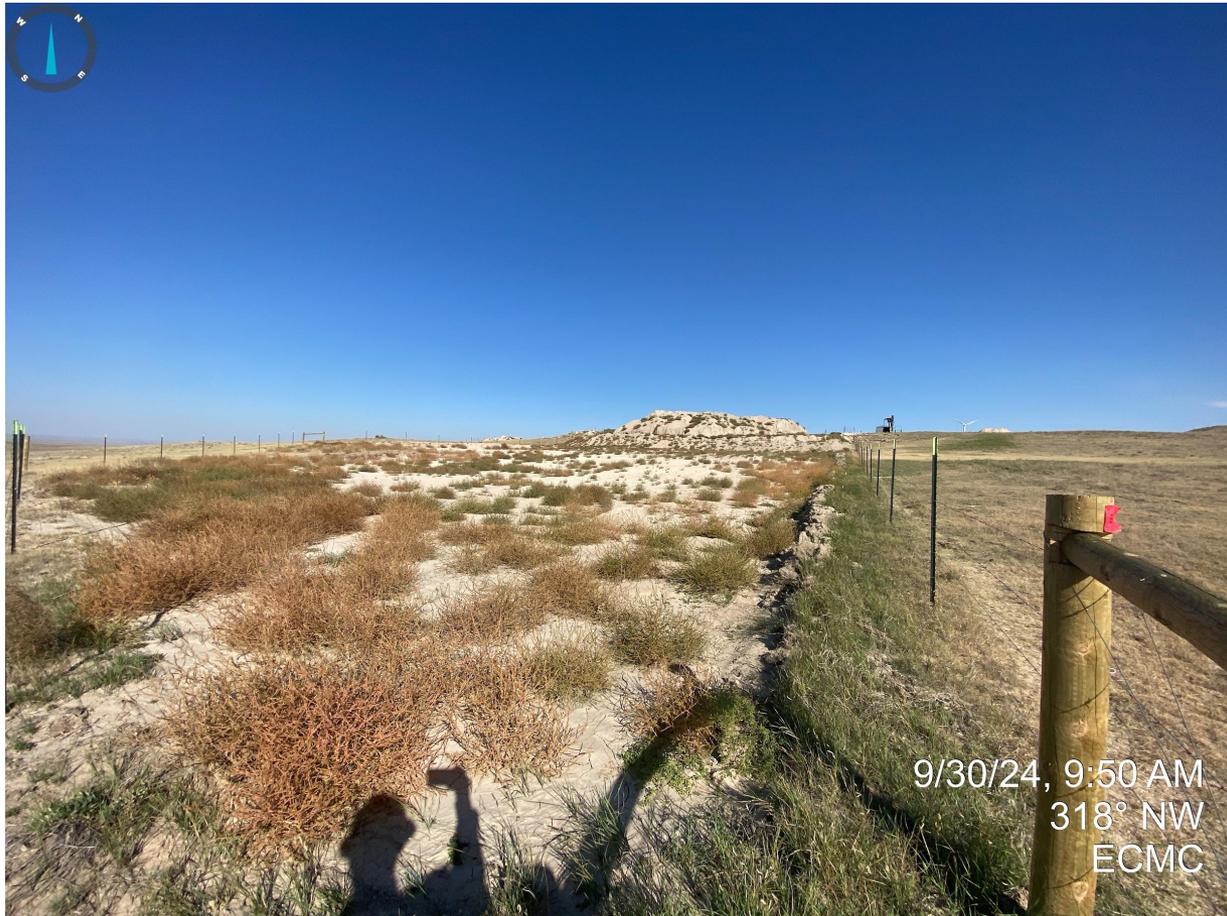
Photo 16. Undesirable vegetation observed throughout the salt kill excavation.

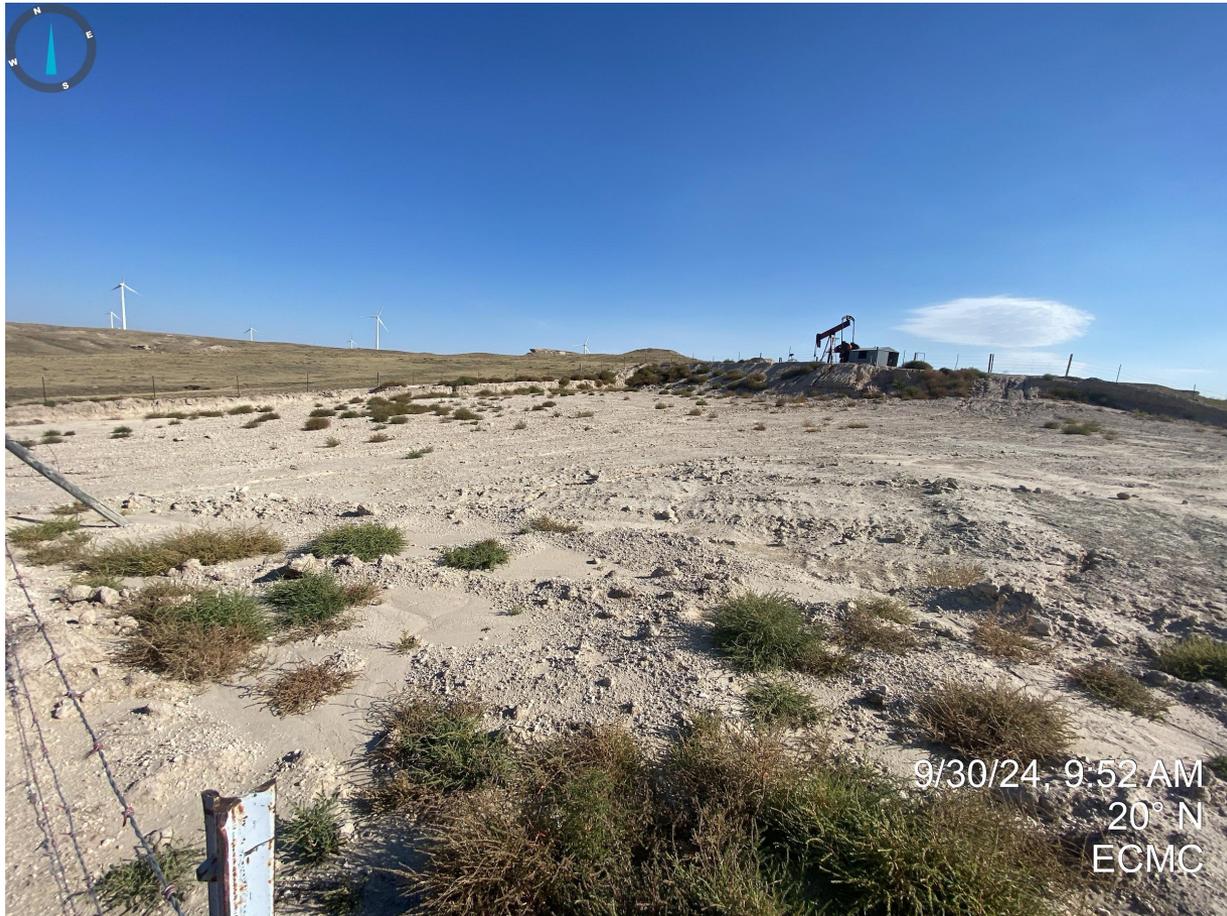
Photo 17. Undesirable vegetation observed throughout the pit excavation.

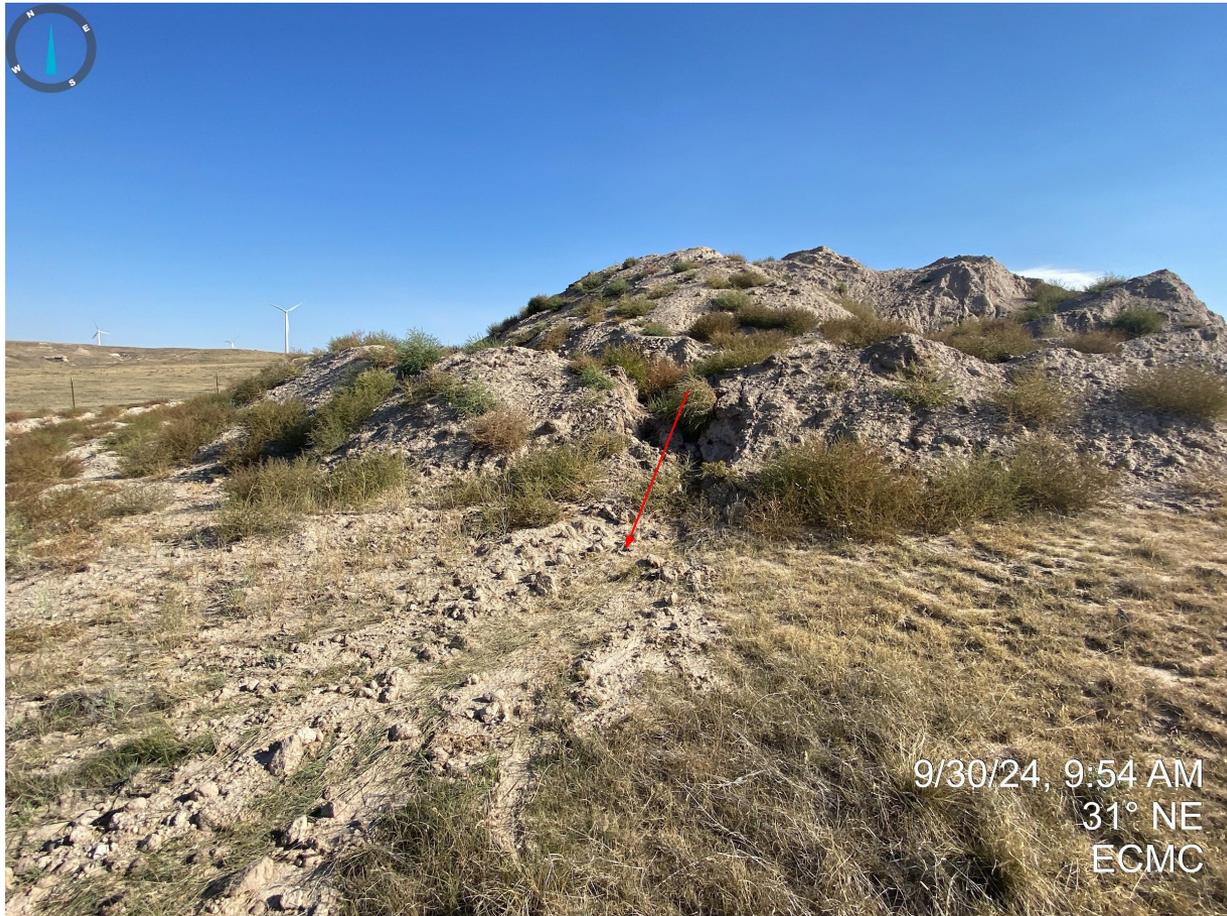
Photo 18. Erosion degradation from the western stockpile which does not appear to be properly stabilized; sedimentation appears to have migrated off location (see next Photo 19).

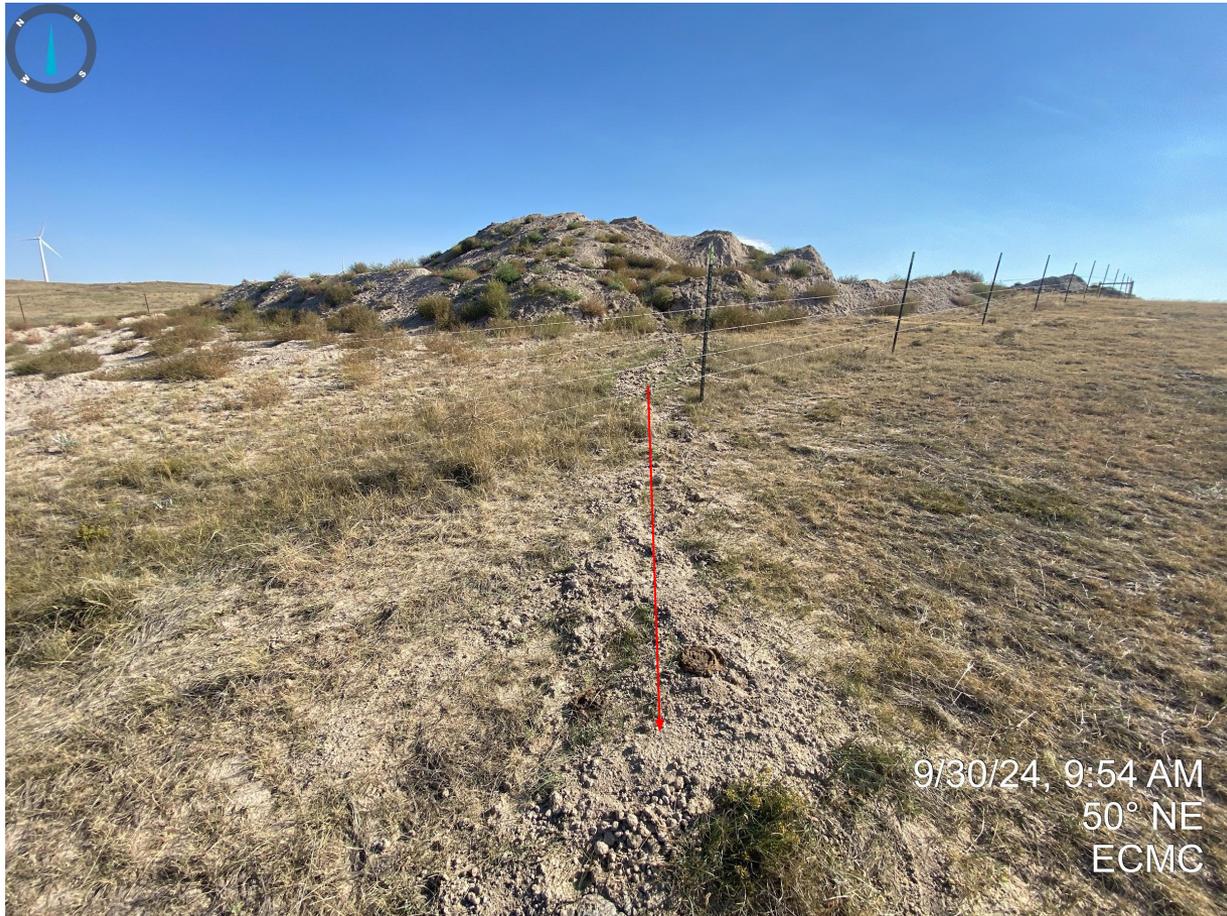
Photo 19. Continued from Photo 18; see comments in previous photo.

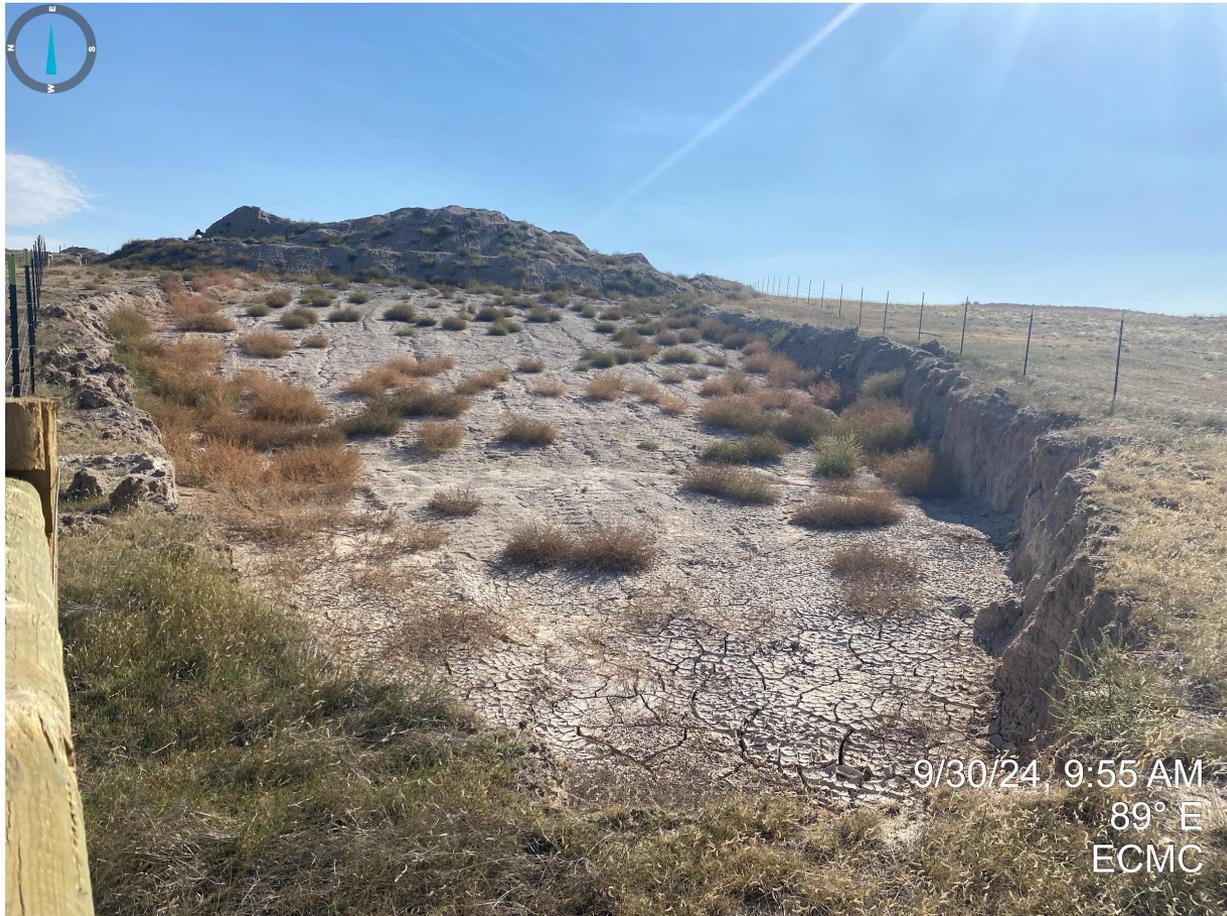
Photo 20. Undesirable vegetation observed within the western salt kill excavation.
