Interim Reclamation and Stormwater Inspection

Date:09/30/2024

Operator: WESTERN OPERATING COMPANY - 95620

Location ID: 312292

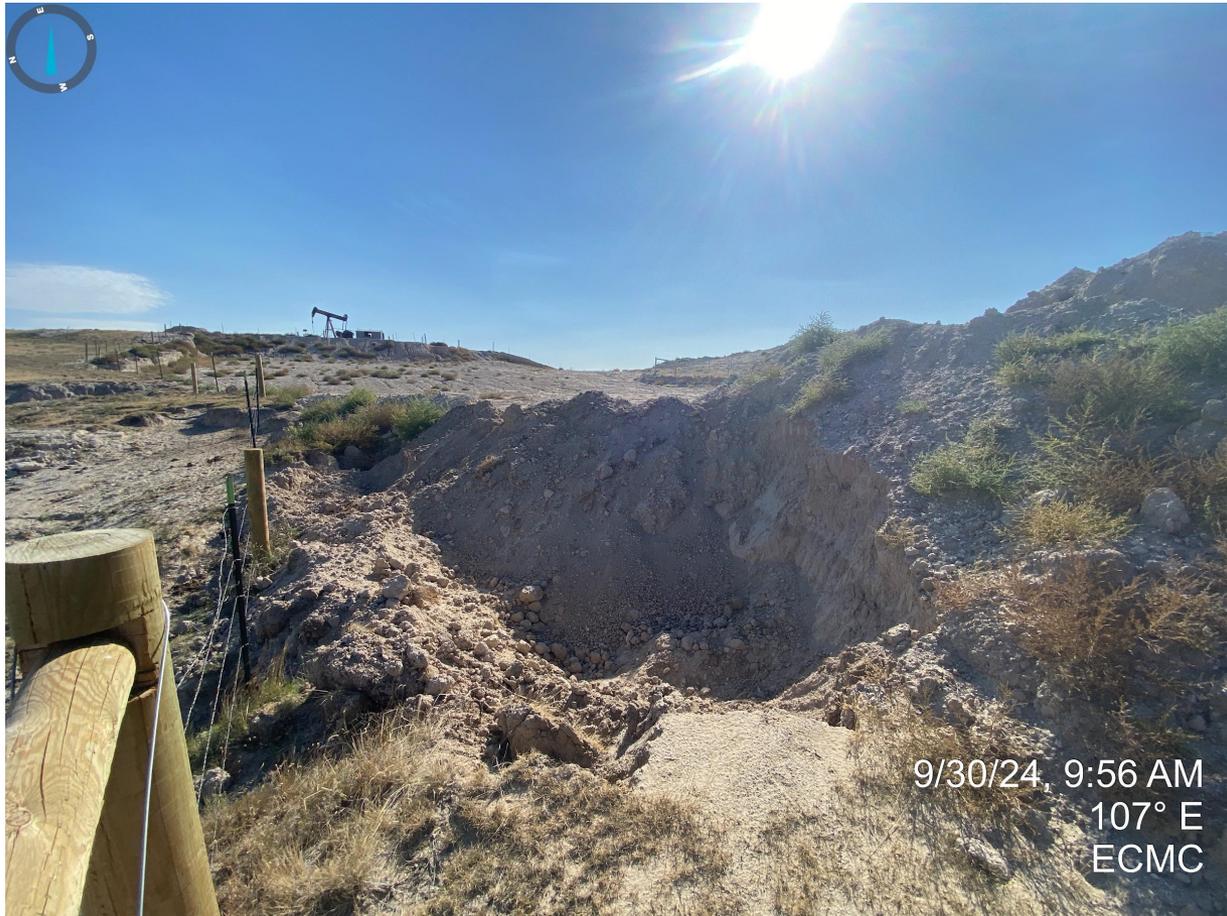
Photo 21. Northwest corner of the excavated pit; photo illustrates dirt work that appears to have been completed to implement additional stormwater controls. However, it appears that stormwater may have breached the berm and discharged stormwater, rock/sediment/debris and E&P waste into the adjacent drainage (see preceding photos).

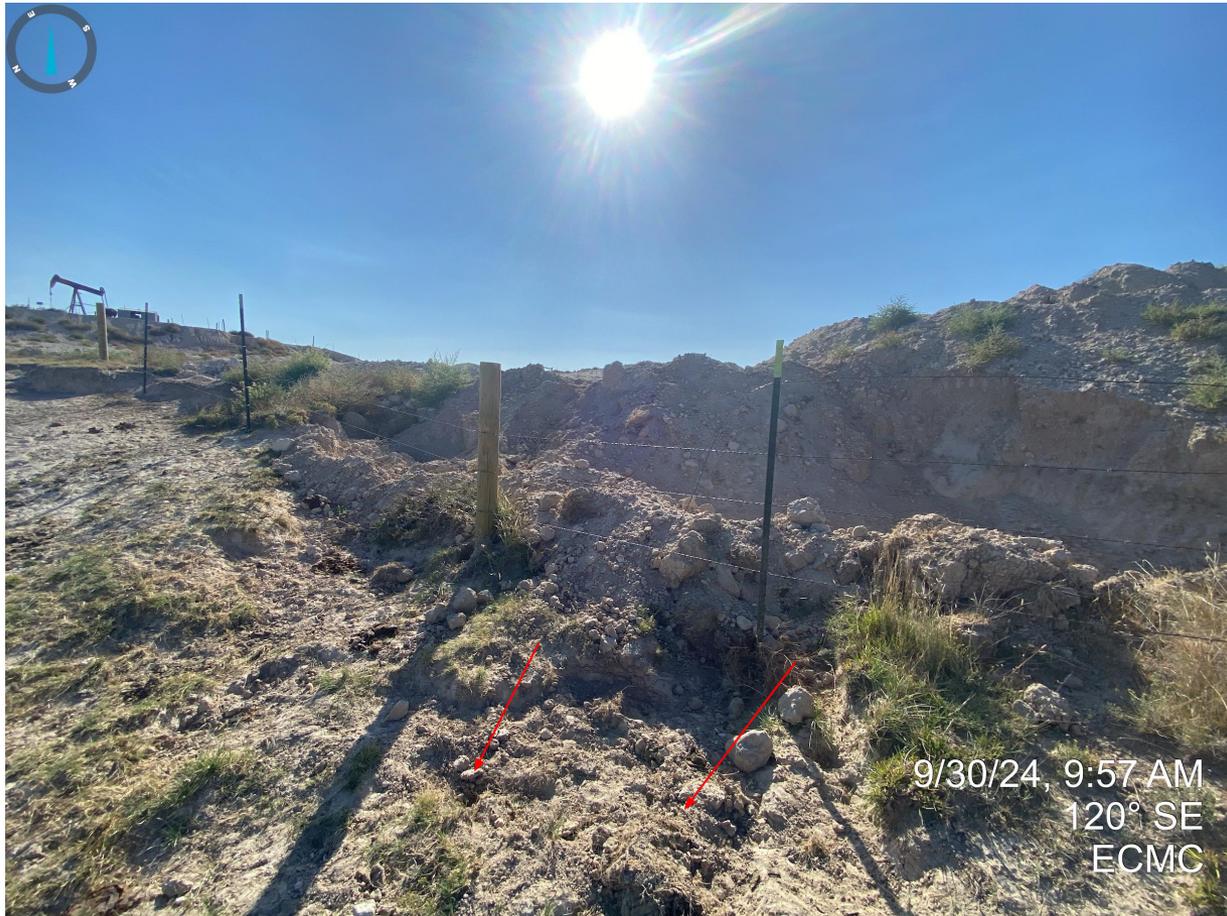
Photo 22. Continued from Photo 21. Evidence of off-location sediment transport observed

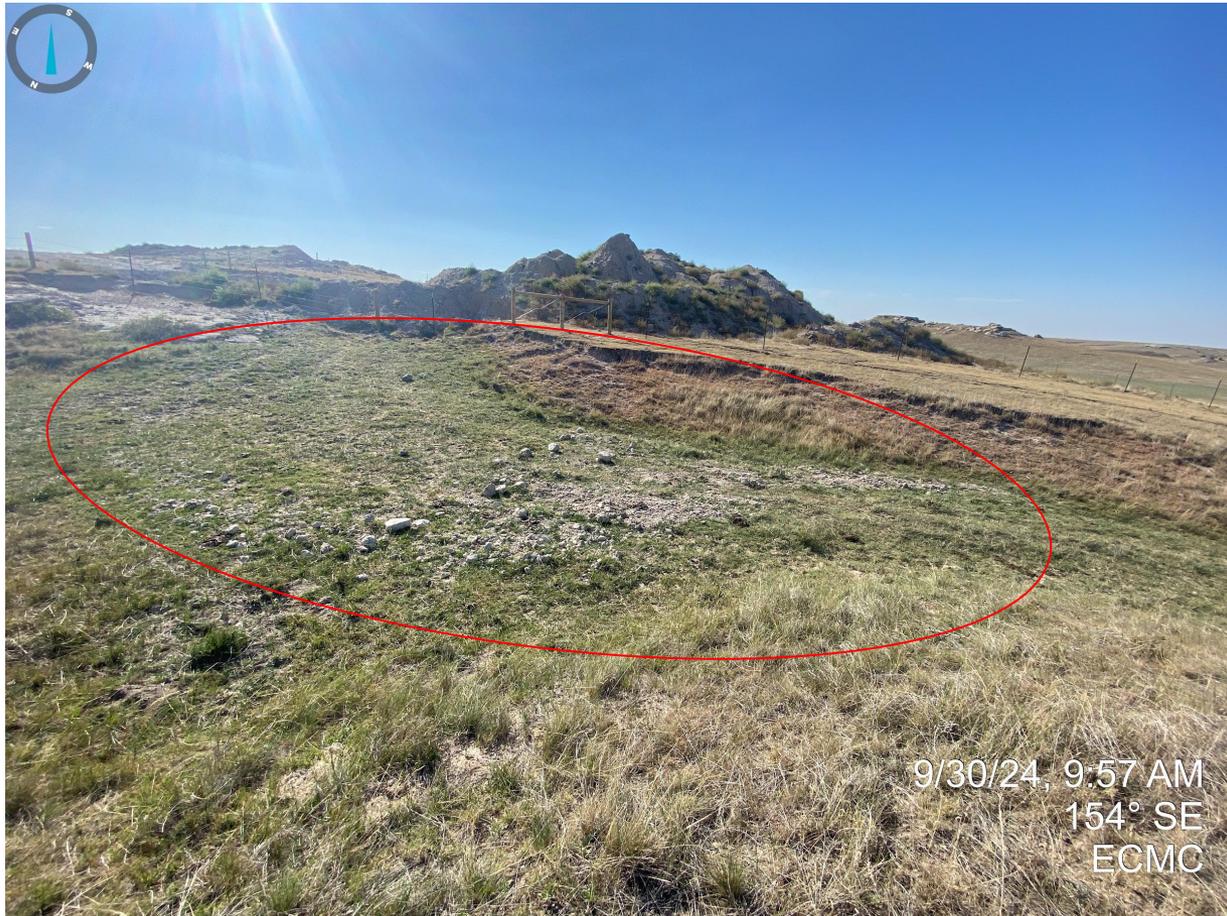
Photo 23. Continued from Photo 21. Evidence of sediment transport into the adjacent drainage.

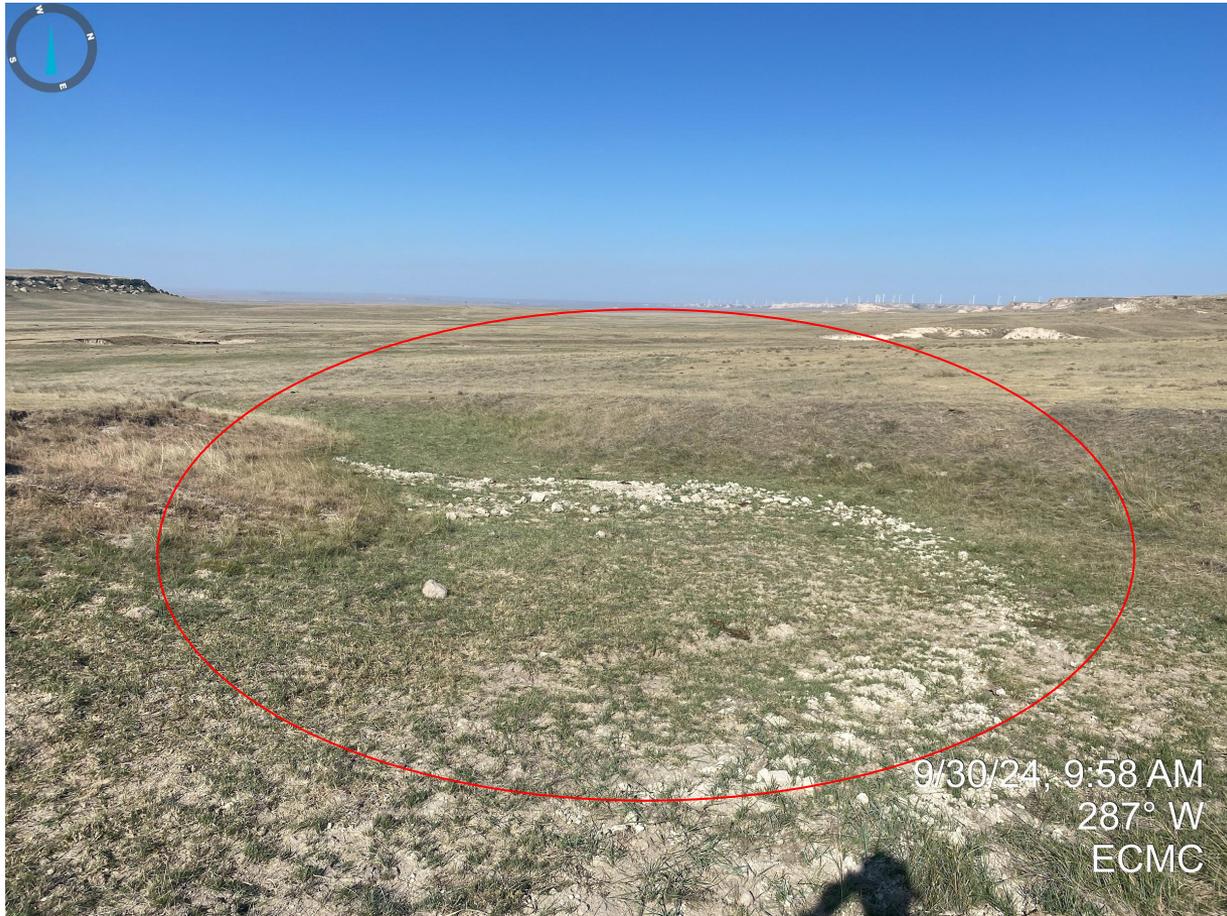
Photo 24. Continued from Photo 21. Evidence of sediment transport into the adjacent drainage.

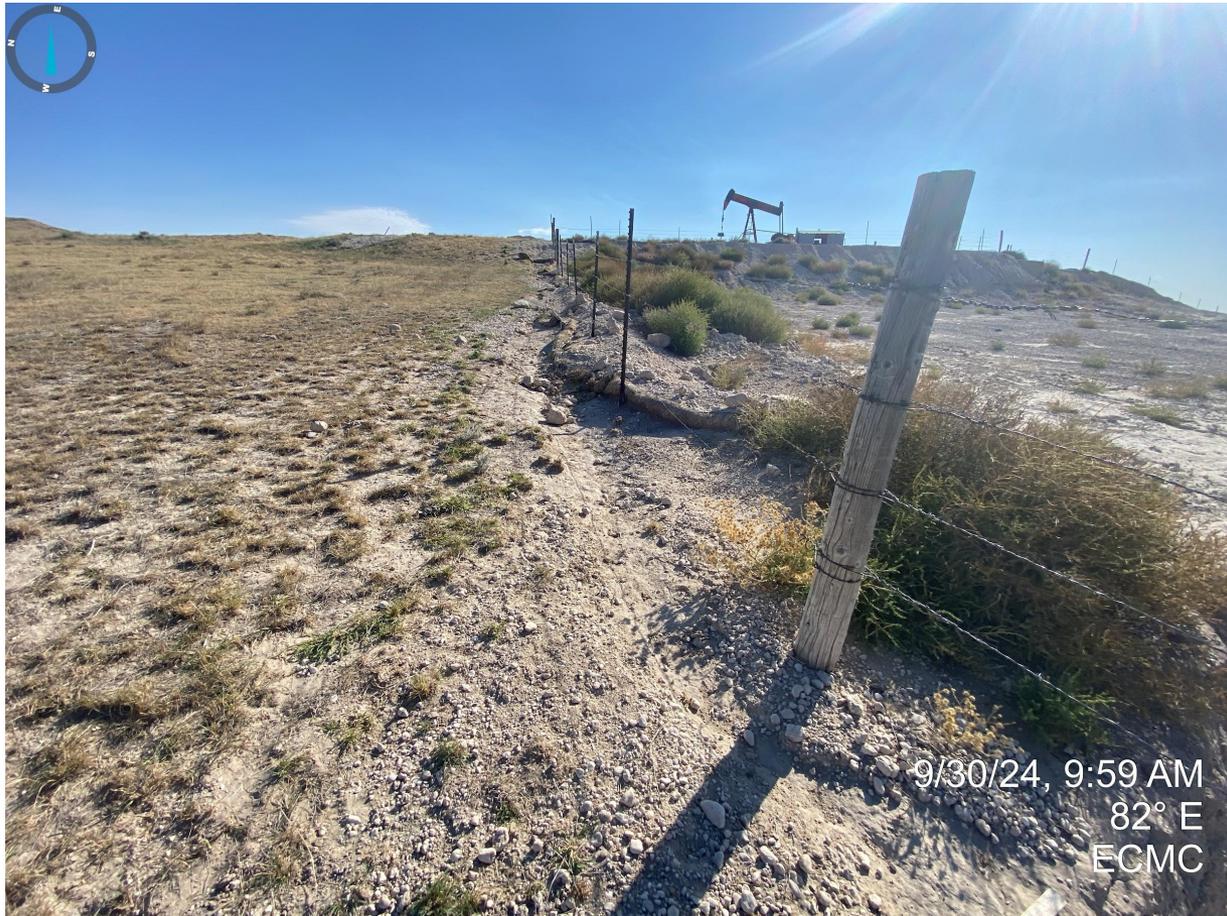
Photo 25. Erosion degradation north of pit remain evident; additional maintenance and/or implementation of more robust stormwater control measures/BMPs required.

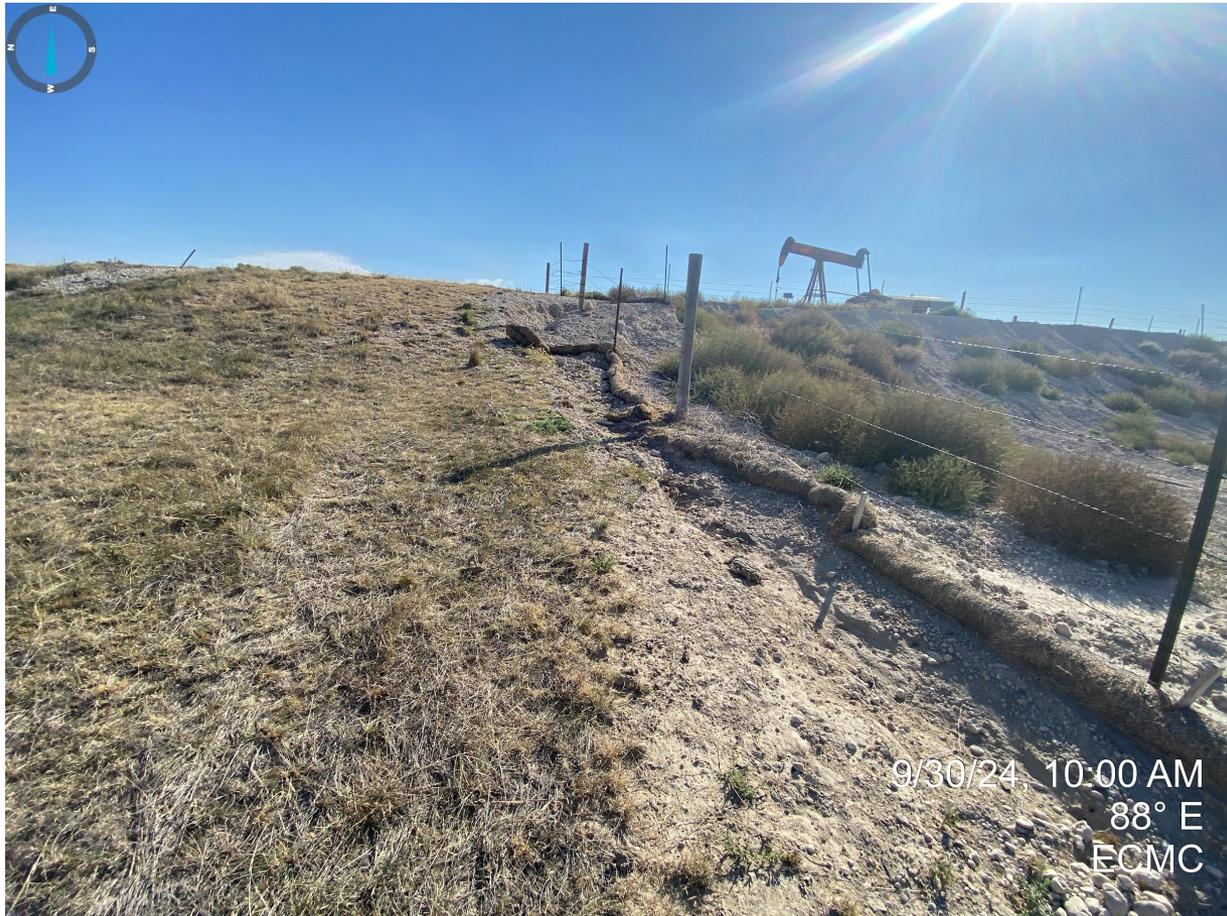
Photo 26. Continued from Photo 25; north side of pit.

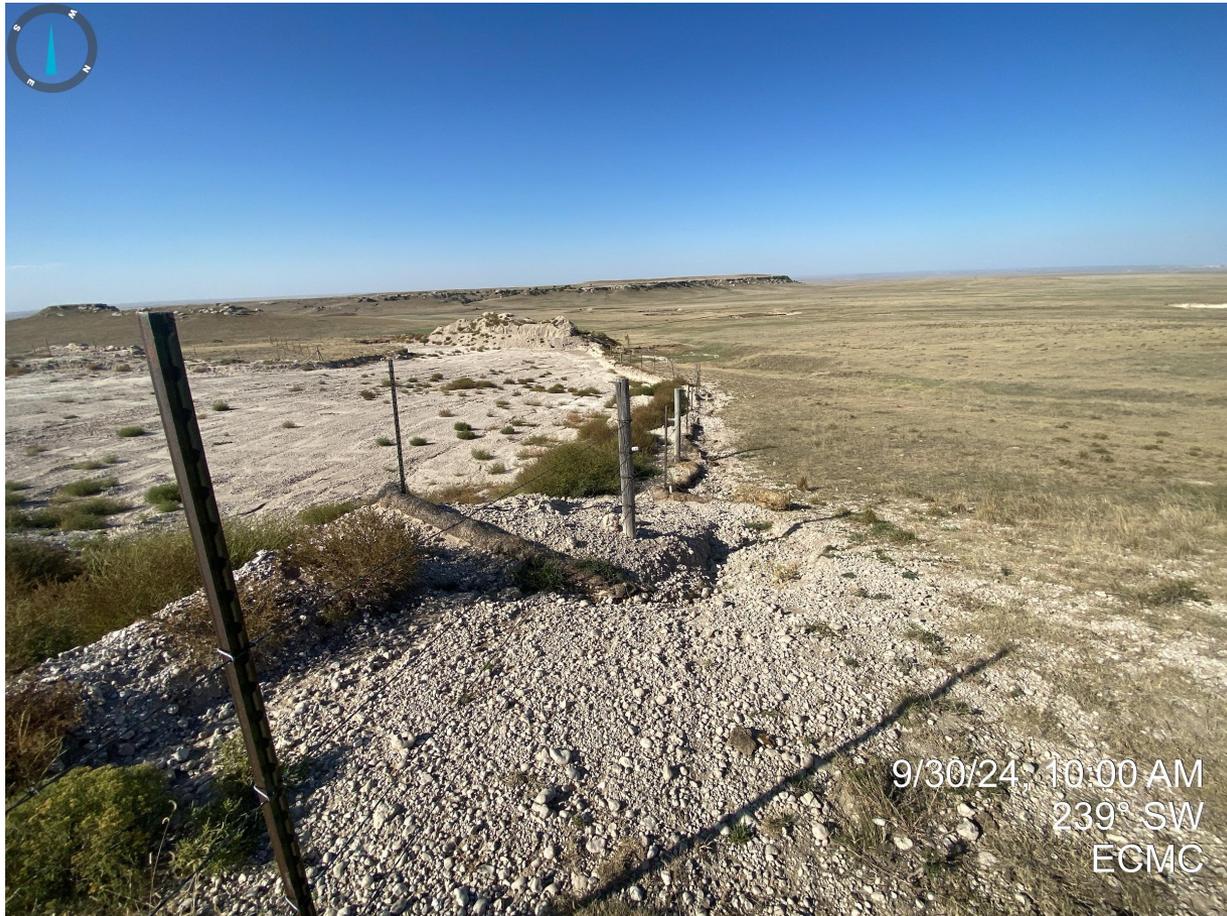
Photo 27. Continued from Photo 25; northeast corner of pit.
