Interim Reclamation and Stormwater Inspection

Date: 09/30/2024

Operator: WESTERN OPERATING COMPANY - 95620

Inspection Photos
Location Name: Propst #1
Location ID: 312291

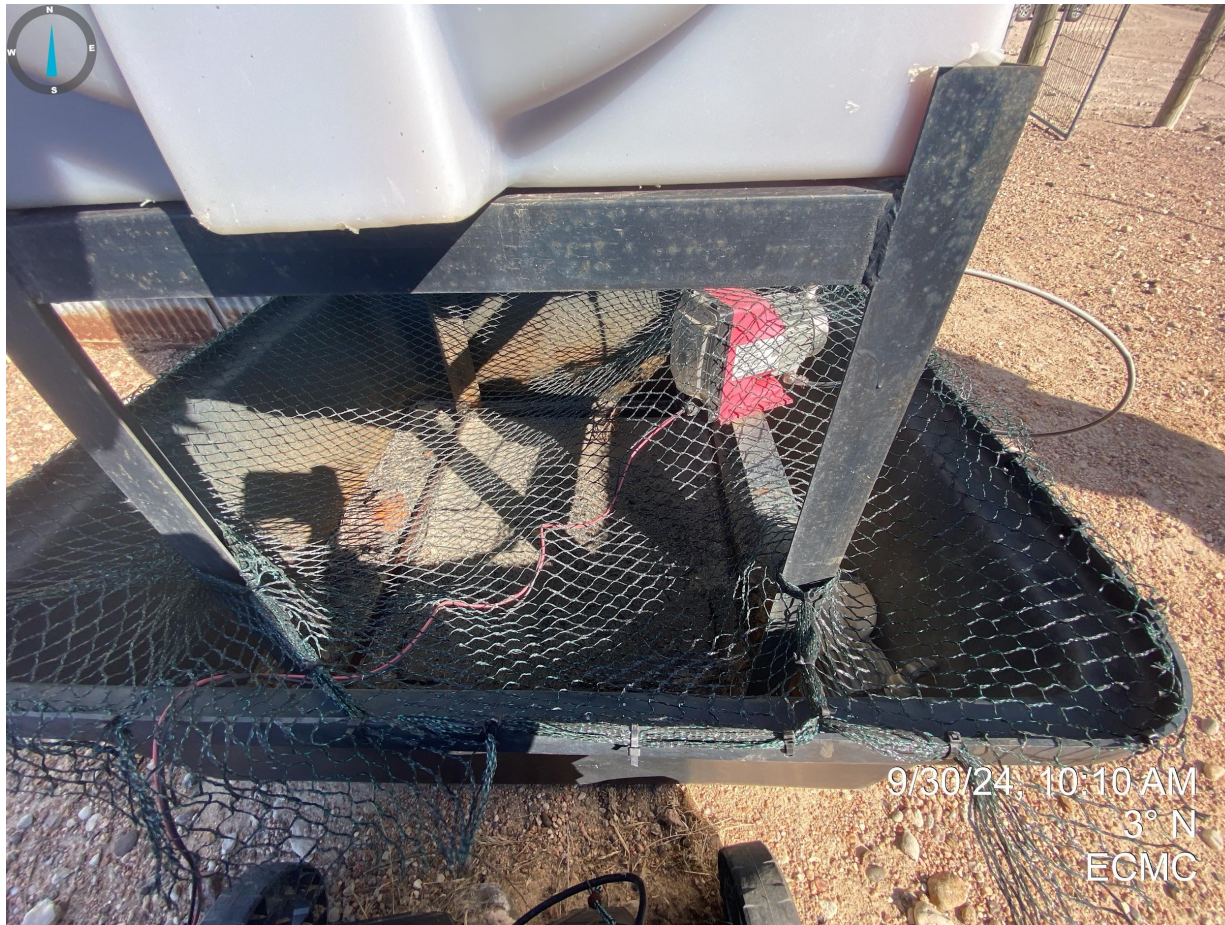
Photo 1. Free fluids appear to have been removed from the secondary containment at day tank.

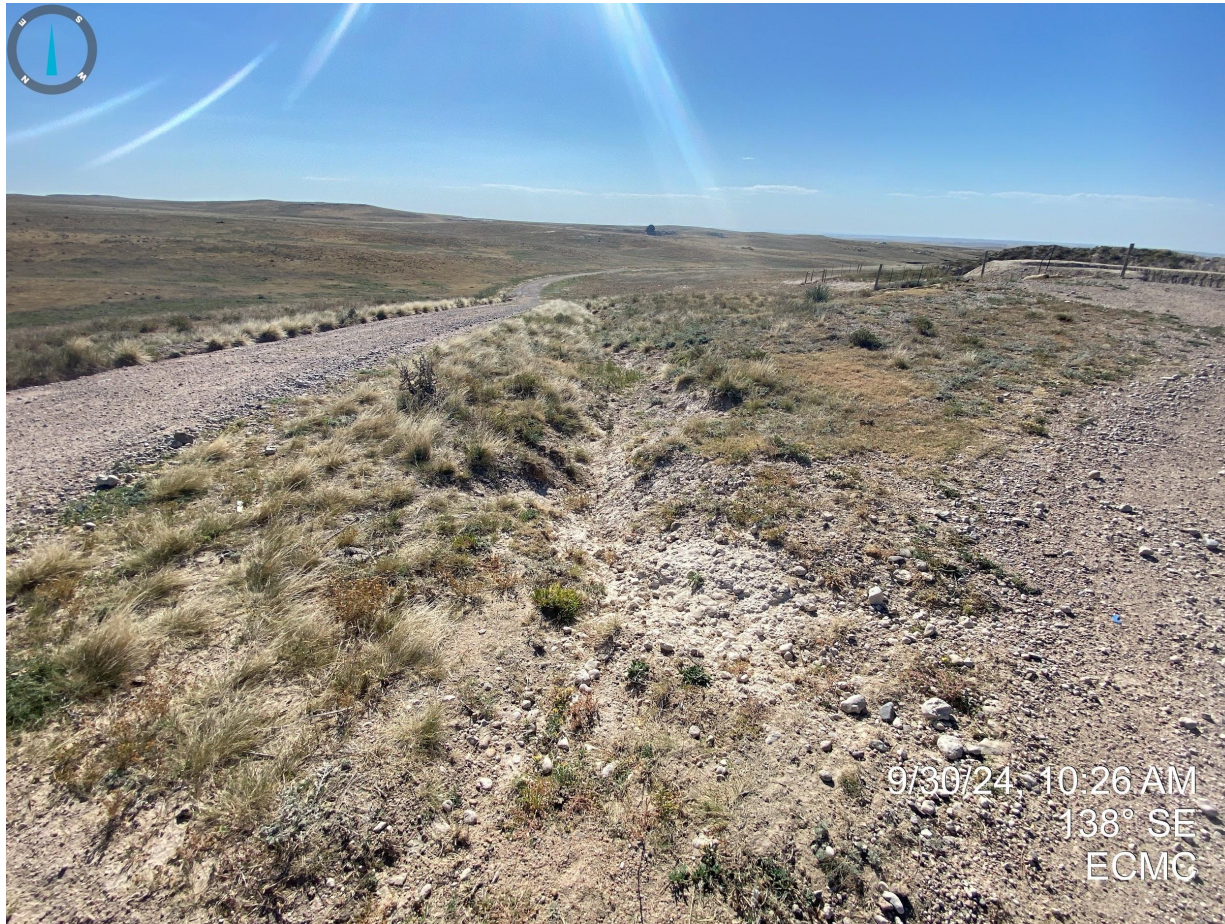
Photo 2. Taken north of pit. Evidence of erosion degradation, previously documented, does not appear to have been repaired/stabilized with no evidence of control measures/BMPs observed that would prevent further erosion of the production areas and access roads.

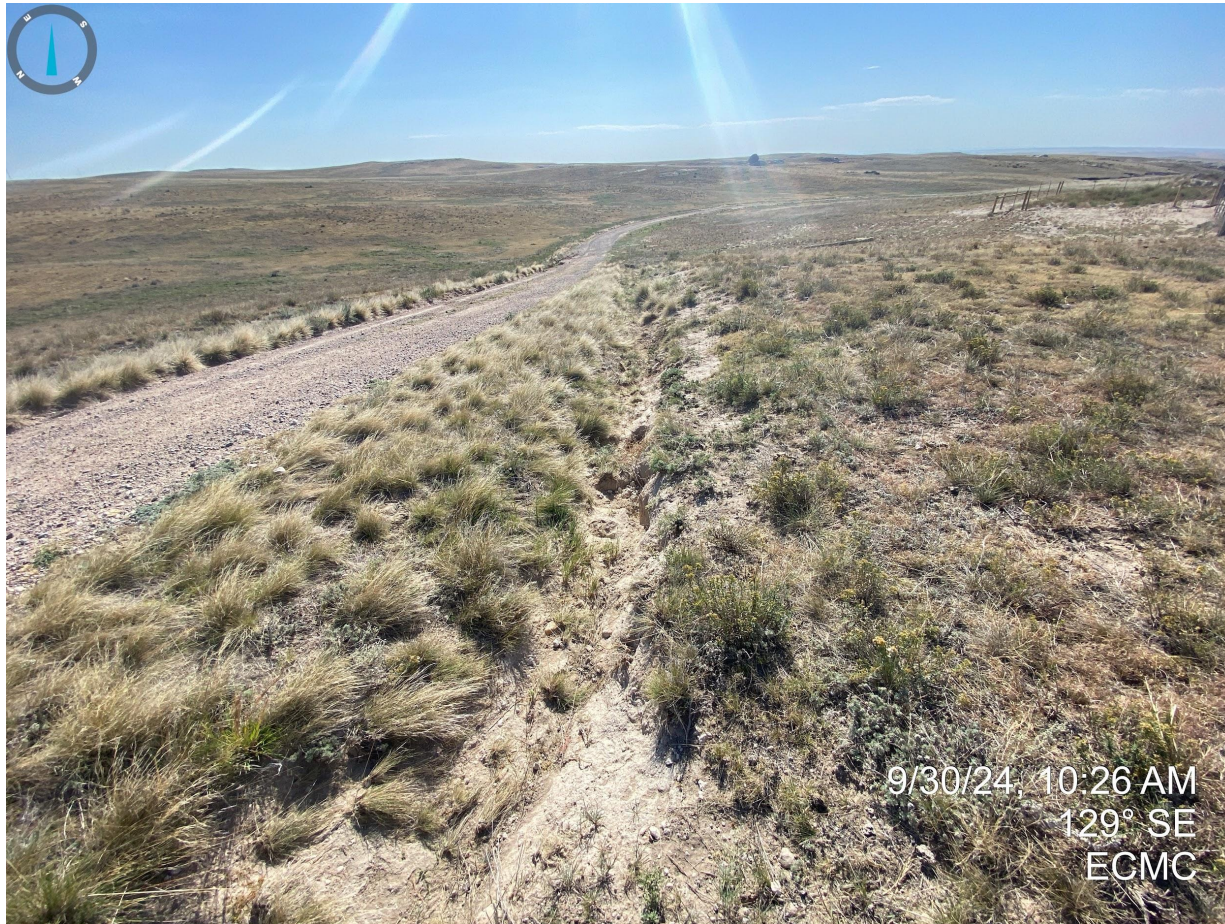
Photo 3. Continued from Photo 2.

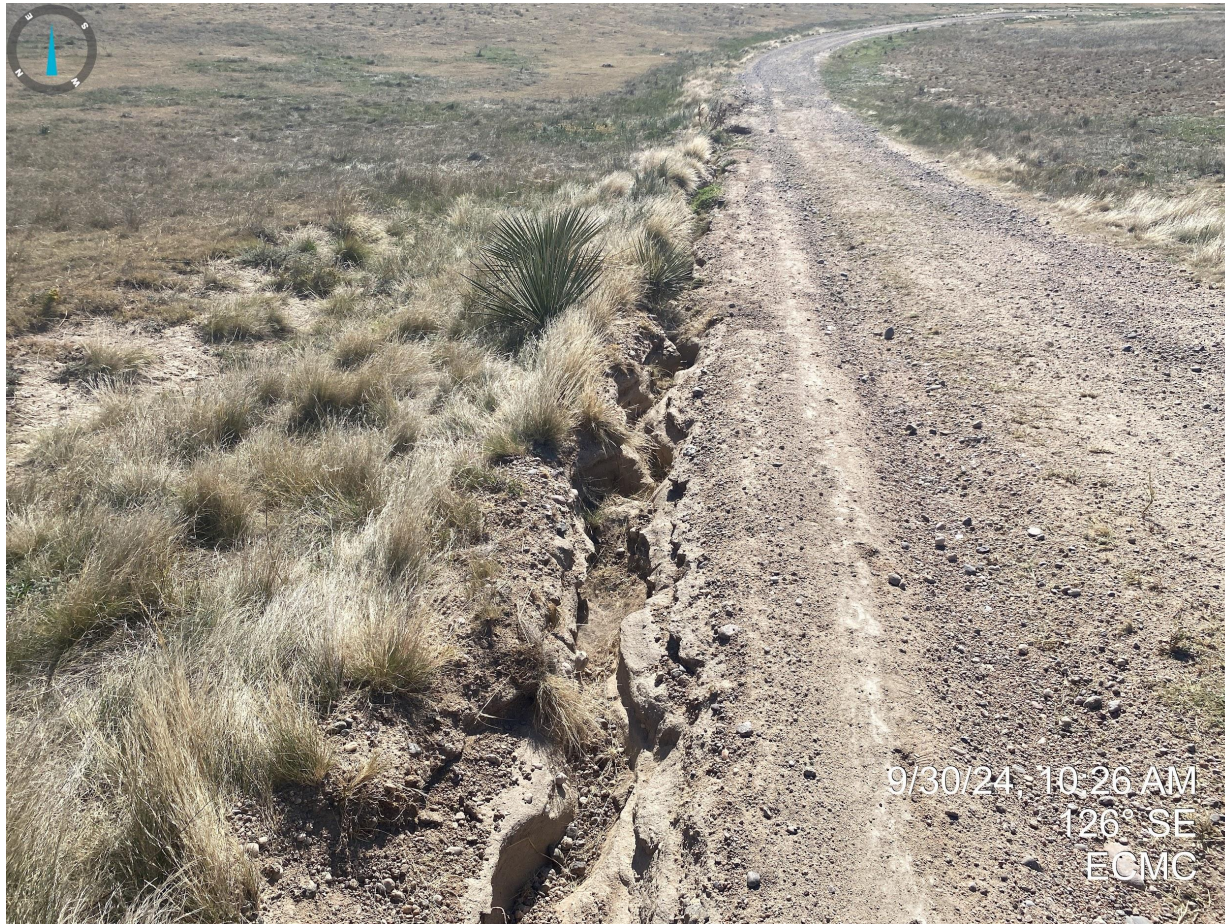
Photo 4. Taken from the access road northeast of the pit. See comments in Photo 2.

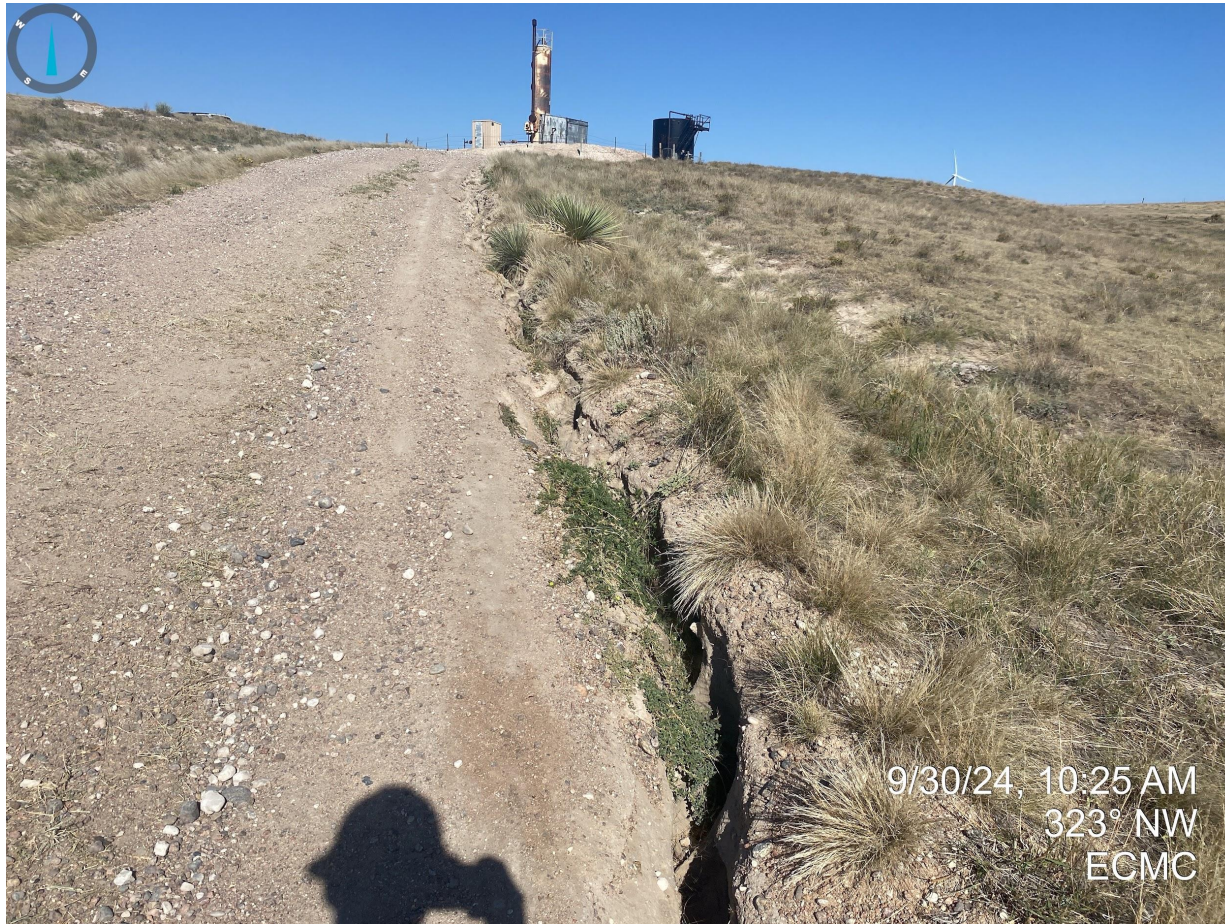
Photo 5. Continued from Photo 4.

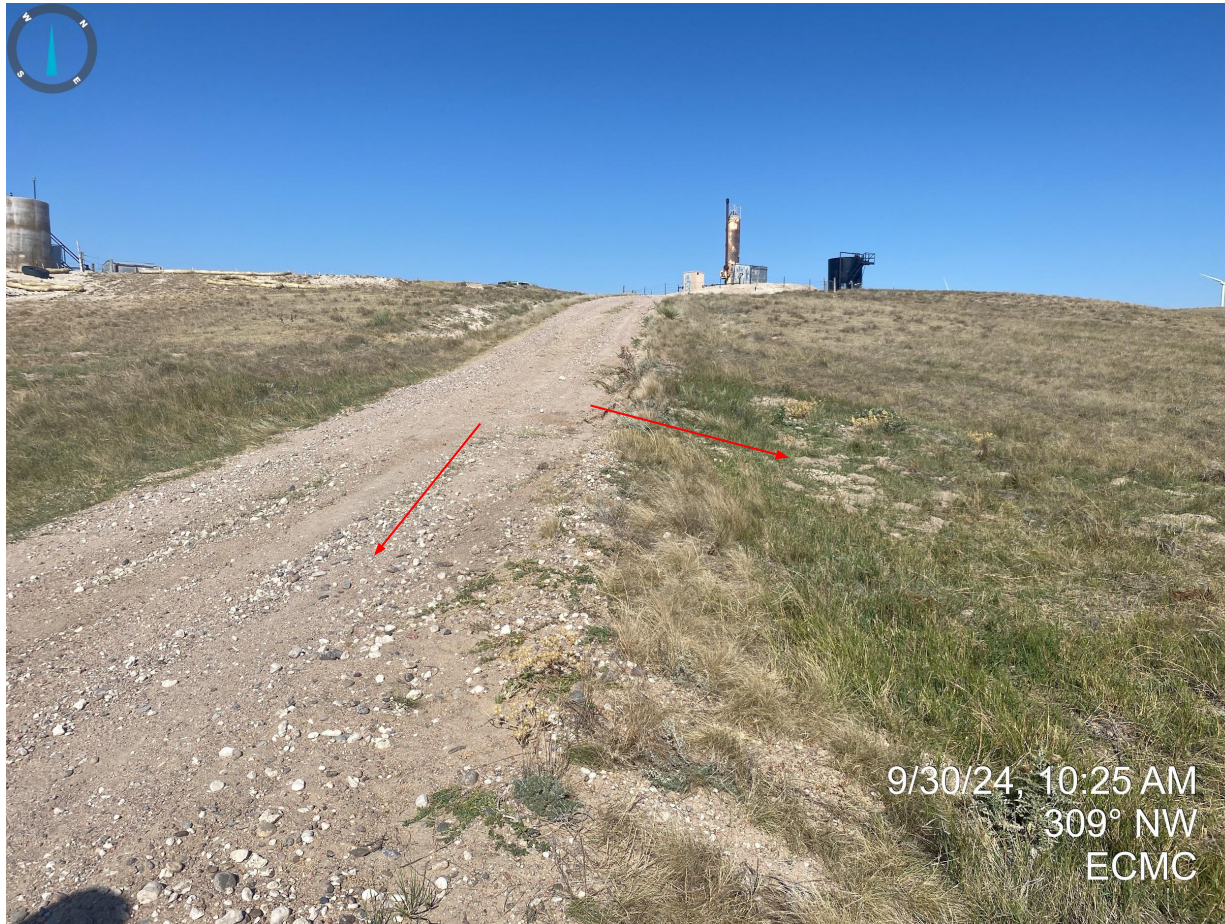
Photo 6. Sediment deposition and erosion degradation along the access road, east of pit.

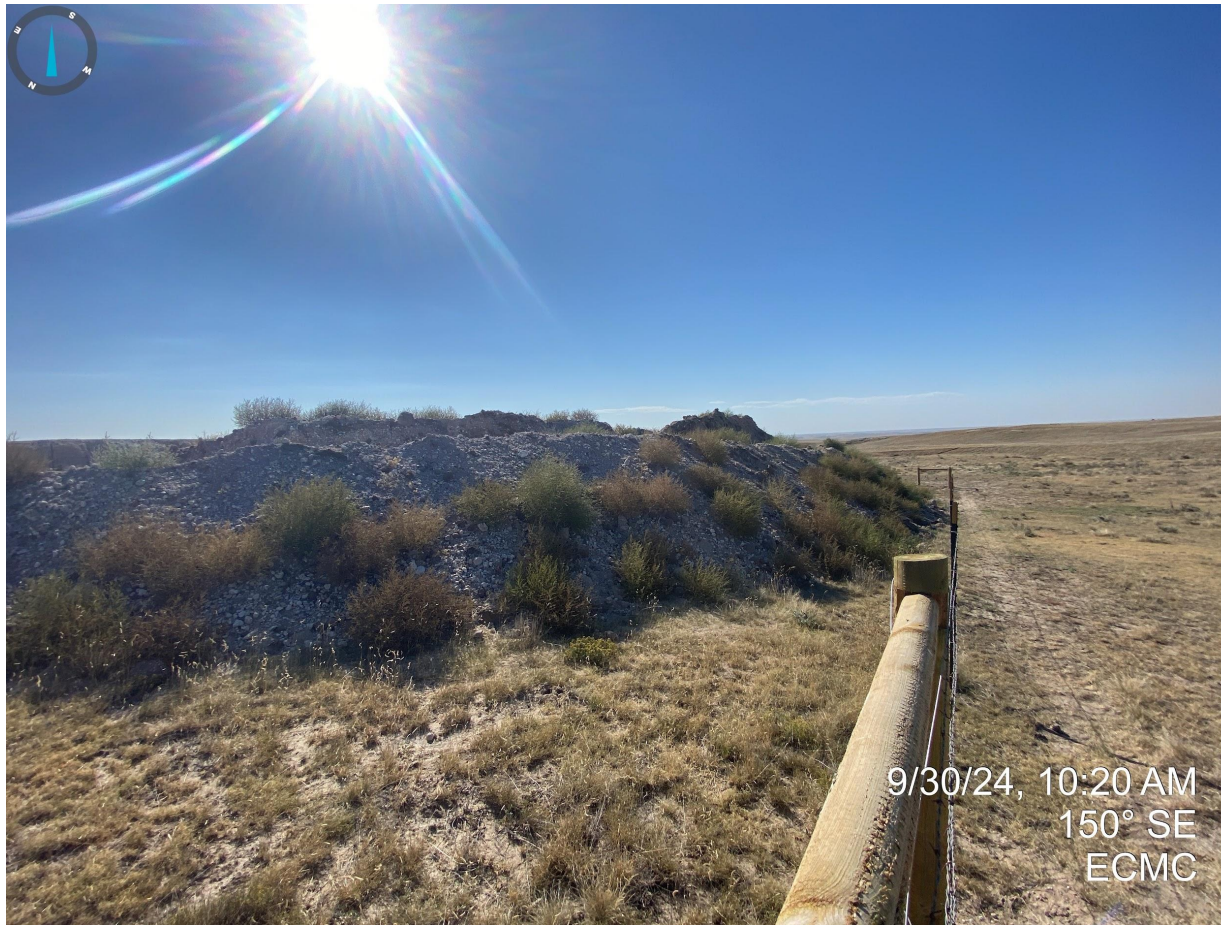
Photo 7. Taken from the north side of the stockpiled soils. No perimeter stormwater control measures/BMPs, or impermeable liners underneath the stockpile were observed during this inspection. Impacted soils appear to have been placed directly on top of undisturbed lands. Additionally, it does not appear that topsoil has been salvaged Per Rule 1002.b prior to stockpiling the soil on undisturbed portions of land. Undesirable vegetation observed throughout stockpiled areas.

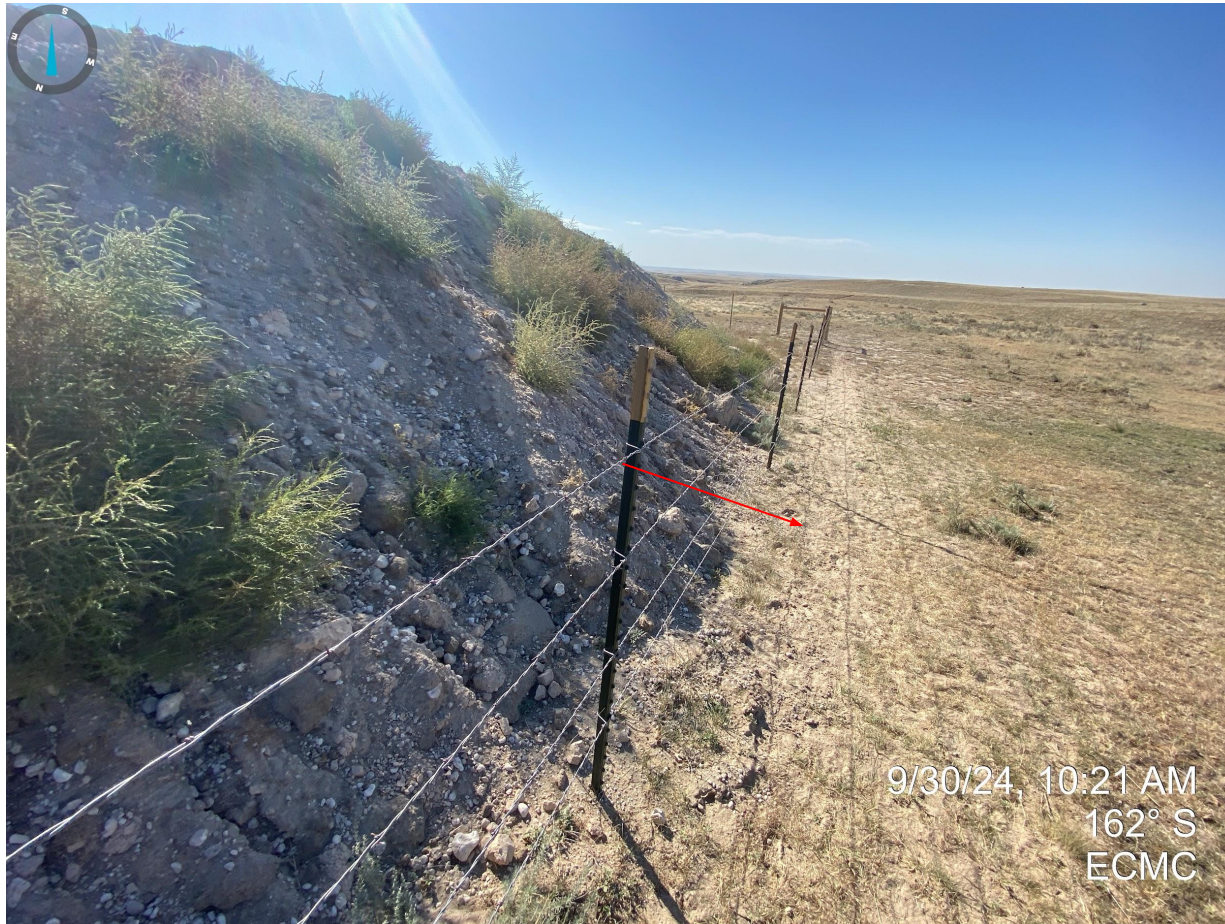
Photo 8. Continued from Photo 7; evidence of unstabilized soils and sediment migration outside of the fenced portions.

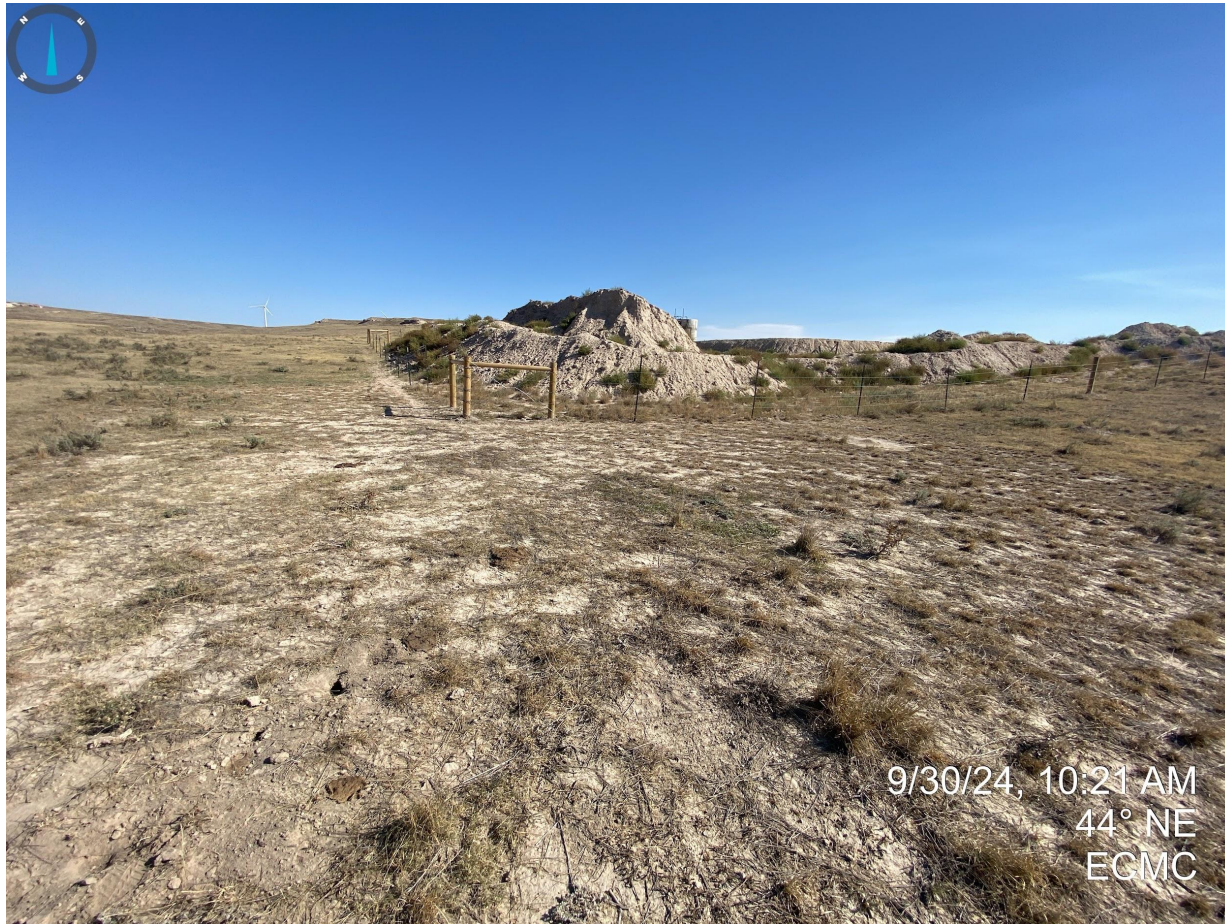
Photo 9. Sediment deposition resulting from unstabilized stockpiles, southwest corner of the pit.

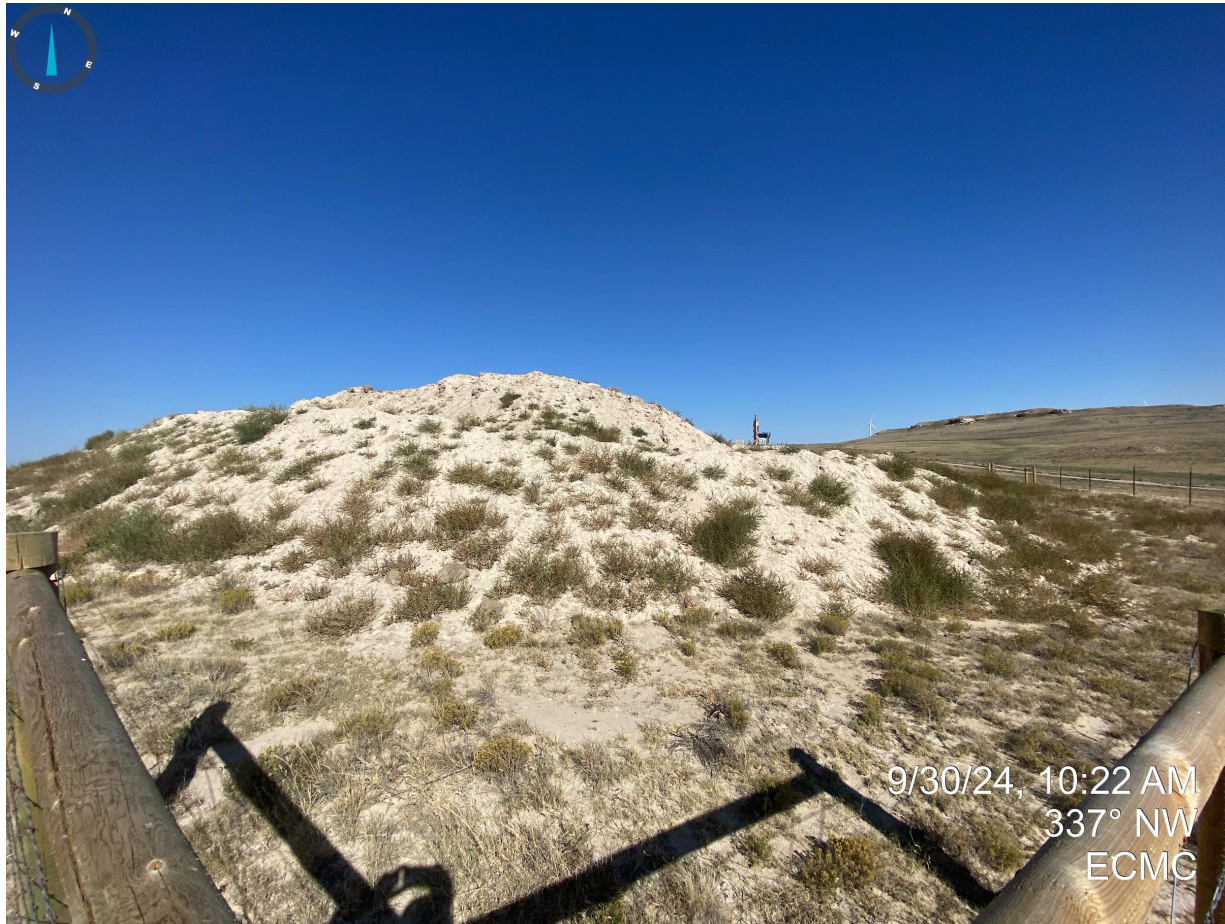
Photo 10. Taken from the southeast corner of the stockpiled material; see comments in Photo 7.

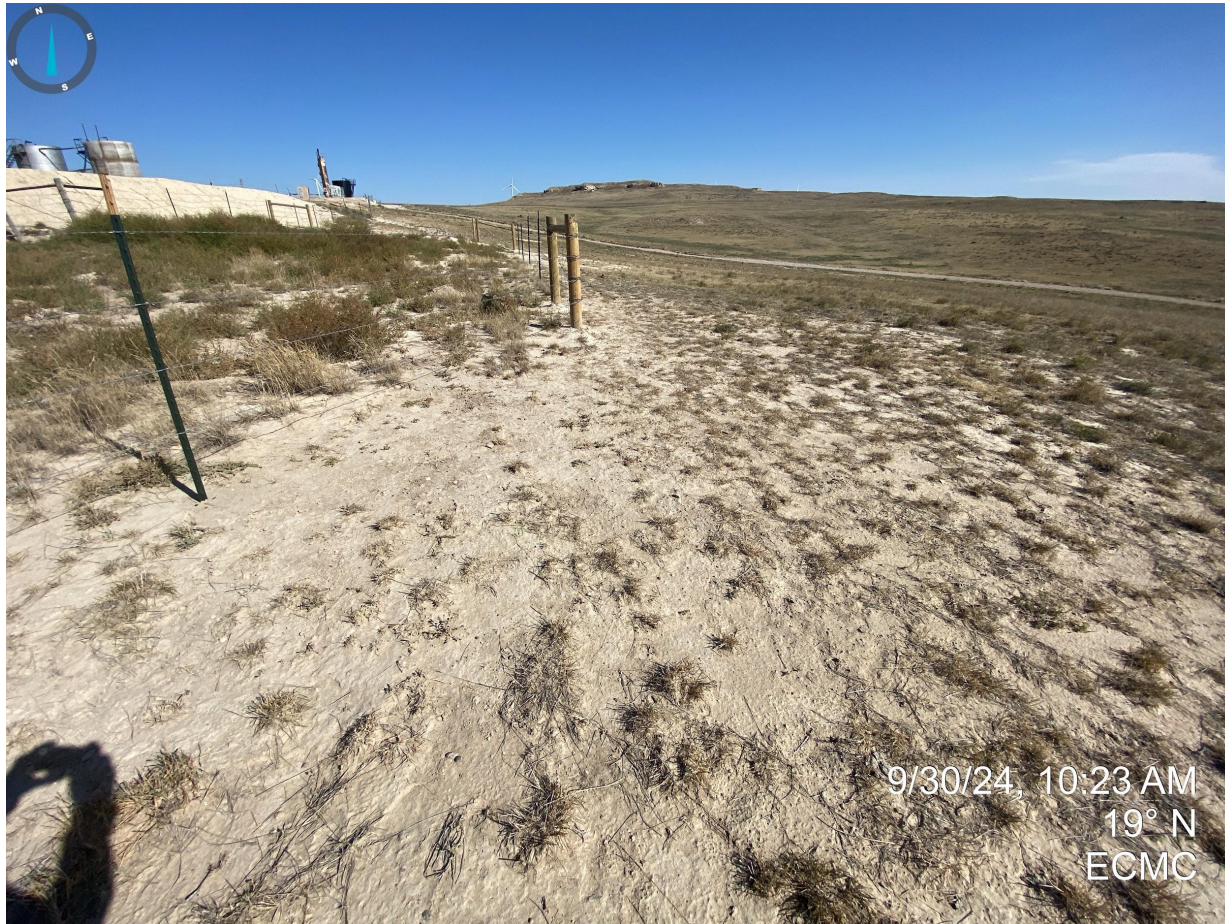
Photo 11. Taken southeast of the excavated area and stockpiled material; no apparent perimeter stormwater control measures and sediment deposition observed.

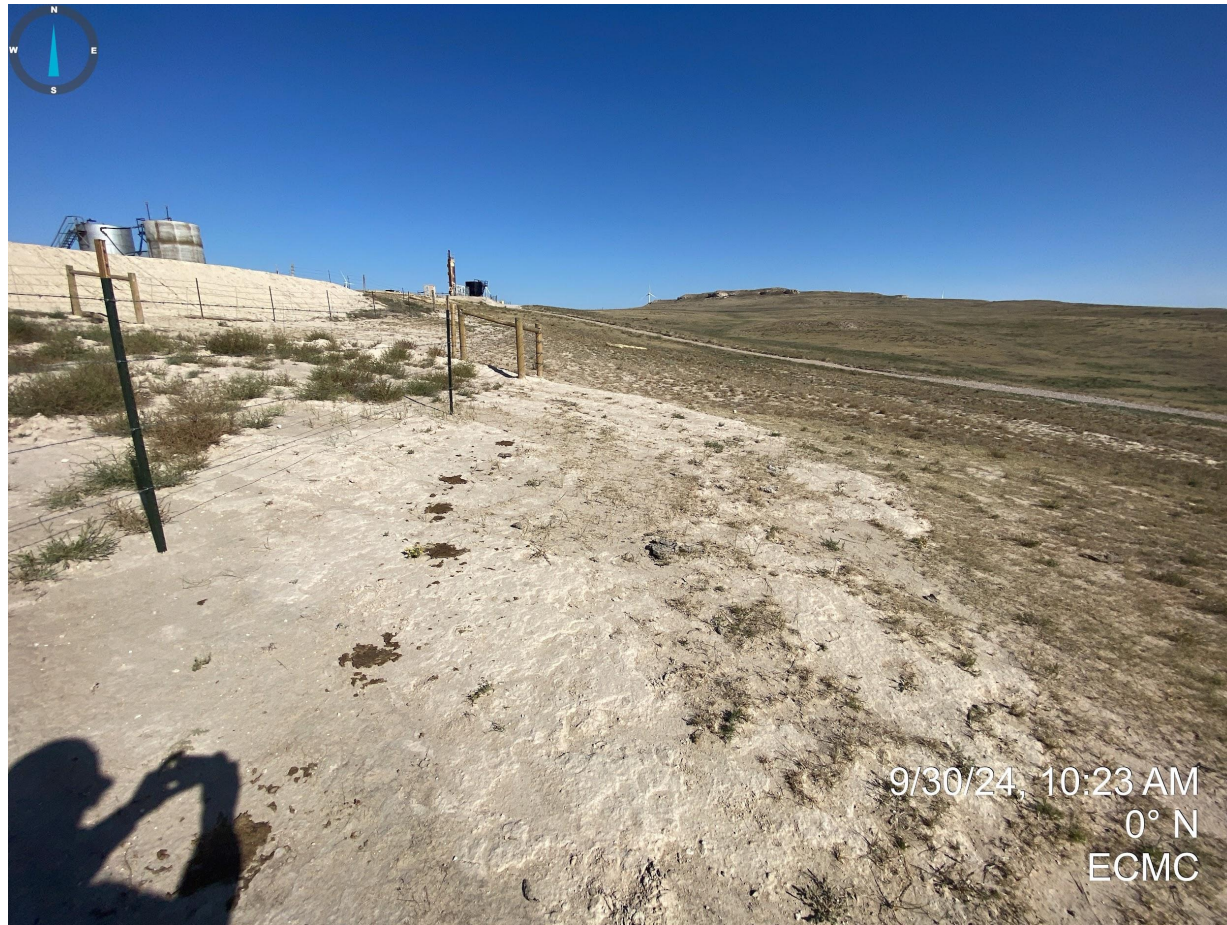
Photo 12. Sediment deposition resulting from unstabilized soils, southeast corner of the pit.

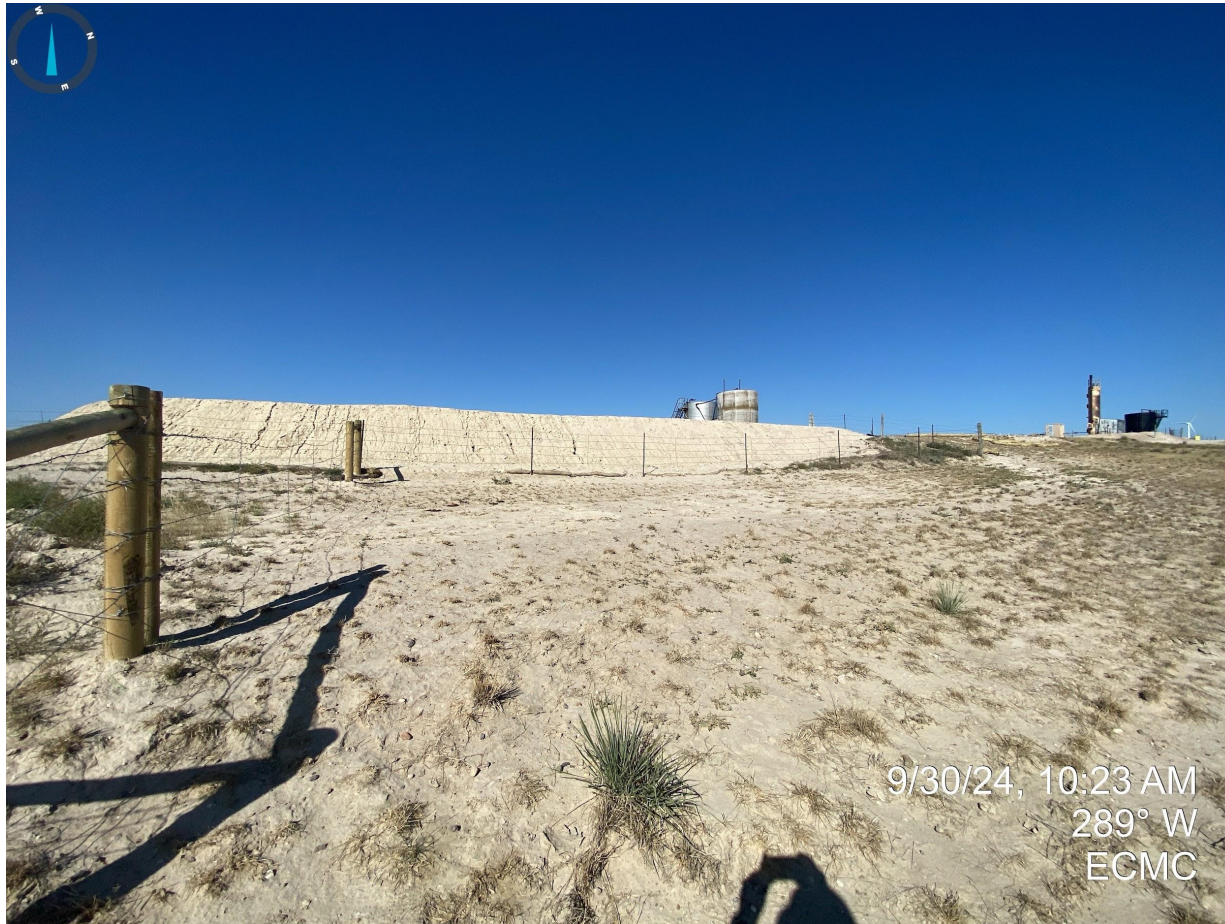
Photo 13. Sediment deposition resulting from unstabilized soils, eastern portion of the pit. Stormwater control measures remain inadequate.

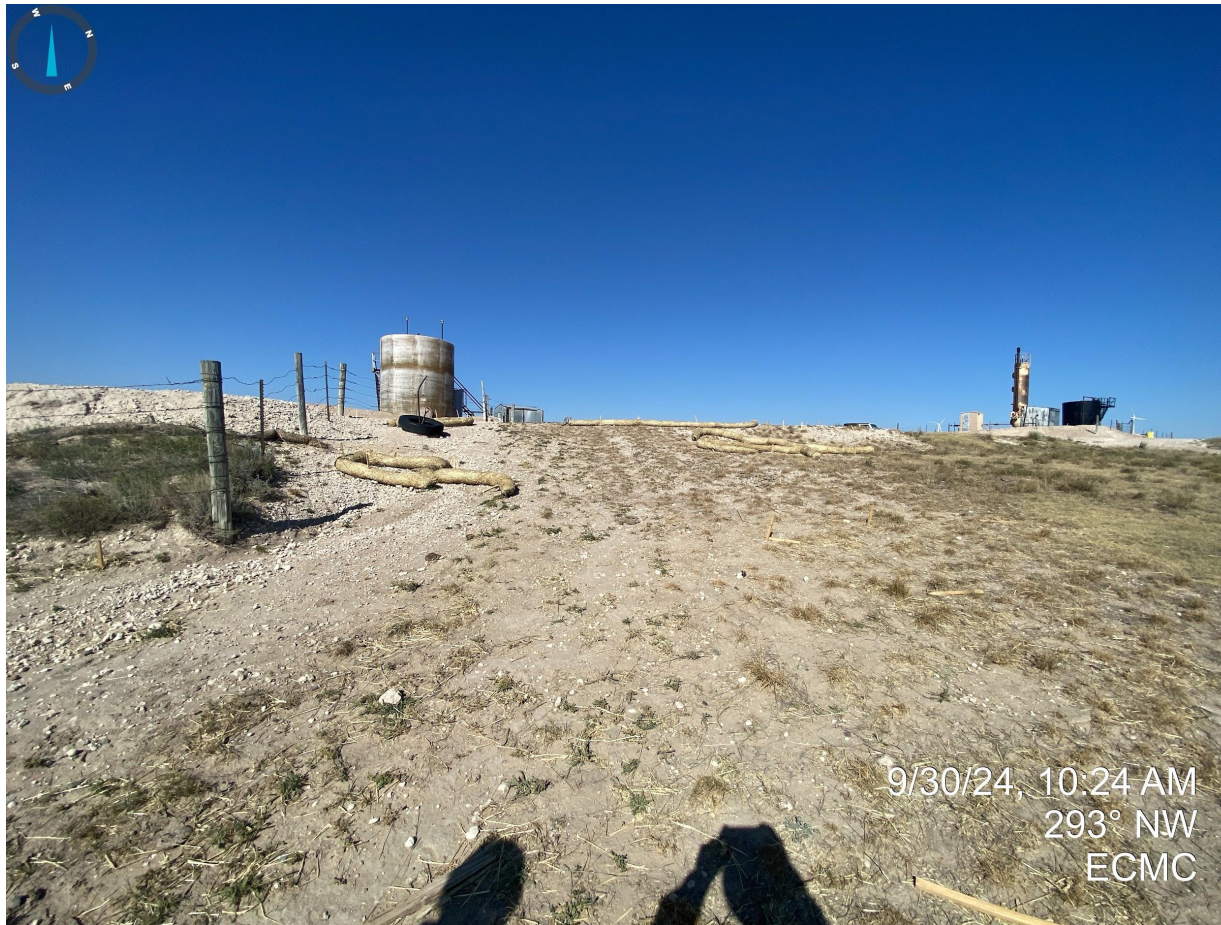
Photo 14. Erosion degradation occurring on the northern/eastern portion of the production areas, near the pit; stormwater control measures remain inadequate as they are not properly installed.

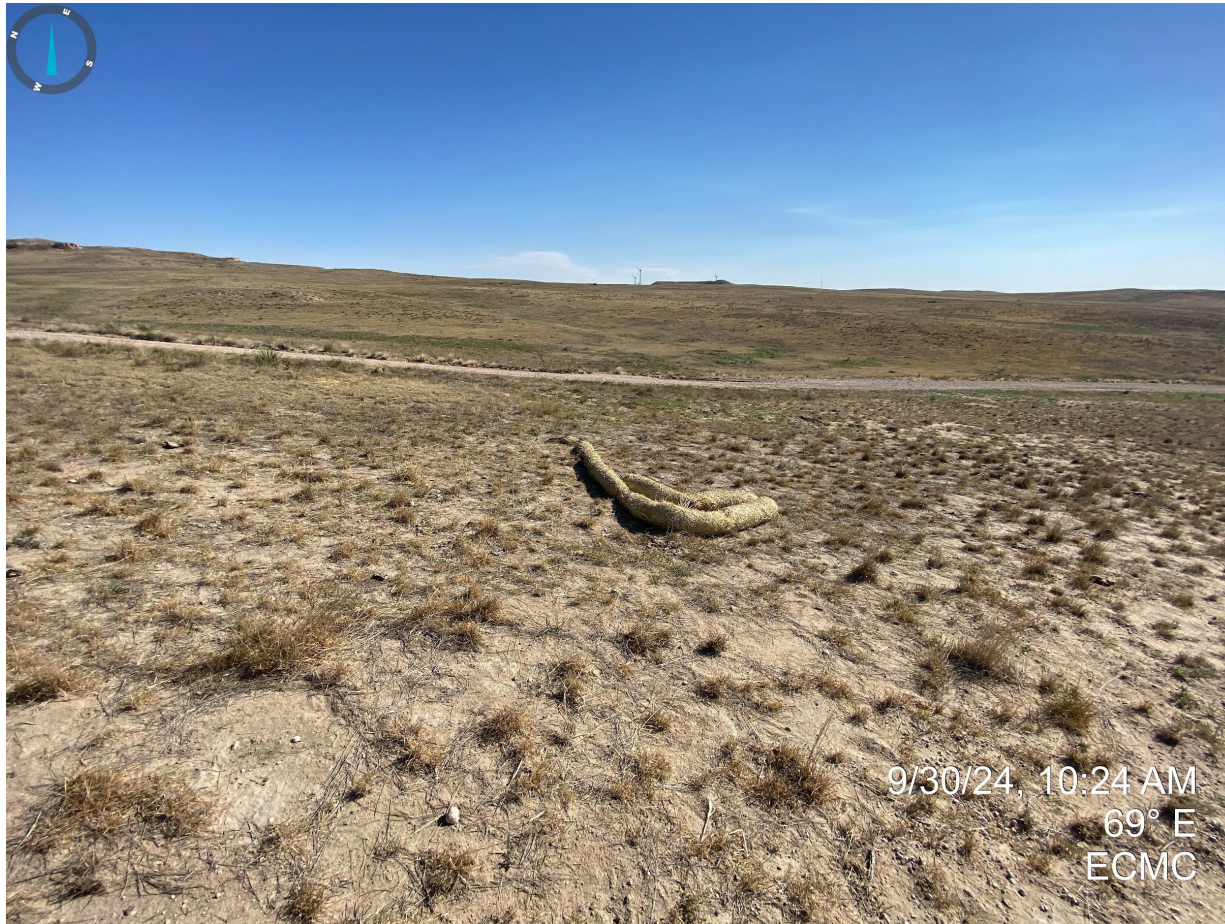
Photo 15. Straw wattle observed east of pit needs to be removed or reinstalled.

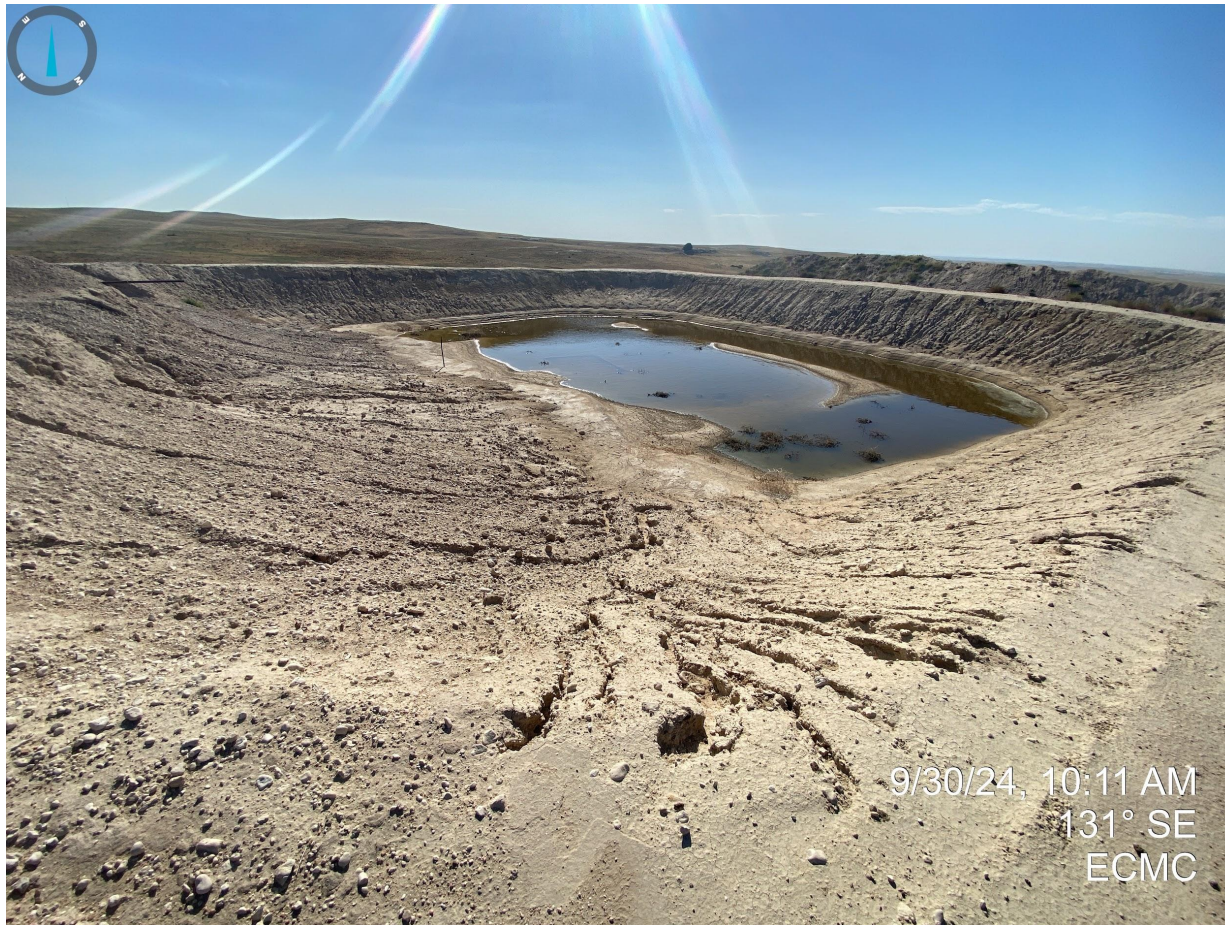
Photo 16. Erosion degradation observed within pit walls.

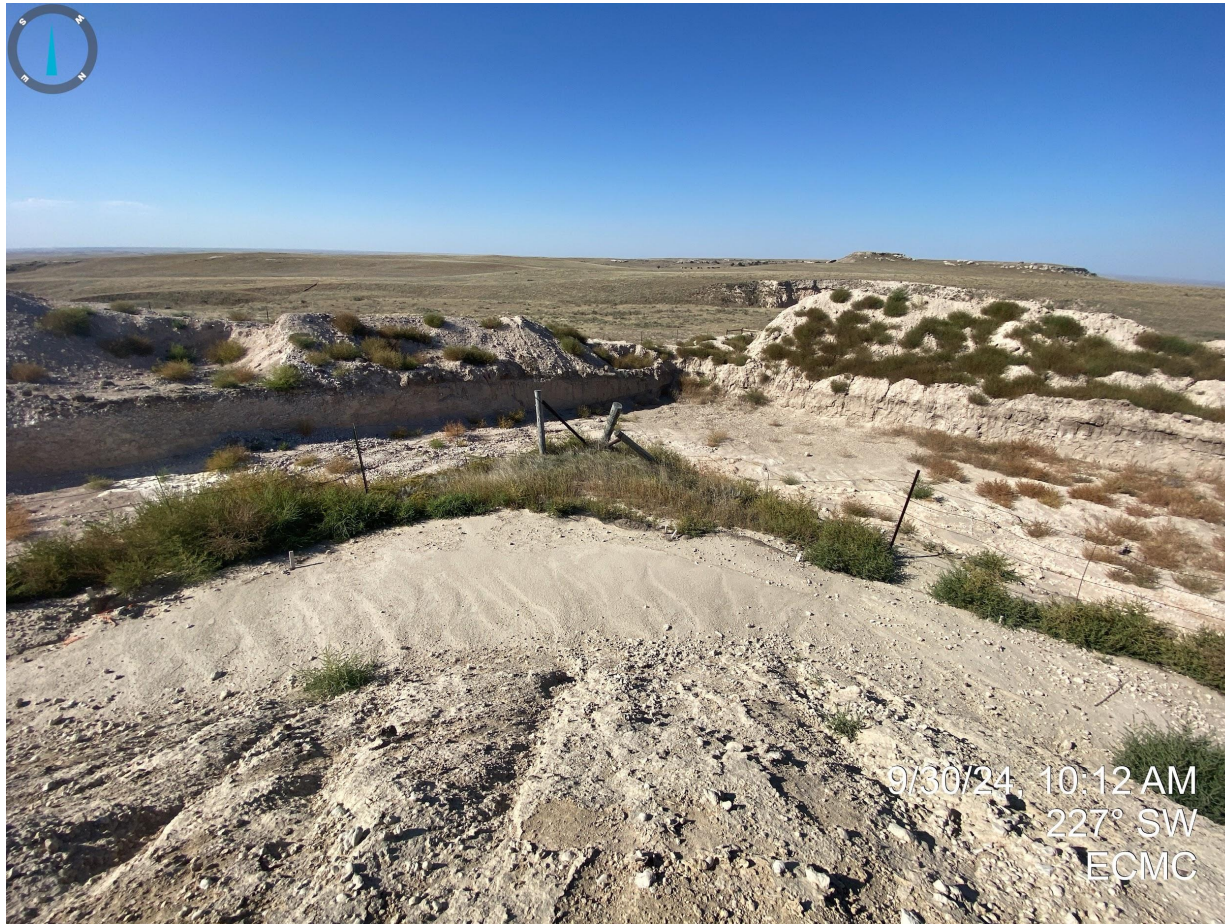
Photo 17. Erosion degradation and undesirable vegetation observed from the southwest corner of the pit, looking into the excavated area.

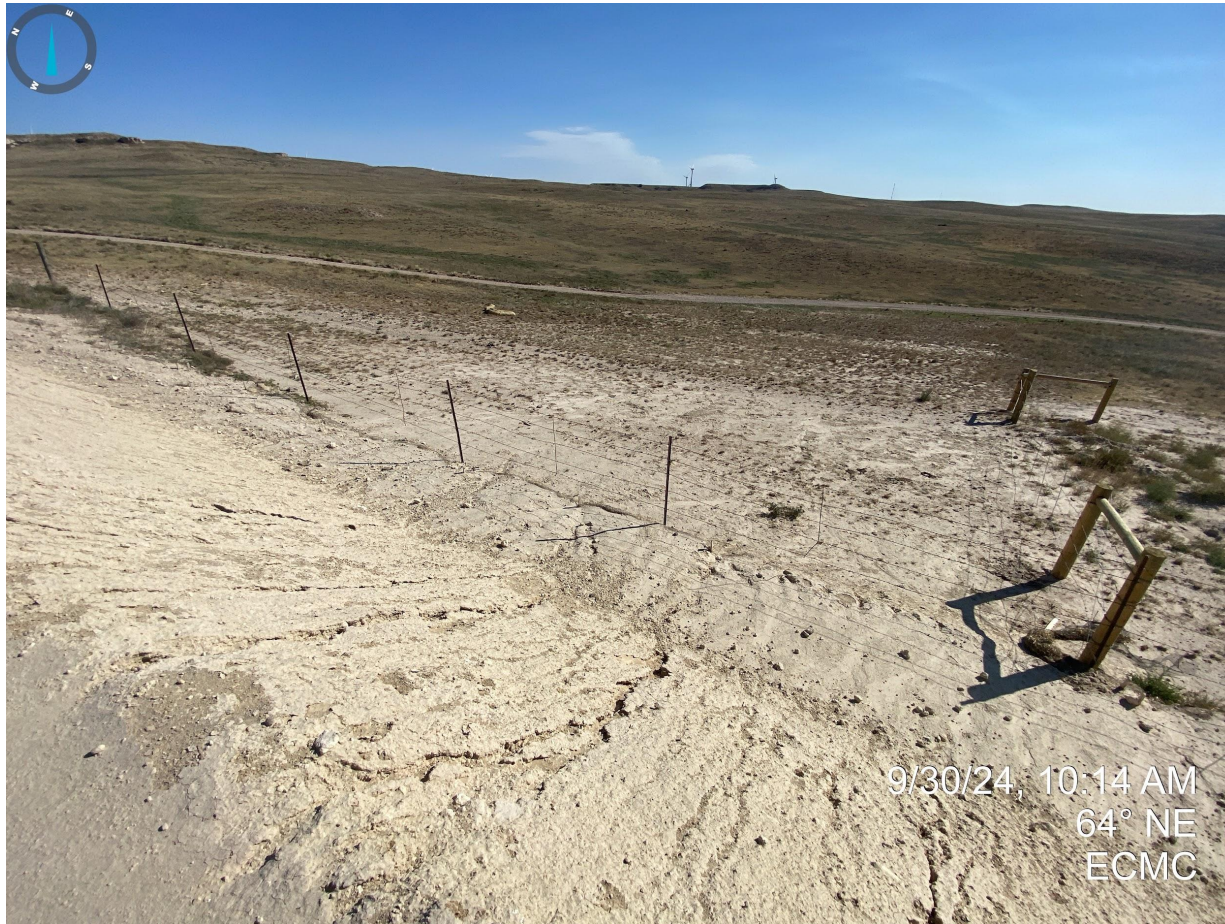
Photo 18. Erosion degradation on the eastern pit walls. This portion of the pit wall was recently repaired and is still experiencing erosion issues; soils remain unstabilized.
