# Interim Reclamation and Stormwater Inspection

Date: 09/30/2024

Operator: WESTERN OPERATING COMPANY - 95620

Location ID: 312228

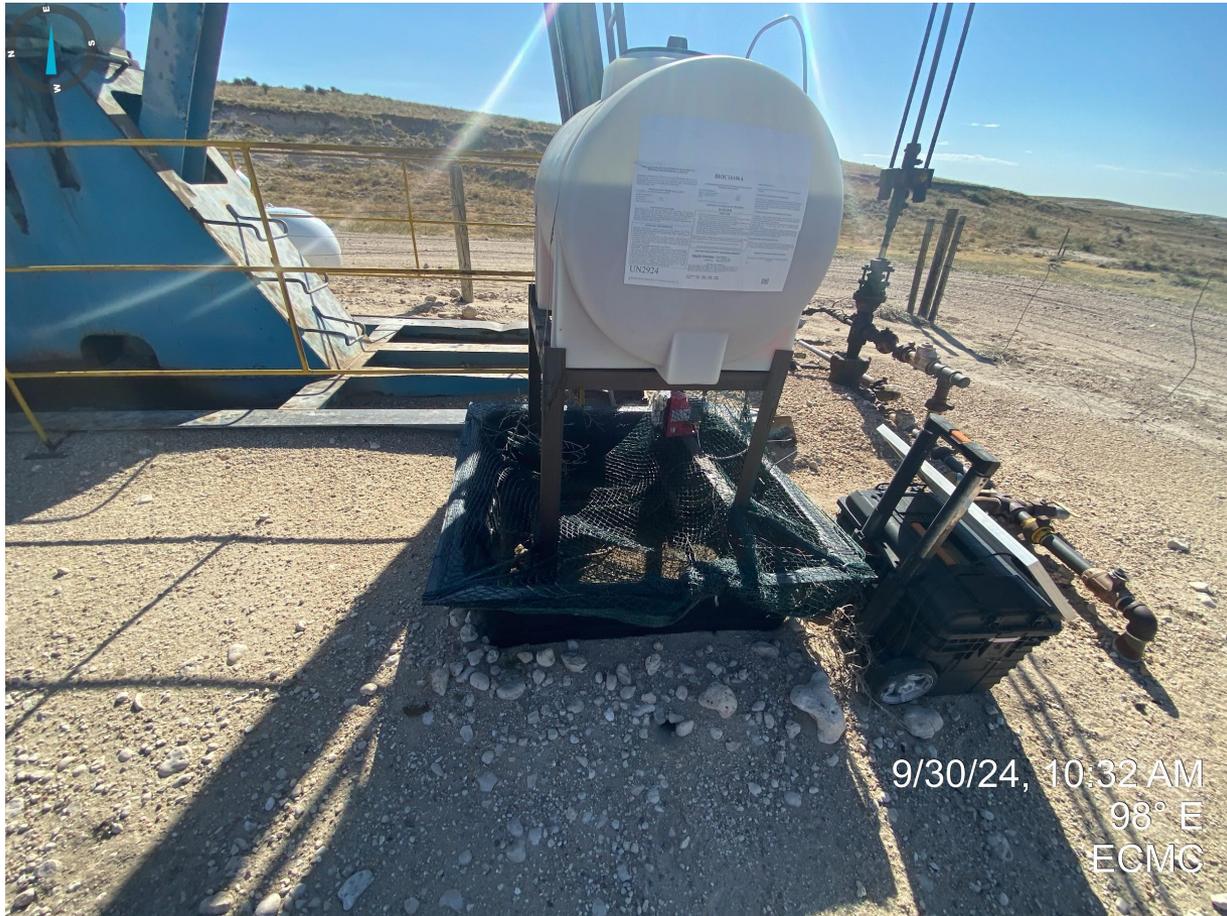
**Photo 1.** Wildlife netting has been installed around secondary containment. NFPA Placard does not appear to have been installed since the previous inspection.

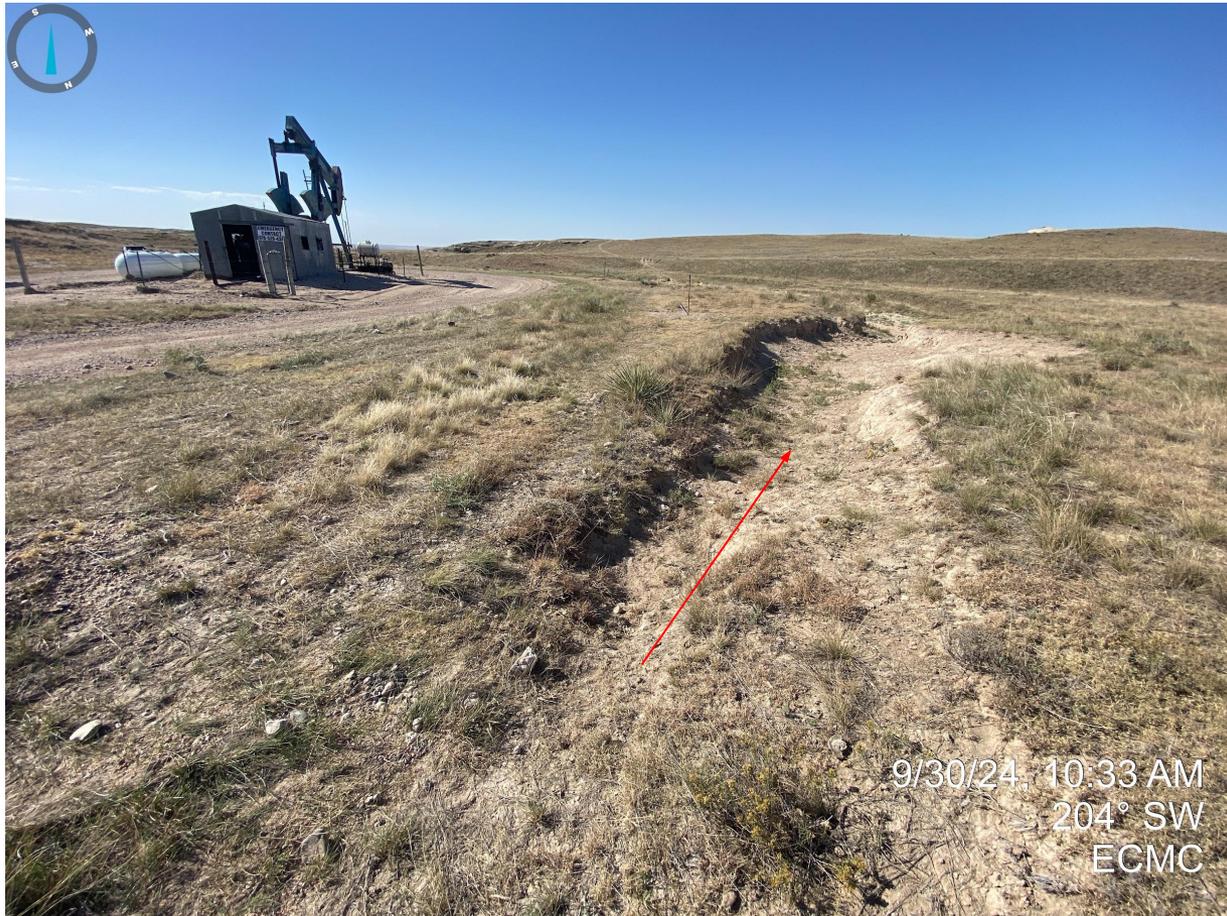
**Photo 2.** Erosion degradation evident on the western portion of the production areas. No apparent stormwater control measures/BMPs observed at the time of this inspection.

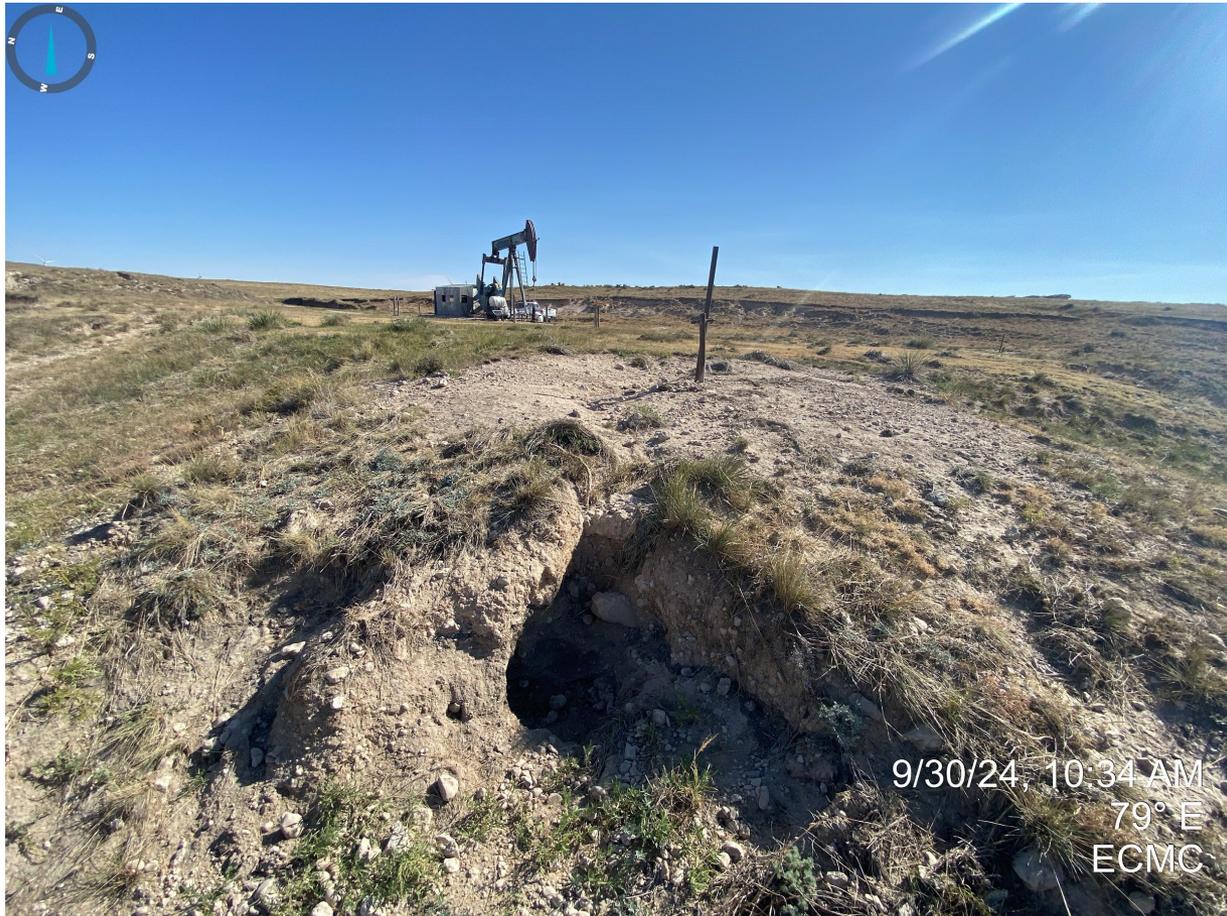
**Photo 3.** Erosion degradation evident on the southwestern portion of the production areas. No apparent stormwater control measures/BMPs observed at the time of this inspection.

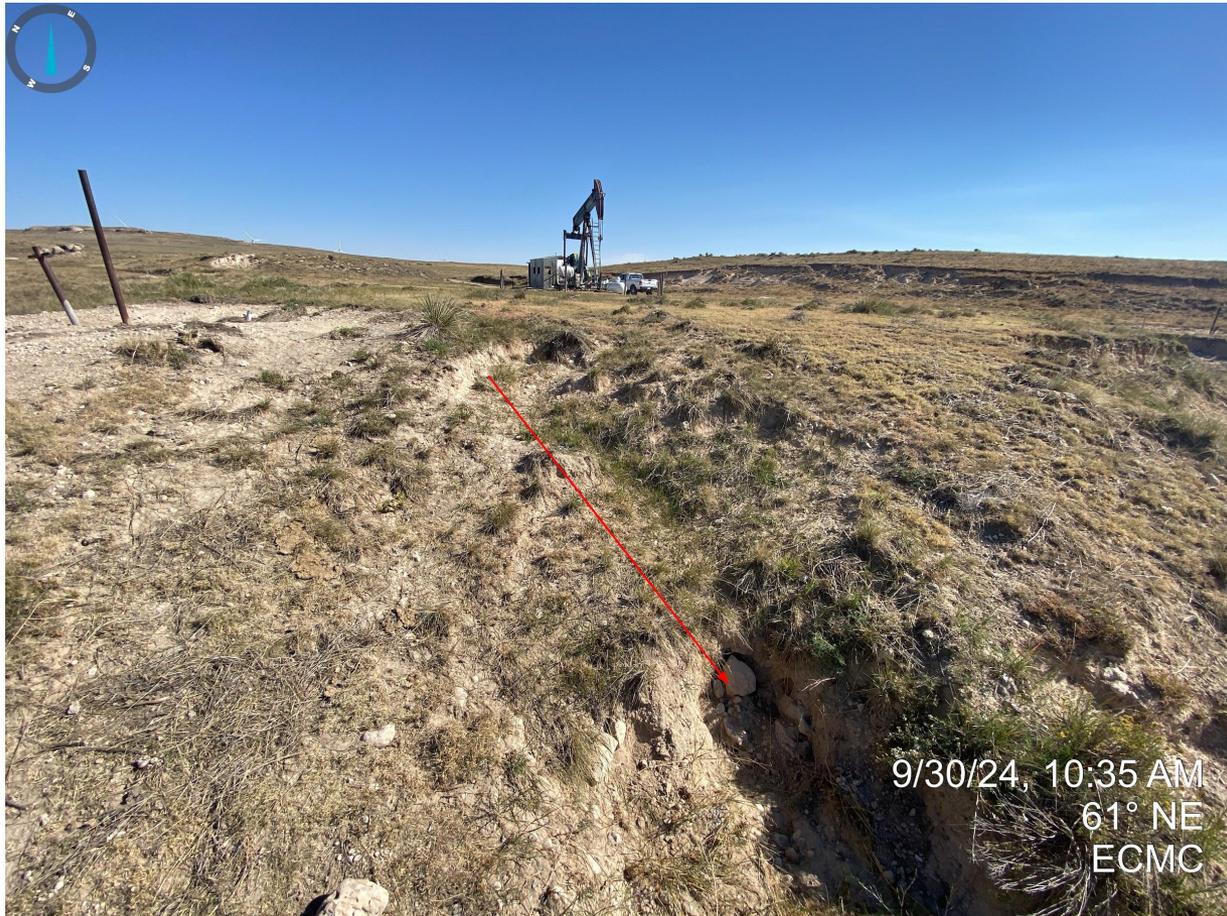
Photo 4. Continued from Photo 3.

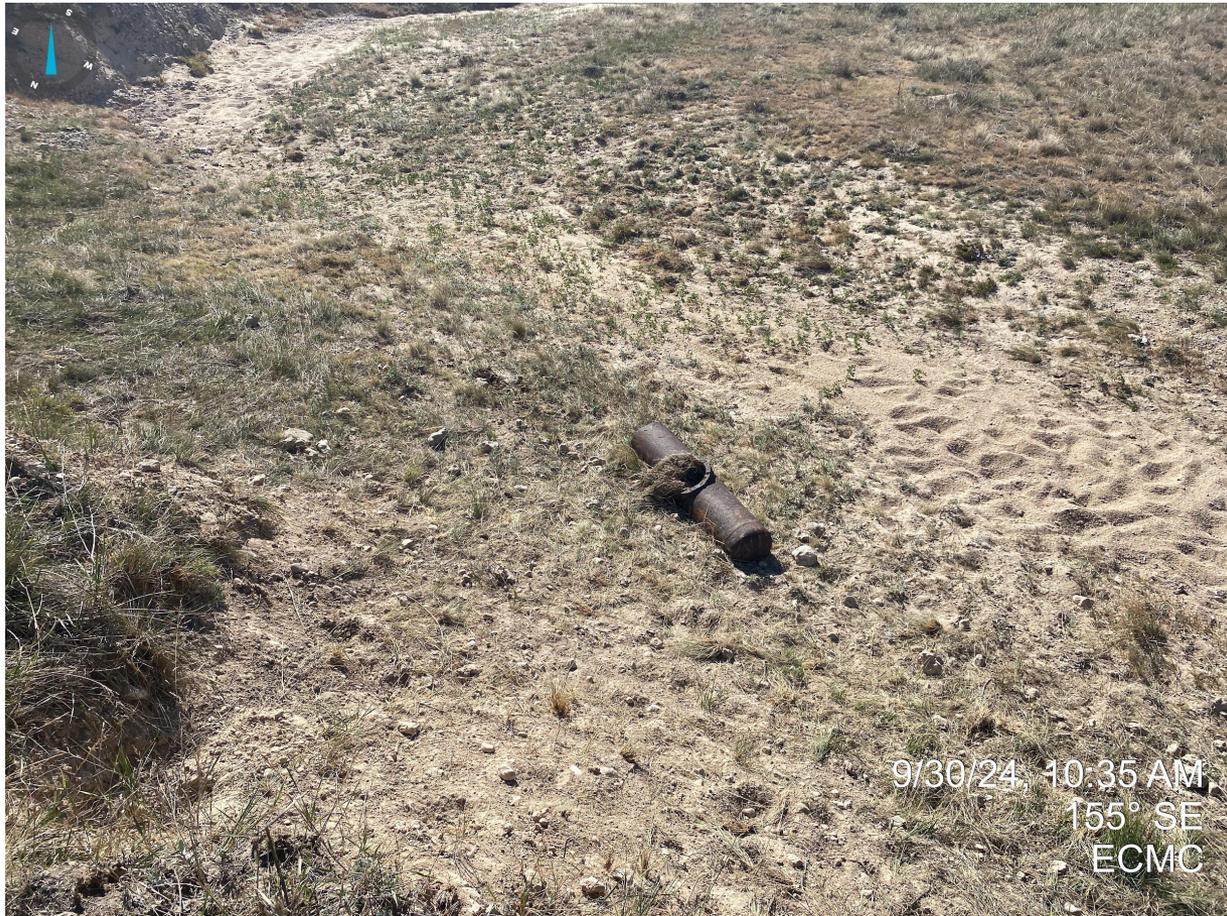
**Photo 5.** Pipe (debris) remains from the previous inspection; south of the well location in nearby drainage.

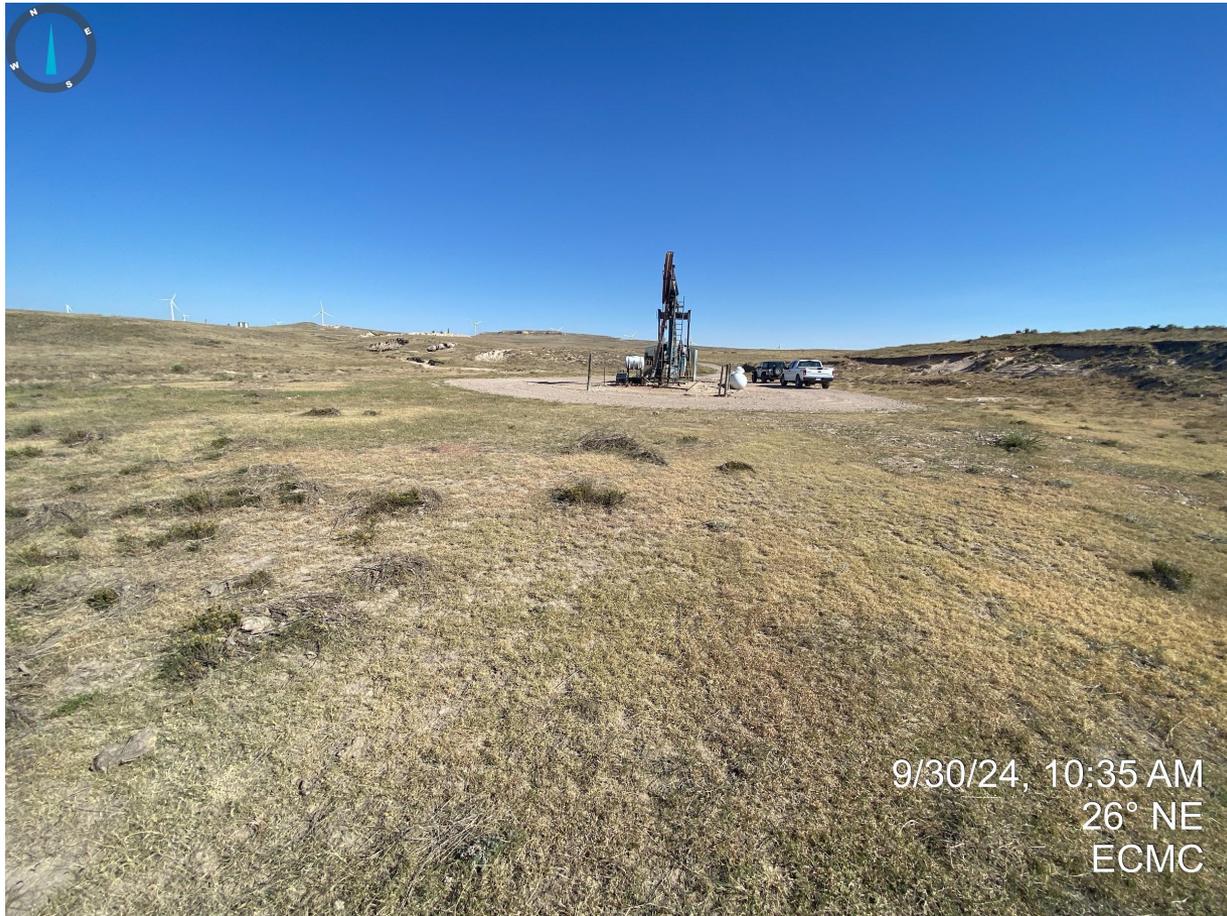
**Photo 6.** South of the well, interim areas appear to be progressing towards Rule 1003 vegetative standards.

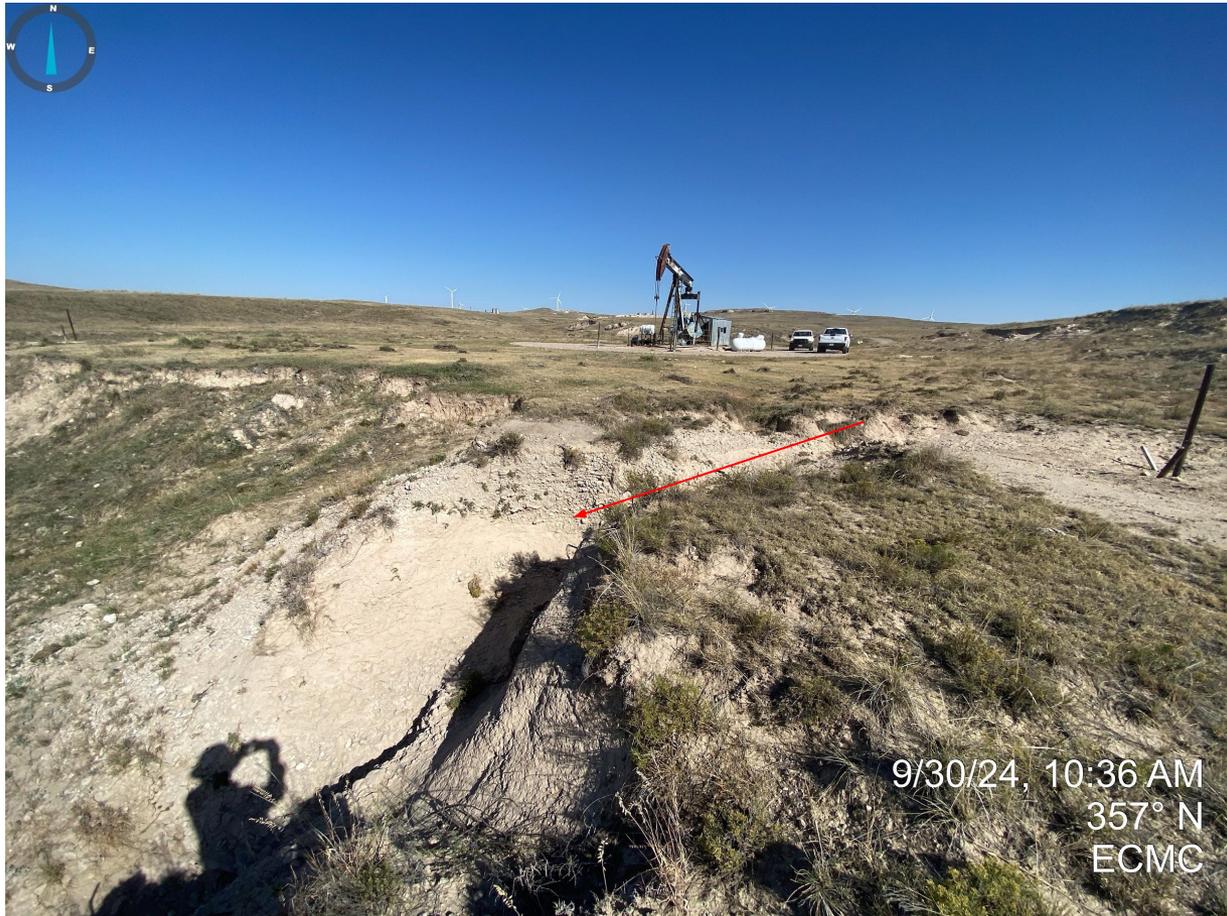
**Photo 7.** Erosion degradation evident on the southeastern portion of the production areas. No apparent stormwater control measures/BMPs observed at the time of this inspection.

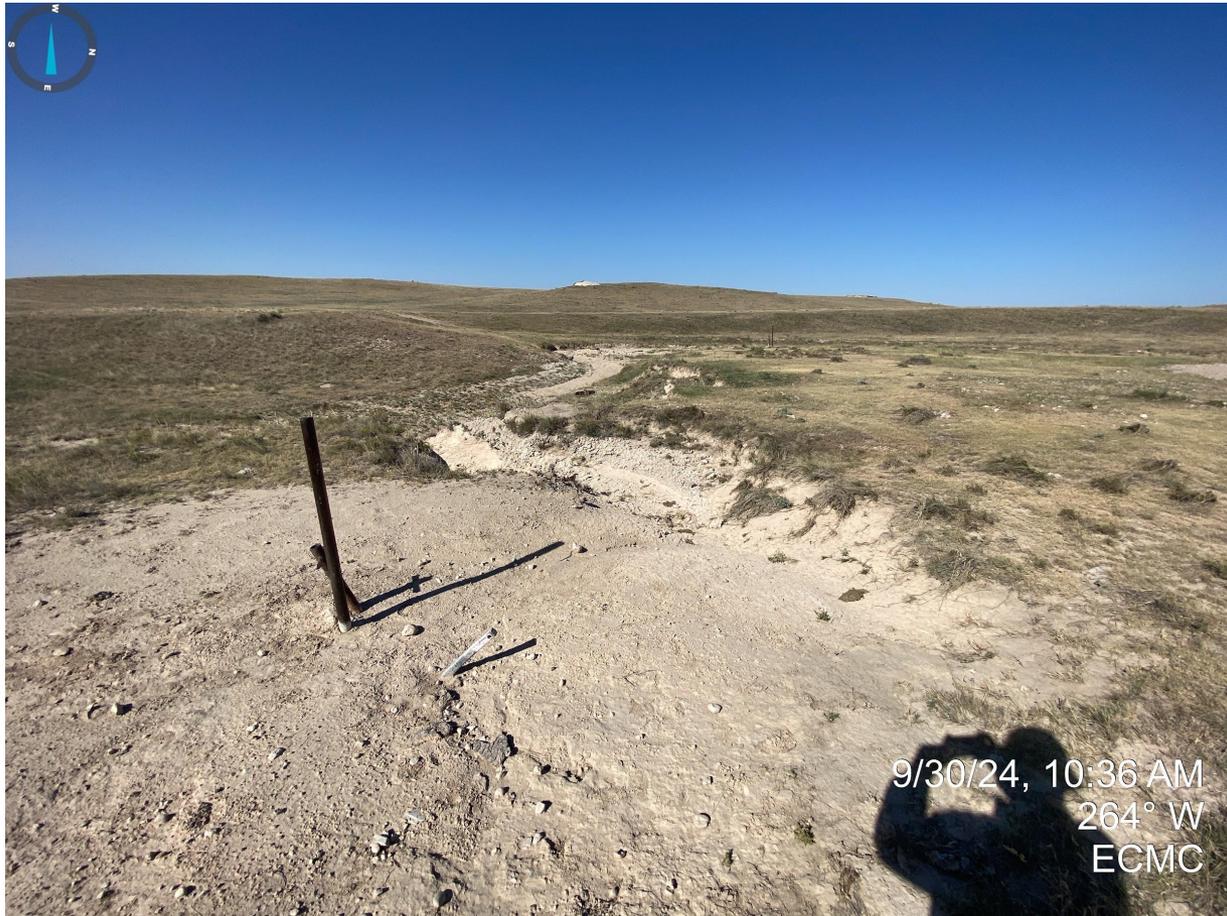
**Photo 8.** Continued from Photo 7.

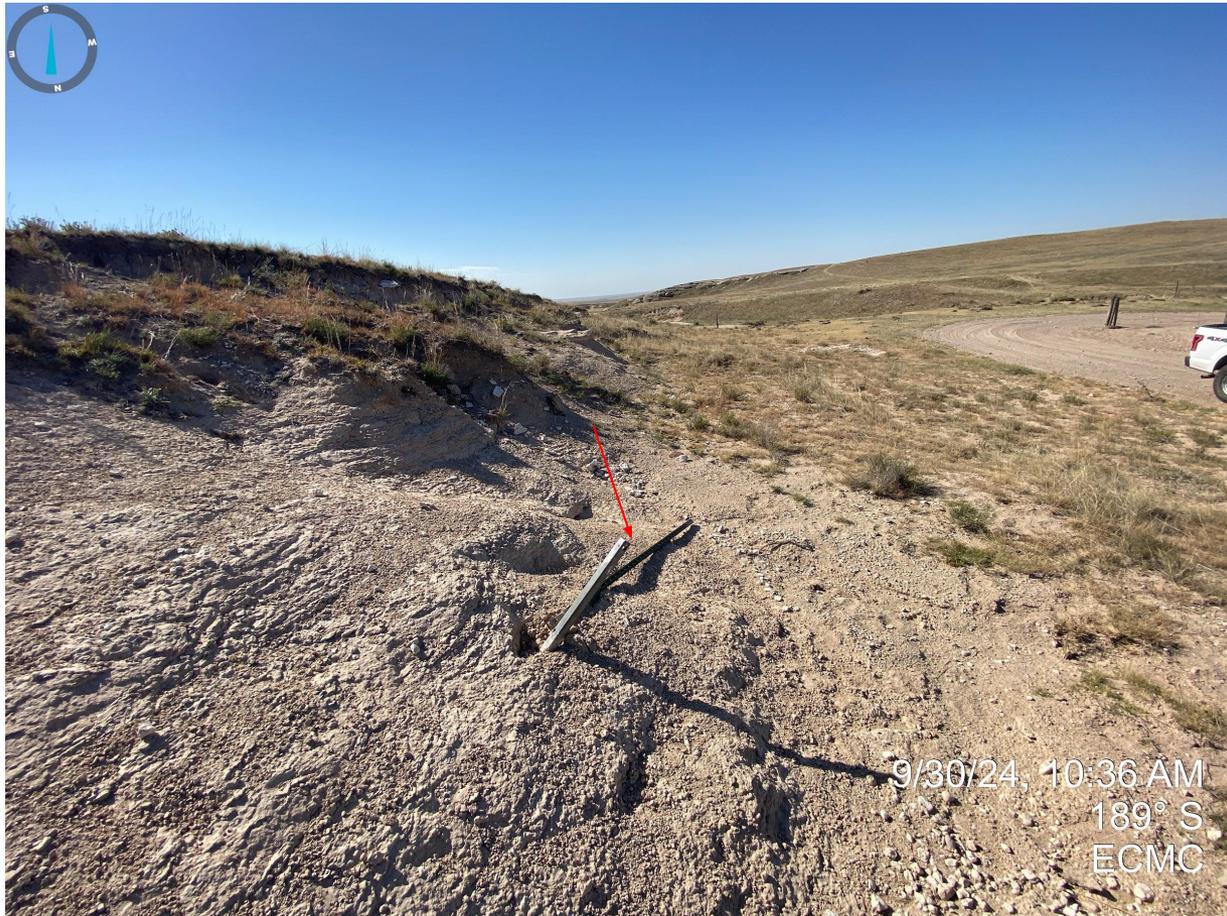
**Photo 9.** Northeastern guyline anchor maker needs to be reinstalled.
